EVALUATION OF PERFORMANCE OF TAIWAN HOUSING STOCK AND SCHOOLS DURING THE $M_w6.4$ KAOHSIUNG/MEINONG EARTHQUAKE OF FEBRUARY 6, 2016

Ramon Gilsanz, Cathy Huang, Jessica Mandrick, Joe Mugford
Gilsanz Murray Steficek LLP (GMS)
New York, N.Y. USA

Shyh-Jiann Hwang, Tsung-Chih Chiou
National Center for Research on Earthquake Engineering (NCREE)
Taipei, Taiwan

Abstract

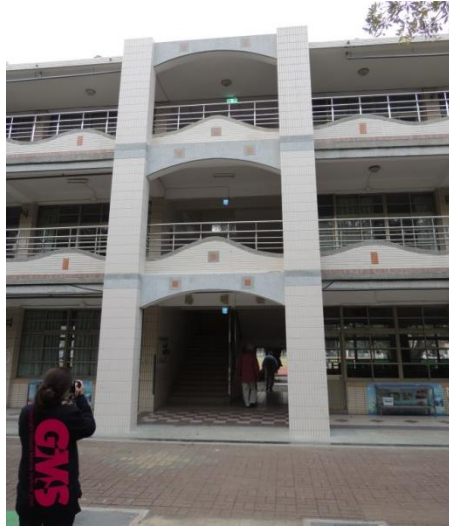
The performance of school buildings in Taiwan after the Meinong earthquake, further verified the assessment method and retrofit schemes of the school retrofit program supported by NCREC is successful and accurate (Figures 6 and 7). In the Tainan area (near the event epicenter), none of the 58 retrofitted schools were observed to have structural damage. Eighteen of the 85 (21%) school buildings earmarked for retrofiting were observed to have severe damage. Of the school buildings that passed the screening evaluation, only 1 of the 158 (0.6%) buildings was found to suffer severe damage (Figure 8).

Figure 6: Guiren Middle School Retrofitted with Added Moment Frame (Minor Damage)

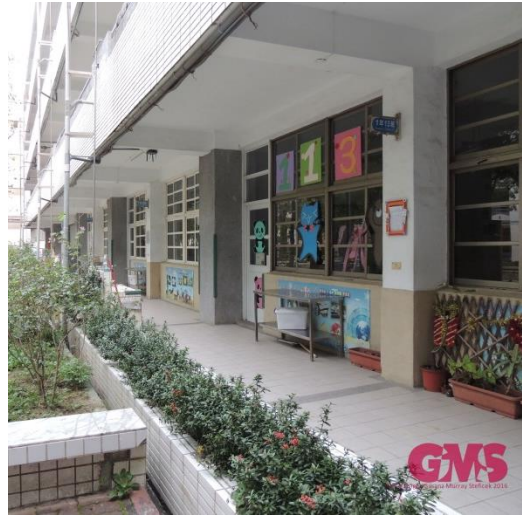
Figure 7: Guiren Middle School Retrofitted with Jacketed Column (No Damage)

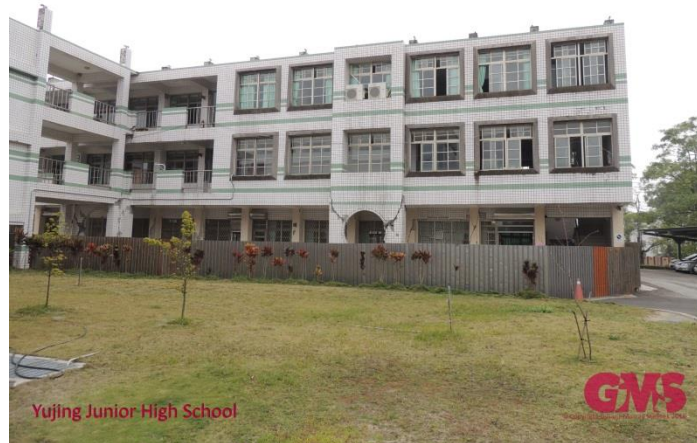
Figure 8: Yujing Junior High School Not Retrofitted (Severely Damage)

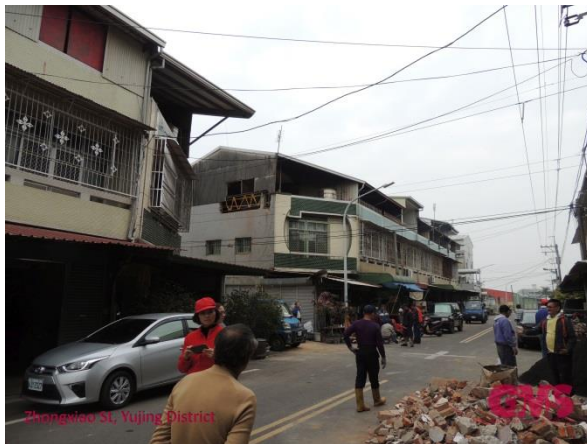
Figure 9: Case Study I, Yujing district “street house”

Case Study I. Multi-family street house in Yujing District with six bays parallel to the street (Figure 9).

Case Study 1 (Interior shear wall failure observed)	35cm x 35cm and 20cm x 35cm	ASSUME TYPICAL	ASSUME TYPICAL	20 cm	20 cm	ASSUME TYPICAL	ASSUME TYPICAL	CFR=.00577 Ap= 0.242 At=0.28 E= 0.867 Is=0.82<1
Case Study 2 (Exterior column failure observed)	19" x 20" 48cm x 51cm 12"x12" stirrups 30x30cm	2.2%	ASSUME TYPICAL	#3@9"o.c. (23cm)	10" (25cm)	ASSUME TYPICAL	ASSUME TYPICAL	CFP=0.0016 Ap=0 E=0 Is=0

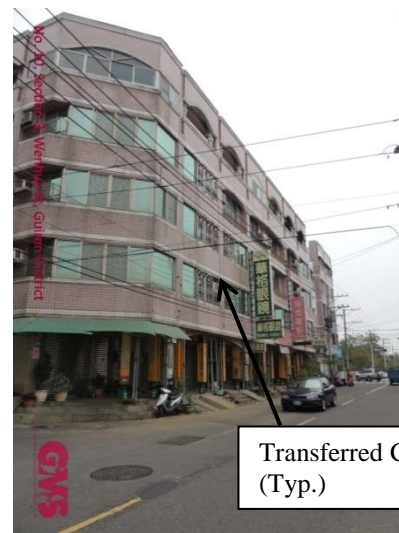
Figure 10: Case Study II, Guiren Tainan “street house”

Case Study II. Multi-family street house in Tainan’s Guiren District with twelve bays parallel to the street and five transferred columns at the first floor level (Figure 10).

Transferred Column (Typ.)
