The Kumamoto, Japan Earthquake of 2016: Summary of Observations and Key Lessons

U.S. – Japan – New Zealand
Workshop on the Improvement of Structural Engineering and
Resiliency
Nara, Japan – June 27-29, 2016

The Kumamoto Earthquake Investigation: A Preliminary Report

April 29, 2016

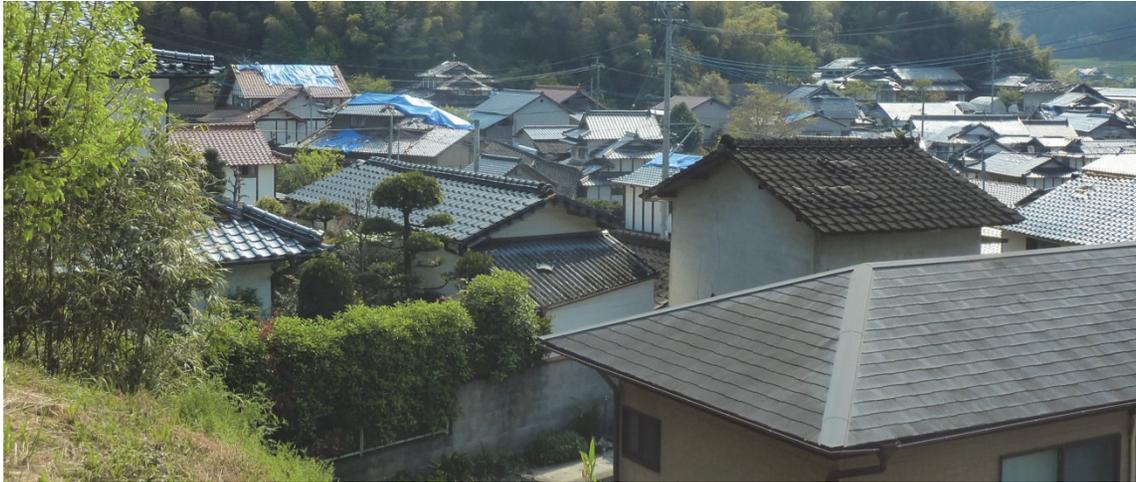
A residential area at the foot of the hills in the Town of Mashiki. All of the damaged houses are wood-frame construction.

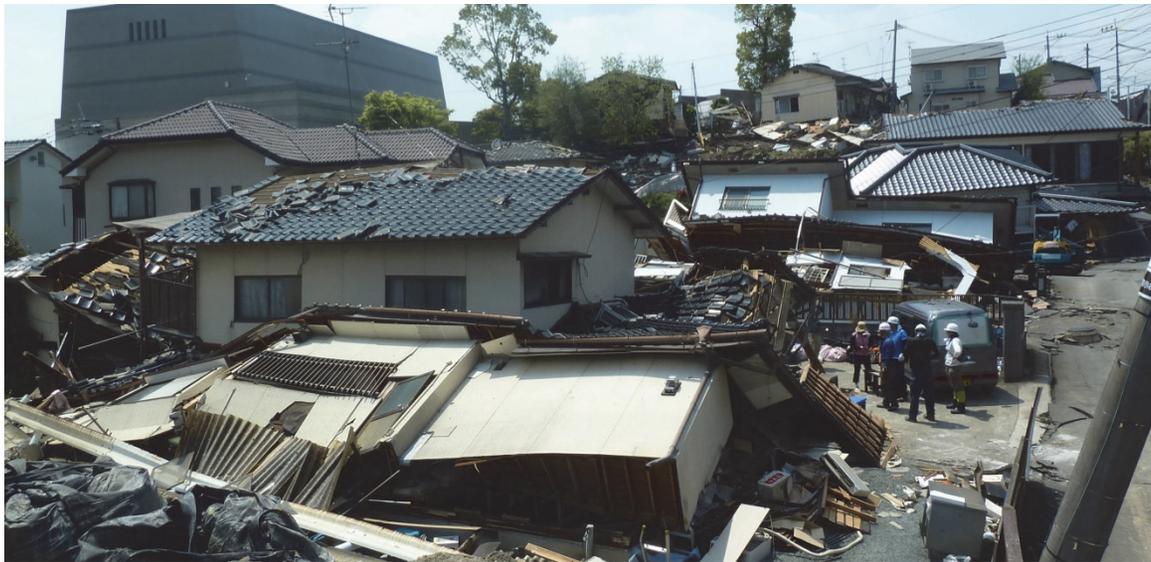
A heavily damaged residential area of Mashiki. All of the houses in the photo are wood frame; most are relatively new.

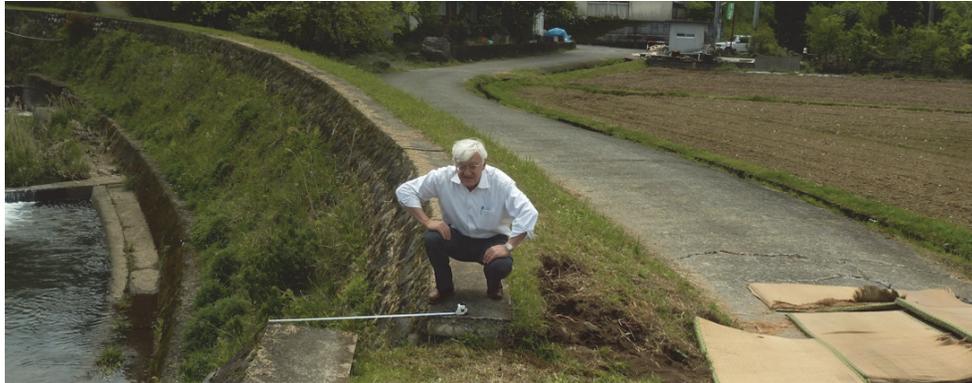
Along the Futagawa fault through a hilly residential area of Mashiki. Here the fault has offset a retaining wall by about 4 feet (1.2m). Houses right on top of the fault were typically completely destroyed. Nearby wood frame houses, not directly on the fault, had various degrees of structural damage – from light to extreme, including many collapses.

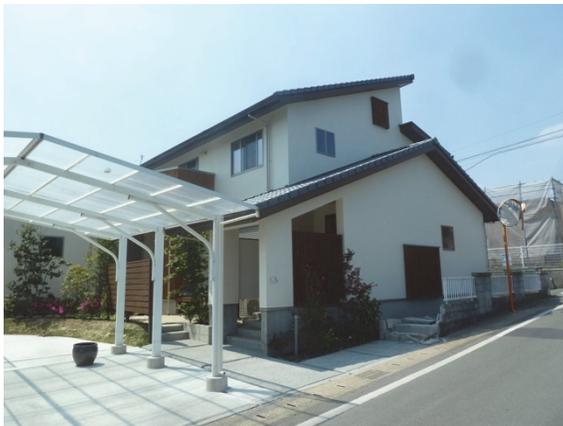
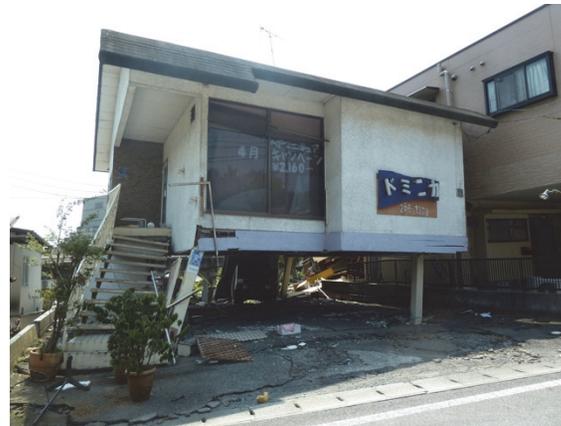
On the left is a practically undamaged house, which is not far away from the severely damaged house on the right. The difference in performance is primarily due to lack of bracing in the garage in the house on the right. Note the unbroken window on the second floor.

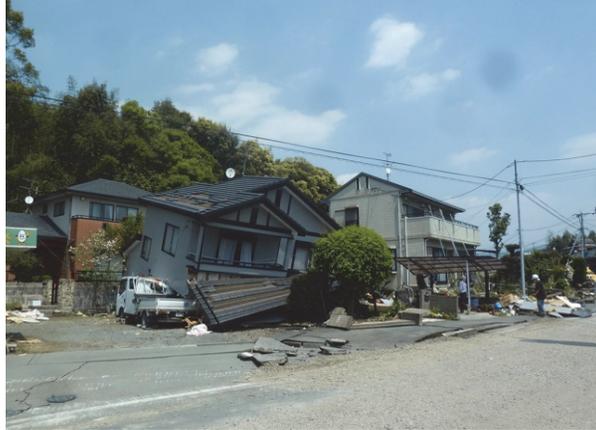
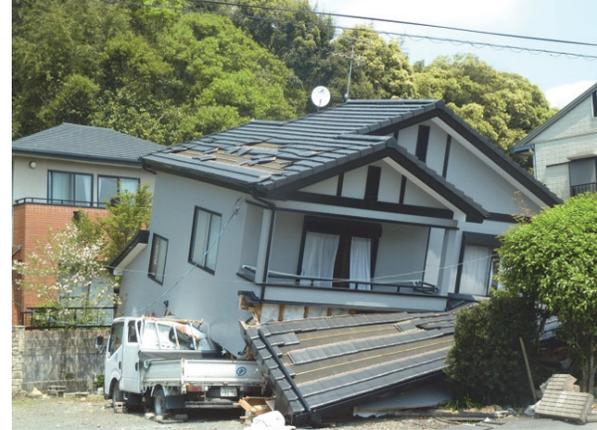
Another house with too many openings (windows) and not enough walls on the ground floor. Note the relatively undamaged houses behind and on the right of the collapsed house.

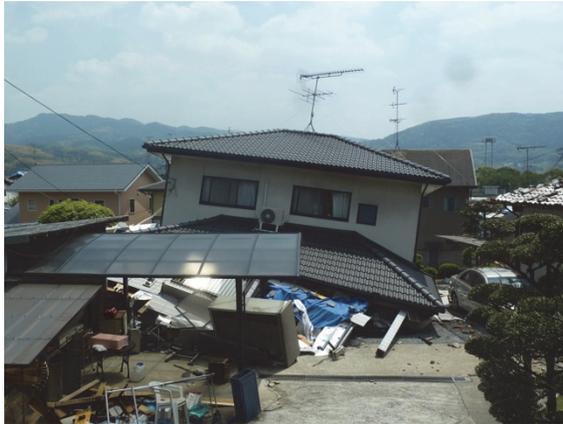
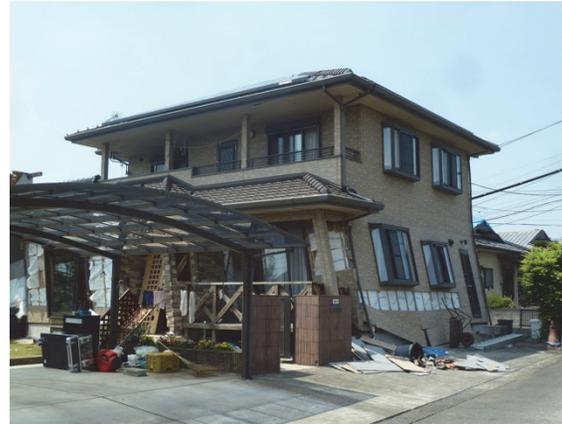
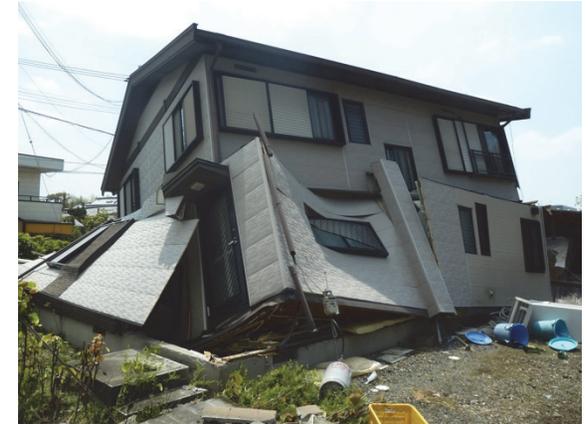
Other severely damaged houses in Mashiki. Most of the damage that occurred was due to inadequate strength in the lower floor walls, including too many windows. That additional strength can be easily provided by adding bracing with a few more well-nailed plywood sheets.

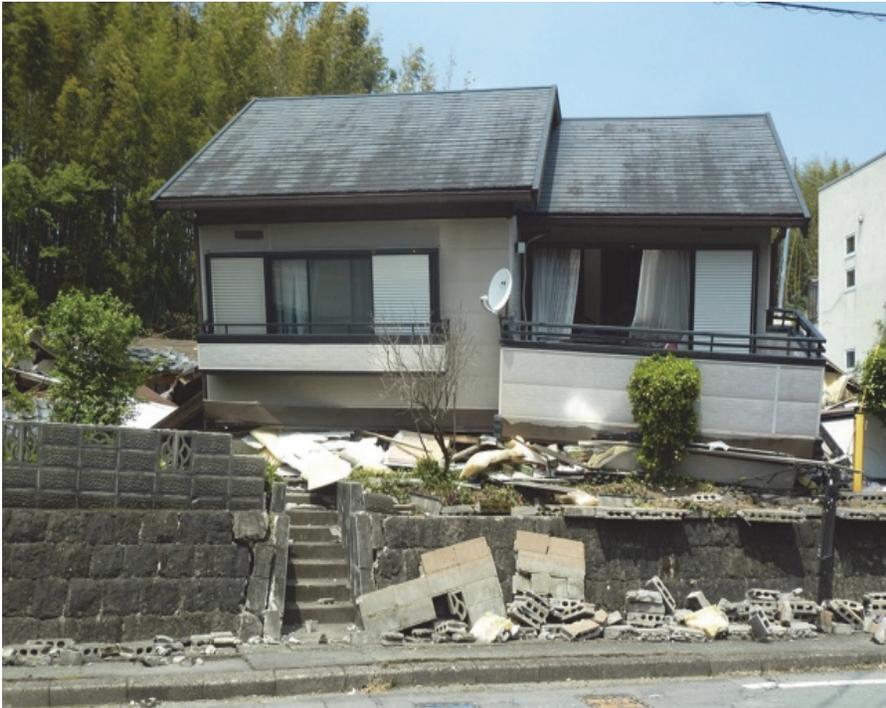
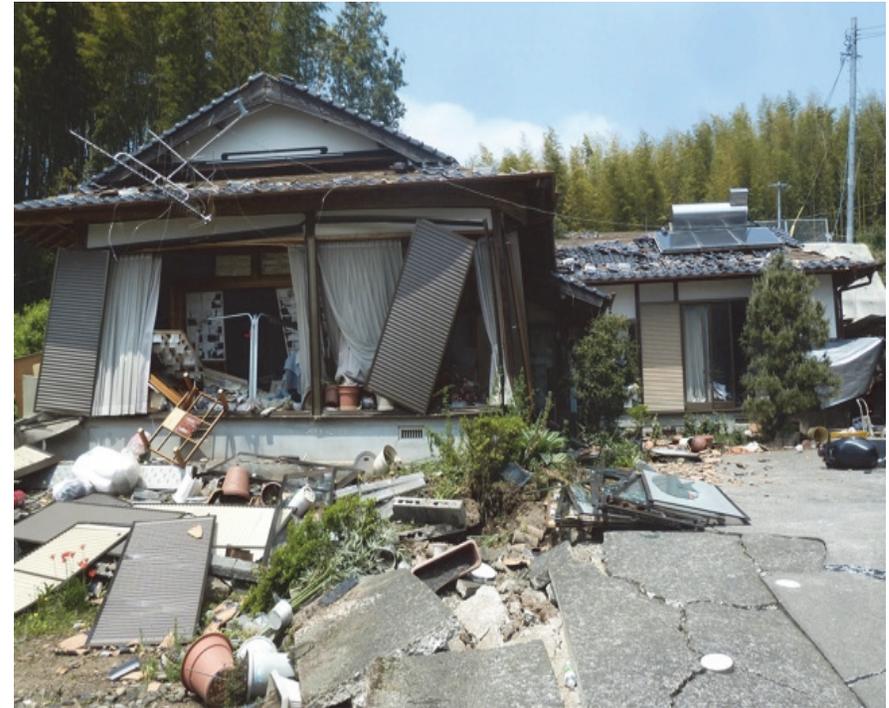
Much of the damage to houses in the hills was also due to ground failures around the house foundations. This was caused by minor local land sliding and/or the slumping of inadequately compacted fills around the houses. These types of fills are necessary to create level pads for the house foundations, and is the common practice along the West Coast of the U.S. and Canada. The extent of such failures in Mashiki was surprising. The likely cause of this unusually high damage is the very strong shaking in the immediate vicinity of the fault.

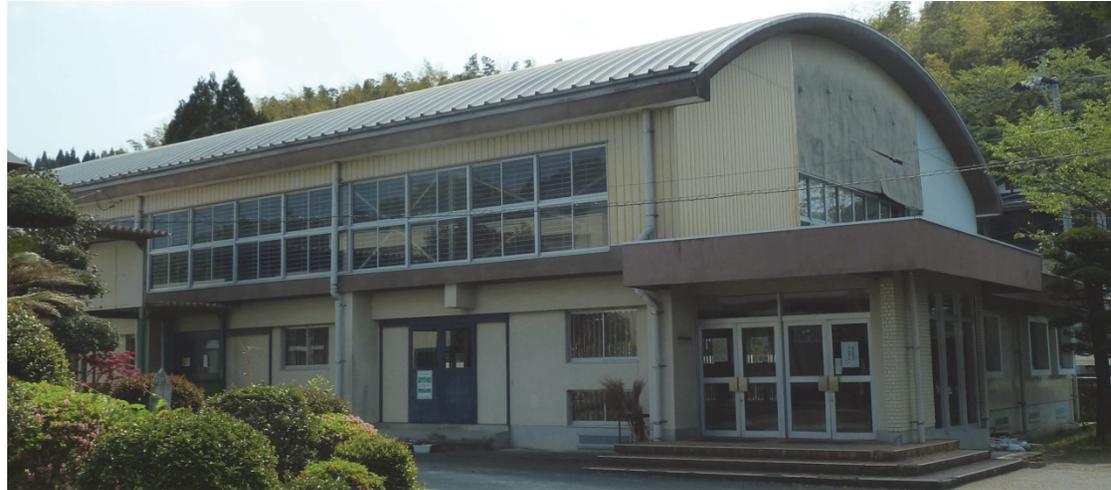
The Tsumori Elementary School gym. One quick look at the building, and adequate familiarity with school earthquake strengthening programs in Japan and around the world, was sufficient for me to realize that this school had been strengthened for earthquakes after it was originally built (well before the more recent earthquake code standards). The steel X-braces (behind the second floor windows and inside the gym) are used often in Japan and elsewhere for strengthening.

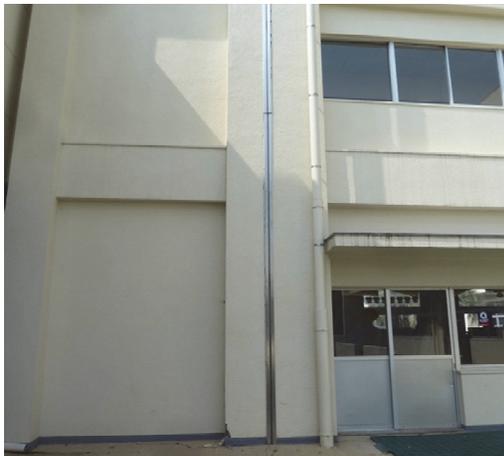
Another obvious strengthening detail - note that the two story solid concrete wall has been added to strengthen the original school. It replaced the windows that were there in the original design. This "shear wall," which adds strength, is a common retrofit detail and works well for this type of concrete-frame construction.

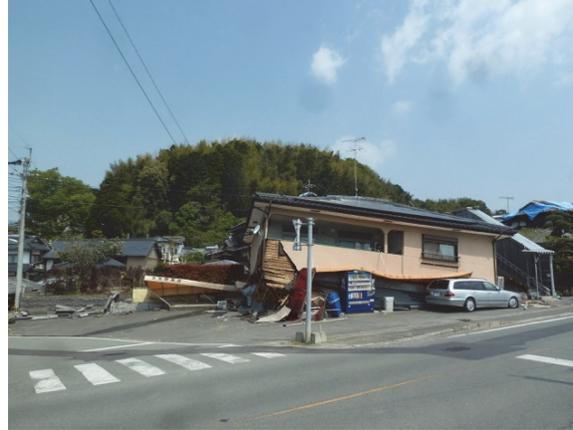
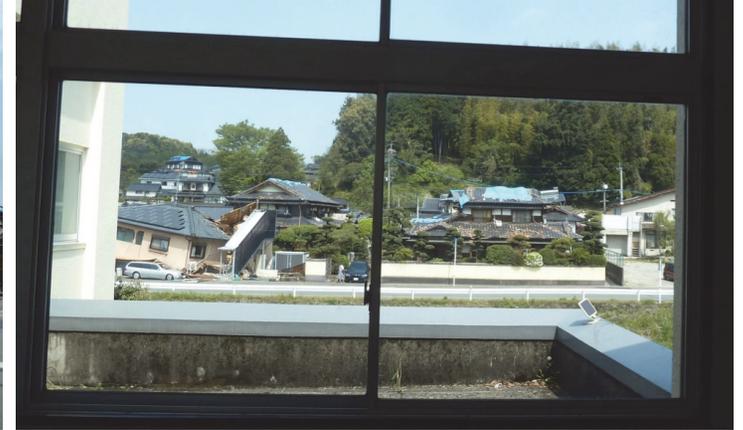
Views of collapsed buildings around the school. The bottom photograph is from inside a classroom, looking at a collapsed small commercial building across the river (also shown in the left photo above).

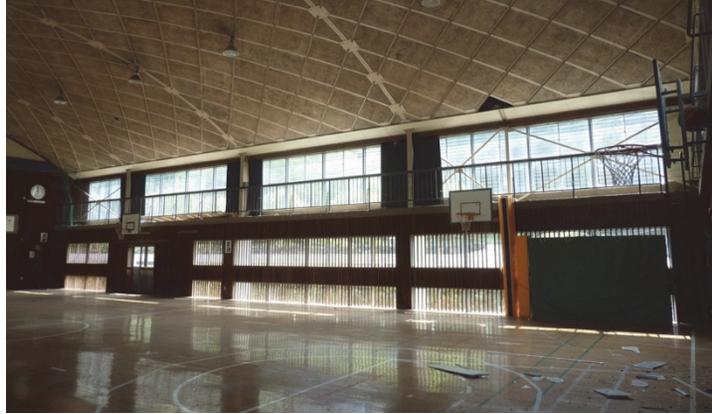
Interior of the virtually undamaged gym. A few lightweight ceiling tiles fell because of inadequate attachment to the structural roof (and ceiling). The debris can be seen in the lower right corner. Note that all of the windows are intact.

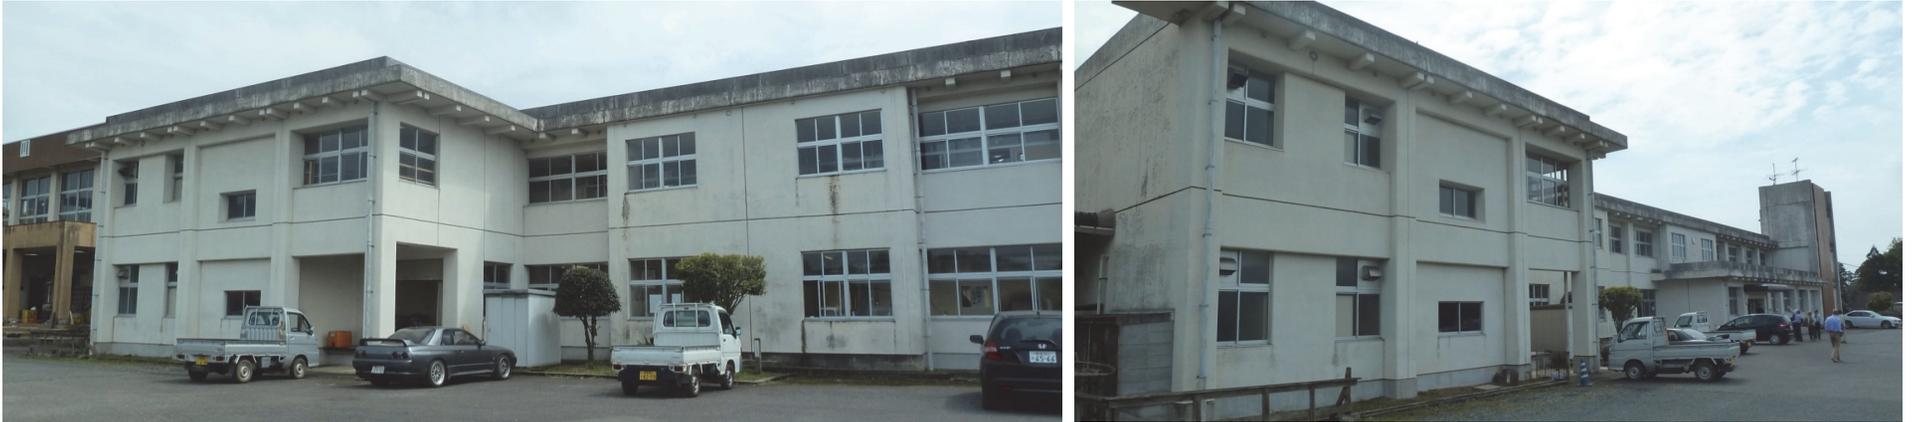
Another essentially undamaged older school in the earthquake area. Again, note the additional “shear walls” that were added, blocking some of the pre-existing windows. Because of the declining student population, the school is no longer used for teaching. Fortunately, the buildings are now available as emergency shelters for those that lost their homes in the earthquake. Other than life safety for students, one of the primary additional reasons for focusing on strengthening schools is their potential use as emergency shelters following disasters.

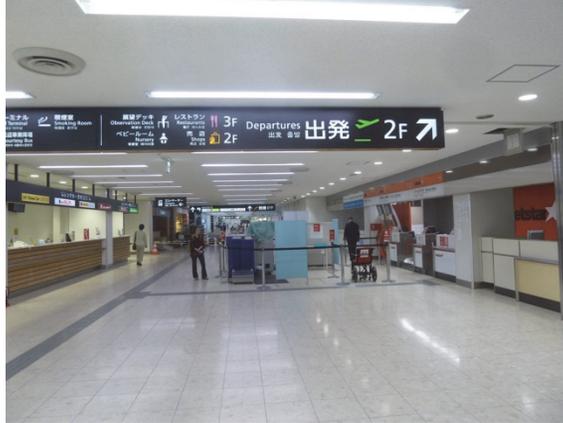
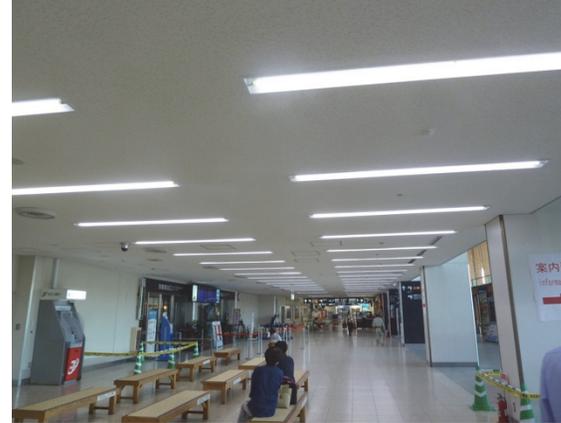
The rigid suspended ceilings throughout the new terminal performed well. We did not notice any significant damage. There was minor damage at interfaces with columns and walls. In the past, damage to flexible suspended ceilings at airports has been a major cause of service interruptions.

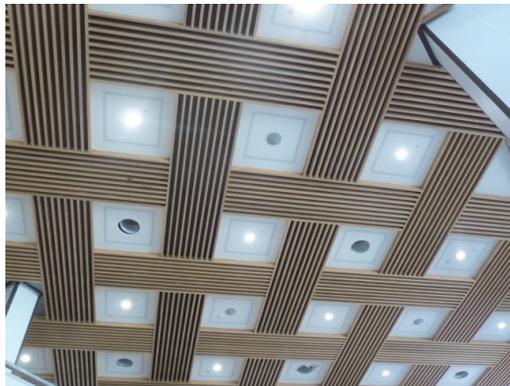
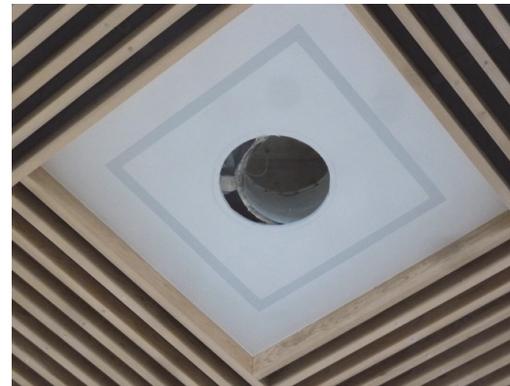
The most life-threatening damage that we observed at the new terminal was the falling of inadequately anchored or braced light fixtures. Note the missing fixture in the right photo. Many of these fixtures had fallen. The ceilings around the failed fixtures are undamaged.

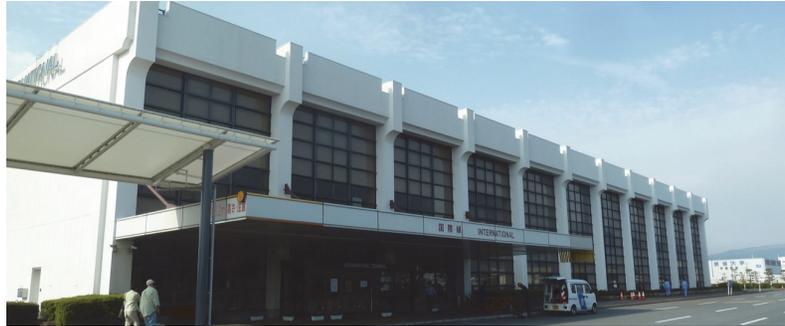
The late 1960s reinforced concrete International Terminal was closed at the time of our investigation due to reported structural damage. We could not observe the damage from the outside, but given the vintage of the structure and the outdated and inadequate code to which it was designed, plus the strength of the ground shaking, serious structural damage should have been expected unless the structure had been strengthened more recently. This type of structure is a classic example of a high-risk structure that requires strengthening for life-safety and for the reduction of business interruptions.

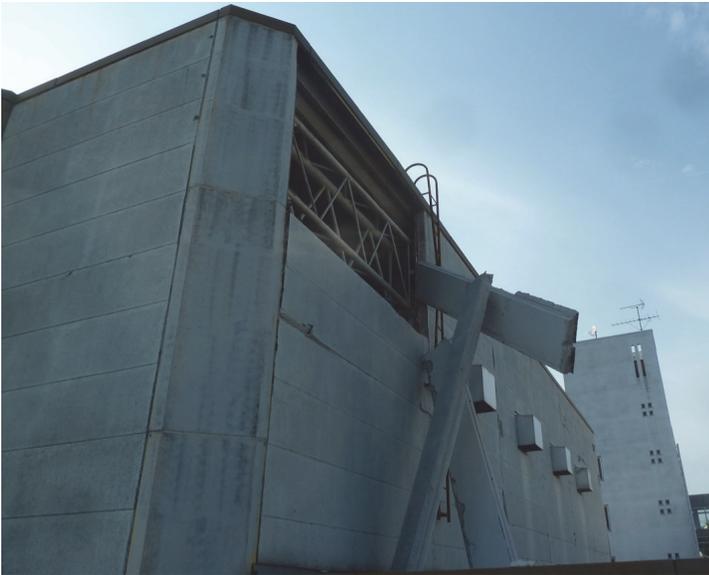
Damage to an older building at the airport training facility, where inadequate attachments for the heavy precast concrete cladding failed. I have observed this type of failure many times in earthquakes in Japan and elsewhere around the world. Typically, older buildings with these types of facades, as well as older precast concrete buildings, are much higher risks than comparable age steel framed and massive concrete shear wall buildings. Several other similar buildings at the airport had comparable, but less dramatic, damage.

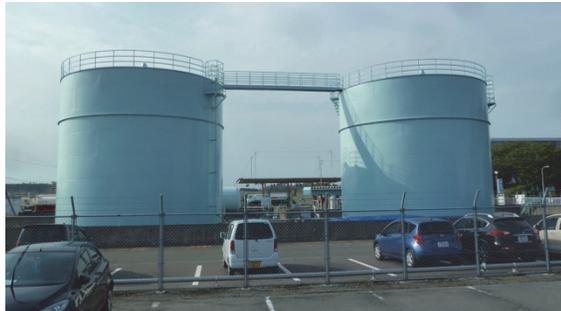
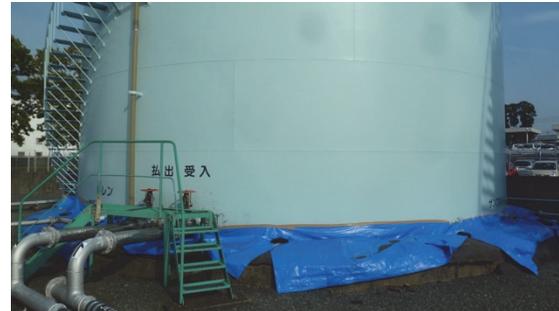
At first glance, this aviation fuel storage facility at the airport appeared to have suffered damage to one of its two tanks. It turned out that the blue plastic tarps covering the effects of the earthquake were providing temporary cover replacing the damaged asphalt waterproofing around the tank base. The damage was inconsequential. Generally, equipment such as this had adequate anchorages and performed well.

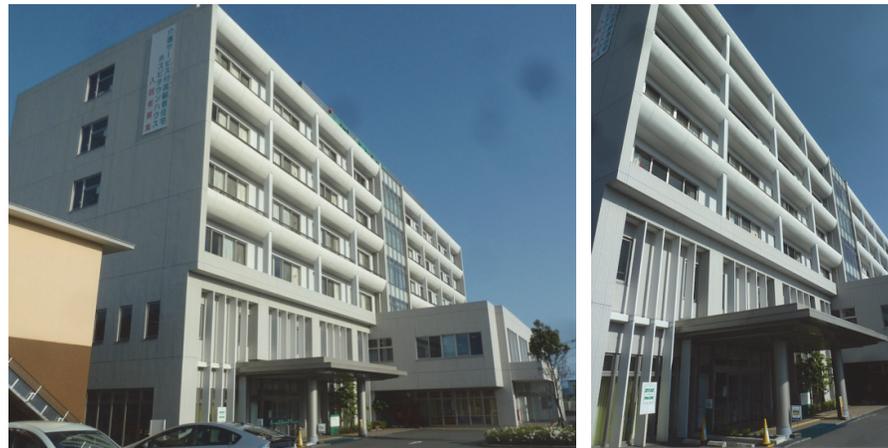
The main building of the hospital was built in 2012 and showed no visible structural damage. The only significant damage inside the building was minor spalling at seismic (expansion) joints. There was also minor settlement of the ground and of excavation backfills around the buildings.

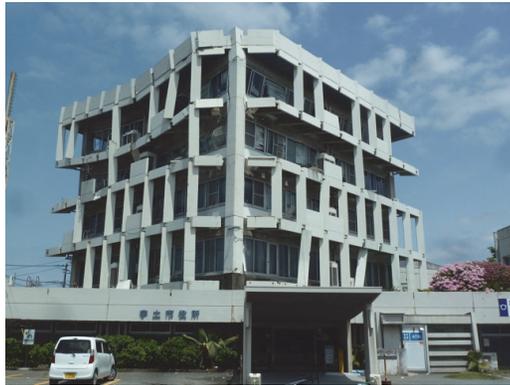
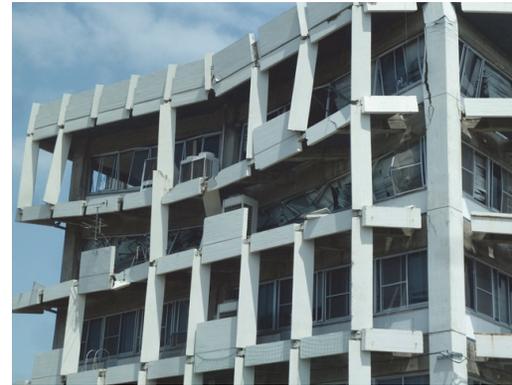
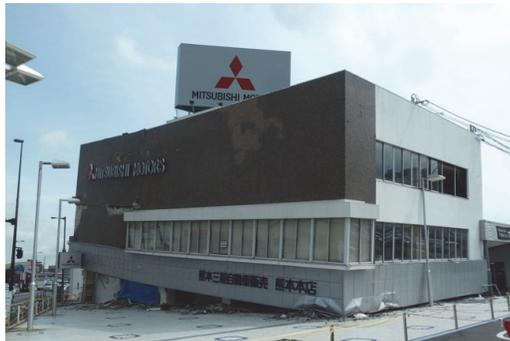
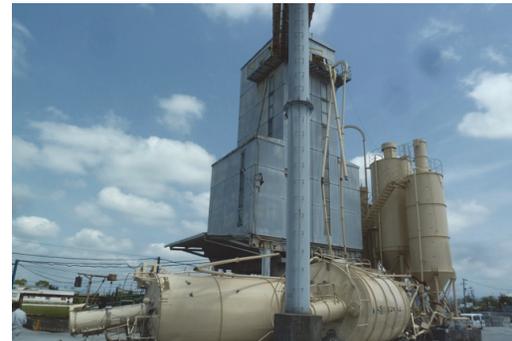
Two heavily damaged reinforced concrete buildings are in the general region and roughly equidistant from the hospital. Both buildings are much older and were designed to outdated building codes. The top building is Uto City Hall. The visible façade damage is due to the failure of precast concrete non-structural façade panels, shown in more detail on the right. The main concrete frame is heavily damaged and near collapse. The recorded ground motions, shown in the previous illustrations, were taken on the City Hall. The three-story building (lower left) had a soft-story ground floor that collapsed. The lower right photo shows collapsed silos at the nearby Kumamoto Ryoko Concrete Co. Two of five silos collapsed. The three newer silos in the back designed to more recent criteria have no significant damage.

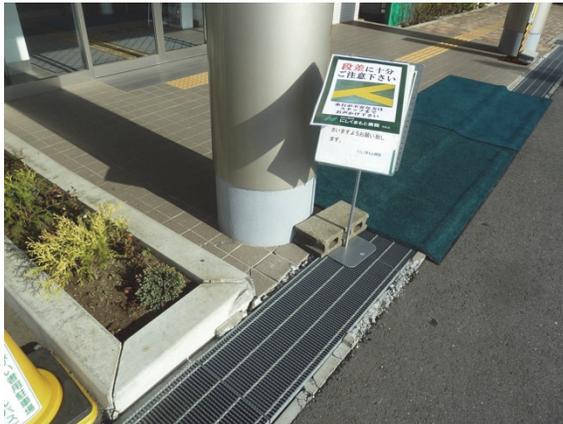
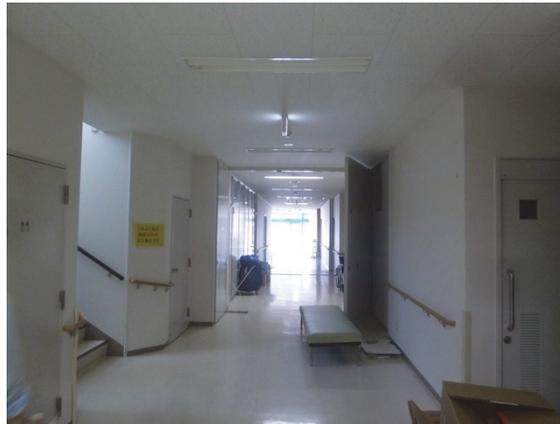
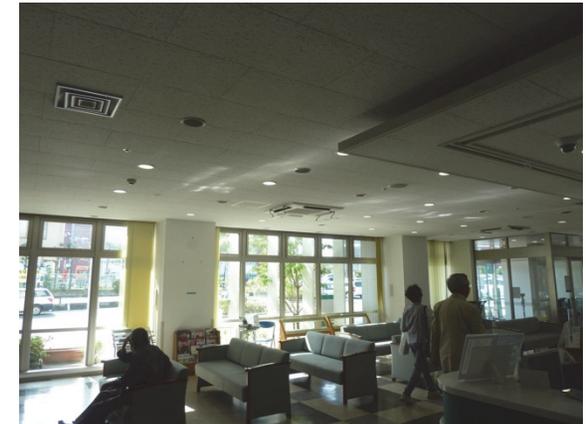
The most obvious and inconsequential damage to the hospital was minor settlement around the periphery of buildings. The photo in the upper left shows some settlement at the main entrance to the hospital. The other three photos are of interiors of the main building, including the lobby (lower right). Note that the undamaged ceilings are rigid, unlike flexible suspended ceilings that are typically easily damaged.

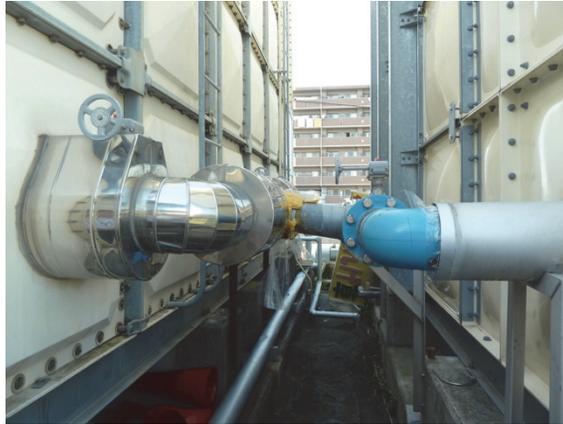
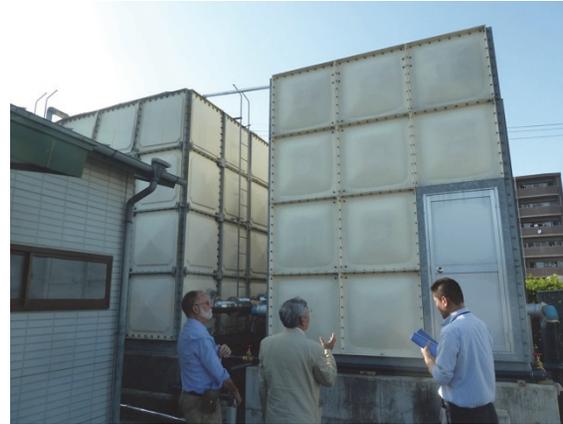
Two anchored potable water tanks lost content when the rigid piping that interconnected them failed due to differential tank movement during the earthquake. The repaired lines are shown on the left. A flexible pipe connection between them would have prevented the only significant equipment and systems damage at the hospital.
