## ON THE DIVERSITY OF DESIGN CRITERIA IN SEISMIC DESIGN

Yozo Shinozaki, Yoji Izumo, Msaaki Watanabe  
Taisei Corporation  
Tokyo Japan

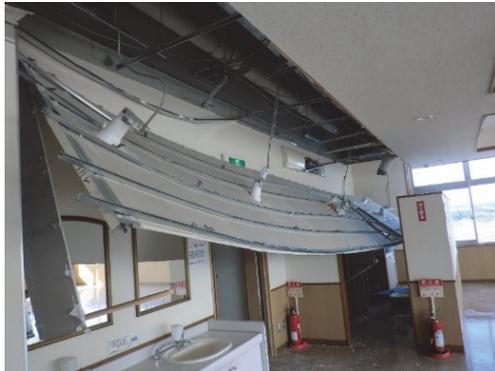
**3-1 Ceiling.** In general ceilings used in Japan, ceiling materials are received by sub-beam, main-beam, as shown in Fig. 1, and hanging them from the upper floor slab is often used. Since these two kinds of beams are clamped with a clip of a fit type, many cases occurred in which the ceiling material dropped due to the shaking of the clip due to the shaking at the time of the earthquake. In addition, cases where the ceiling material was only suspended from the slab, sufficient horizontal rigidity was lacking enough to vibrate, and cases of falling after the deformation were also seen.

Figure 1. Damage of ceilings

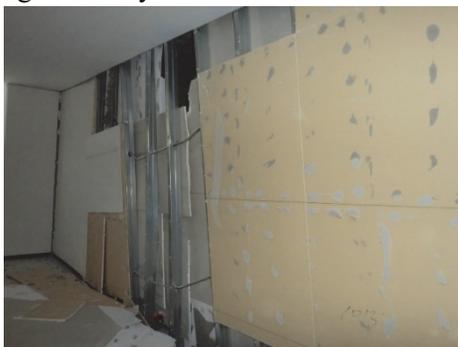
**3-2 Partitions.** Figure 4 shows the structure of a typical dry partition wall used in Japan. A lightweight steel frame post is fitted at regular intervals between the slabs above and below the layer, or between the slab and the ceiling, as shown in Figure 1, and constitutes the base material of the wall plate. Experiments have confirmed that the underlying material can move horizontally along the socket and follow the interlayer deformation to some extent. In the Kumamoto earthquake, many posts were detached from the sockets due to deformation of the surface which could not follow the interlaminar deformation of the building and many were seen.

Figure 3. Damage of dry partition.

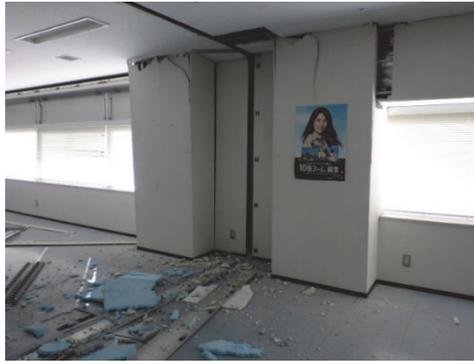
**3-3 Expansion Joints.** In the conventional thinking, expansion joints follow the relative deformation between buildings during the middle earthquake, and at the time of a large earthquake, in many cases, the criteri is not to collide with each other even if the hardware is damaged. Therefore, as the damage of the expansion joint, expansion joint joint hardware cannot keep up with the building deformation at the time of the large earthquake, and there are many cases where the finish around the expansion joint is damaged.

*Figure 5. Damage of expansion joints.*

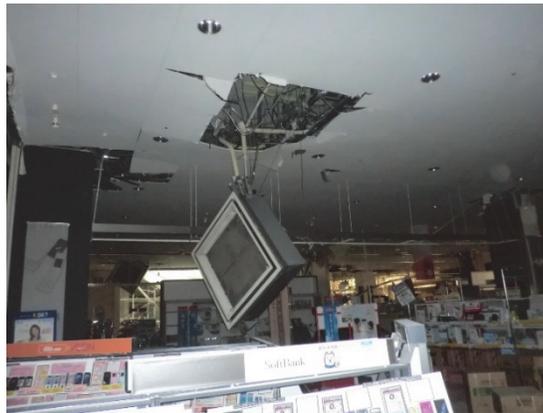
*Figure 6. Damage of equipment.*

On the other hand, however, a seismic performance of "structural body", "building non-structural member" and "facility" is set independently and many buildings are not consistent. For that reason, damage cases such as breakage and dropout of support members designed with underestimated stress, mutual interference and collision due to excessive deformation are also seen.

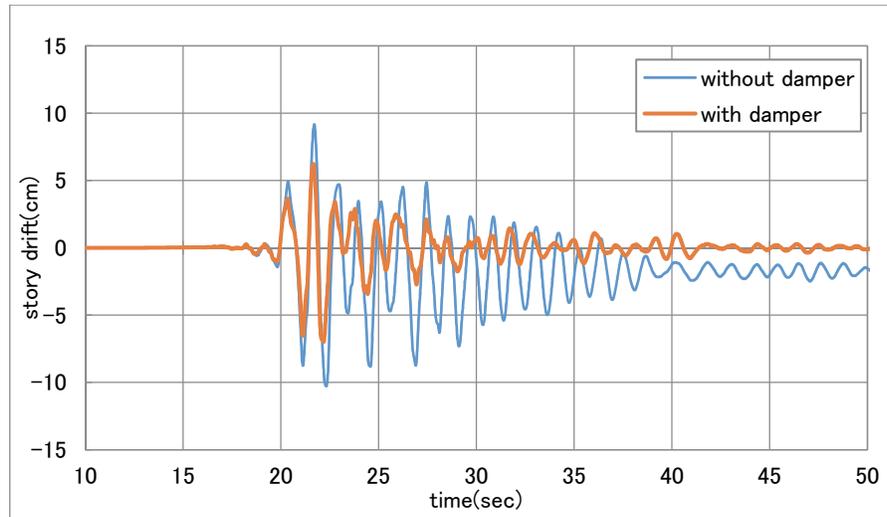
Figure 10. Story drift of 1st floor.

In order to reduce the damage of non-structural members from past damage cases, it is considered important to suppress story deformation in accordance with securing sufficient rigidity of nonstructural member. We compare earthquake response when oil damper is inserted as a method to reduce interlaminar deformation. The input earthquake ground motion was the actual earthquake ground motion recorded near the factory affected by the Kumamoto earthquake. The building model assumes the installation of a 7% damping device in the same model as above. As for the maximum response deformation, it is only about a 30% reduction effect compared with the case without damper, but it is understood that the response characteristics are greatly different when compared in response in time history. Especially, the effect after the maximum response is more than 50% is seen. This discussion is only an analysis case using one observed seismic motion and cannot be concluded as a general theory. However, considering that the damage to the nonstructural members in the past is not so large at the time of the short-time large acceleration earthquake, considering that the damage to the seismic motion for a long time is large, the dry partition due to the story deformation It can be inferred that the vibration damping structure has utility against damage to non-structural members such as expansion joints.

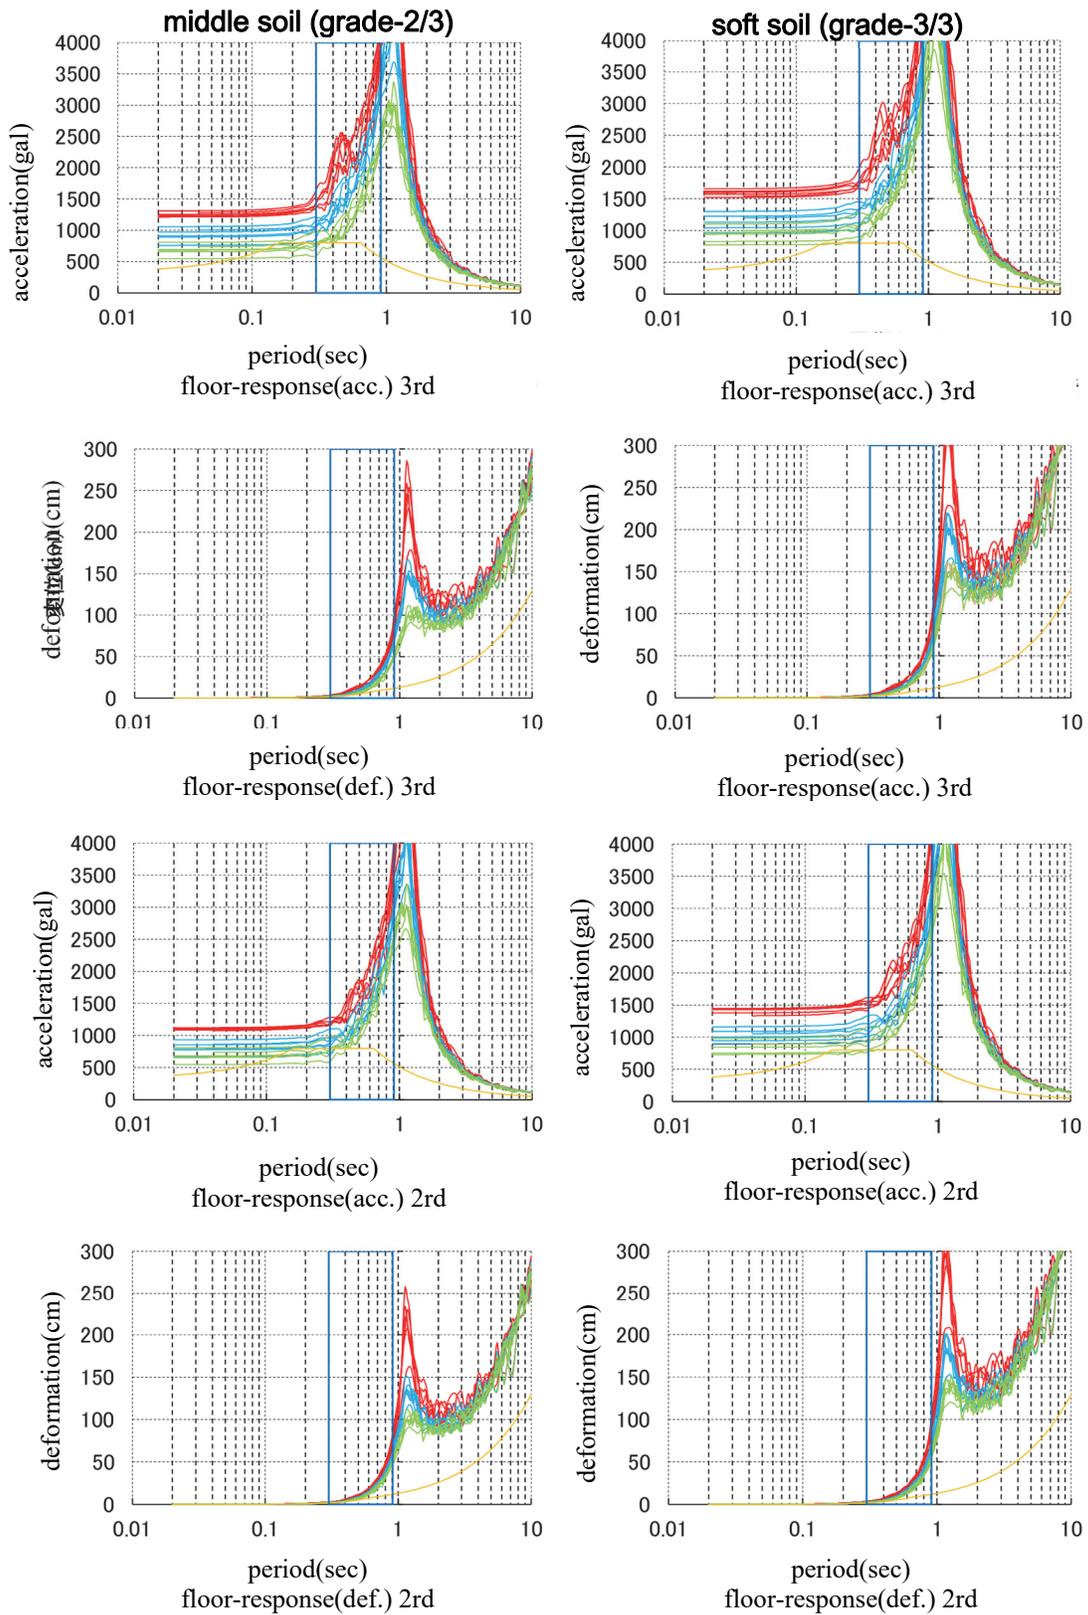
Figure 11. Floor-response for 2nd&3rd floor.

Fig. 11 shows the response acceleration and the response displacement of the non-structural member fixed to the floor of the upper floor from the basement of the building.

1. From the analysis results the following can be seen. A large response (resonance) occurs in the acceleration / displacement near the building primary period ( $T_1 = 1.14$  seconds).

4. If the natural period of the non-structural member is set to 0.3 seconds or less, for example, the amplification of the response acceleration is limited to some extent and the response displacement becomes small.

5. Even if the period of nonstructural members is increased to avoid resonance with buildings, large response deformation cannot be avoided.
