# On the Diversity of Design Criteria in Seismic Design

Yozo Shinozaki

Taisei corp.

# Kumamoto Earthquake 2016

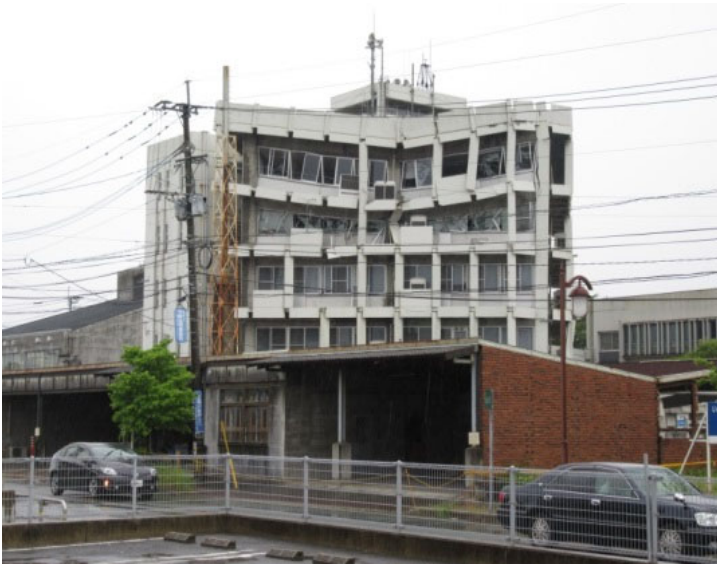
Building damage (old city hall)

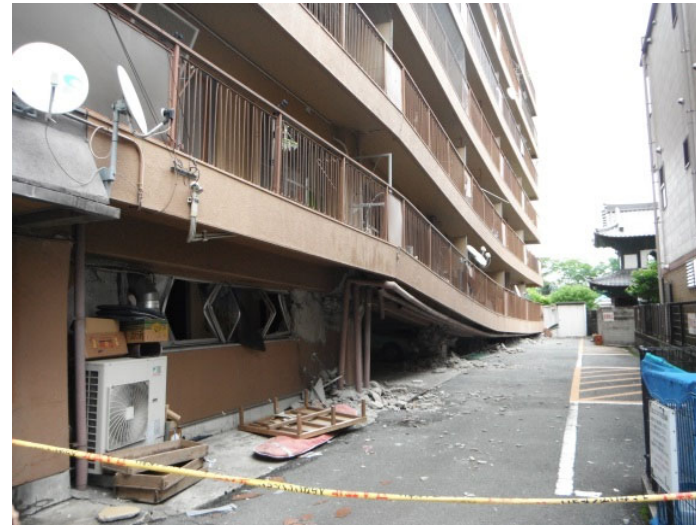
Broken 1<sup>st</sup> floor

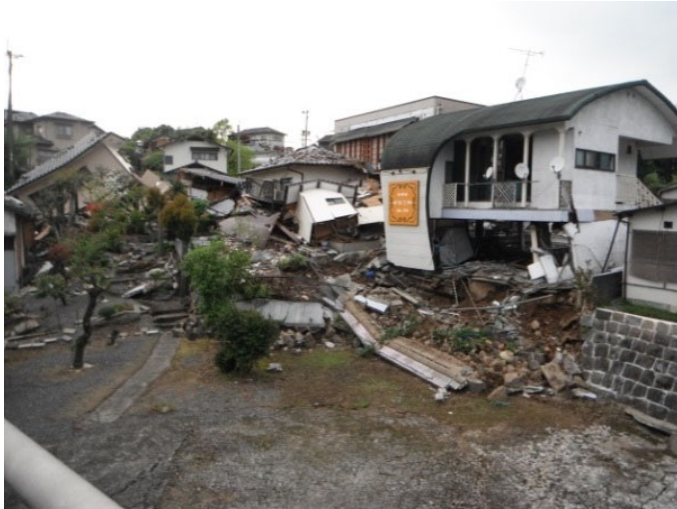
Damaged wooden houses

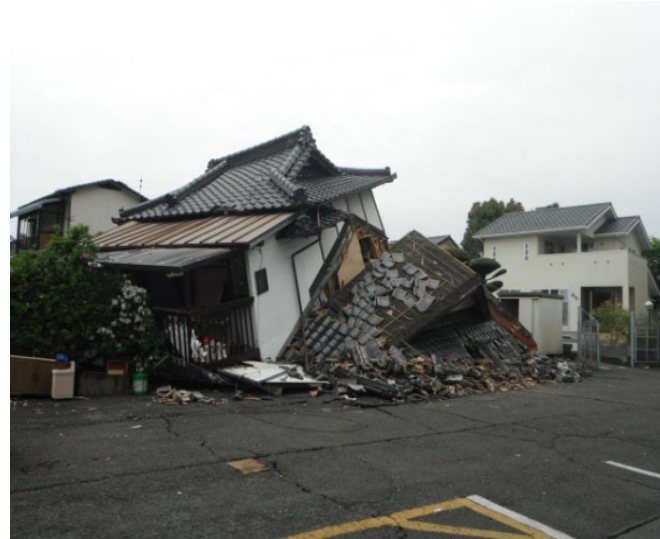
Damaged wooden houses

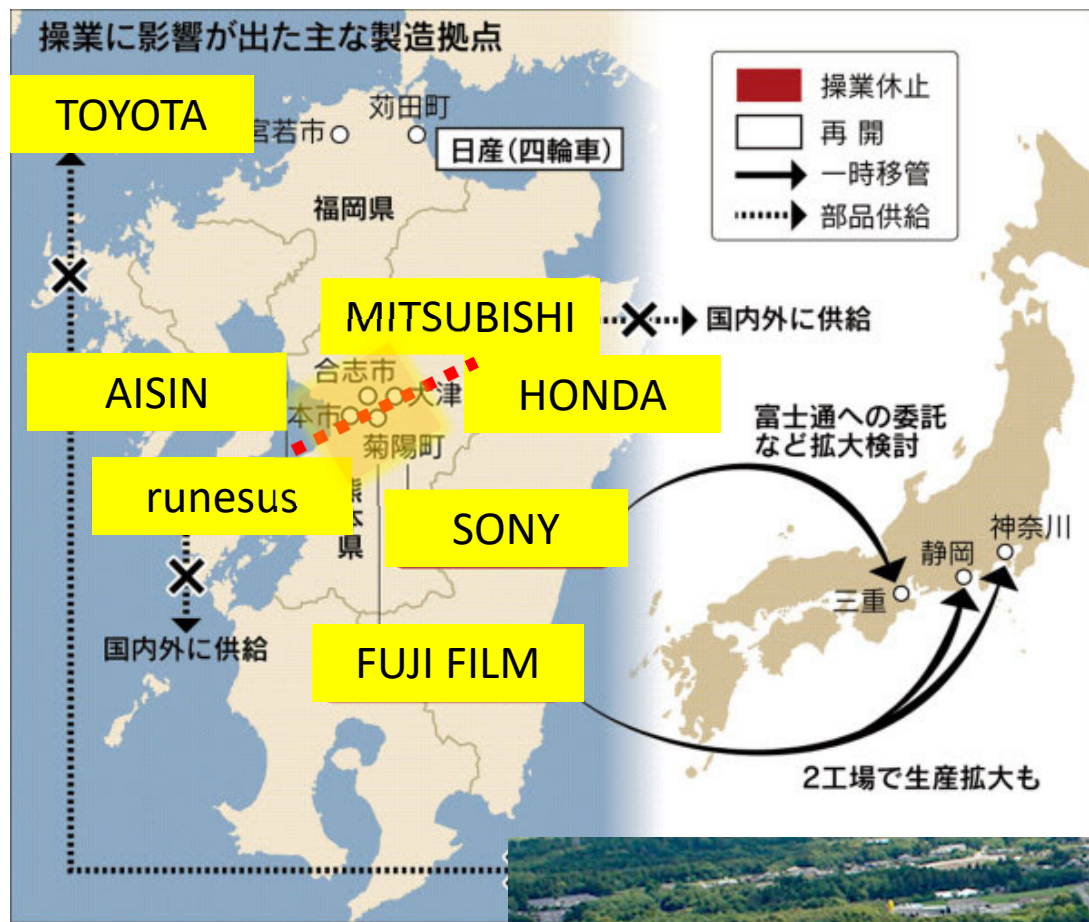
A-factory  
 Building-damage :  
 \$ 20~30million  
 Sales loss :  
 \$ 600~800million

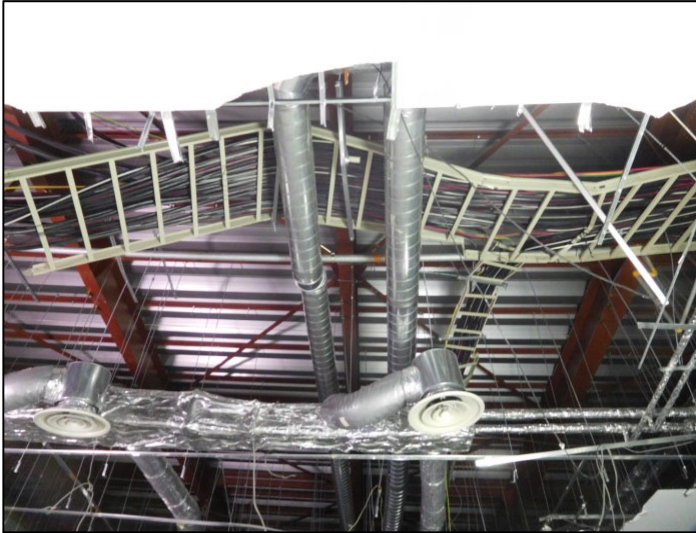
**RACK broken**

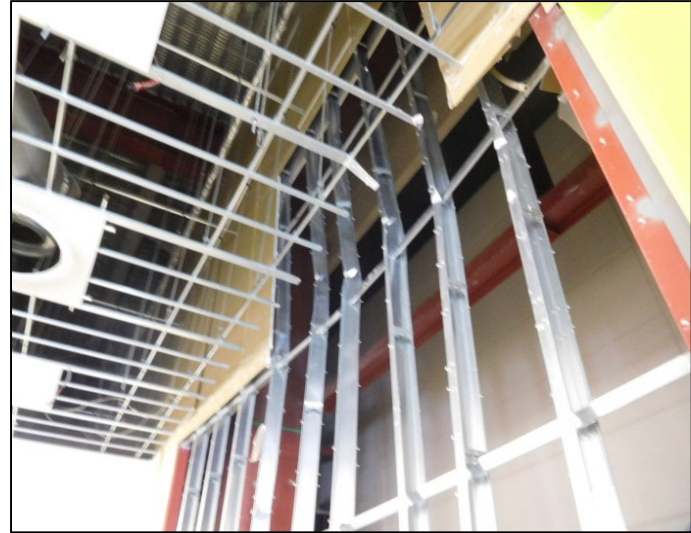
**Partition & Ceiling**

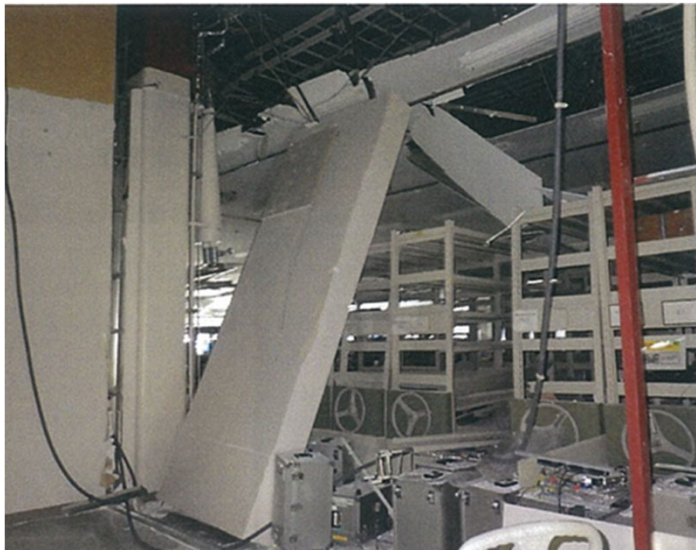
**M&E equipments**

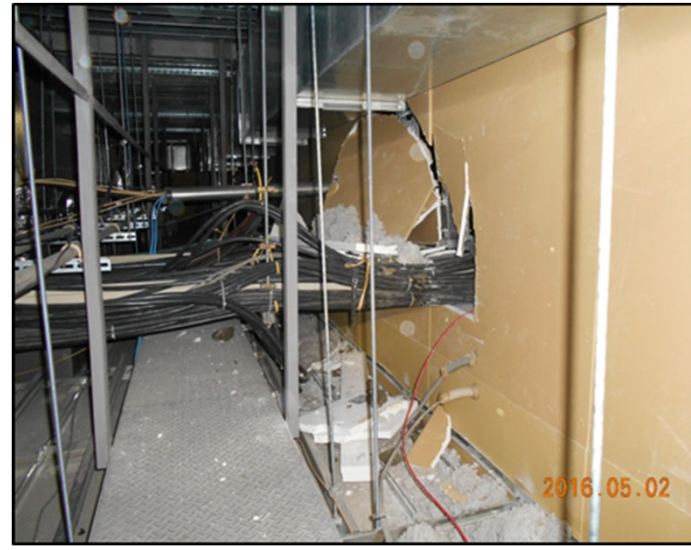
**Patition broken**

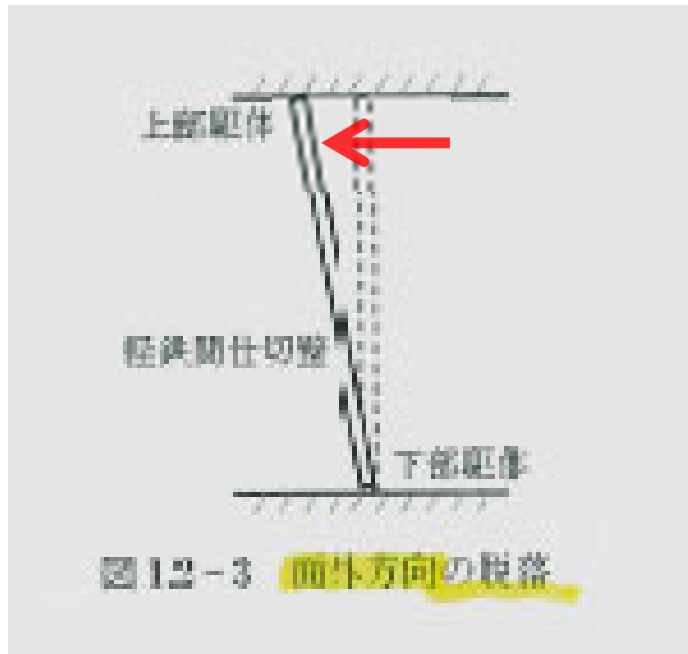
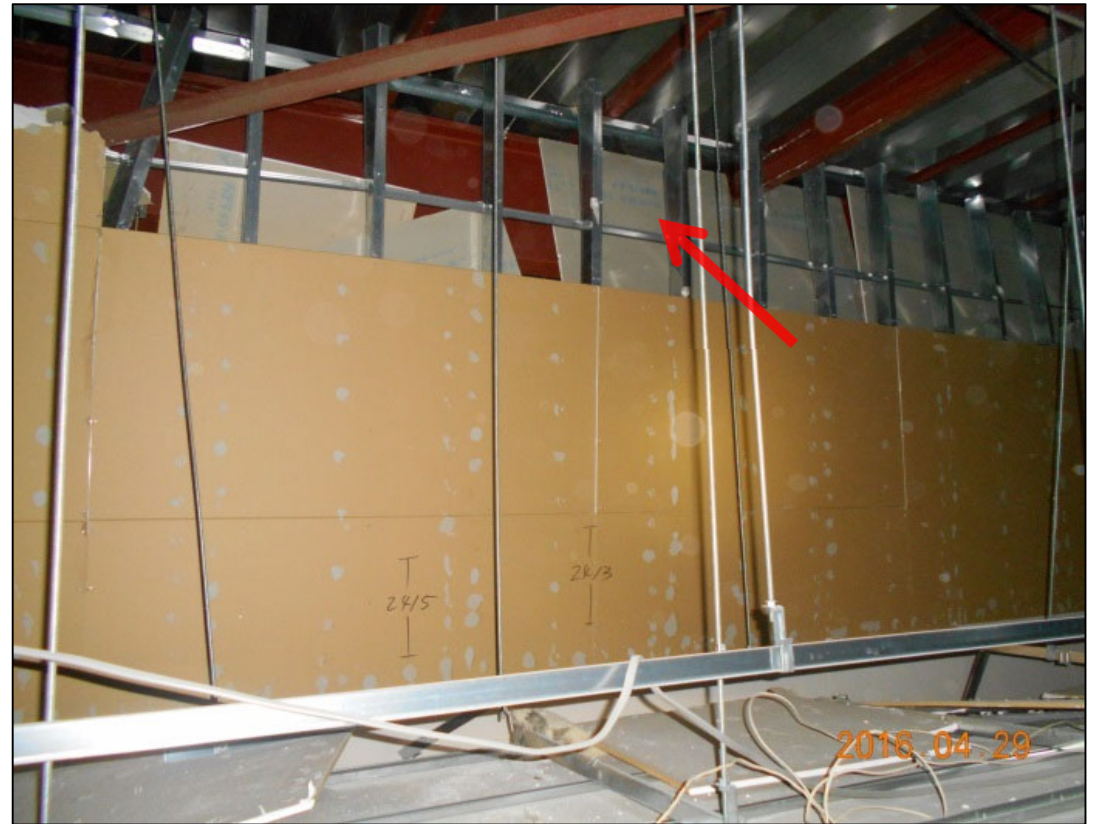
# Partition fell down due to large-deformation of story

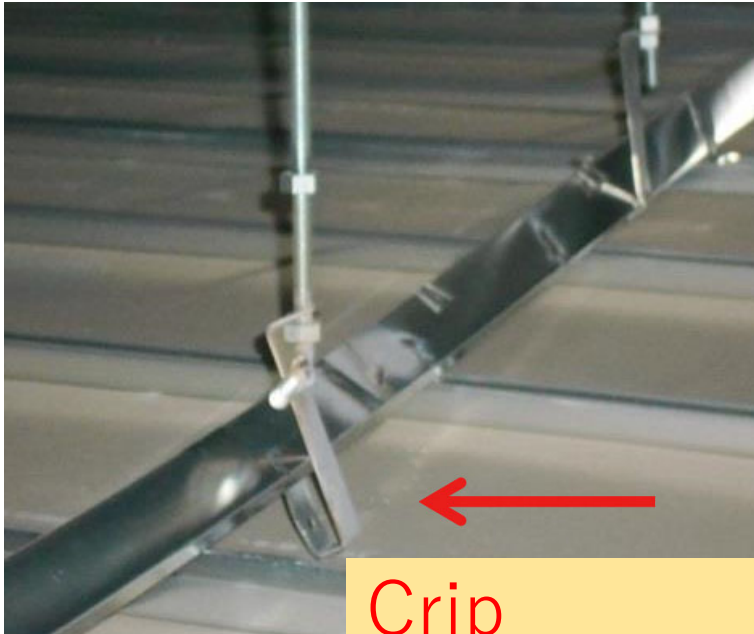
Crip  
deformed

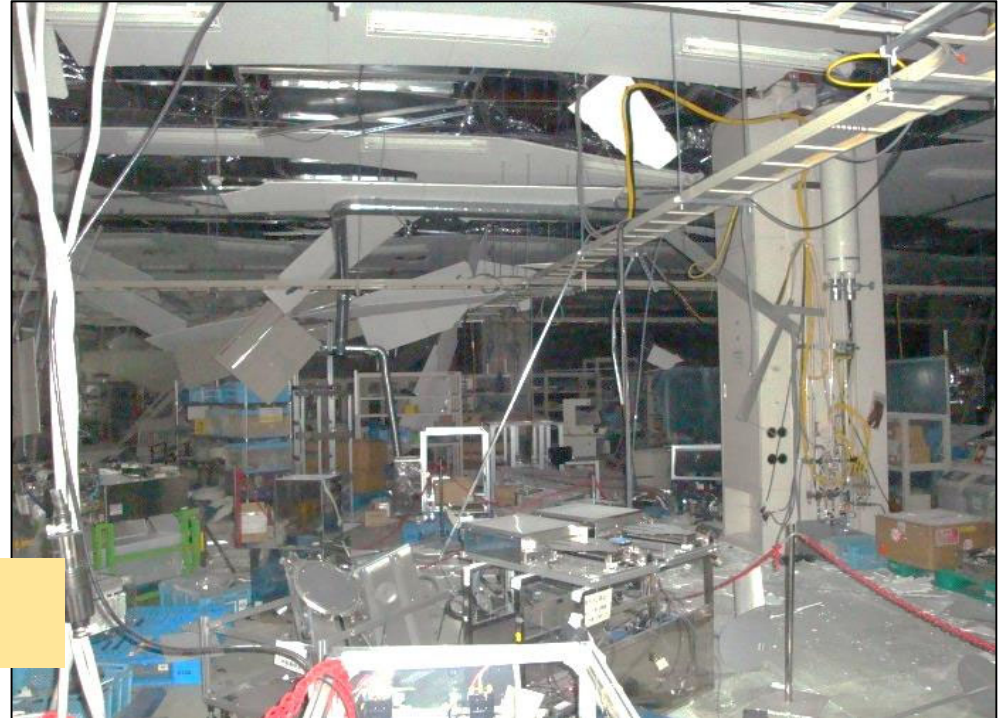
**Design seismic-force was proper for ceiling.  
Detail was not enough.**

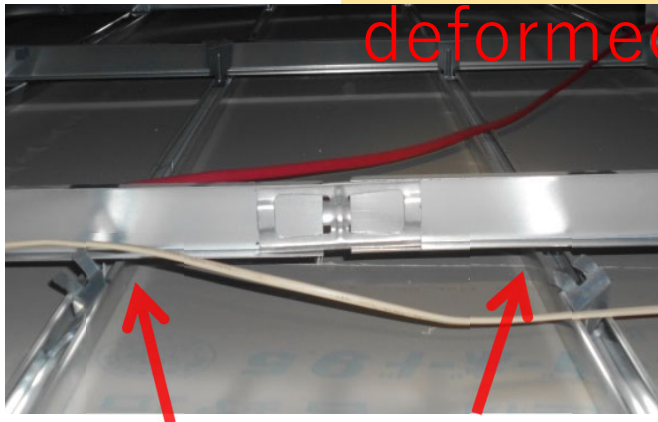
Sub-beam crip  
deformed

Not only partition & Ceiling also, many non-structural element
