# BRIEF REVIEW OF BUILDING DAMAGE BY THE 2011 TOHOKU JAPAN EARTHQUAKE AND FOLLOWING COPING ACTIVITIES

Isao NISHIYAMA\*<sup>1</sup>, Izuru OKAWA<sup>1</sup>, Hiroshi FUKUYAMA<sup>1</sup> and Yasuo OKUDA<sup>2</sup>

<sup>1</sup> Building Research Institute, Tsukuba, Japan

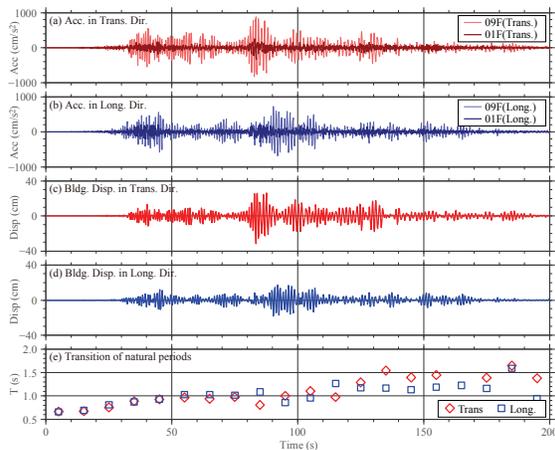
**Strong Motion Records of Damaged Buildings.** At least 4 buildings suffered severe earthquake motions with some damage. One example of the damaged buildings is the 9 storied steel reinforced concrete building in Sendai city. This building has a long history of recording of strong motions. Among them, strong motion records on the ninth floor that were obtained during the 1978 Miyagi-Ken-Oki earthquake are well known to have exceeded a maximum acceleration of more than  $1000\text{cm/s}^2$ . By that earthquake, multi-story shear walls suffered shear crack and later repaired to behave in a ductile manner. In the meantime, during the Tohoku Japan earthquake, the repaired multi-story shear walls suffered flexural failure. Figure 1 shows the records of the strong motions and the fundamental natural periods of the building ( $T$ ) calculated every 10 seconds (Kashima and Kitagawa 2005).  $T$  increased from 0.6 seconds to 1.5 seconds during the earthquake, which clearly shows and is consistent with the building damage. After the earthquake, free access to all the recorded digital data including those of this building is strongly requested even from overseas researchers.

Figure 1. Recorded strong motion and the calculated fundamental natural period

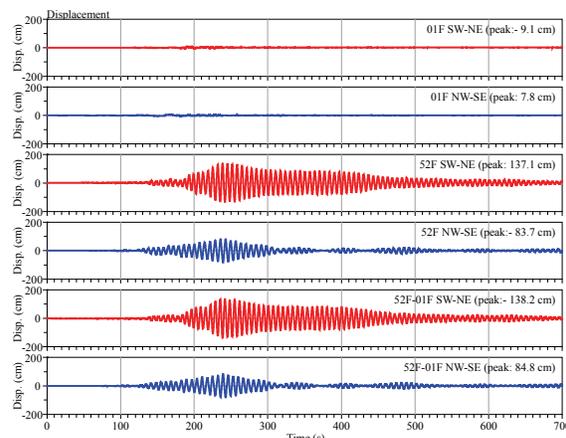
**Long-period Earthquake Ground Motions in Osaka Bay.** During the Tohoku Japan earthquake, long-period earthquake ground motions with long duration were observed in Tokyo, Osaka and other large cities. One example is the 52+3 storied steel office building on the coast of Osaka Bay that is 770 km away from the hypocenter. Figure 2 shows the records of the absolute displacement waveforms. The absolute displacements in the SW-NE and in the NW-SE directions on the 1<sup>st</sup> floor was less than 10 cm, but the 52<sup>nd</sup> floor in the building suffered a large motion with a zero-to-peak amplitude of more than 130 cm, which is thought to be due to a resonance phenomenon. This indicates the importance of the prediction of long-period ground motions by mega-earthquakes possibly to occur in Nankai trough.

Figure 2. Recorded strong motion of 52+3 storied steel office building located 770km from the epicenter

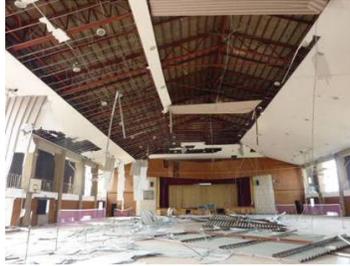
Figure 5. Fallen down of ceiling

**Fallen Down of Ceilings and so on.** The problem of fallen down of the ceilings which cover large space such as gymnasiums has been indicated by the BRI and the NILIM since 2001 Geiyo earthquake, and technical advice to install appropriate amount of diagonal braces on hanging bolts and to keep appropriate clearance between ceiling and surrounding structure have been announced from the MLIT. In the Tohoku Japan earthquake, huge number of large space ceilings (about 2,000) fell down and even casualties occurred. Therefore, extensive detailed survey on ceilings fell down during the earthquake was restarted, where 151 damaged ceilings are collected and 11 of them were studied in detail. Based on this study in addition to the previous knowledge, the current qualitative technical advice is planned to be modified into much quantitative one. Figure 17 compares the ceiling height and unit mass of the fell down ceiling with the cases of with and without injury.

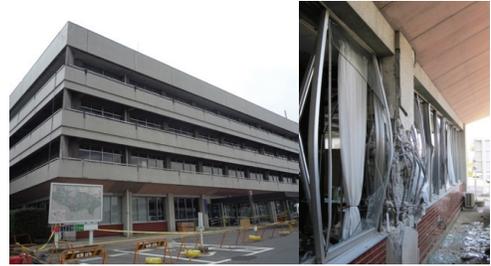
Figure 6. Survived but not functional

- Higher level of performance based design so as to reduce those buildings, which survived but not functional after earthquake (will be studied in the BRI)

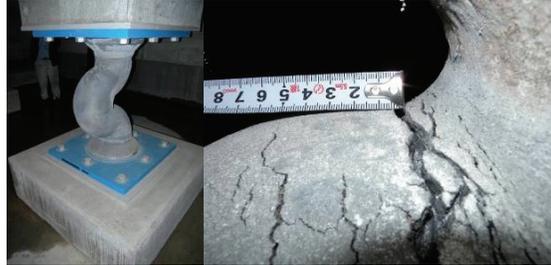
Figure 8. Lead damper cracked

- Addition to the building structural codes to deal with the problems of fallen down of ceilings and so on
- Evaluation of residual structural performance of fractured lead damper in seismically isolated buildings (was conducted by the Japan Society of Seismic Isolation)

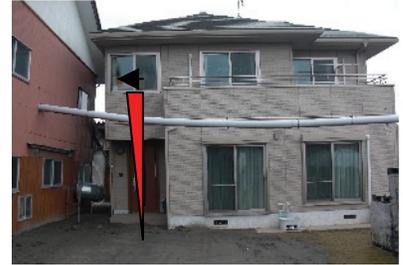
Figure 9. Tilted house by liquefaction

The 112 sites are selected in Kanto area and carried out liquefaction evaluation at each site by  $F_L$ -method (Japan Road Association 2002), and the results were compared with the observation as shown in Figure 19. All liquefied sites were predicted, but still many sites without liquefaction were cautioned, which requires the further improvement of evaluation accuracy. So as to apply  $F_L$ -method, N-value by SPT (standard penetration test), fine fraction content, water level, and so on are needed. The cost necessary for getting these information is not affordable for the owner of residential house, thus the BRI is now trying to study the possibility of only using SWS (Swedish weight sounding test) plus water level and soil judgment, instead. Study on development of countermeasure techniques applicable for existing buildings is also underway.

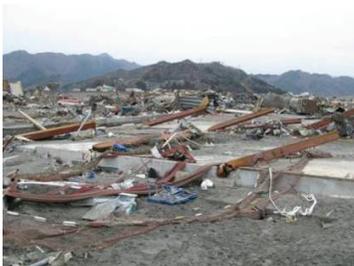
Figure 10. Complete washed away

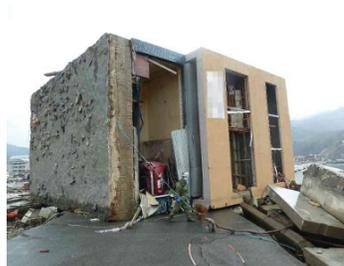
Figure 11. Overturning

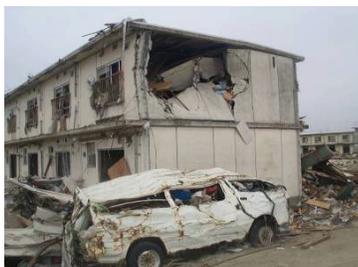
Figure 13. Debris impact

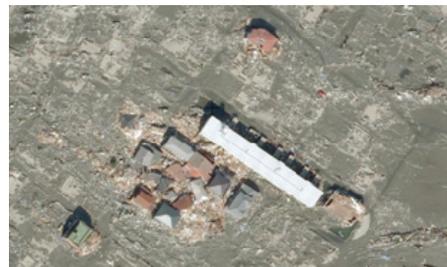
Figure 14. Shading effect by front building

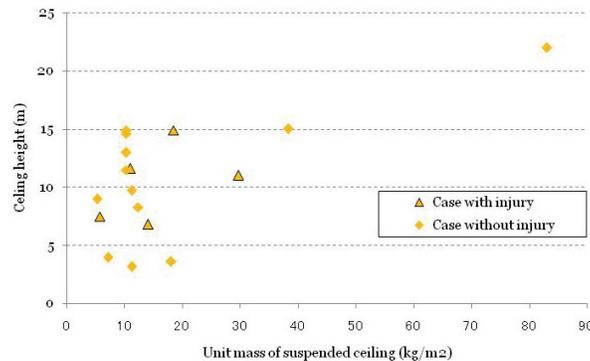
Figure 17. Fall down of ceilings and with/without injury

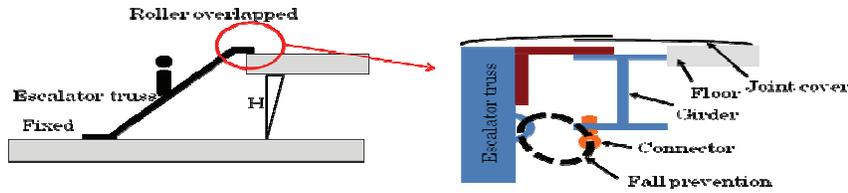
Fallen down of the escalator trusses in shopping centers were reported on October 26, 2011 by mass media. In ordinal practices, overlapping between the escalator truss and the girder on the upper story is selected as  $H/100+20\text{mm}$ , where  $H$  is the height of the escalator. Currently, the requirement of overlapped length is planned to be increased with the exceptions with fall prevention device as shown in Figure 18.

Figure 18. Prevention of fallen down of escalator truss

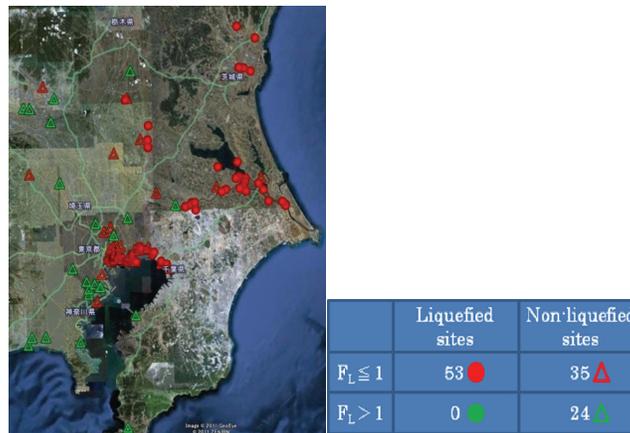
Figure 19. Comparison of liquefaction evaluation and observation results

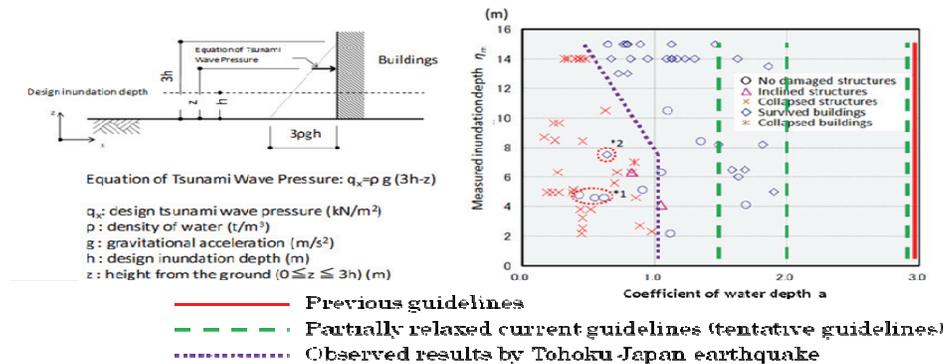
As explained above, about 100 buildings were carefully selected and studied in detail. First, the horizontal resistant strength of each building is evaluated whether damaged or not from the surveyed dimensions. Next, the coefficient of water depth is calculated so that the tsunami horizontal force estimated considering the observed inundation depth at or around the building as a function of the coefficient agrees with the calculated building strength. Figure 20 (right) shows the relation of tsunami inundation depth and the estimated coefficient for the studied buildings. It can be seen that the coefficient of water depth is

about 1.0 and it reduces as the inundation depth increases shown by dotted lines. In the tentative guidelines announced from the MLIT in December 2011, the coefficient of water depth was relaxed as 2.0 in case the building was blessed by the shading effect from front building and/or embankment and further relaxed as 1.5 in case the building located at 500m or larger from the coastline and river in addition to shading effect as shown by dashed lines.

Figure 19. Estimated coefficient of water depth of detailed studied buildings
