STRUCTURAL ANALYSIS CASE STUDIES OF BUILDINGS DAMAGED DURING THE TOHOKU TSUNAMI

Lyle Carden¹, Gary Chock¹, Ian Robertson² and Guangren Yu¹

¹Martin & Chock, Inc.

²University of Hawaii at Manoa
Honolulu, Hawaii/USA

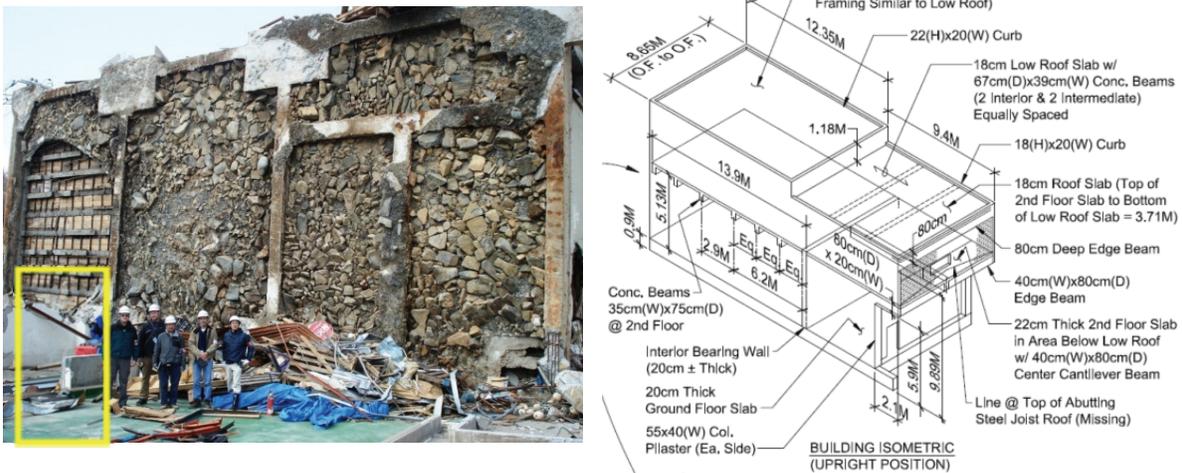
Onagawa Two-Story Cold Storage Building Buoyant Uplift. The reinforced concrete building shown in Figure 2 was lifted by hydrostatic buoyancy off its pile foundation, which did not have tensile capacity due to minimal reinforcing steel development. This building was approximately 22m by 8.7m by 12m tall. The total deadweight of the structure was calculated to be 8995 kN based on detailed measurements of the structural framing and foundation. The refrigerated room portion of the ground floor was effectively sealed off, leading to a neutrally buoyant condition as soon as the water inundation depth reached 7m. The building was lifted off its original site and carried over a low wall (at the left of the Figure 2), before being deposited about 15m inland from its original location.

Figure 2. Onagawa uplifted and overturned 2-story RC building – floated over low wall in box

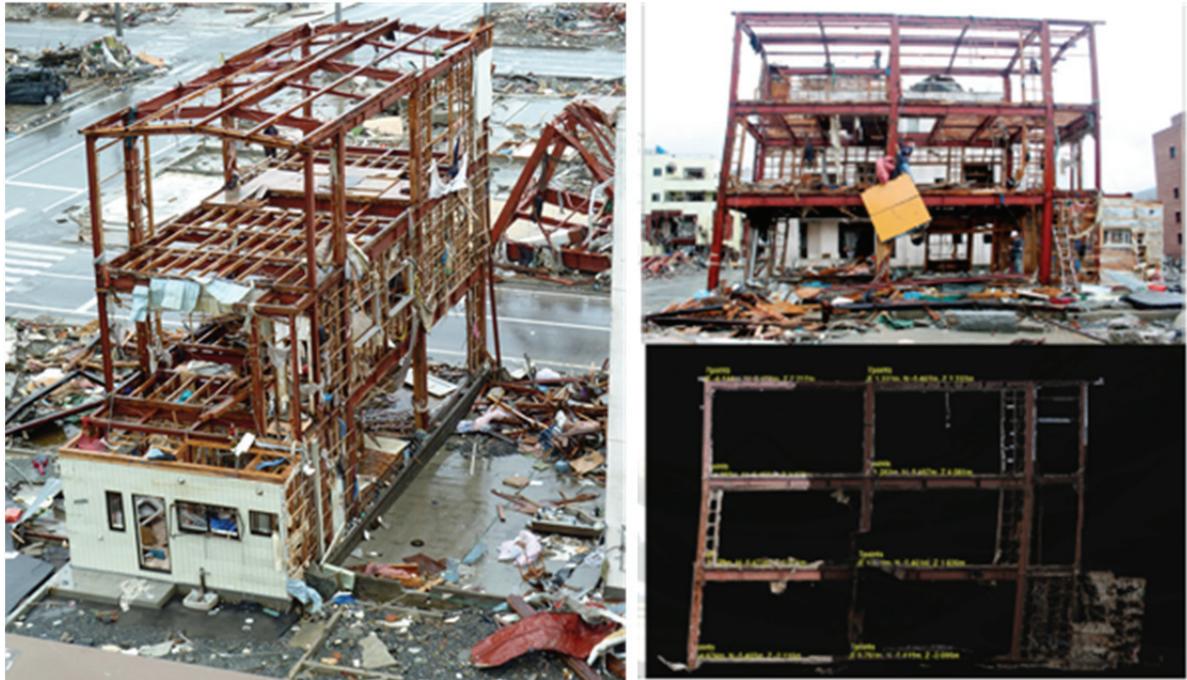
Onagawa Three-Story Steel Building Lateral Pushover. The Onagawa three-story steel moment-resisting frame (Figure 3) was submerged in the flow returning to the ocean estimated from video analysis at about 7.5 m/s (Koshimura and Hayashi, 2012). The building was partly shielded from the inflow by larger concrete buildings. The columns of this frame were wide flange sections with welded 12 mm cover plates to make a box section. The wide flanges were oriented such that they were bent about their weak axis and had pinned base plate detailing. Beams were the “small width” series of JIS 3192 H-shapes with depths of 25cm - 35 cm. Yield and tensile strength are assumed to be consistent with commercial practice of Grade 365MPa and 490 MPa, respectively (similar to U.S. Grade 50).

The flow was sufficient to yield the top and bottom of the second story columns and top of the first story columns assuming 60% blockage of the original enclosure, either from cladding still intact or debris accumulation. At first yield, the calculated lateral drift at the third floor would be about 30 cm with additional flow causing increased displacements. The LiDAR scan of the frame shows a third floor drift of up to 50 cm. It is proposed that once yielding of the structure had occurred with 60% effective cladding blockage, the load was sustained for some period until loss of all remaining cladding later relieved the structure of this lateral pressure. Without such load shedding, collapse would have occurred.

Figure 3 Onagawa 3-story steel frame pushover during drawdown phase

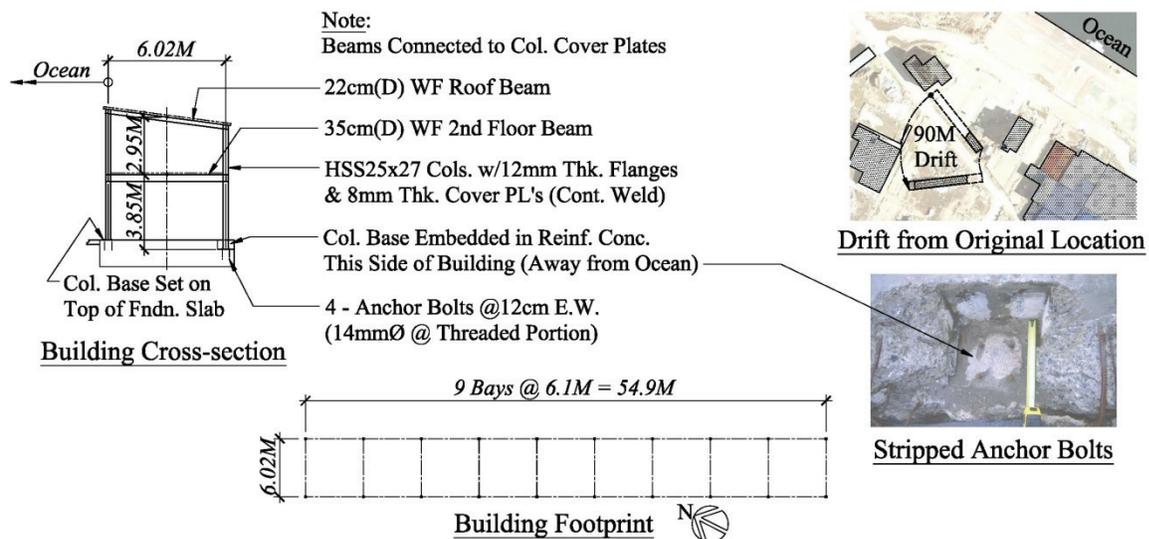
Kesennuma Port Two-Story Warehouse-Office Lateral Pushover. A two-story fish product warehouse in Kesennuma Port was located in between two larger and taller multi-story reinforced concrete buildings. When a seawall was overtopped by the tsunami surge, the flow was directed against the longitudinal face of the building, which was oriented perpendicular to the flow. This was a repetitively framed structure with two-story steel rigid frames in the transverse direction every 6.1m for nine bays (Figure 4). The flow velocity determined from video analysis was 5.5 m/s, and the building was sheared off its foundation when the flow depth reached 5.6m.

Figure 4. Lateral translation of entire warehouse building and failure of anchor bolts.

The front column base plates were set on the slab-on-grade and the rear base plates were embedded in a 25 cm deep blockout filled with concrete set inboard of a 30 cm-thick reinforced perimeter. Four anchor bolts were provided at the base of each column. Failure occurred by shearing of the 14 mm diameter mild steel anchor bolts (nominal tensile strength of 400 MPa) at the front columns and shear friction breakout of the monolithic concrete edge that was reinforced with 2-15 mm bars assumed to be JIS G3112 SD345 and by bolt shearing at the rear columns. Examination of the debris showed that the first story utilized horizontal steel girts, and the second story was ordinary vertical steel stud framing. This caused the lower story to capture and retain more debris and remain less open. Despite being translated 90m, building contents were still found in the lower floor between the girts on both faces of the lower floor. The upper story was stripped clean of its contents. Analysis of the video with verification by structural analysis using Equation 1 (with a C_d of 2.0) indicates that approximately 75% blockage of the first story cladding and at least 50% of the second story cladding remained prior to failure (Figure 4).

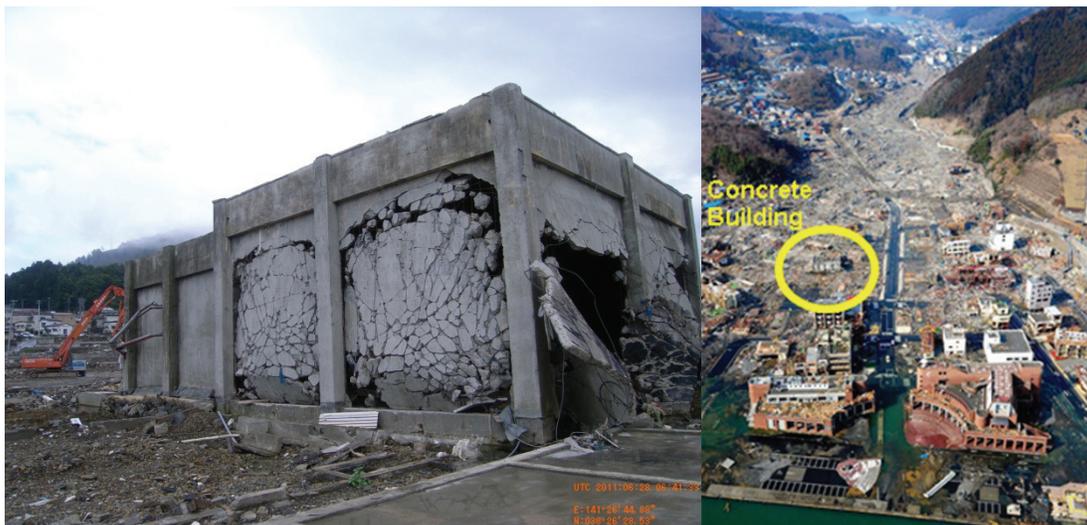
Flow Stagnation Pressurization Analysis of a Concrete Warehouse in Onagawa. This case study was used to verify hydrodynamic pressures during the drawdown phase of the tsunami at Onagawa. Analysis of video taken by a survivor from the top of a reinforced concrete building provided a flow velocity of 7.5 m/s in the free field during drawdown (Koshimura, 2012). The concrete warehouse building (Figure 5) became internally pressurized by flow stagnation during tsunami drawdown. The building only had wall openings facing the drawdown flow and was solid on all other sides. The larger wall panels were observed to have completely failed, with outward highly inelastic deformations showing the formation of membrane action. The smaller wall panels did not fail. It is likely that the walls were subject to several cycles of reversing external and internal pressure forces. However, given that the side walls perpendicular to the shoreline suffered similar damage to the front wall parallel to the shoreline, internal stagnation pressure during drawdown is likely to have been the governing condition.

The wall panels were 120mm thick with a single central layer of 8mm smooth reinforcing spaced at 200mm on center horizontally and vertically. The expected concrete strength was estimated at 30 MPa for nominal 20 MPa concrete based on the vintage of the building. The reinforcing yield and ultimate expected strengths were estimated at 558 MPa and 620 MPa, respectively, assuming Japanese Industrial Standard (JIS) SD490 reinforcing. A finite element analysis was performed, using SAP2000 v15 with non-linear layered shell elements, on the larger and smaller of the typical wall panels. Each layered shell element includes five layers. One layer represents the full thickness of concrete and the other four layers

Figure 5. Concrete wall failure due to internal pressurization (left) and building location (right)

represent wall steel reinforcing at each wall face in each direction. In these walls there was on a single layer of centrally placed steel in each direction. The analysis was compared to deformations measured using a LiDAR scan with a magnitude of around 0.5 m in the larger wall panels, while the smaller panels had negligible lateral deformations. Analysis based on a stagnated hydrodynamic load showed that the larger exterior wall panels failed after flexural yielding of the panels followed by formation of a catenary membrane, followed by shear failure around the perimeter of the wall. The maximum force is plotted against the maximum displacement at the middle of the wall in Figure 6, with the point at the formation of the different limit states shown. Due to the reduced spans, it was calculated that only the edges of the smaller wall panels reached their yield point, therefore some flexural cracking may be expected and was observed in the field, but significant yielding was not expected nor observed. In summary, application of theoretical loading based on internal stagnation pressure and corresponding analysis was able to well characterize the response of the building.

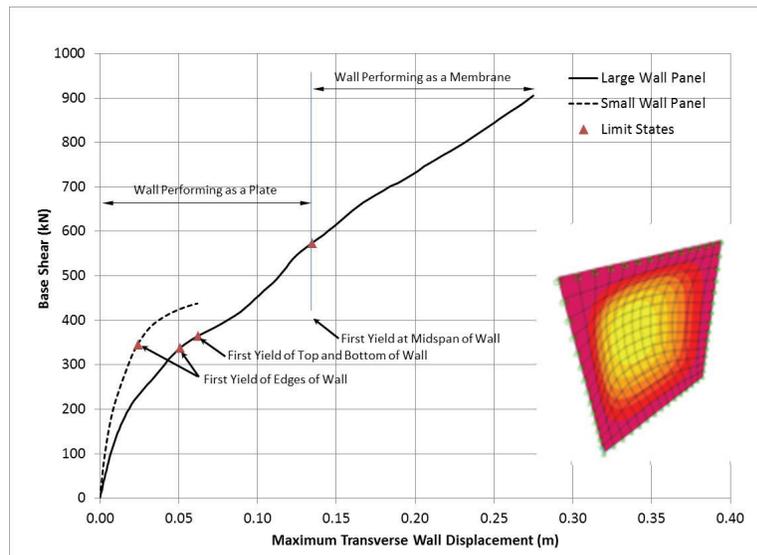
Figure 6. Total applied force versus maximum displacement of the wall and corresponding limit states for large and small wall panels.

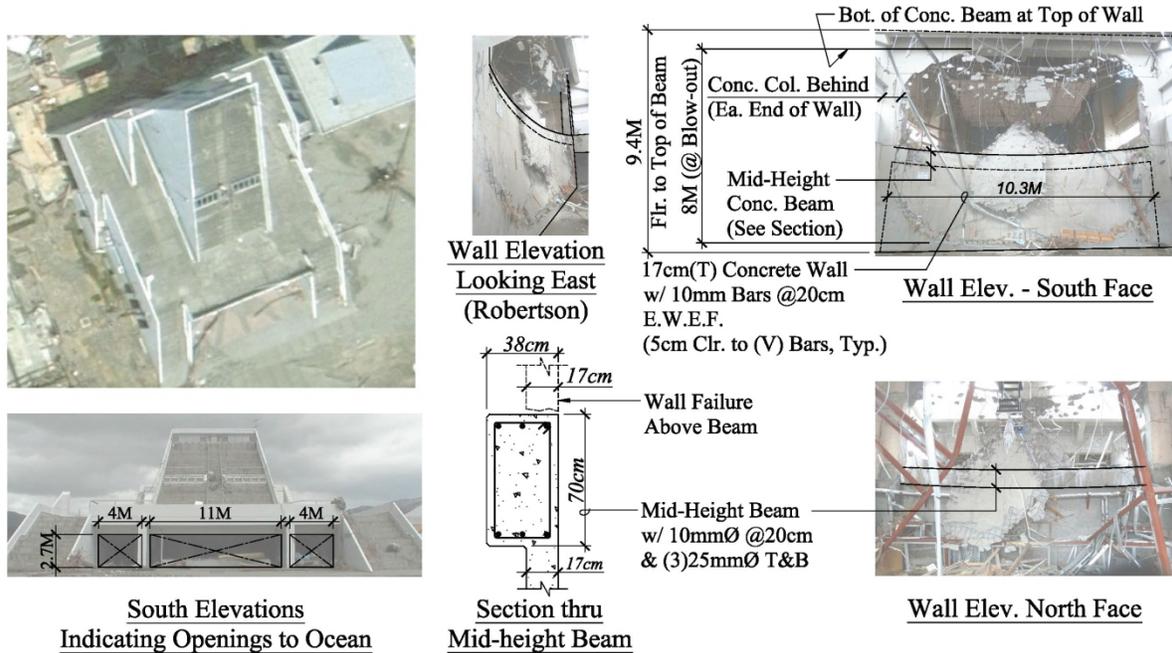
Hydrodynamic Loading. The Takada Matsubara building in Rikuzentakata, shown in Figure 7, endured a 10.5m tsunami inundation depth with flow of about 7.5 m/s, estimated using analysis of simple “flow surrogate” structures. The tsunami caused failure of its principal transverse shear wall due to unbalanced hydrostatic and hydrodynamic forces of the incoming tsunami surge. The wall was at the rear face of a three-sided concrete box with the opening in the fourth side being a main entrance into the building at the front (north elevation). The tsunami loading was estimated as a triangular distribution of hydrostatic pressure and a uniform distribution pressure representing the hydrodynamic effects.

The wall was analyzed using finite element analysis. The wall panel including the horizontal mid-height beam was modeled utilizing non-linear layered shell elements. Reinforcing steel was sampled and tested and the four reinforcing steel specimens result in a 510 MPa average yield strength, as per JIS G3112 SD 490. The ultimate strength ranges from 647 MPa up to 734 MPa. A multi-step nonlinear time-history analysis was performed to simulate tsunami flow level increased from zero to full inundation depth. In addition to dead load, included for determining P-Delta effects, seven tsunami load stages corresponding to increasing flows depths up to the maximum flow depth of 9.4m were defined. The analysis was terminated at 9.4 m, close to but shy of the 10.5m maximum observed flow depth, when the model became unstable due to excessive deformations and minimal residual strength indicating complete collapse.

Figure 7. Large wall failure in the Takada Matsubara building in Rikuzentakata

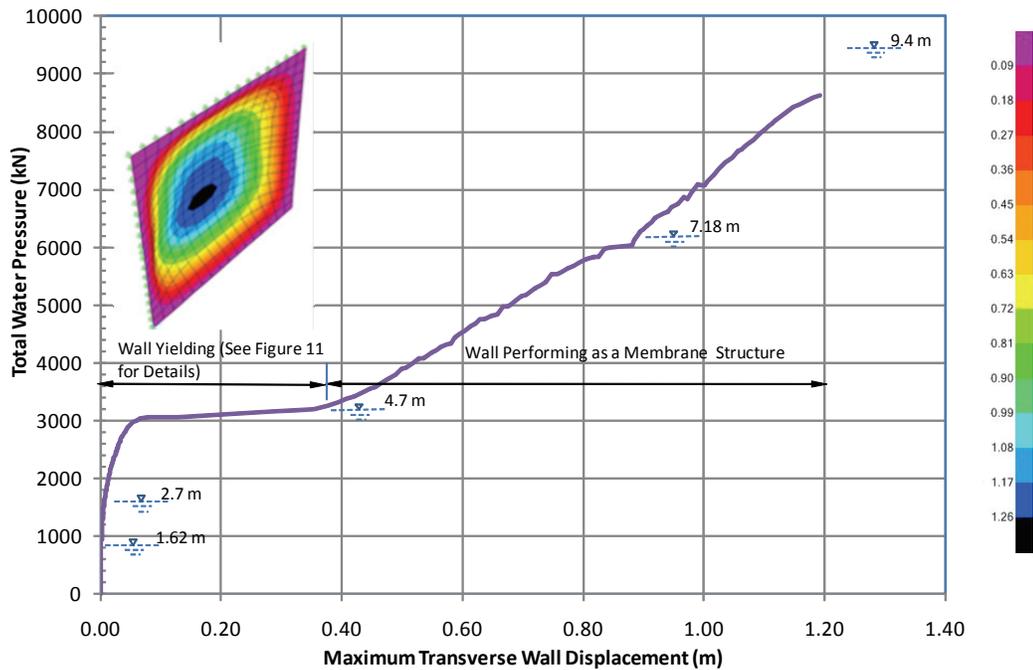
The calculated maximum out-of-plane wall displacement near the center of the wall is plotted against the total lateral load, which equals the integrated tsunami water pressure (Figure 8). The deformed shape of the wall at this stage is also shown. The wall stiffness started to reduce after concrete cracking at the wall base as soon as the tsunami inundation reached 1.6m, and then the slope further reduced as the tsunami water level rose. At the depth of 4.7m, the reinforcing steel yielded at almost all critical areas and the wall changed from a flexural system to a catenary system.

Figure 8. Load history of the total applied force versus maximum displacement of the wall

When the flow level approached 9.4m, reinforcing steel stress reached 730MPa at the wall base and both ends of the horizontal beam. Reinforcing steel stress reached about 650MPa at other areas. The wall is calculated to fail or blow out due to reinforcing steel fracture or loss of bond in the fragmented pieces of the concrete membrane before the tsunami flow level reached the full depth of 10.5m. The calculated displacement at the center of the wall was over 1m.

It is unlikely that wall reinforcing steel was fully developed for the ultimate strength at the supports of the wall. Anchorage and bond failure likely occurred before the reinforcing steel reached its ultimate strength. This final failure mode was not captured in this model; however, except this anchorage failure the failure modes captured in this analysis were consistent with the final condition observed during the survey. It is concluded that the calculated water pressure distribution accurately reproduced the failure modes found in the wall.

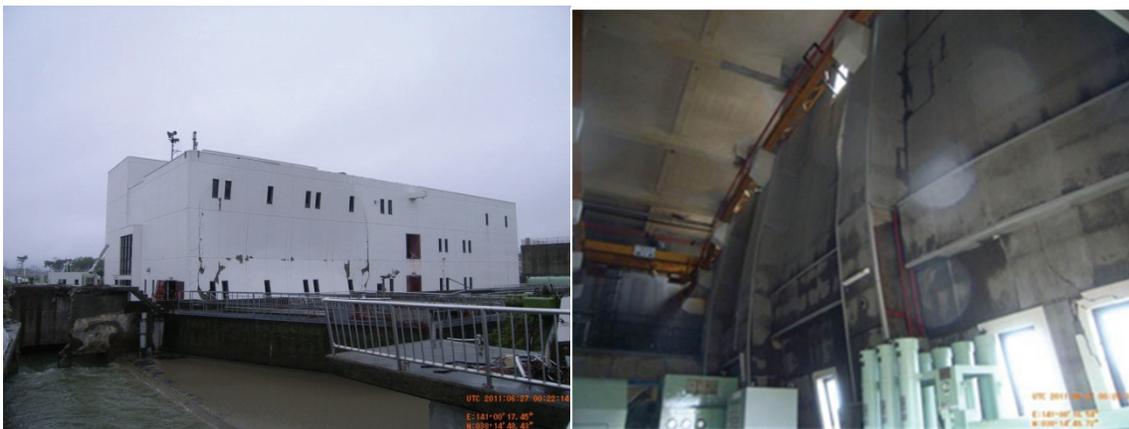
Minami Gamou Wastewater Treatment Plant Direct Tsunami Bore Impact on Wall. The Minami Gamou Wastewater Treatment plant has a number of buildings and structures located on the Sendai coastline, south of the main port and approximately 350m from the coastline. Video of this facility in Sendai showed a soliton bore directly striking the longitudinal walls of buildings. Figure 9 shows the ocean facing wall of one particular building with a two story high-bay on one side of the building that failed through out-of-plane flexure. The other side of the building, where the exposed exterior wall was laterally braced by a floor near the mid-height, did not fail. Therefore the upper and lower bound of bore forces can be obtained by studying this building.

Figure 9. Ocean-facing reinforced concrete wall at the Minami Gamou Wastewater Treatment Plant pump station building damaged by direct strike from tsunami bore (a) exterior view, (b) interior view

Using inundation height estimates by the Joint Survey Group and video footage from the roof of the nearby administrative building, bore velocity and height were estimated. Equation 4 provided the wall force due to a bore strike applied with a triangular pressure distribution with maximum pressure of $2F/(h_b+h_r)$ at the base and zero pressure at a height of (h_b+h_r) . For this building the stillwater height, d_s , was estimated to be 0.5 m from the small inflow preceding the bore. The bore height h_b was estimated at 6 m from the video footage. The bore velocity was estimated from the video at 6.5 m/s. Therefore from Equation 5 the rejected water height, h_r , was estimated to be 5.1 m, which was consistent with what was observed at other buildings shown in the video. The resulting pressure distribution and wall cross section represents a maximum applied load of 780 kN/m of width of the wall. The tsunami surge hydrodynamic drag force following the bore impact was estimated at around 50% of the bore impact force.

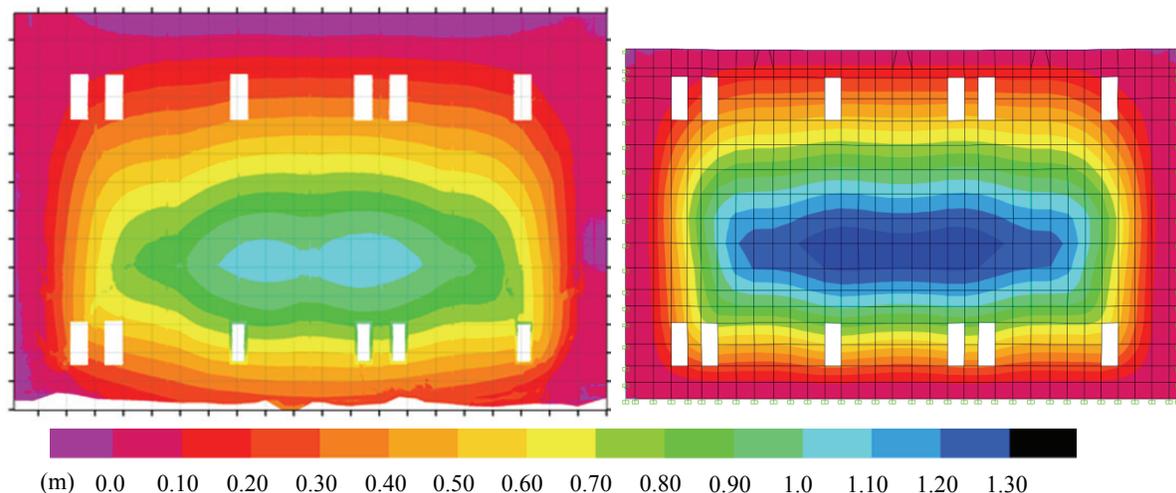
A comparison of the deformation pattern in the wall from a LiDAR scan and the corresponding finite element analysis is shown in Figure 10. With the assumed material properties, the magnitudes of the highly inelastic wall displacements were similar to the observed permanent deformation from the LiDAR imaging. The distribution and magnitude of the highly inelastic calculated wall displacements were in agreement. The bore forces were found to be sufficient to create mid-height and bottom flexural yielding in the wall and columns, and yielding of the roof beams and slab at the top of wall, consistent with the failure mode observed.

Once all the critical components of the wall had yielded, there was minimal post-yield stiffness as the effects of material hardening and large displacement stiffening were offset by the distribution of yielding and P-delta effects. It was concluded that the calculated pressure distribution accurately captured the failure mode of the wall, with the theoretical bore pressure distribution most accurate. The OCADI procedure calculated similar deformation magnitude and profile, while the SMBTR method significantly overestimated the deformations. Applying the different loading distributions to the other side of the building with the wall braced near the mid-height, resulted in minimal calculated damage, consistent with the observed behavior of the building.

Figure 10. Deformation modeling using a triangulated LIDAR scan showing out-of-plane deformation (left) compared to a FEM analysis of damaged wall (right).
