CATEGORIZATION OF DAMAGE TO BUILDINGS CAUSED BY THE 3.11 TSUNAMI

Hiroshi Fukuyama, Hiroto kato, Tadashi ishihara, Seitaro Tajiri, Masanori Tani
Building Research Institute (BRI), Tsukuba, Japan

Yasuo Okuda and Toshikazu Kabeyasawa
National Institute for Land and Infrastructure Management (NILIM), Ministry of Land, Infrastructure and
Transport (MLIT), Tsukuba, Japan

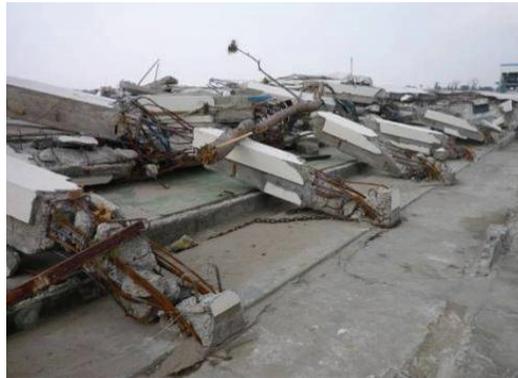
- (1) Pancake Collapse: This reinforced concrete building is completely collapsed due to tsunami loads in transvers direction as shown in Figure 1. The structure is two story moment resisting frame, which has 6 bays in longitudinal direction, and 1 bay in transverse direction. The bending failure at the bottom of 1st story columns indicates that base shear induced by tsunami exceeded lateral load carrying capacity of the 1st story in this building. The round steel bar was used for the reinforcement of elements and it seems to be constructed before the present Japanese building code requirements. Collapse of whole building structure has not been observed in 3-story or higher buildings in the past investigations.

Figure 1. Pancake collapse of a two-story building

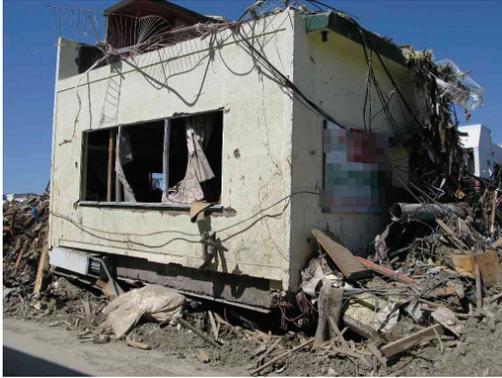
- (2) 1st story collapse: A case where column capitals and bases on the 1st floor in a building were subject to bending failure and subsequently to story collapse was seen in two-story buildings (Figure 2). These buildings have a column-to-beam frame. The first floor has a relatively small number of walls, but many concrete block walls are placed on the second floor. The first and second floors of the building in Picture 1 are used as a shop and dwelling, respectively. The relevant buildings are estimated to have structural characteristics of low strength and rigidity on the first floor. Due to that an opening on the second floor is not large, it is assumed that the second floor suffered a large tsunami wave pressure and a shear force acting on the first floor exceeded the same floor' lateral load-bearing capacity, resulting in the collapse of the building.

Story collapse of a first floor has not been observed in 3-story or higher buildings in the past investigations. In 3-story buildings, in general, reinforced concrete walls are often used for a first floor. For this reason, the first floor's strength is considered to have been larger in these buildings, and it is difficult to refuse the possibility of collapse in 3-story or higher moment resisting frame by tsunami loads.

Figure 2. 1st story collapse of a two-story building

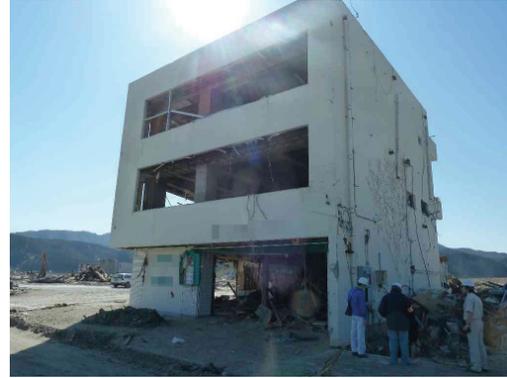
Figure 3. Survived three-story building

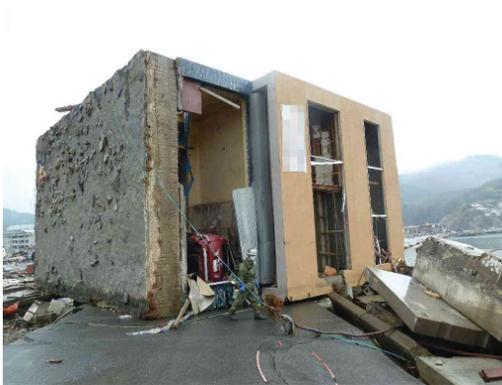
- (3) **Overturning and Movement:** Overturning was observed in 4-story or lower buildings. In all overturned buildings, a maximum inundation depth exceeded their height. Overturning types that were observed include building that felt sidelong and building that was turned upside down. Most of overturned buildings are of spread foundation (Figure 4). In one of overturned buildings on pile foundation, piles were pulled out (Figure 5).

An overturning case was often seen in 4-story or lower buildings with the relatively small openings. However, there are many cases where 4-story or lower buildings with large openings were not overturned. Consequently, a size of an opening on an exterior wall is considered to have greatly affected overturning. Some cases are that there were tsunami traces at heights of the upper end of openings on the top floor in the inside of the buildings whose height were exceeded by maximum inundation depths (Figure 6). It is considered that air has been accumulated in an area to the ceiling above the upper end. Overturning is believed to occur when an overturning moment by tsunami wave force exceeds overturning strength by a dead load of a building (considering the effect of buoyancy as required). Even a slight horizontal tsunami force may overturn a building, in which a distance from an opening's upper end on each floor to a ceiling is long, when buoyancy significantly acts on the building.

Figure 4. Overturned building with mat foundation

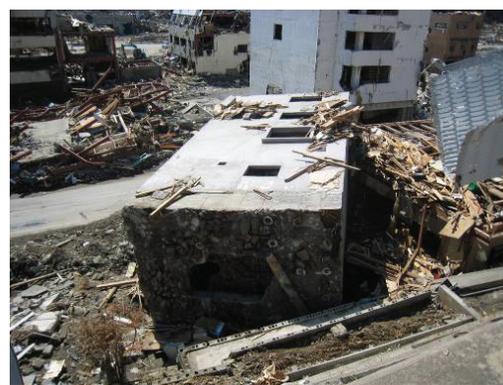
Figure 5. Overturned building with pile foundation

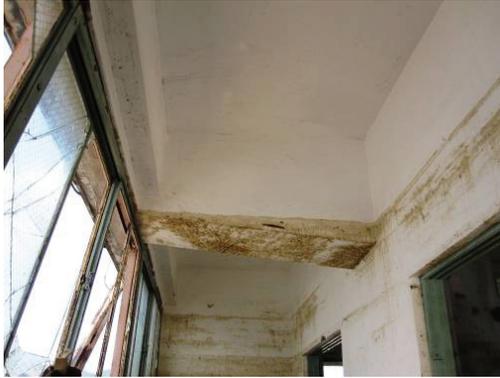
Most of overturned buildings were moved from their original positions. It is estimated that large buoyancy acted on the buildings. The overturned four-story building moved 70 m from its original positions without dragged traces on the ground. One of the buildings climbed over a concrete block fence on an adjoining land (about 2 m) without destroying the fence (Figure 7). The building seems to have floated up by buoyancy.

Figure 6. Tsunami traces

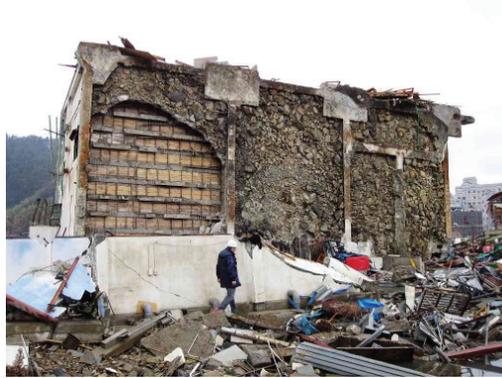
Figure 7. Building climbed over a concrete block fence

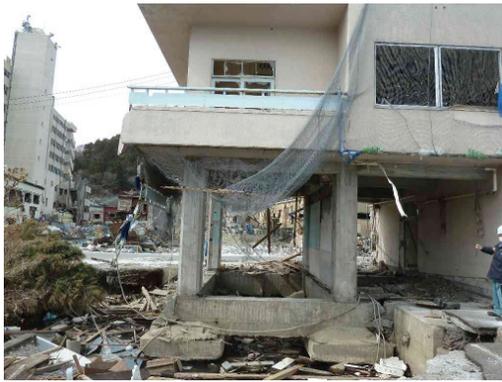
- (4) Tilting and Drifting by scouring: When tsunami acted on a building, a strong stream was generated around the corner of the building, resulting in many large holes on the ground that was bored by scouring (Figure 8). One building on spread foundation fell into a hole bored by scouring (Figure 9)

Figure 8. Large holes on the ground by scouring

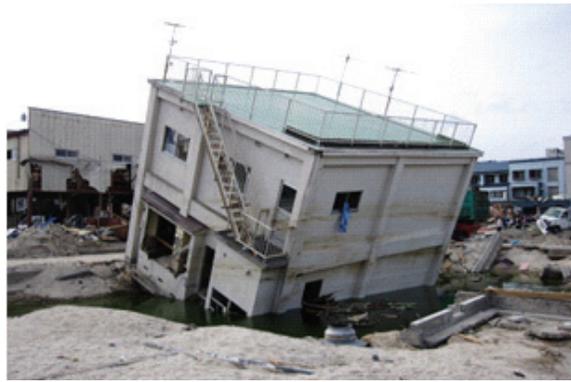
Figure 9. Two-story building tilted by scouring

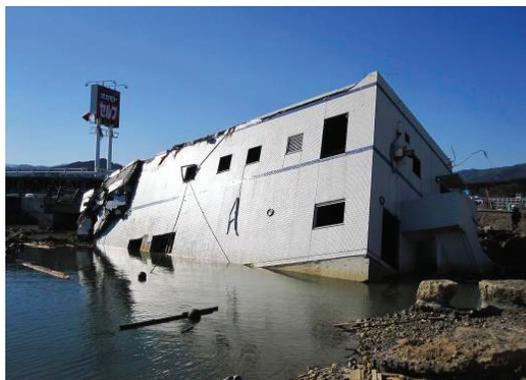
- (5) Sliding: A buildings on spread foundation moved 70 m by a combination of lateral tsunami loads and scouring of footings (Figure 10).

Figure 10. Sliding of two-story building with scoured spread foundation

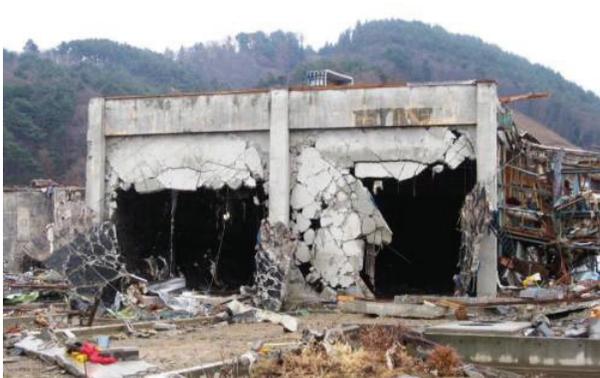
- (6) **Fracture of wall (fracture of opening):** When tsunami acts on openings in a building and opposite openings are smaller than the affected openings, a stream flowing from the affected openings is concentrated on the opposite small openings. In one observed case related to this event, a stream generated by tsunami provided a large pressure to a reinforced concrete non-structural wall around small opposite openings in buildings. The pressure enlarged the concrete wall to the outside and fractured the wall reinforcement. A case where such wall reinforcement was fractured is often seen in wall members with single layer bar arrangement (Figure 11).

Figure 11. Fracture of non-structural RC walls

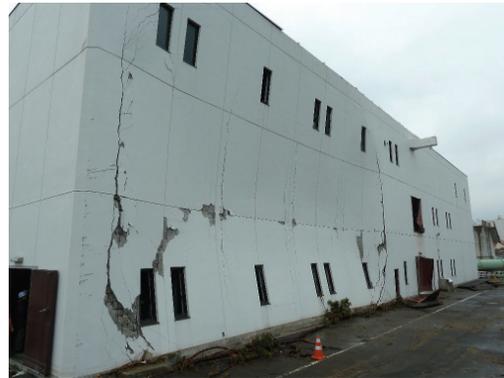
In one case of a damaged building (Figure 12), a 300 mm-thick shear wall with double layer bar arrangement and a support span of more than 10 m and without no 2-story floor was bent inside by a tsunami wave pressure. However, a shear wall in an area (Figure 12, Back of the building), where there is a floor on the second story and a support span is not long in the same building, was not bent. A tsunami wave force that acts on a building will be reduced if the building's opening becomes larger. However, a size of outlet openings should be also taken into consideration in order to flow out of the building in design.

Figure 12. Out-of-plane fracture of RC shear wall

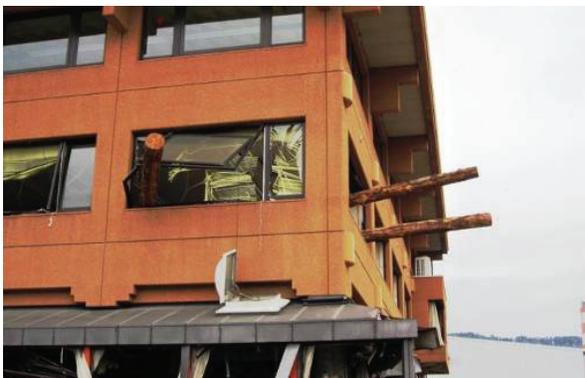
- (7) **Debris Impact:** Variant debris such as wooden logs (Figure 13), cars, shipping containers, and ships are attacked on the buildings. In most of those buildings, non-structural members such as window, ceiling materials and veranda are broken. The obvious damage to structural frames was not observed, but in one case, a multi-story wall in an apartment house was probably bored by debris impact (Figure 14).

Figure 13. Debris (Wooden Log)

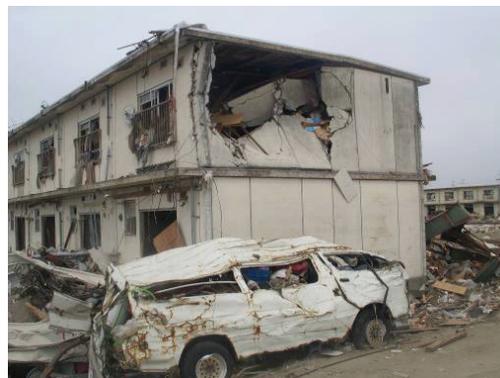
Figure 14. Precast concrete wall opening generated by debris impact

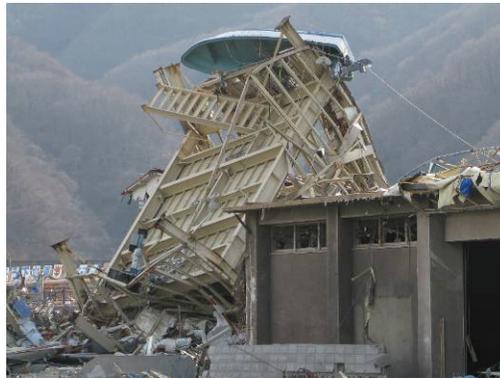
Figure 15. Steel building overturned by fracture of column base anchor bolts

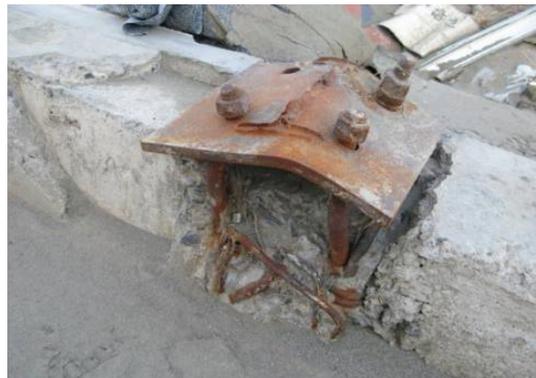
- (1) Movement and washout by fracture of exposed column base: A typical case of building movement and washout is that a building moved and flew due to the fracture of anchor bolts and/or base plates at steel exposed column bases and the fracture of a weld between the column and the base plate (Figure 16). In most cases, a foundation and some column bases were left in a site (Figure 16), but the body of a building was moved beyond the site and missing.

Figure 16. A building washed out due to the fracture of anchor bolts and/or base plates

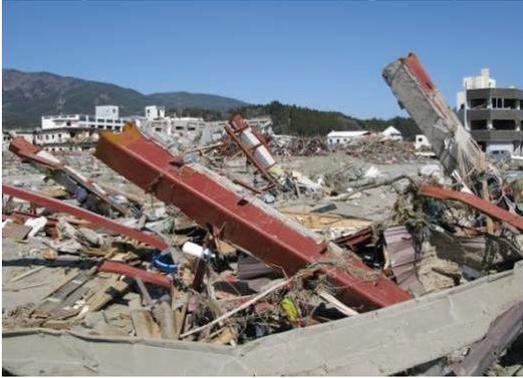
In one case, a foundation in a building, and several columns on a first floor (or up to a second floor) were left on a site, and the columns fell in the same direction as if the building's trace had been indicated (Figure 17). In most cases, a weld between a diaphragm with upper flange and 1st-floor column was fractured and a section of the column was exposed. In one building, flanges of 2nd-floor

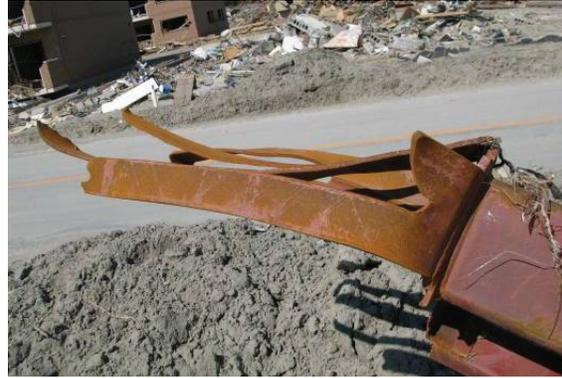
H-shaped beams were torn (Figure 18).

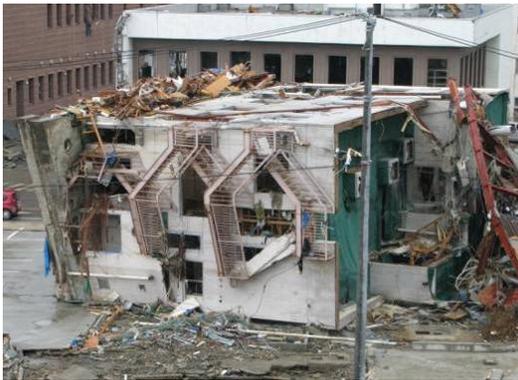
- (3) Overturning: Overturning of steel building structures is classified into two cases; (a) overturning of overall frame with base foundation, (b) overturning with partially collapse of 1st story. The former type of overturning was observed in a four-story building with pulling out of piles in Onagawa (Figure 19). A large part of exterior ALC panels survived in the building. The distance from slab on the upper floor to the upper end of openings is about 800 mm. The buoyant force on each floor will be 0.8 ton/m² supposing water inflow completely inside of the building, which is almost equal to the self-weight of the buildings.

It seems that the overturning of the building will cause easily, though the weight of base foundation and the piles resist to overturning.

Figure 19. Overturned four story steel building

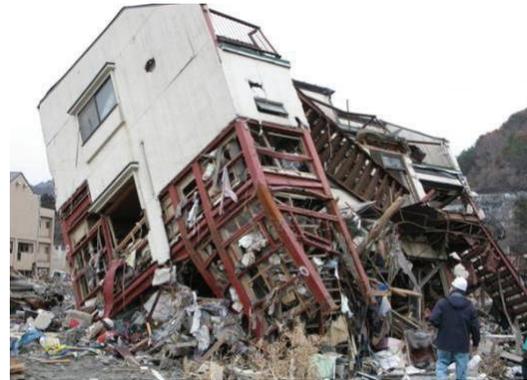
The latter type of overturning generates due to a pull out and buckling of 1st story columns. (Figure 20)

Figure 20. Overturned building with a pull out and buckling of 1st story columns

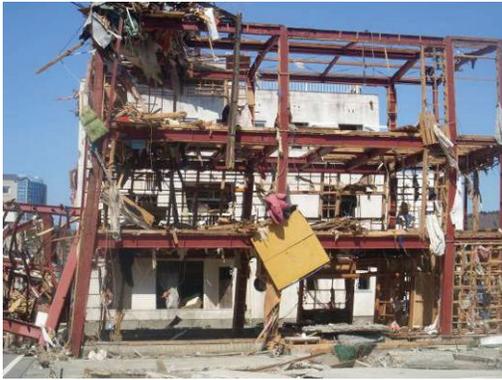
- (4) Large residual deformation: Slight tilting was often observed in steel constructions with only a skeleton left (Figure 21).
- (5) Full fracture and washout of cladding and internal finishing materials: Cladding materials such as ALC panel were almost fully fractured and washed away, and a steel frame as a skeleton was left. This case was often seen (Figure 22). Due to early washout of the cladding materials, an external force that acts on the skeleton became small. This is considered to contribute to the residual building. In the residual building, slight tilting of the skeleton, member deformation on a face affected by tsunami, or members locally damaged possibly by debris impact, was observed.

Figure 21. Residual deformation in 3-story steel building

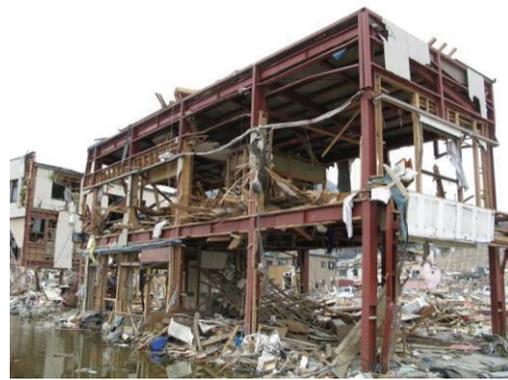
Figure 22. Residual 2-story steel building

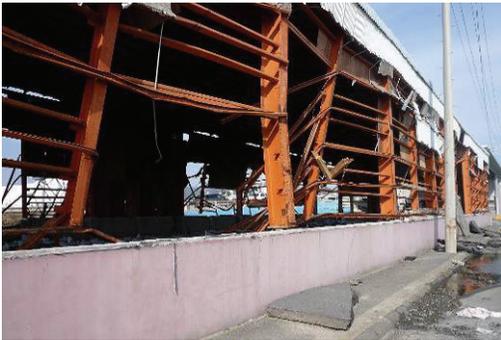
- (6) Local deformation in structural frames and nonstructural elements: Columns, braces and nonstructural elements are deformed locally by tsunami wave pressure or debris impact force.

Figure 23. Local deformation of columns

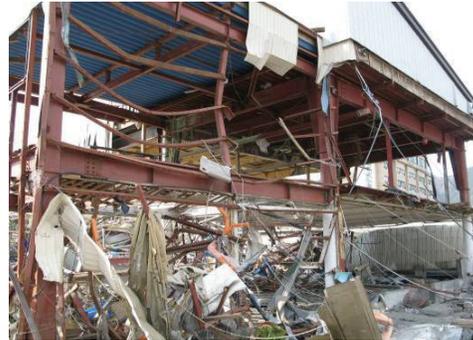
Figure 24. Local deformation of nonstructural elements
