# PERFORMANCE OF BASE-ISOLATED BUILDINGS UNDER THE 2011 EAST JAPAN EARTHQUAKE

Yoshikazu Fukasawa\*

Soon after the earthquake, the Japan Society of Seismic Isolation (JSSI) established a research committee to find the actual performance of base-isolated buildings.

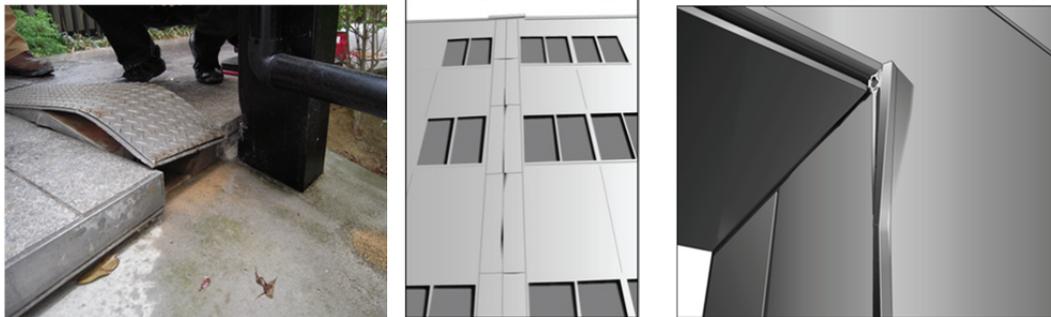
Figure 5. Examples of damage

The examples of damages during East Japan Earthquake are shown in Fig.3.

Floor Panel to Post

Wall Panel

Ceiling Panel to Wall Panel

According to the survey, damages of finishing material to expansion joints were the result of causes listed below.

1. Insufficient consideration of dynamic and cyclic behavior.
2. Unintended contact with other elements.
3. Lack of strength and deformation capacity.

4. Neglecting unique considerations required for joints during construction.
5. Misunderstandings the required deformation capacity to one direction only.

To prevent similar damages at future earthquake, JSSI has developed the recommendations. The recommendations include method of quality control and maintenance management.

The recommendations emphasize the importance of setting up appropriate target performance of finishing material to expansion joints at the design stage and to carry out and maintain the actual performance after construction.

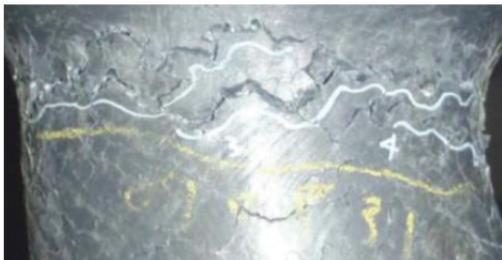
Some cracked lead dampers were found in Sendai and Yokohama. Examples are shown in Fig.6.

(cracked depth) 30mm

The possibility of cracking in lead dampers was reported a few years ago by the manufacturer. The manufacturer had reported that repetition of small strain for many times might cause the crack. The East Japan Earthquake was a huge earthquake and the earthquake motion continued for a long time. Also the aftershocks continued many times. Therefore, such repetition of ground motion is assumed to be the cause of cracks of lead dampers.

When such crack occurred, to know the residual capacity of the lead damper is an important subject. According to our study, the residual capacity can be presumed as follows.

The coating method for preventing crack is now under research.

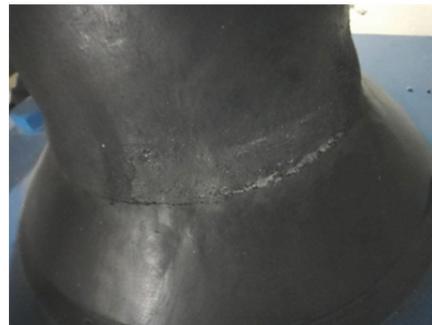
(cracked depth) 7mm.

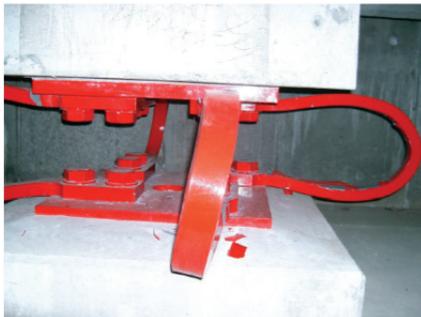
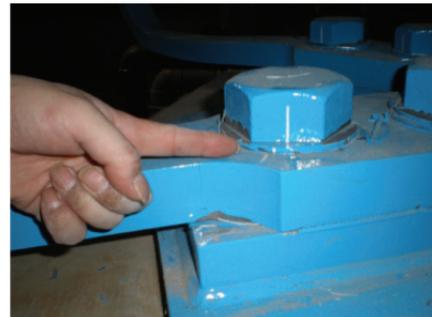
*Figure 7. Damage of bolt fasteners of steel dampers*

The paint coat was peeled off and bolt fasteners were loosened in some steel dampers. (Fig.7)

Suggestions for improving the painting and bolt tightening method have been made.
