Recovery Cooperation for Padang Earthquake Damage by Seismic Isolation Buildings Design

EWBJ (Engineers without Boarder, Japan)

Dr. Takayuki Teramoto Dr. Toshio Okoshi

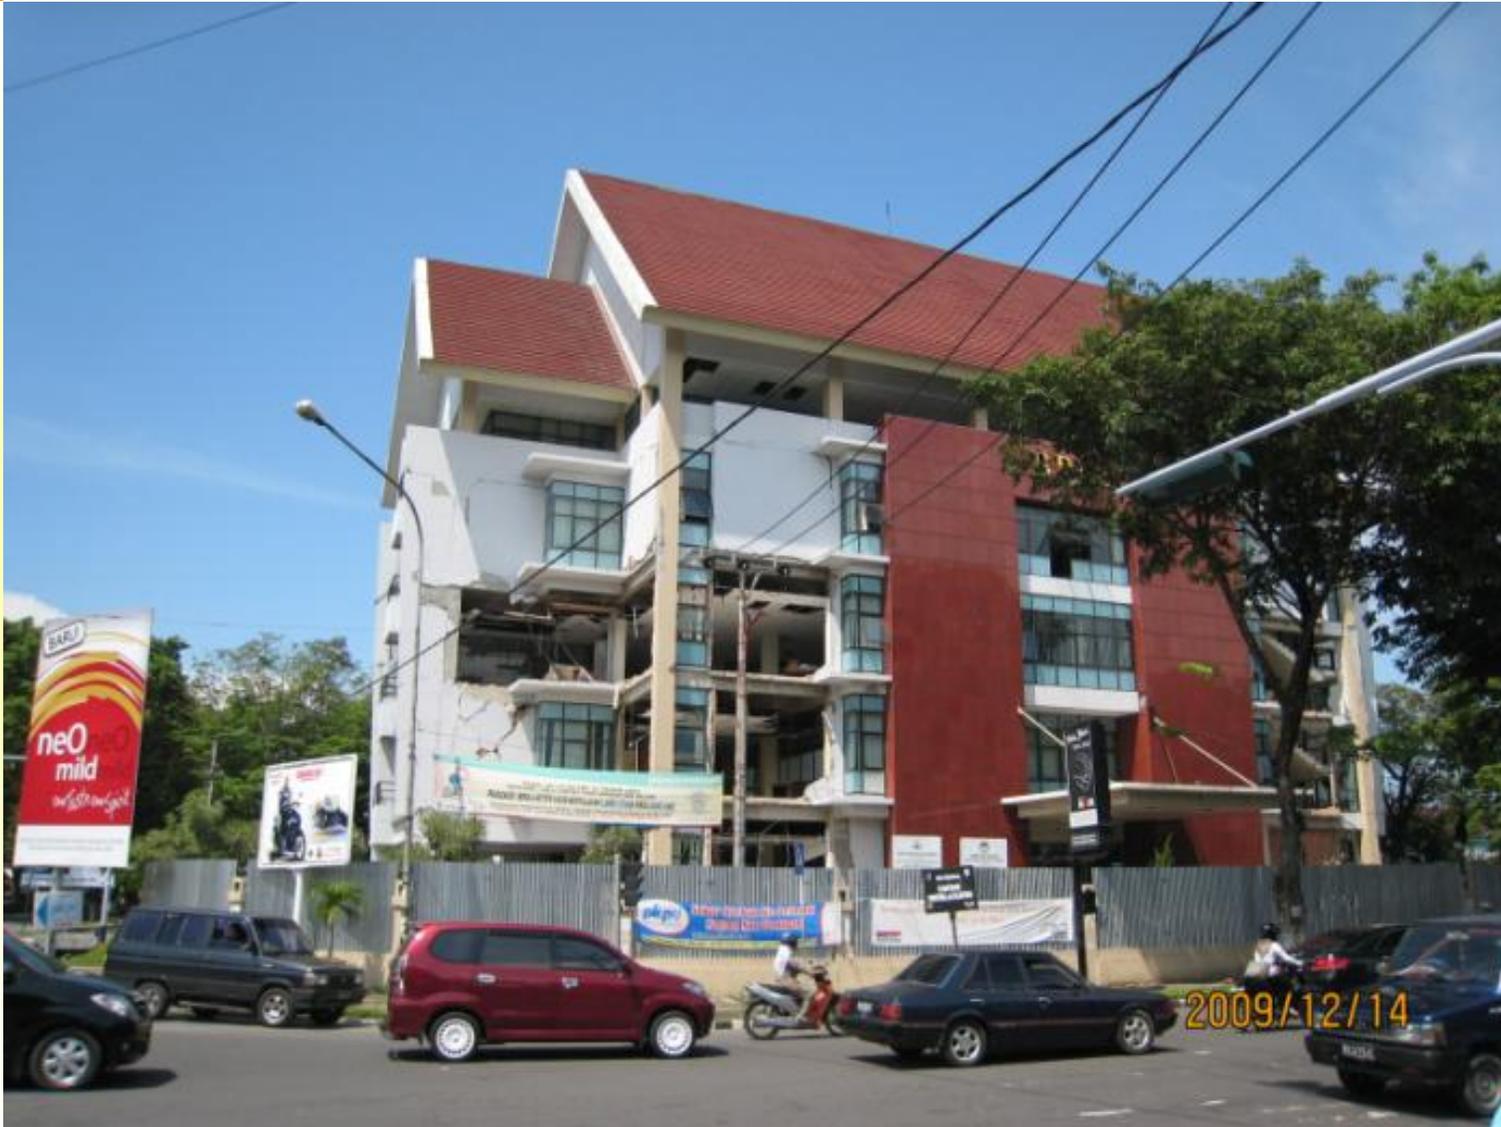
3.1 Building damage 1 / Board of audit (BPKP)

Reinforced concrete rigid frame structure of 6-story with brick wall

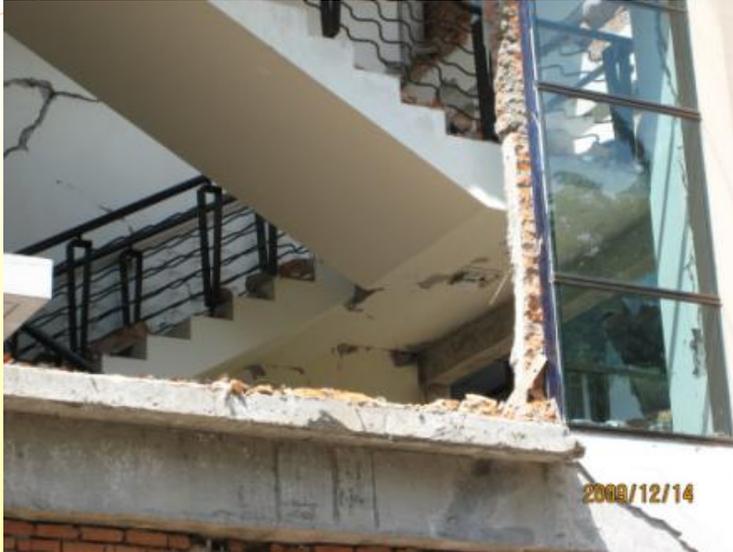
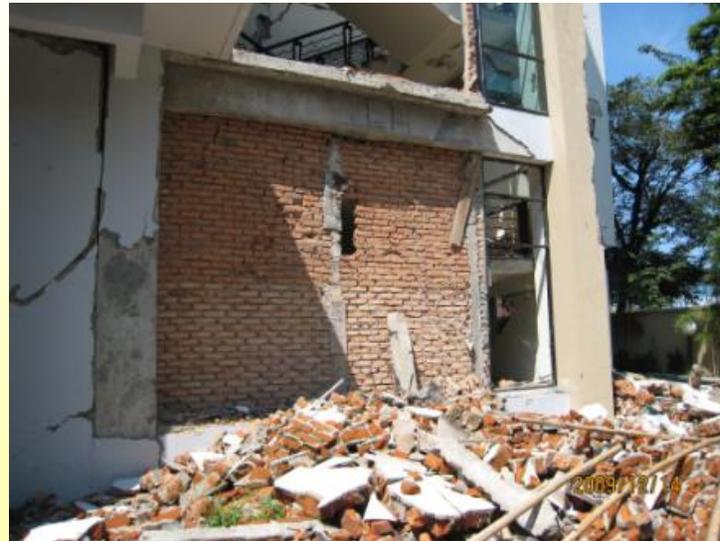
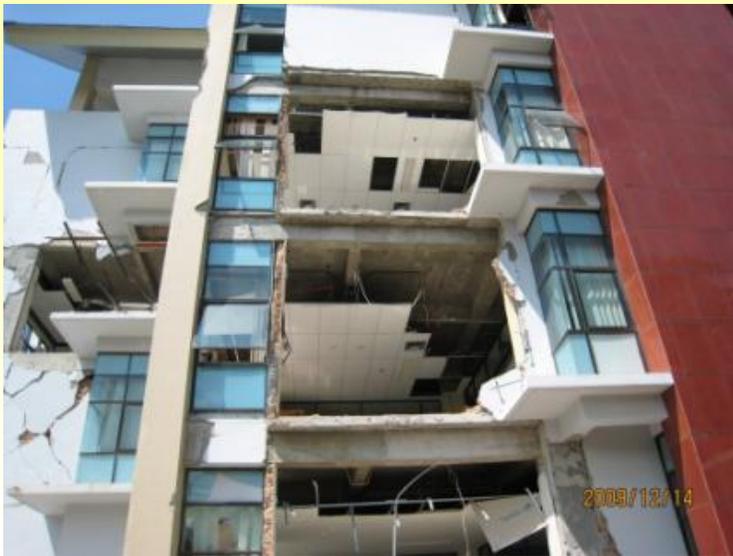
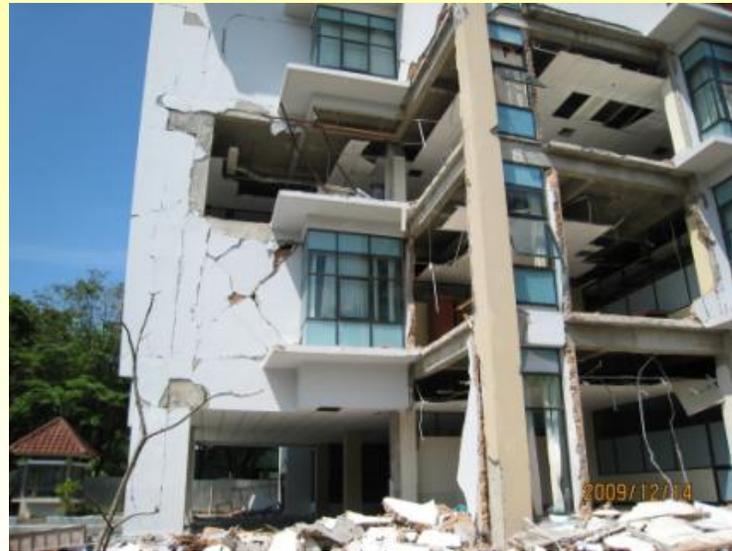
3.1 Building damage 1 / Board of audit (BPKP)

Damage of exterior brick wall and curtain wall

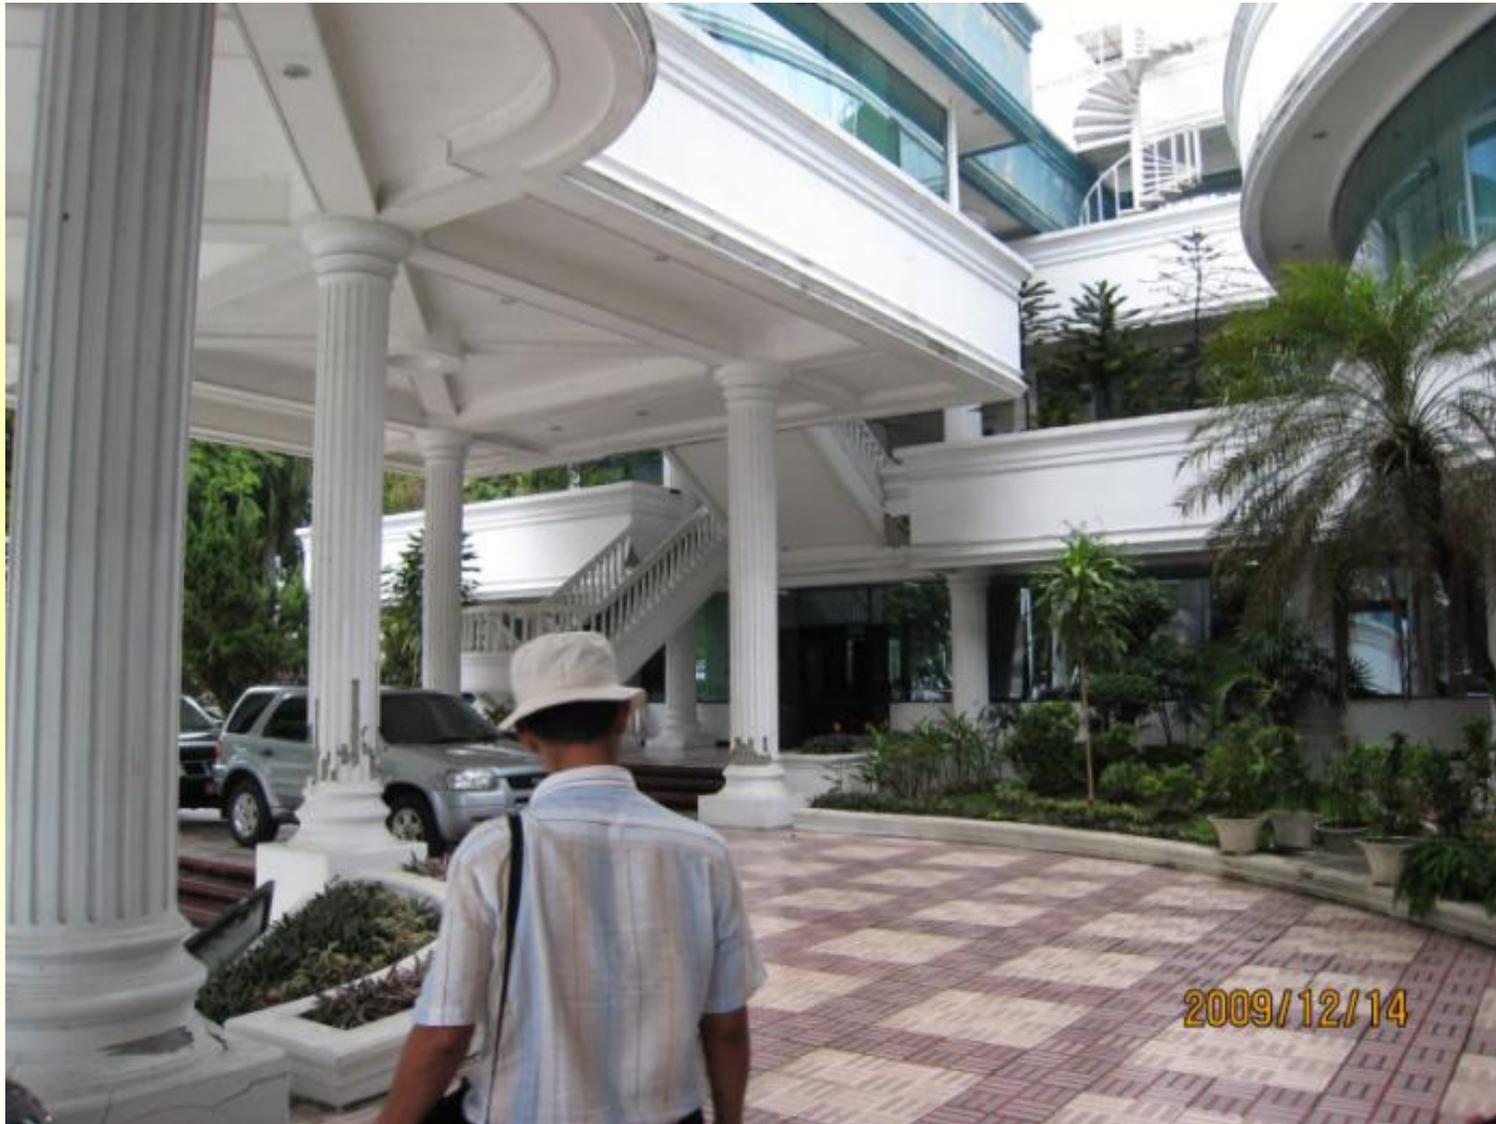
3.2 Building damage 3/ Public works office

Reinforced concrete rigid frame of 4-story with brick wall

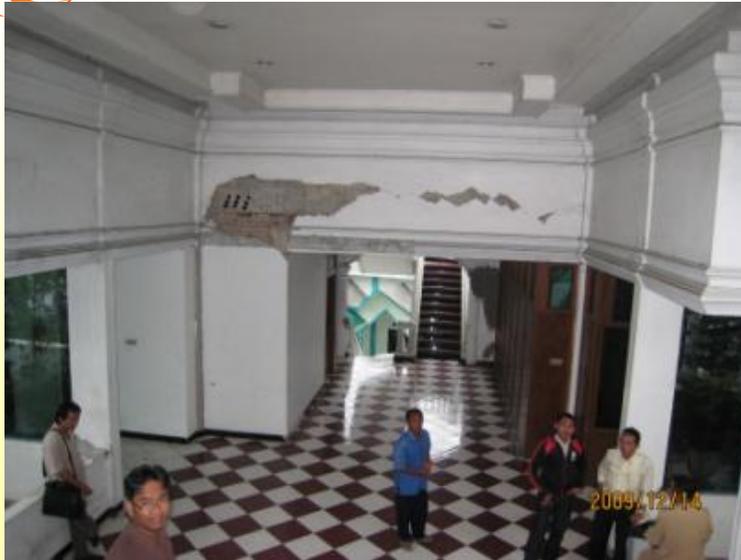
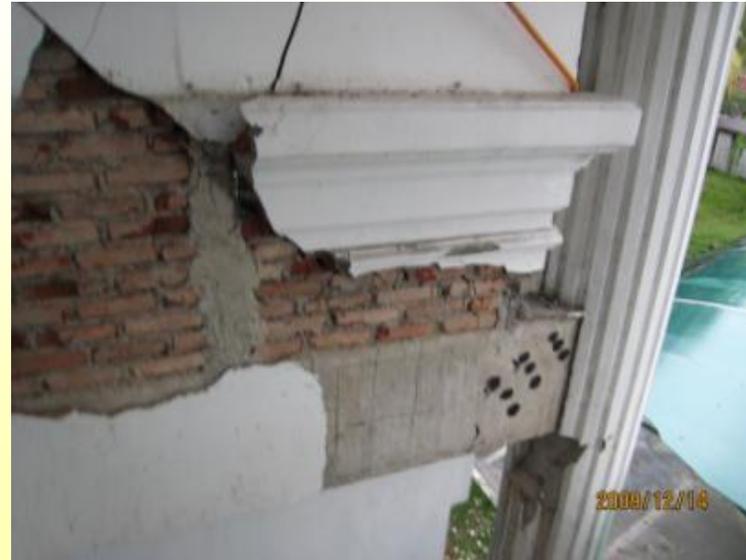
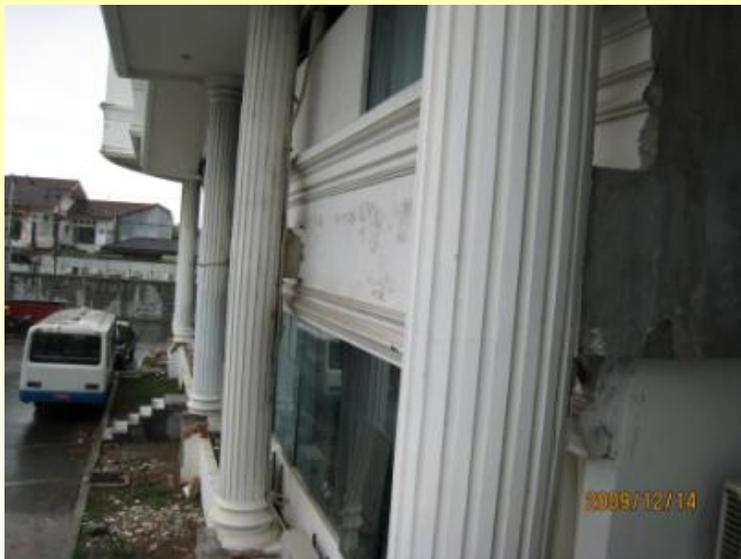
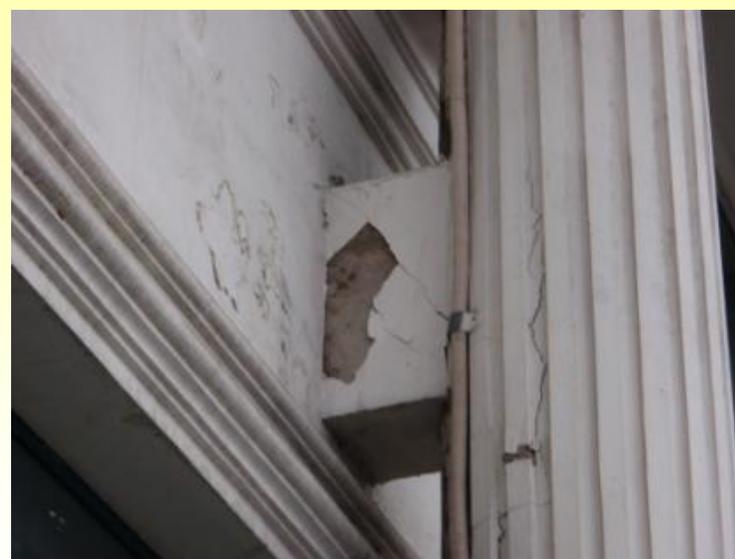
3.2 Building damage 3/ Public works office

Shear-crack of reinforced concrete beams connected to the outer columns

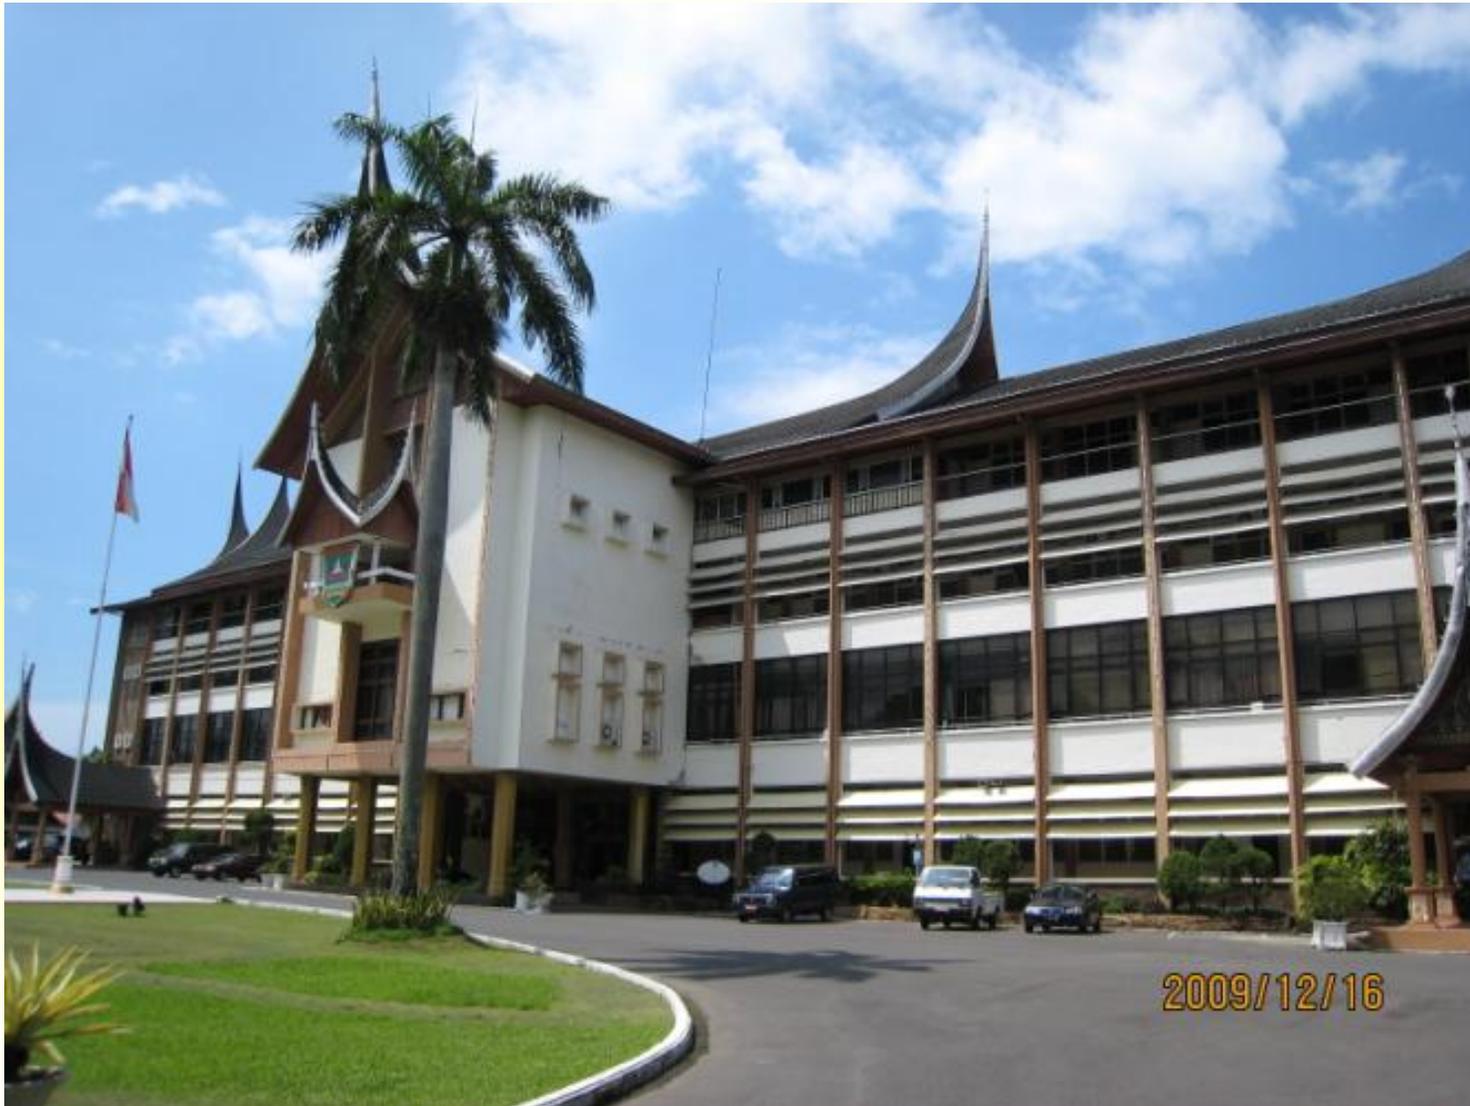
3.3 Building damage 10/ State government office

Historical reinforced concrete rigid frame with brick wall

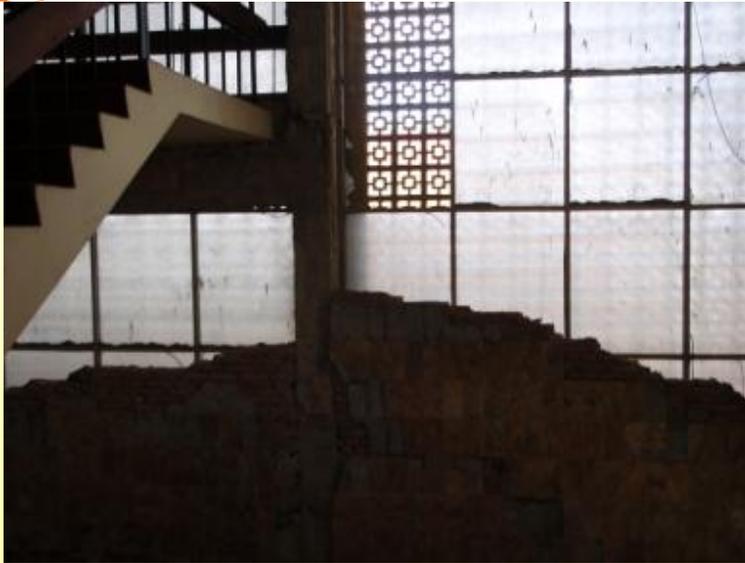
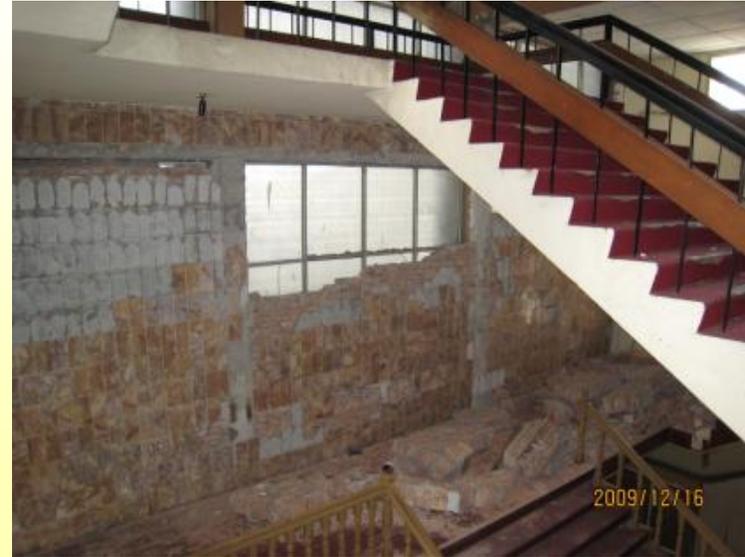
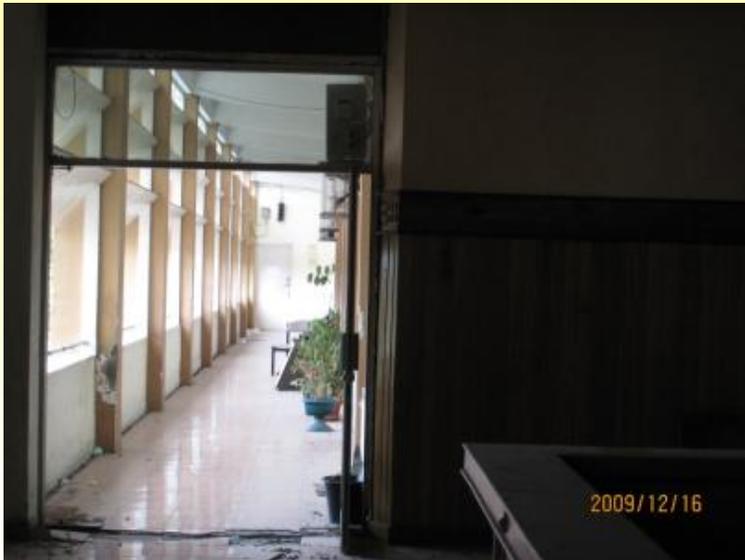
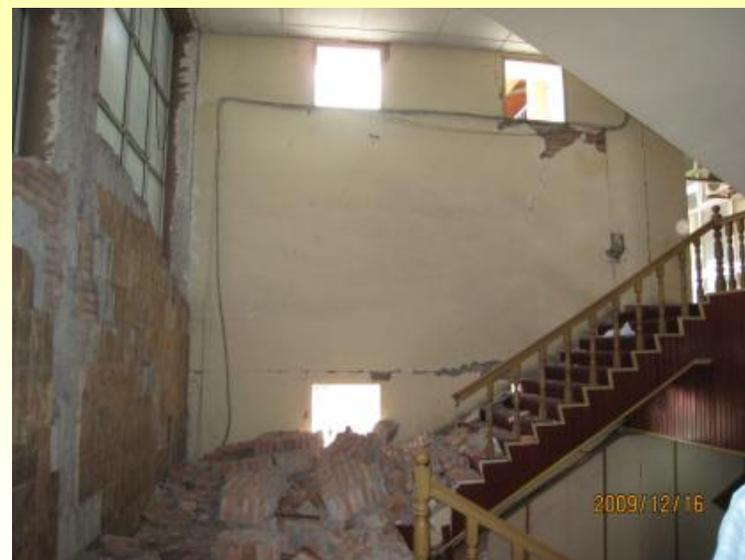
3.3 Building damage 10/ State government office

Brick wall with curtain wall and conflict of exp. joint

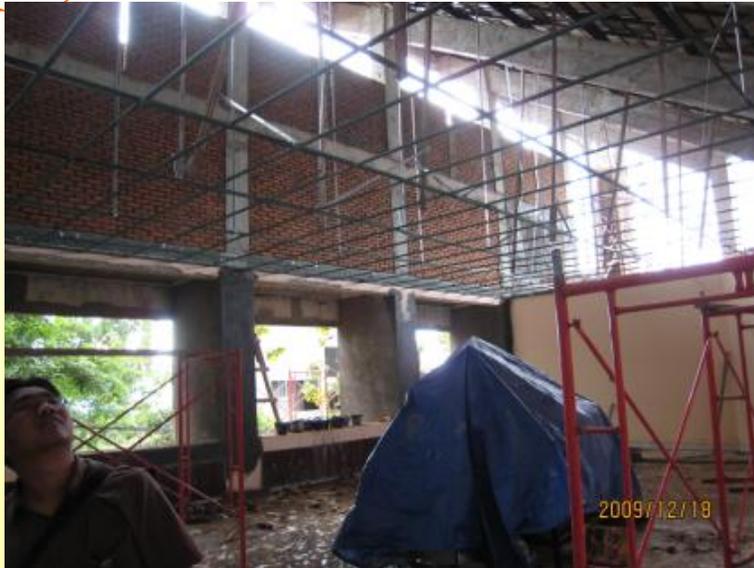
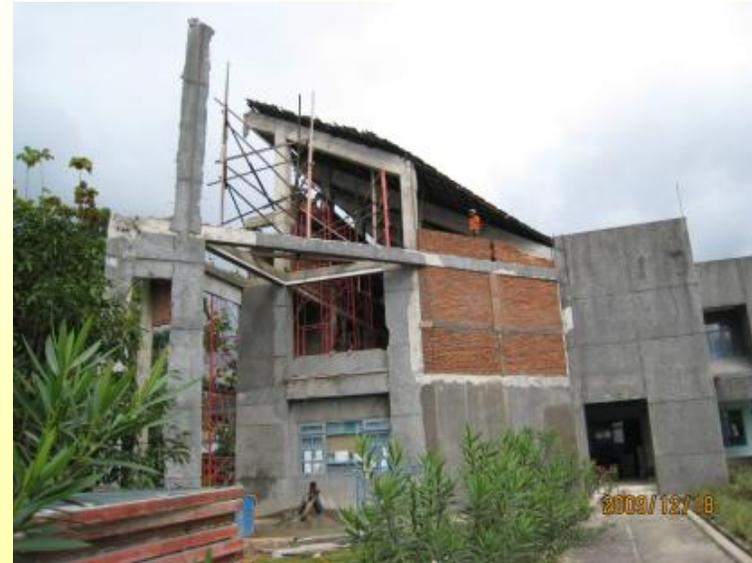
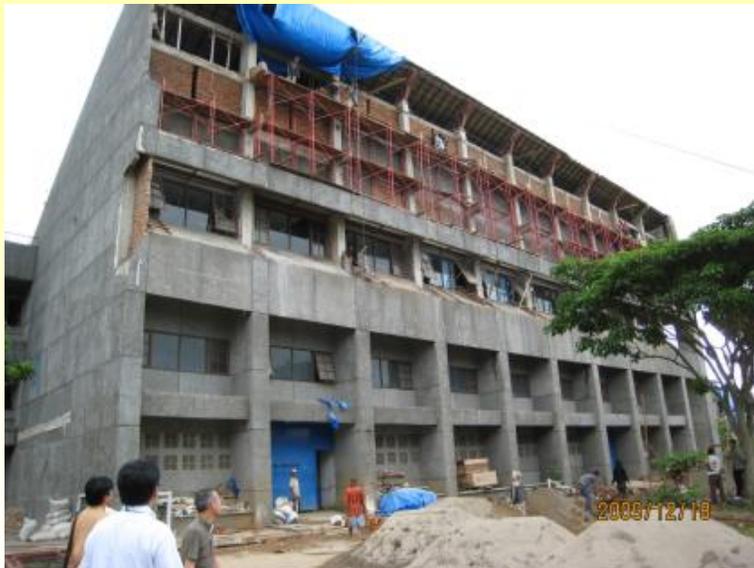
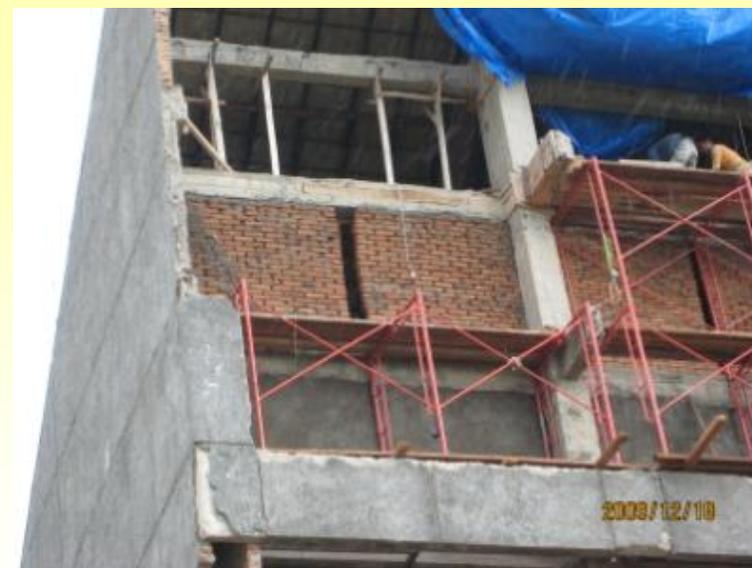
3.4 Building damage/ Andalas university

Falling-down of brick wall, they started to repair using the same method.

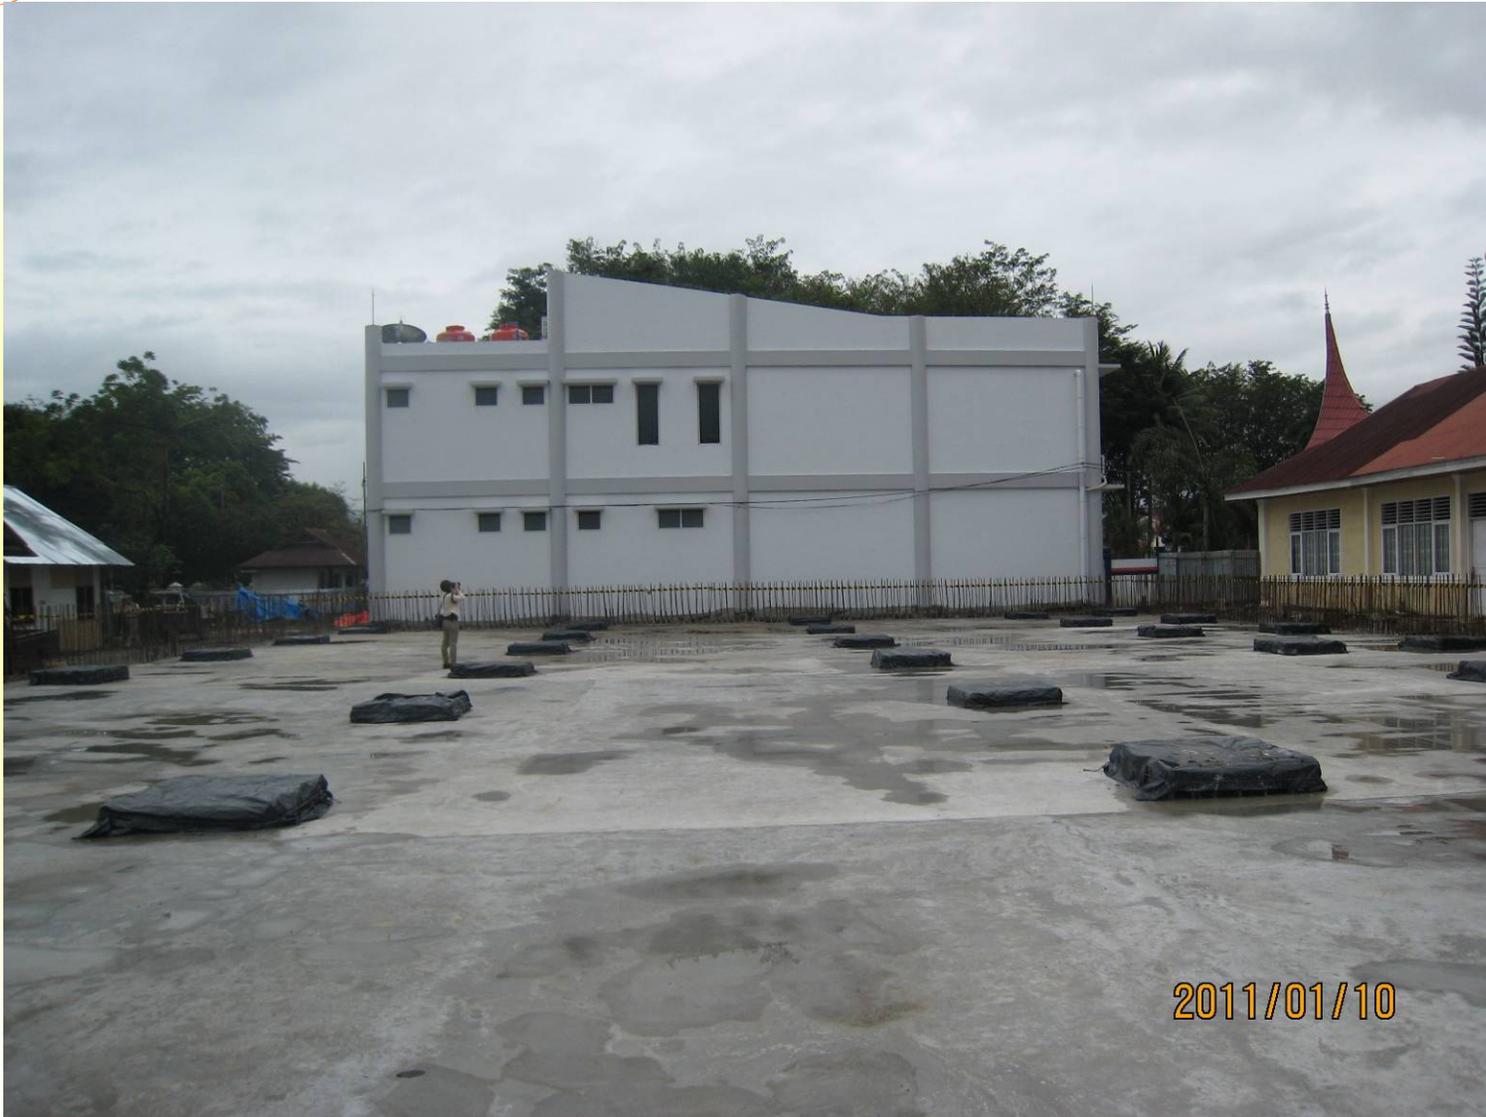
No.1 building construction site

Mat slab is under construction. Governor work space has completed already.
