Performance of Buildings and Nonstructural Components in the 2014 South Napa Earthquake

FEMA P-1024 / February 2015

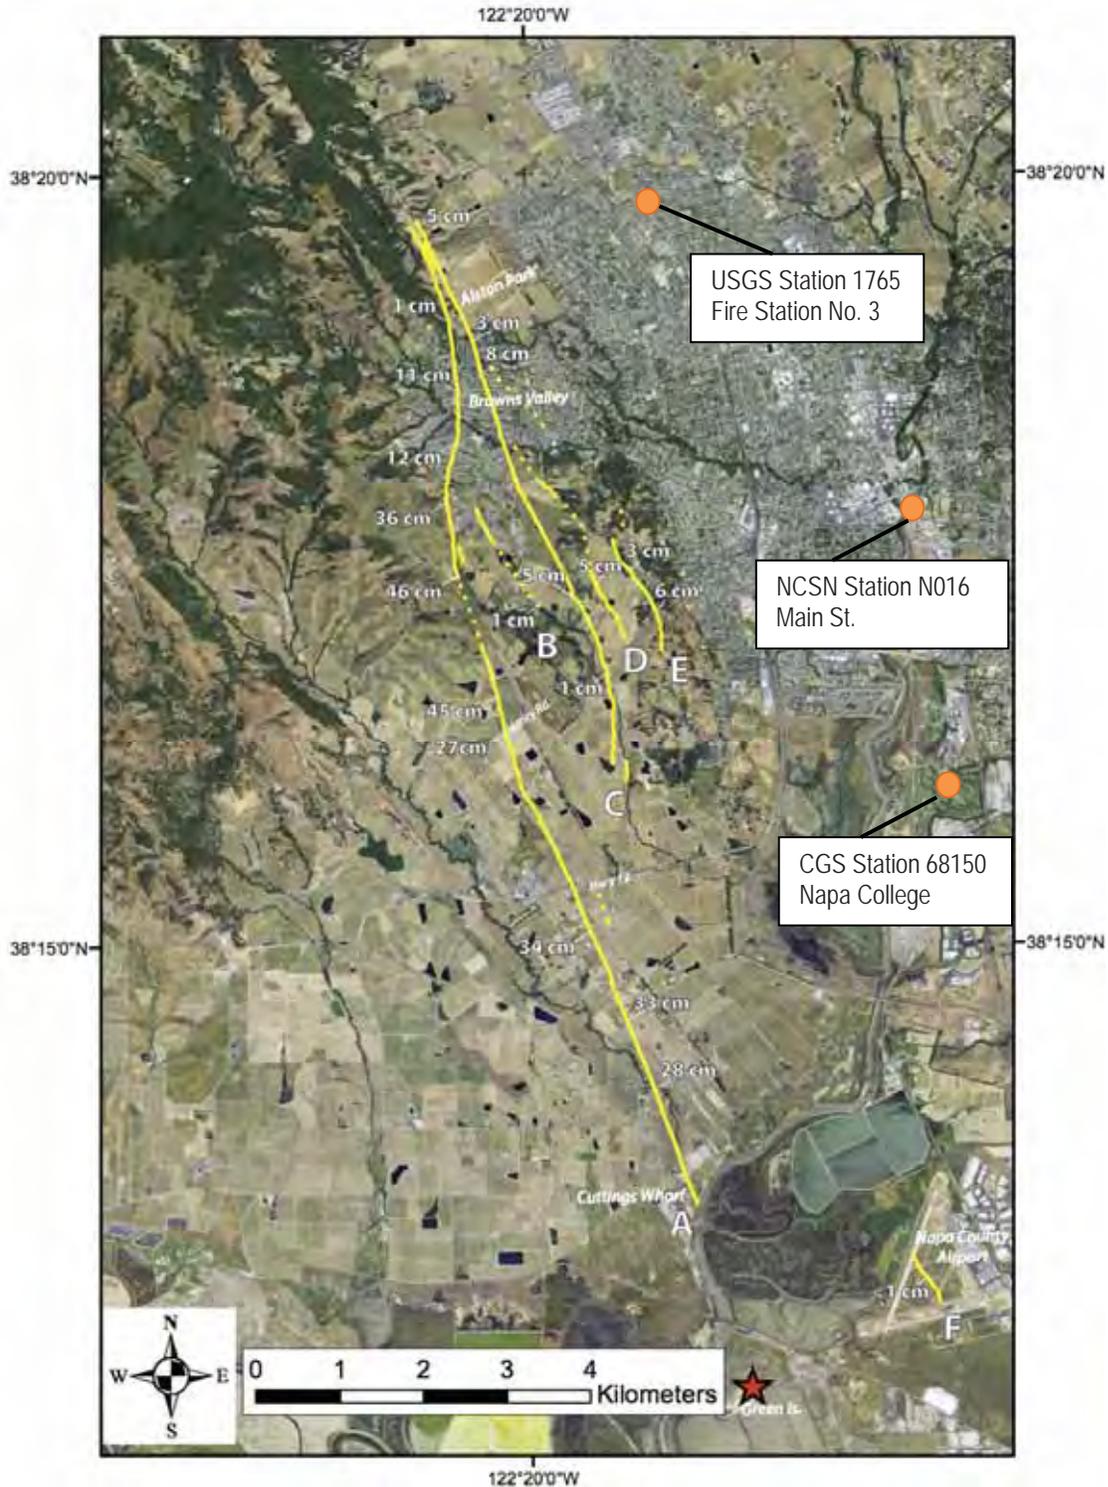
Figure 2-3 Surface faulting (yellow lines) produced by the August 24, 2014 South Napa earthquake (USGS, 2014). Numbers show maximum measured right-lateral offset at selected sites, rounded to the nearest cm; includes both coseismic, as well as measured afterslip as of November 17, 2014. Red star shows the location of earthquake epicenter, orange circles show the location of three ground-motion recording instrument stations.

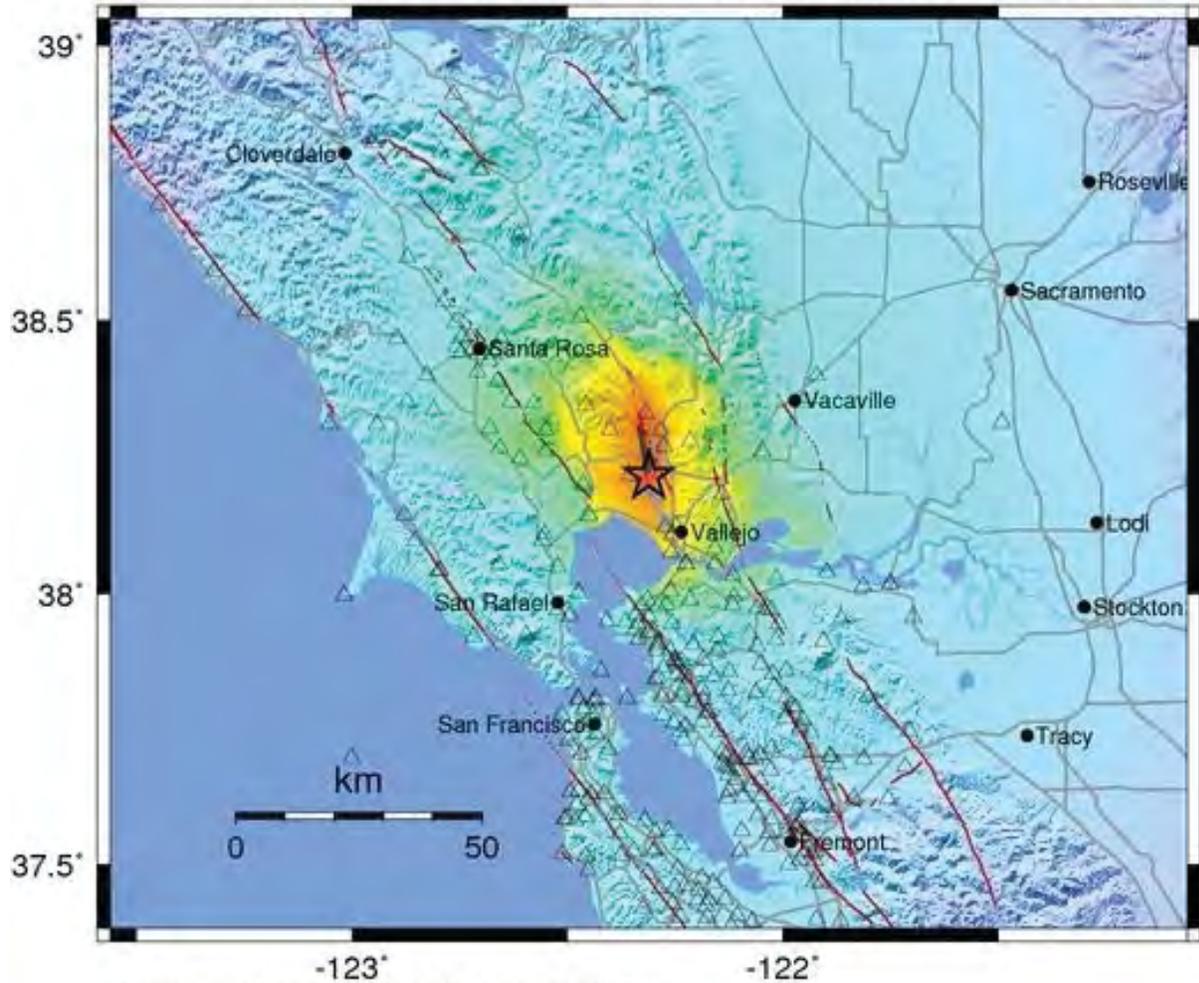
Map Version 27 Processed 2014-09-19 05:13:08 PM PDT

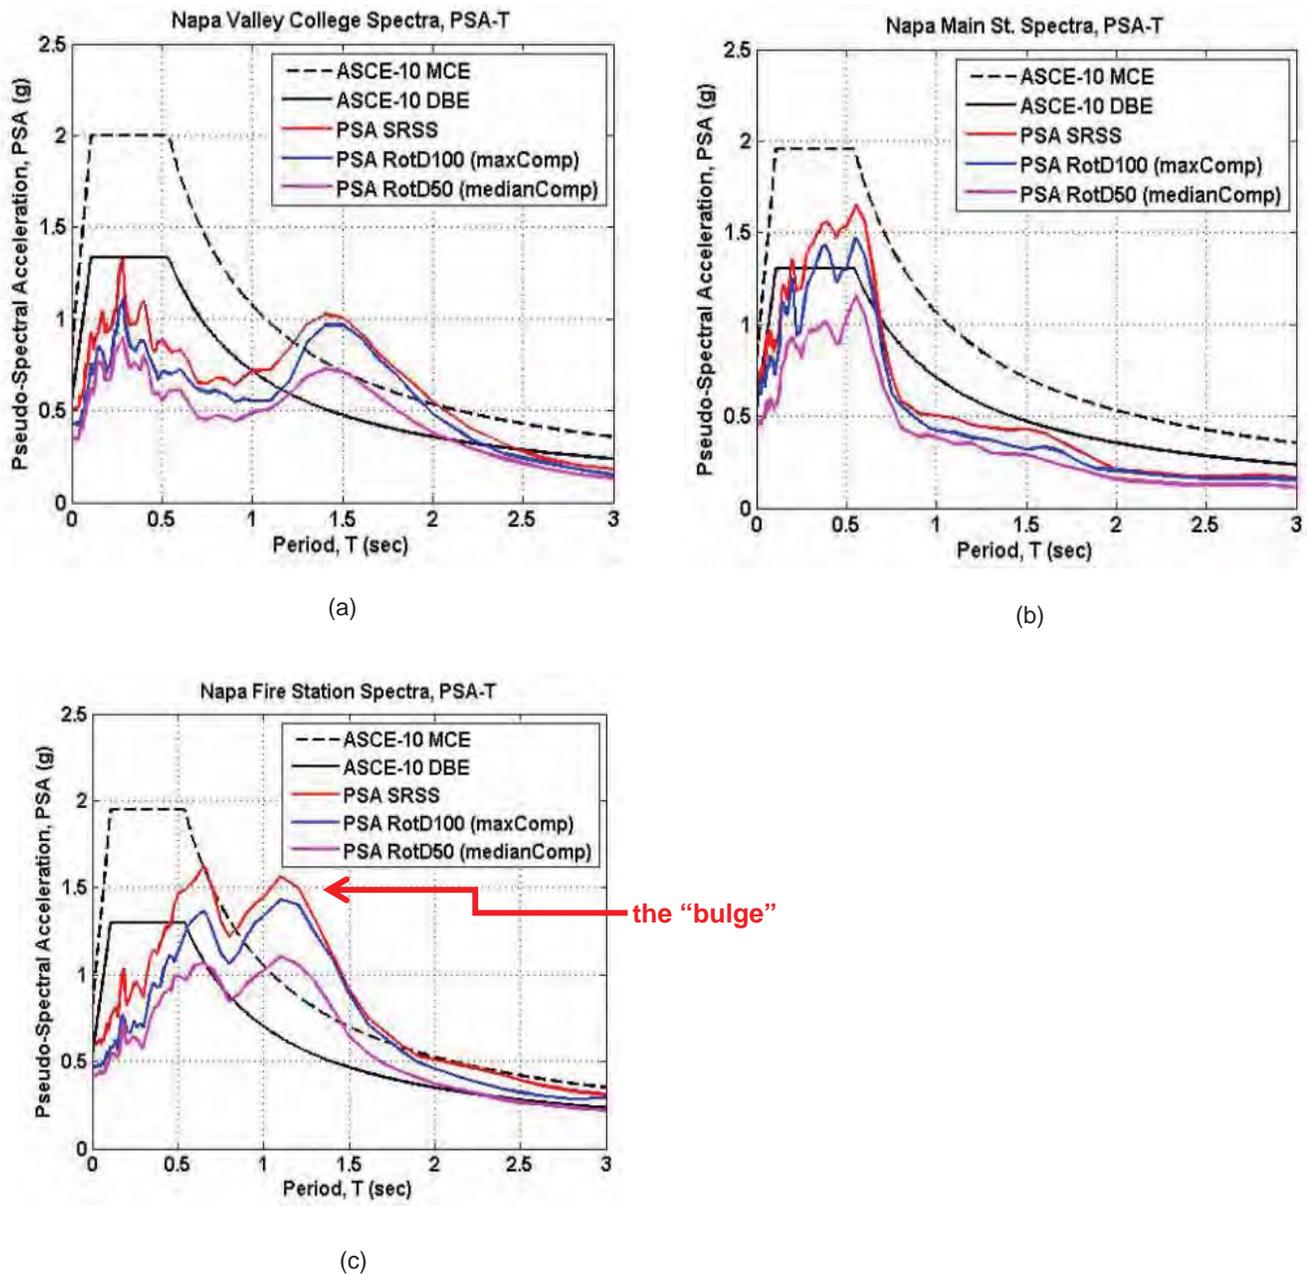
Figure 2-8 Comparison of code-based versus resultant pseudo-spectral acceleration (PSA) spectra on Site Class D for: (a) Napa Valley College; (b) Main Street; and (c) Fire Station No. 3. Red arrow indicates the bulge. From GEER (2015).

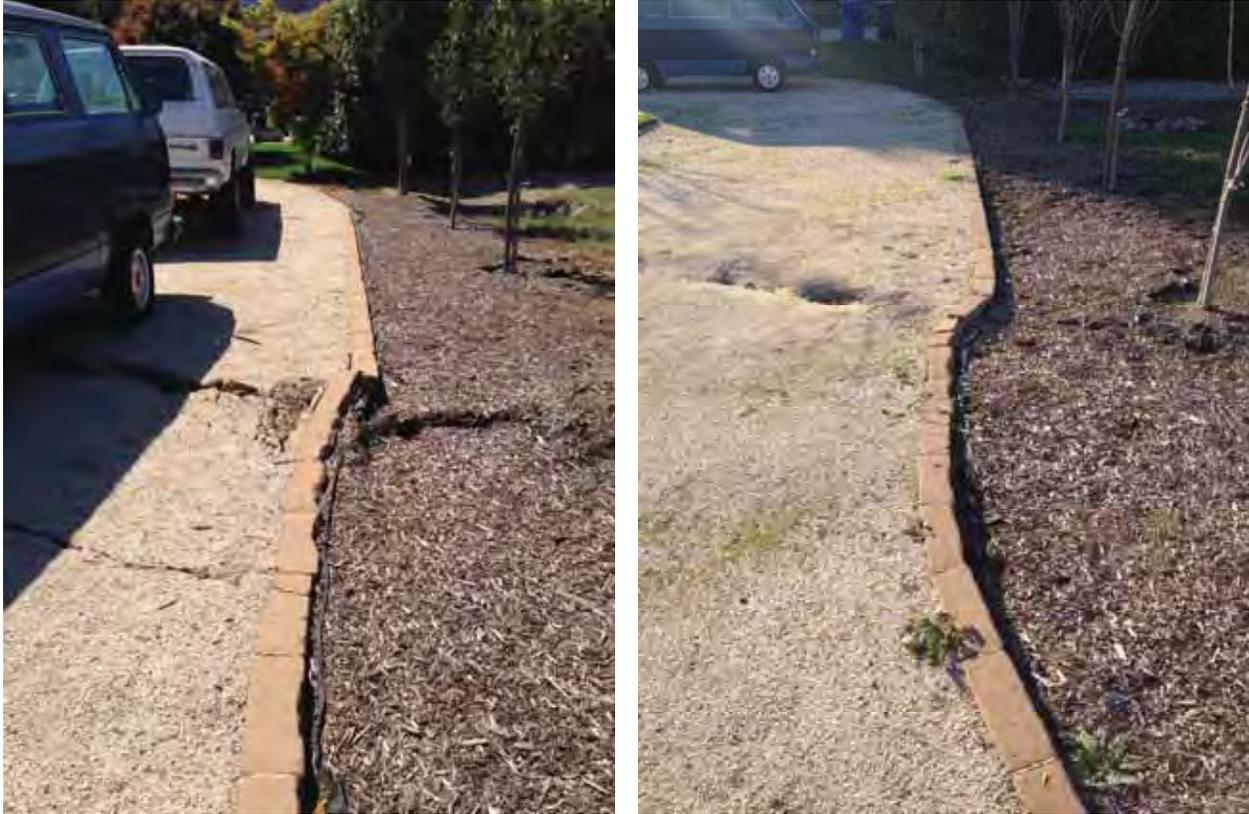
Figure 2-9 shows the same location 11 hours after the earthquake on August 24, 2014 and on January 12, 2015, over four months after the earthquake. According to the USGS, 11 hours after the earthquake (Figure 2-9a), the slip was observed to be several inches, and 135 days later on January 12, 2015 (Figure 2-9b), the slip was measured as 15 inches. Even though the creep rate several months after the earthquake is barely perceptible, the West Napa Fault Zone main strand at this location (and in the south, near Highway 12 crossing) is still creeping faster than the San Andreas fault's creeping section. However, the creep rate is slowing down and is expected to drop down to lower than the San Andreas creep rate in the coming months.

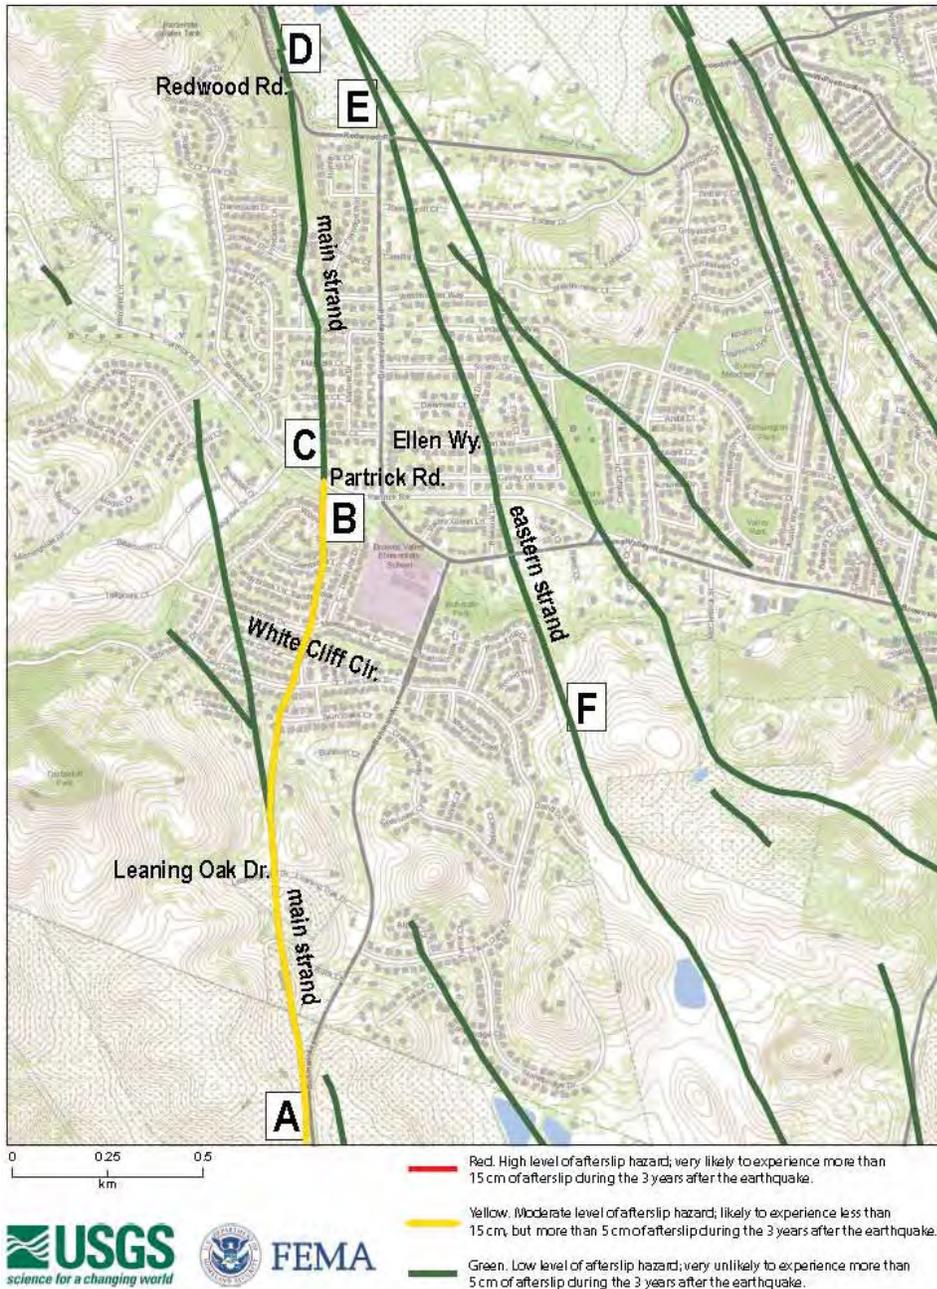
Figure 2-10 Afterslip map (USGS, 2014). Note that there are no red lines in the figure.

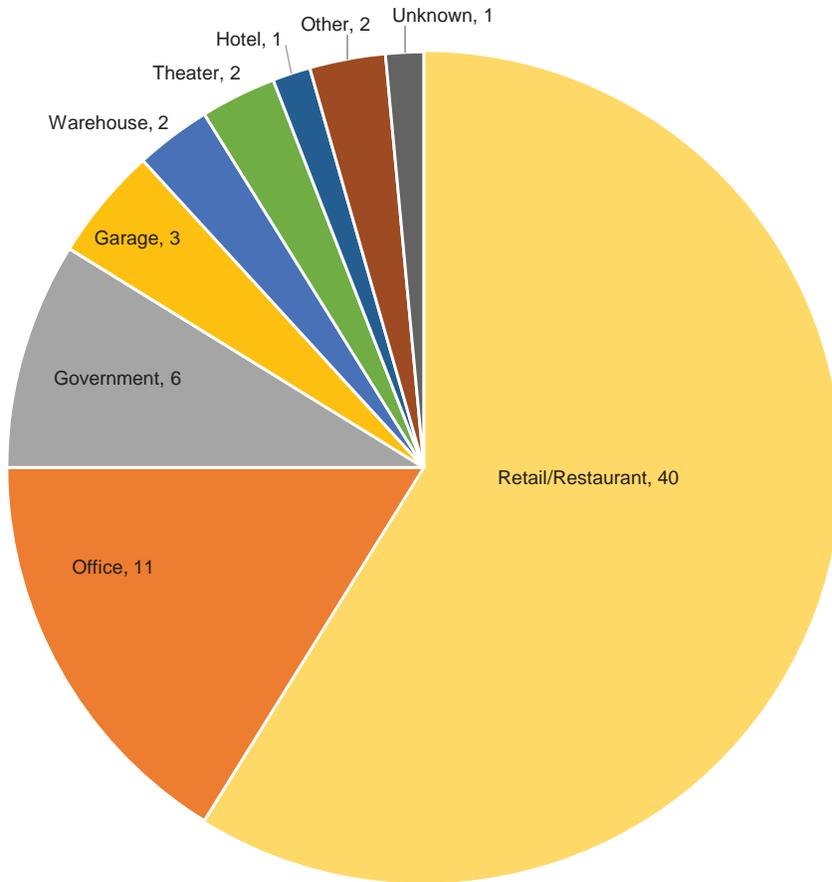
Figure 3-3 Distribution (by count) of buildings by occupancy type (of a total of 68 buildings).

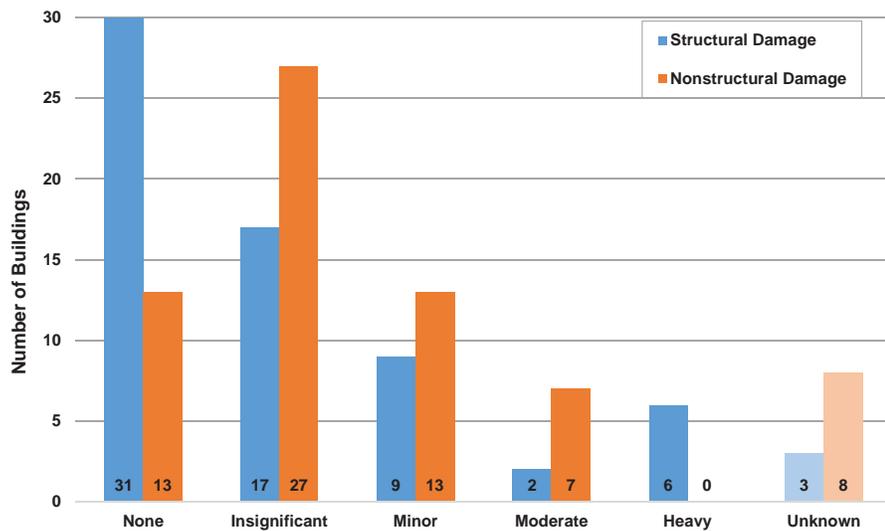
Figure 3-6 Distribution of building damage according to general damage classification.

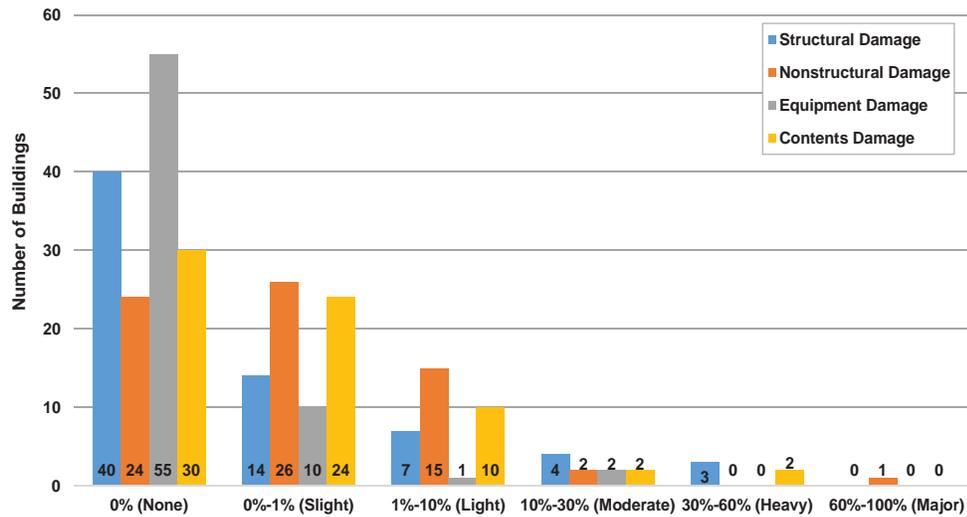
Figure 3-7 Distribution of building damage according to ATC-13 damage states.

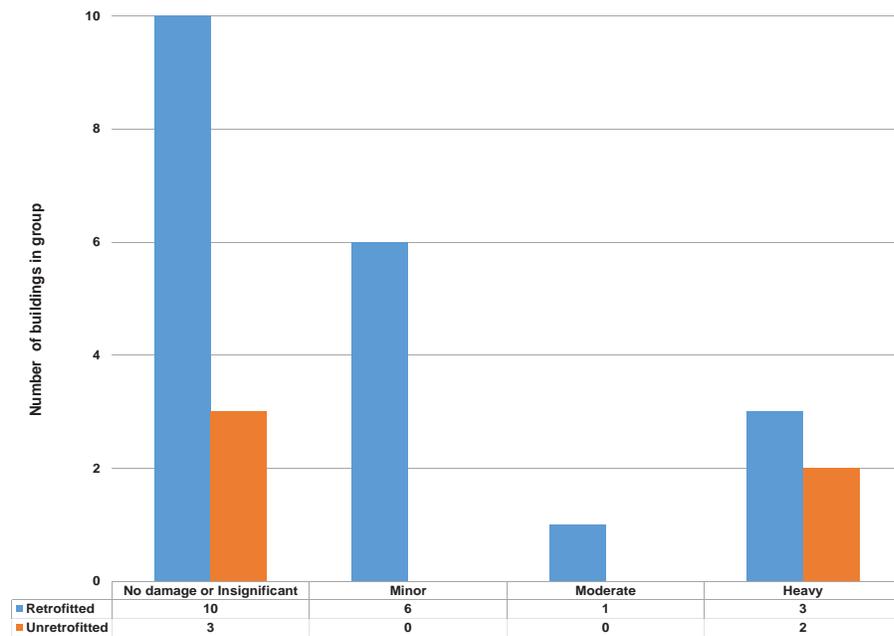
Figure 3-8 Damage comparison between unretrofitted and retrofitted URM buildings.

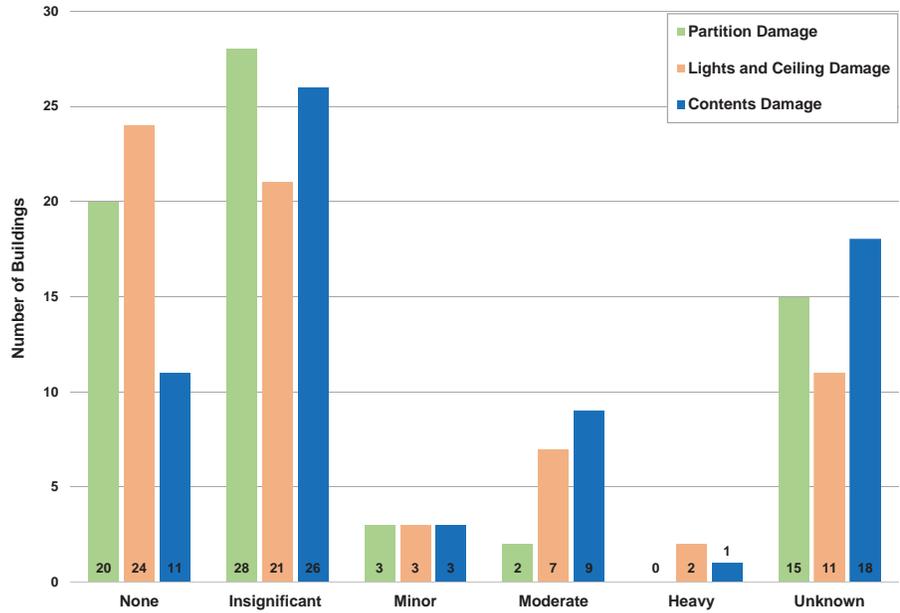
Figure 3-9 Number of buildings where select types of nonstructural damage was observed.

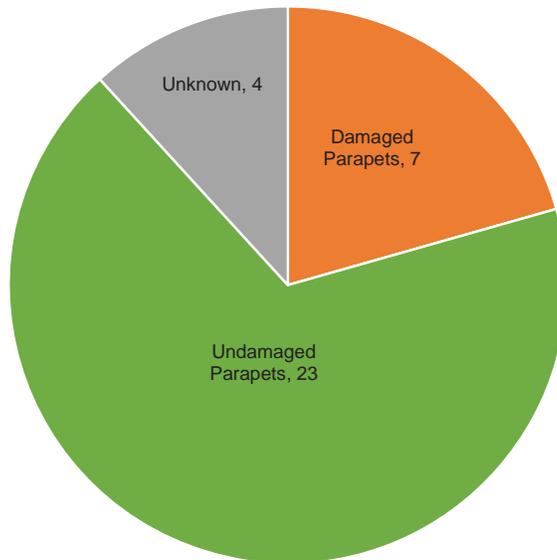
Figure 3-10 Distribution of parapet performance.

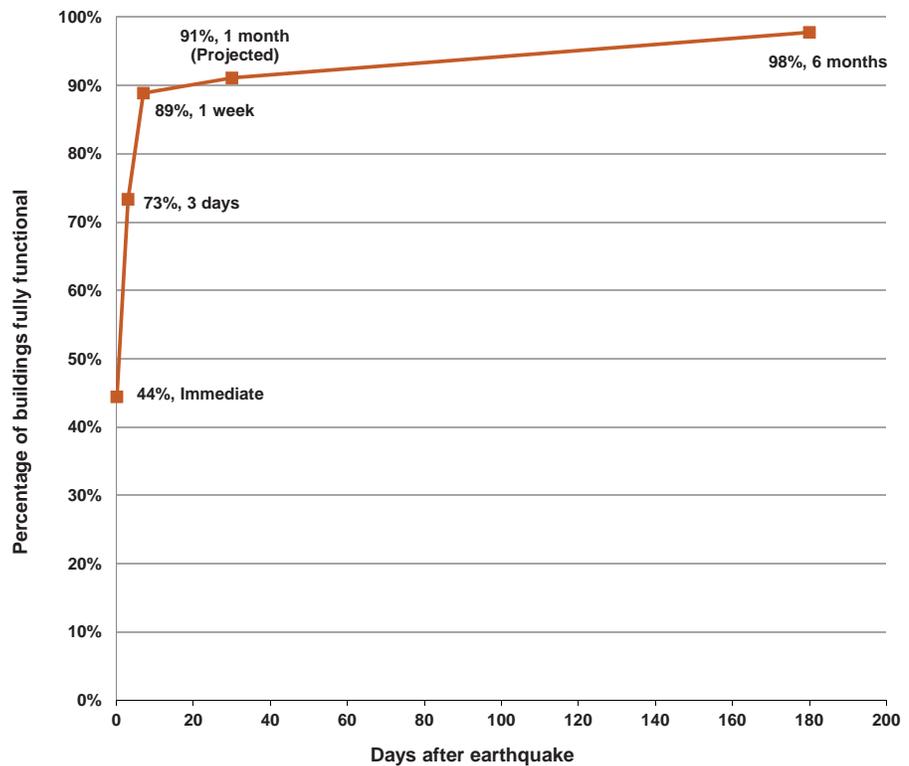
Figure 3-11 Building functionality: duration (in days) after earthquake to resume full functionality.

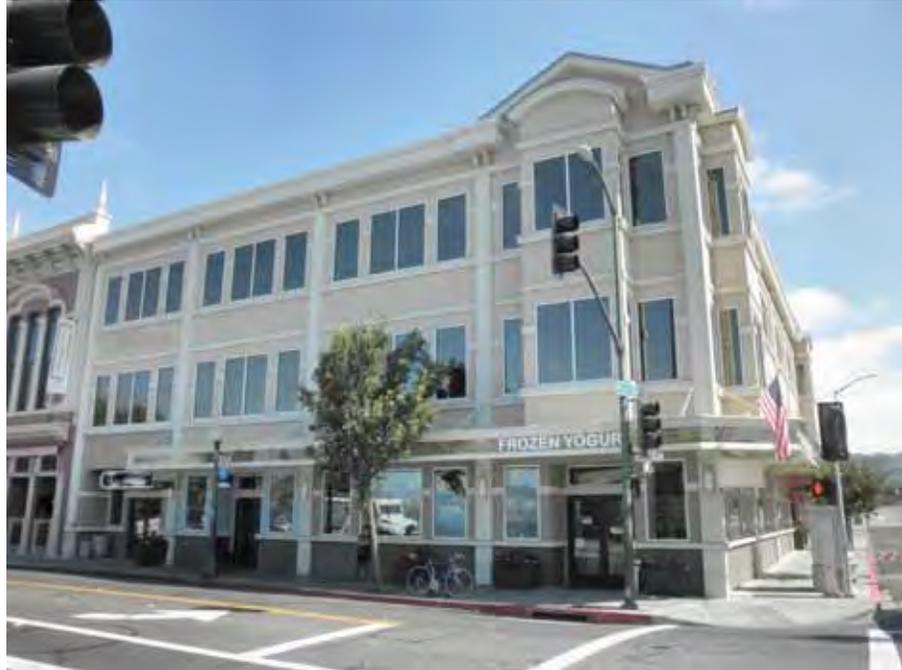
Figure 4-3 Exterior view of building.

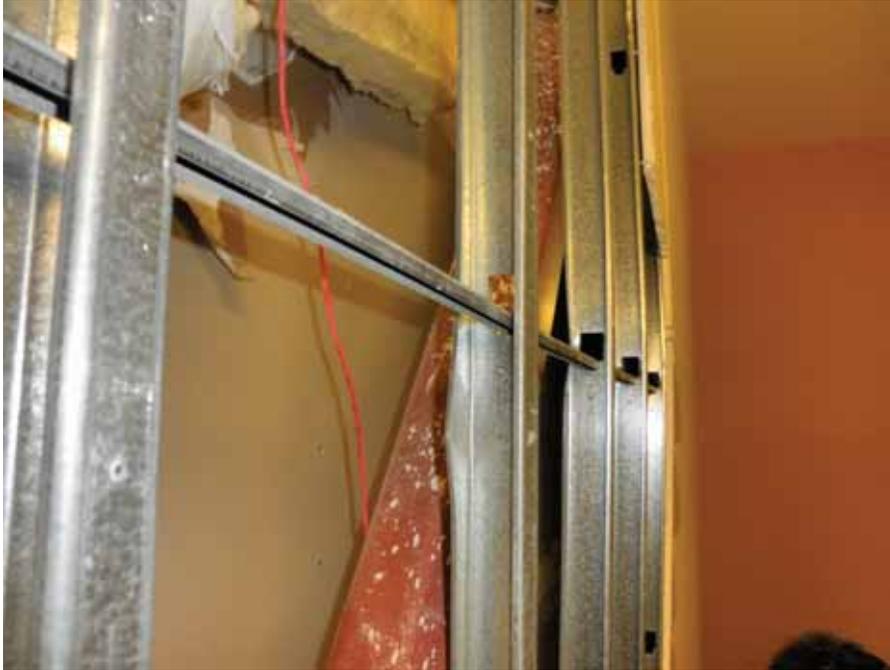
Figure 4-4 Damage to steel studs due to out-of-plane buckling of brace.

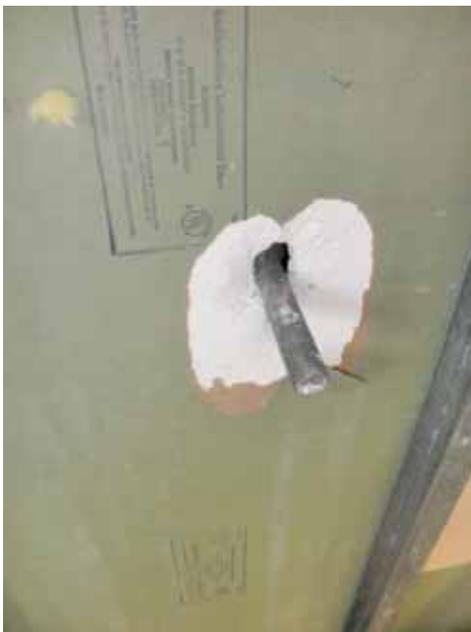
Figure 4-5 Out-of-plane wall anchor of adjacent building penetrated drywall.

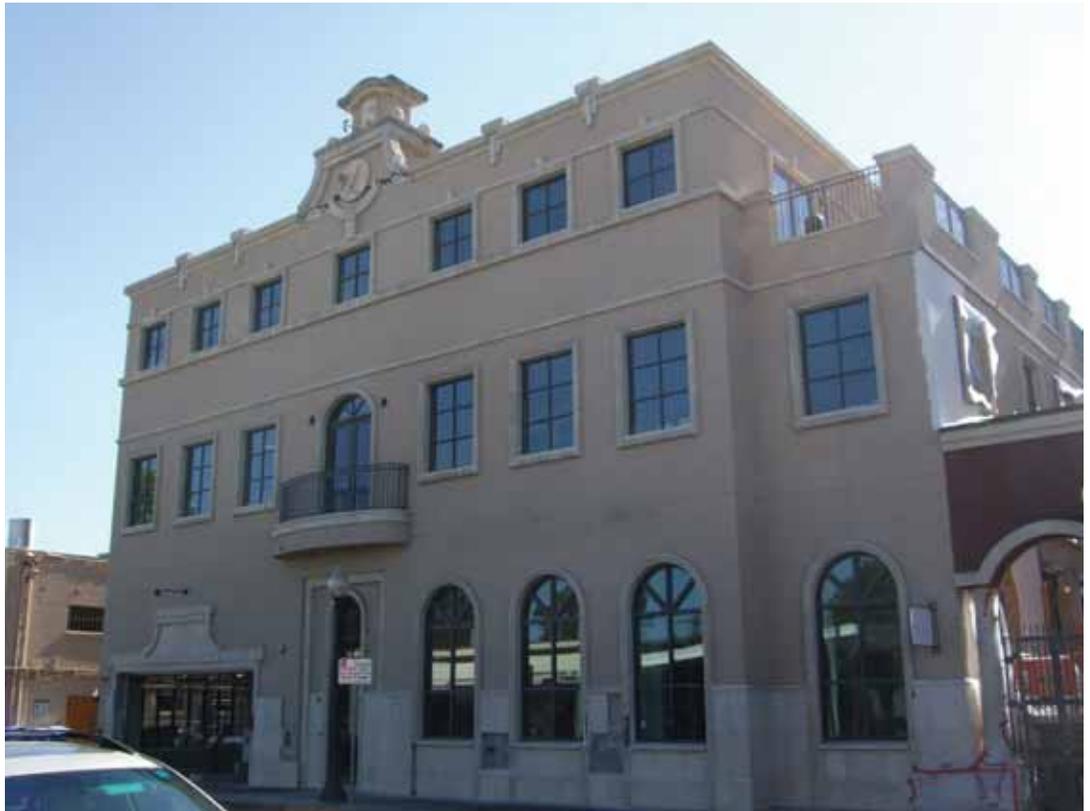
Figure 4-6 Exterior view of building.

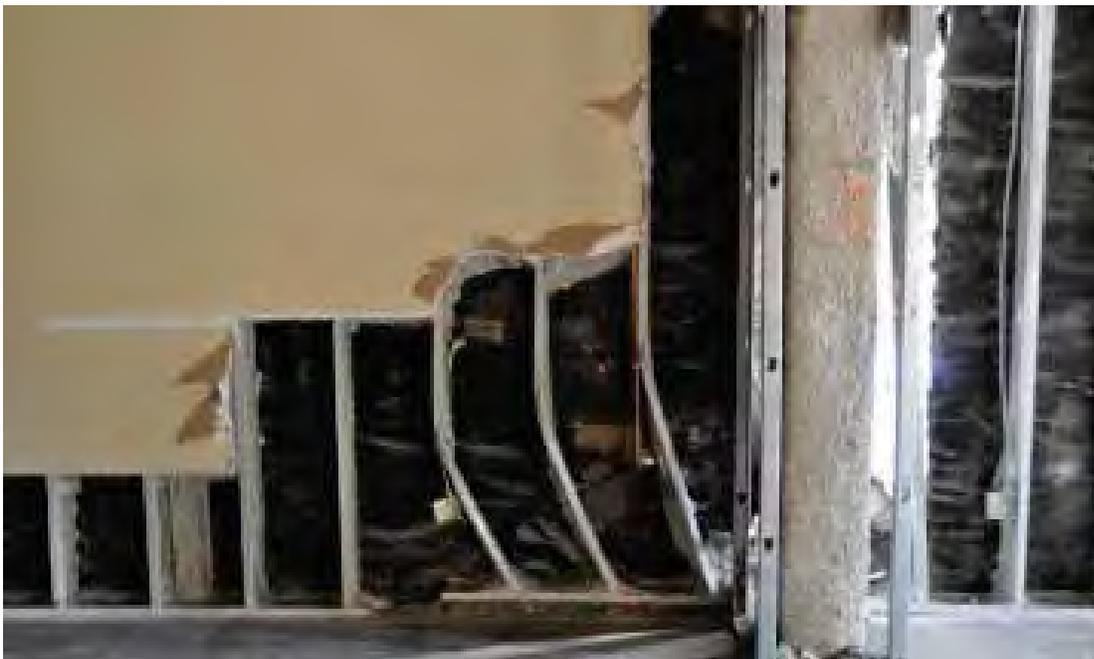
Figure 4-7 Damaged studs in exterior wall.

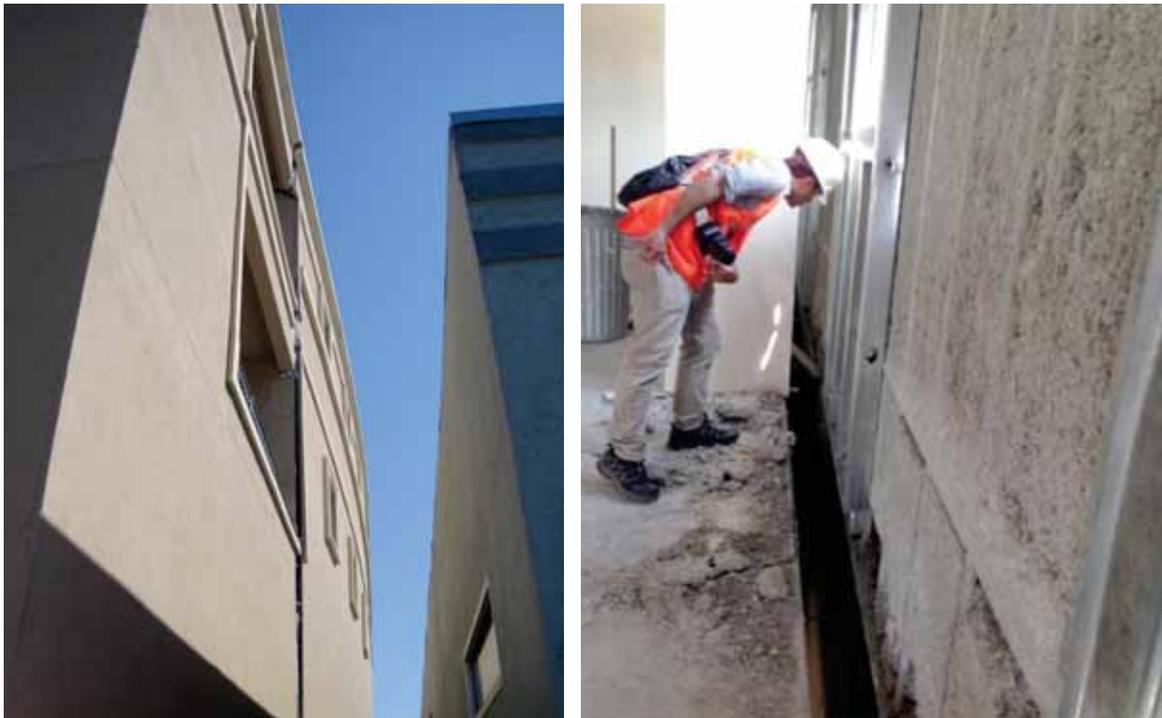
Figure 4-8 Bowed wall separated from floor (photo on right from Lauren Biscombe).

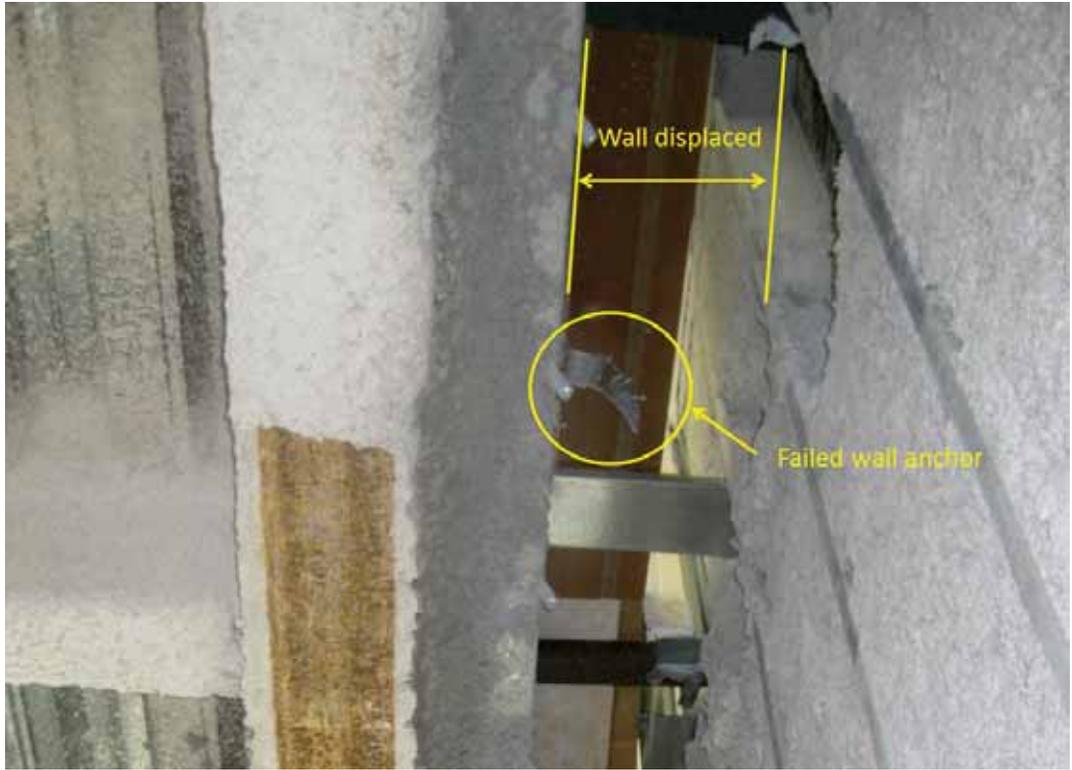
Figure 4-10 Failed wall anchor at bowed wall.

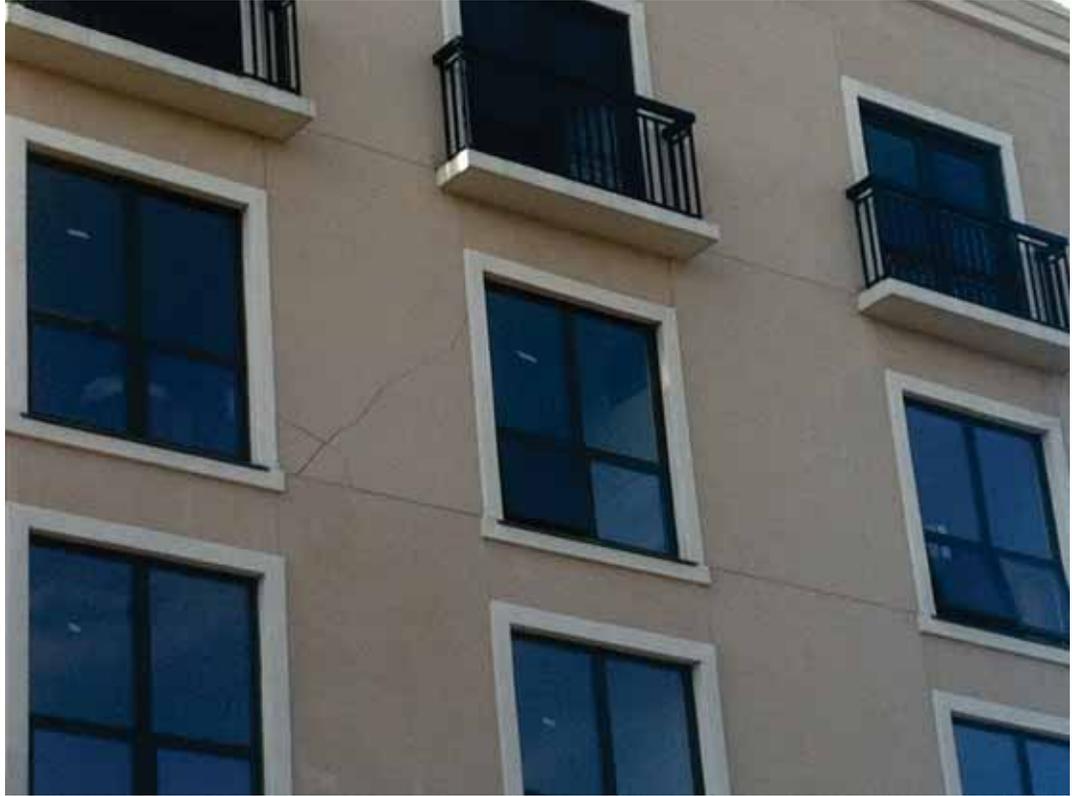
Figure 4-11 Exterior wall, cracked plaster.

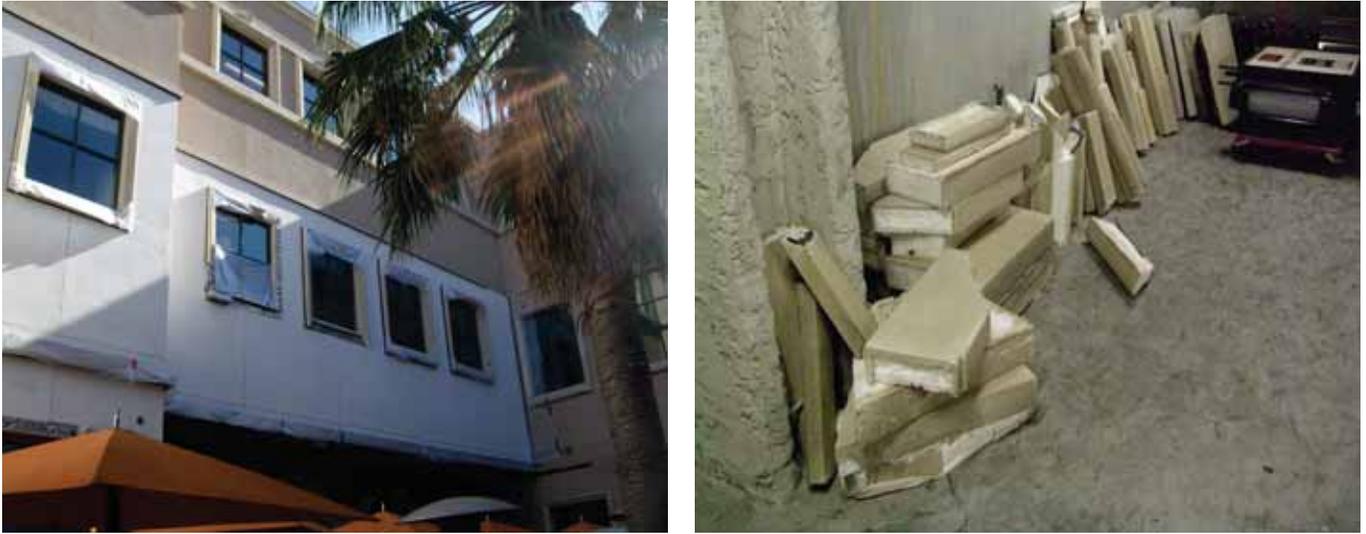
Figure 4-12 Dislodged adhered veneer.

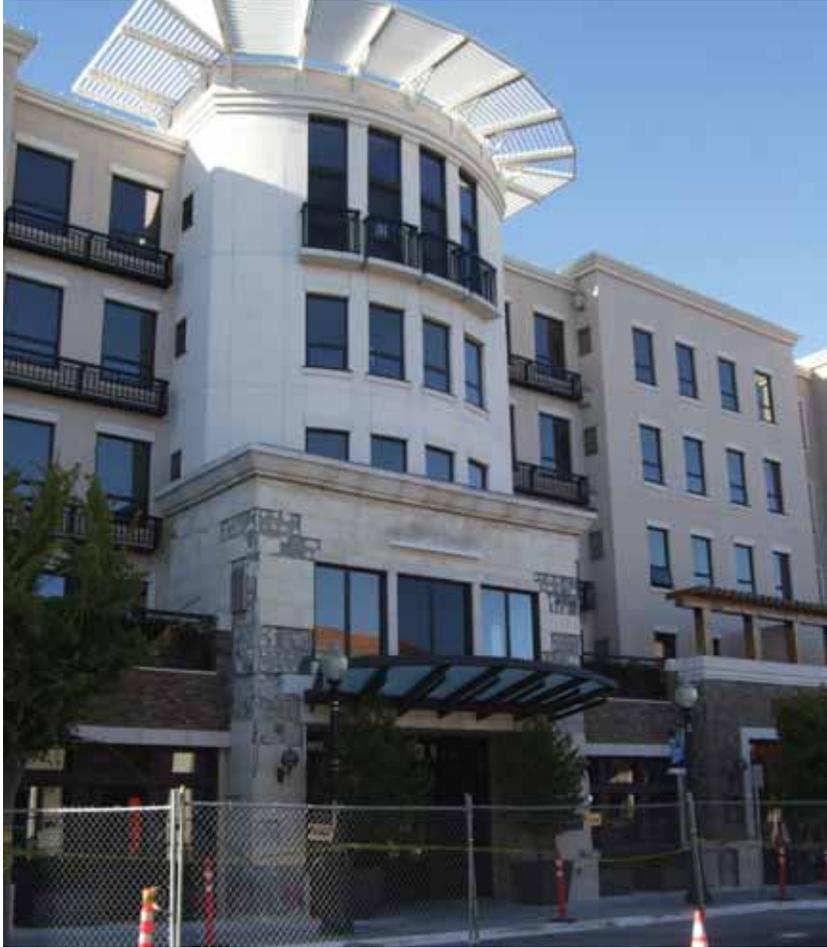
Figure 4-13 Exterior view of building.

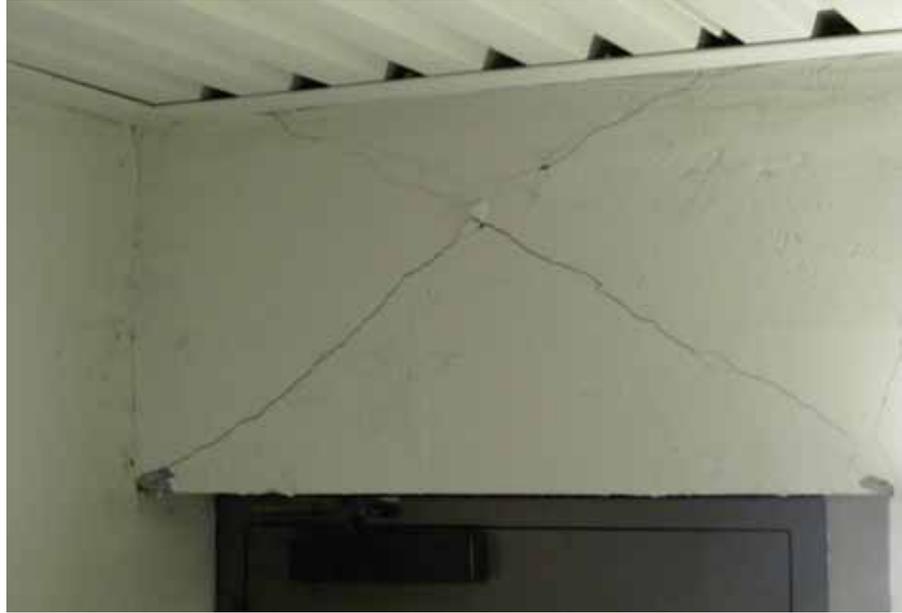
Figure 4-14 Cracking in spandrel in concrete stair core.

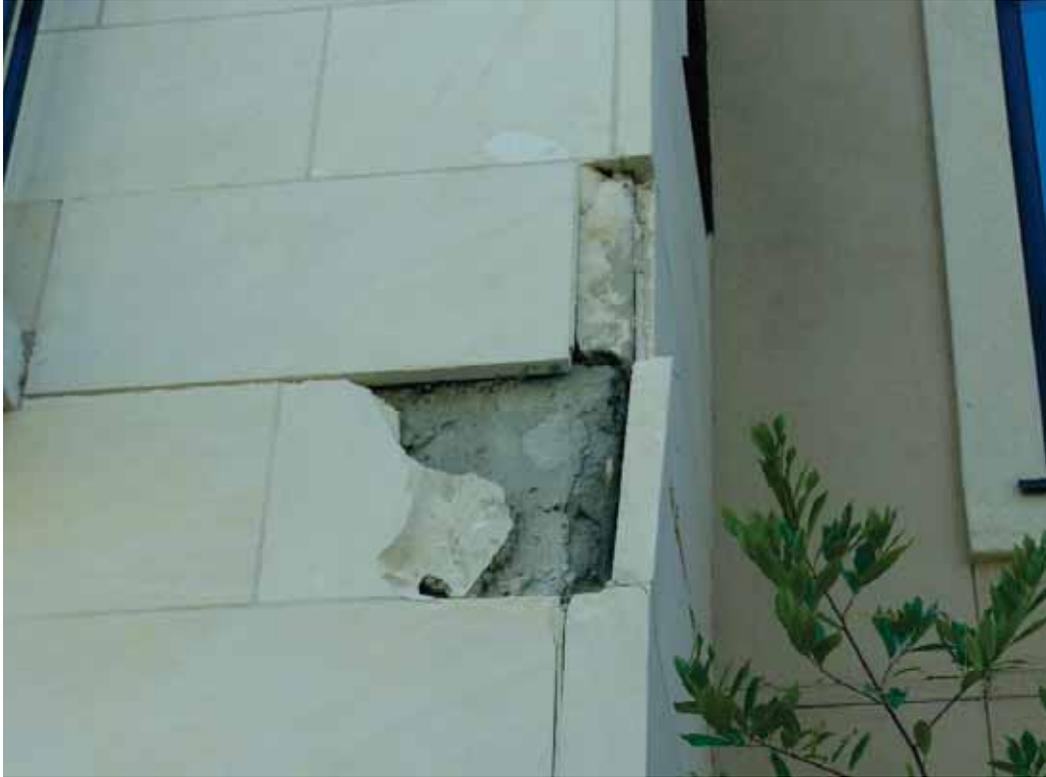
Figure 4-15 Adhered veneer damaged during the earthquake.

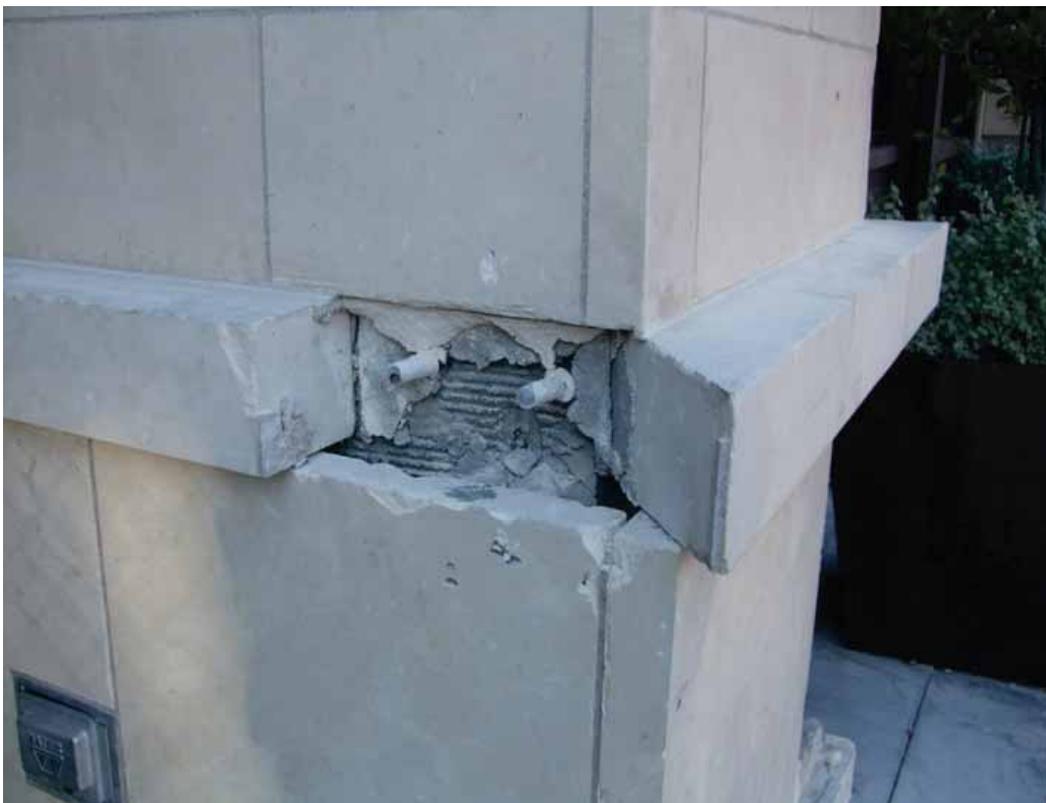
Figure 4-16 Photo showing failed anchored veneer.

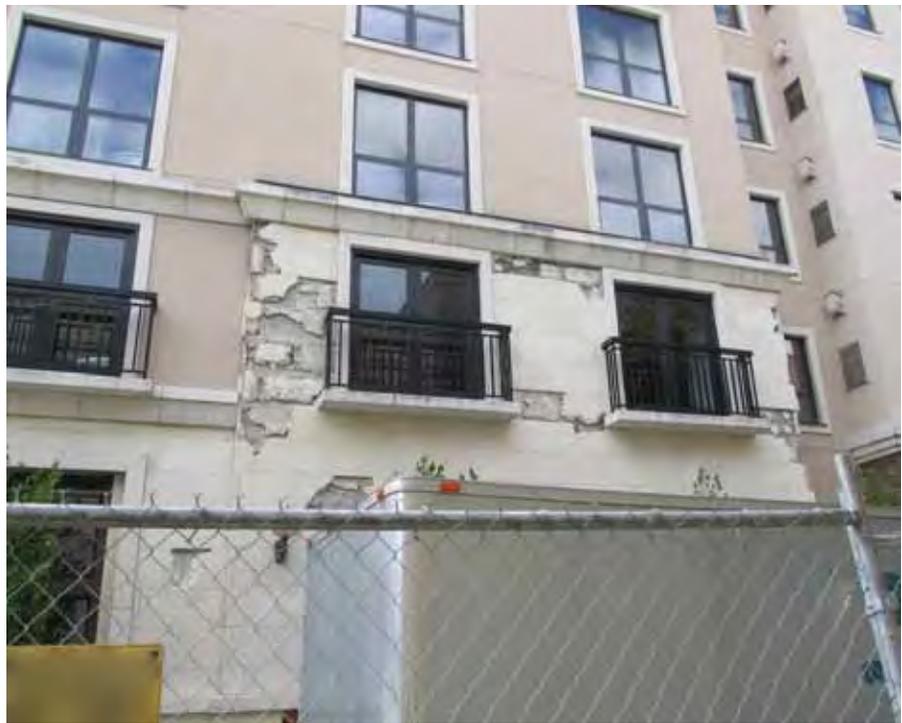
Figure 4-17 Stone masonry veneer, showing where loose units have been removed.

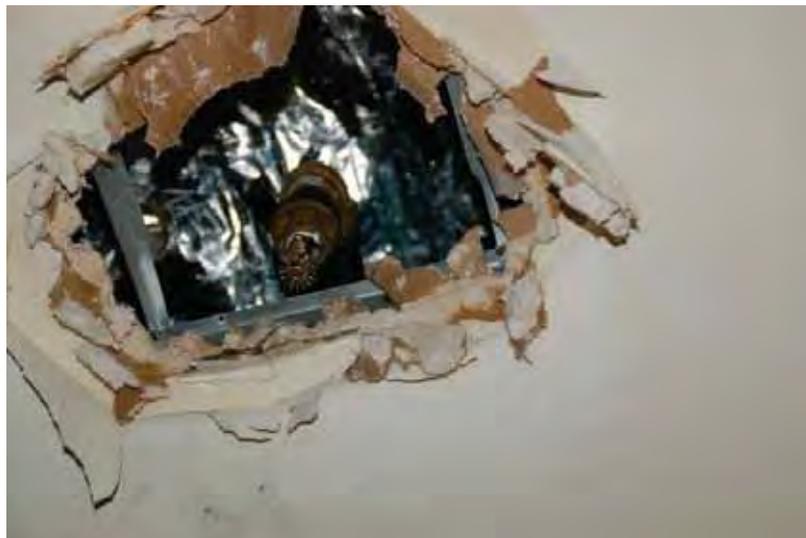
Figure 4-18 Sprinkler impacted HVAC components and discharged.

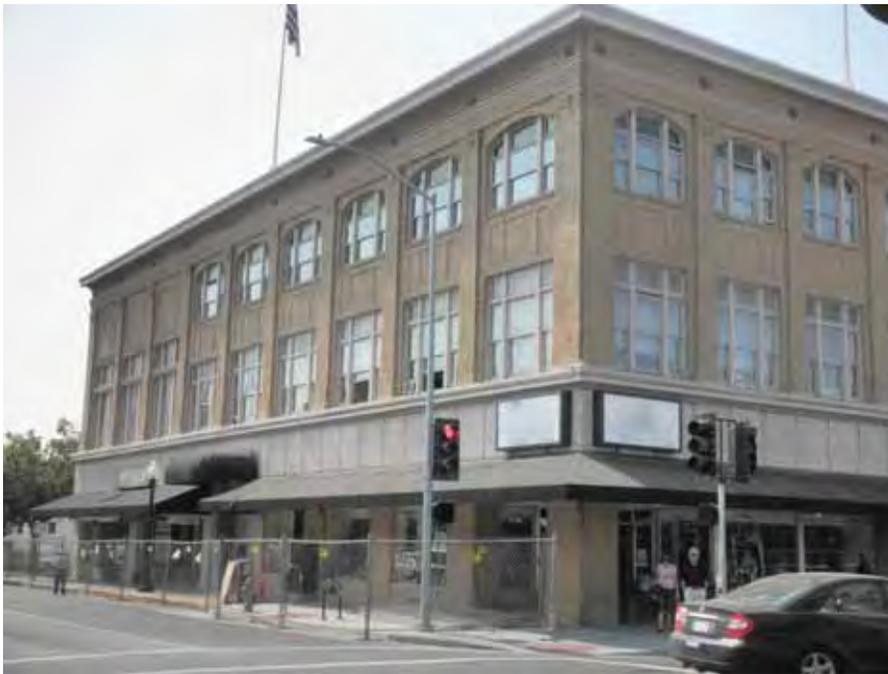
Figure 4-19 Exterior view of building.

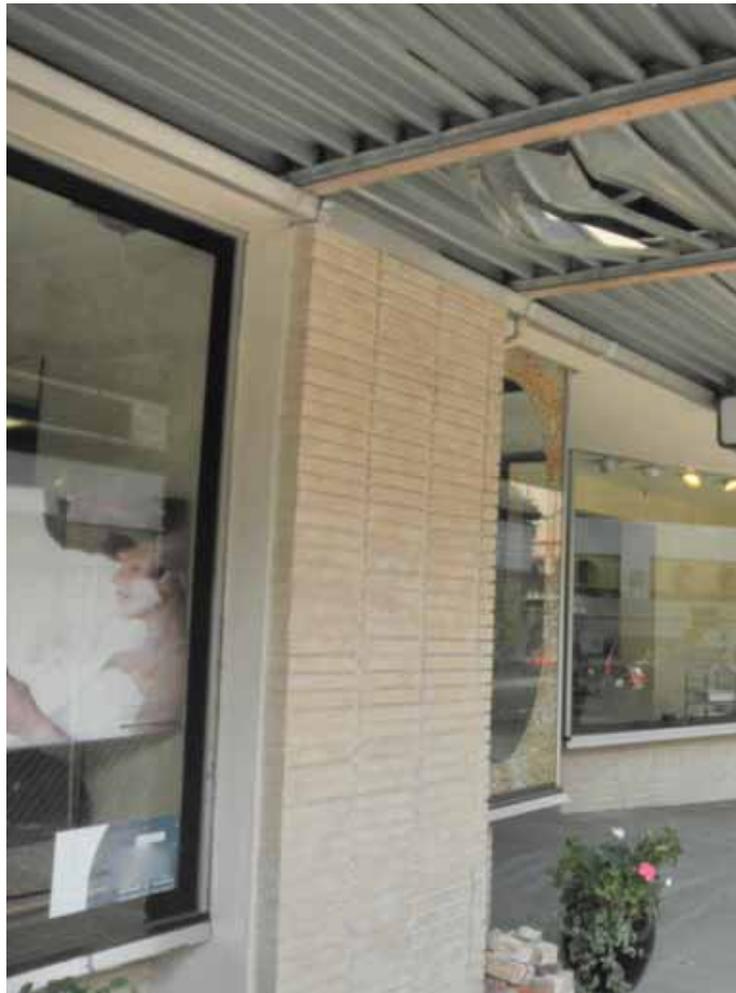
Figure 4-20 Damage to canopy due to falling brick.
