Performance of Buildings and Nonstructural Components in the 2014 South Napa Earthquake

FEMA P-1024 / February 2015

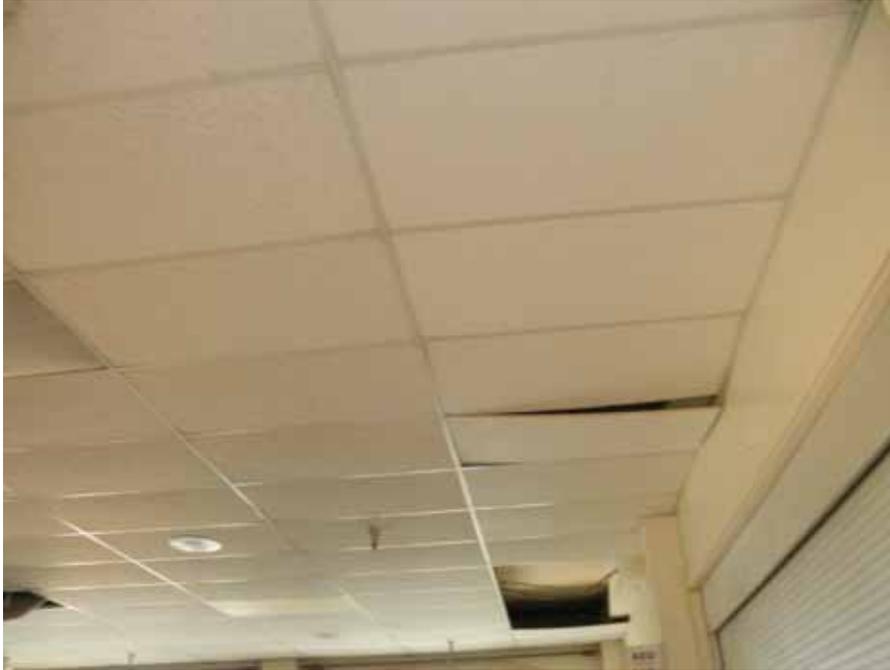
Figure 4-21 Minor damage to suspended ceilings.

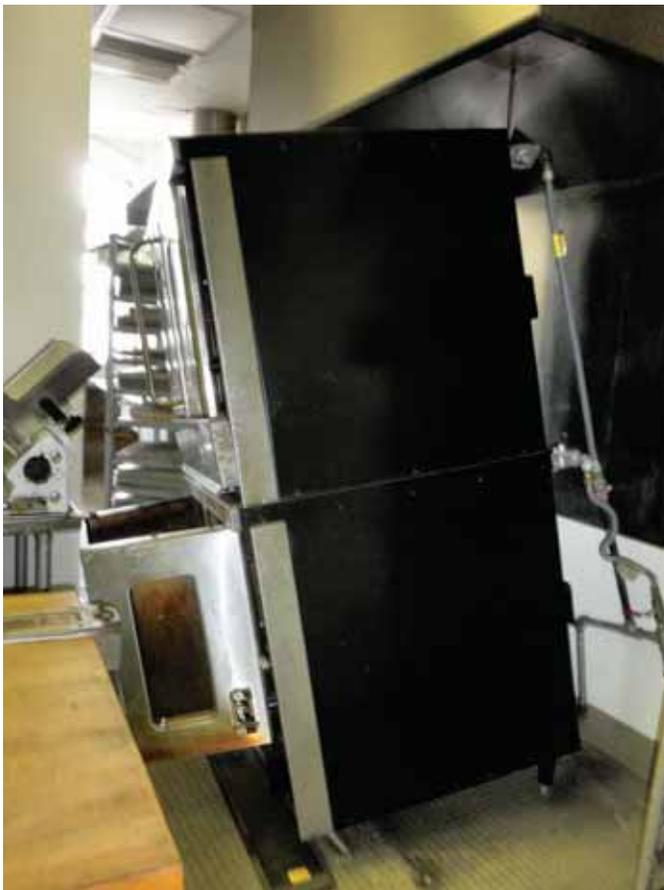
Figure 4-22 Convection oven with failed support leg.

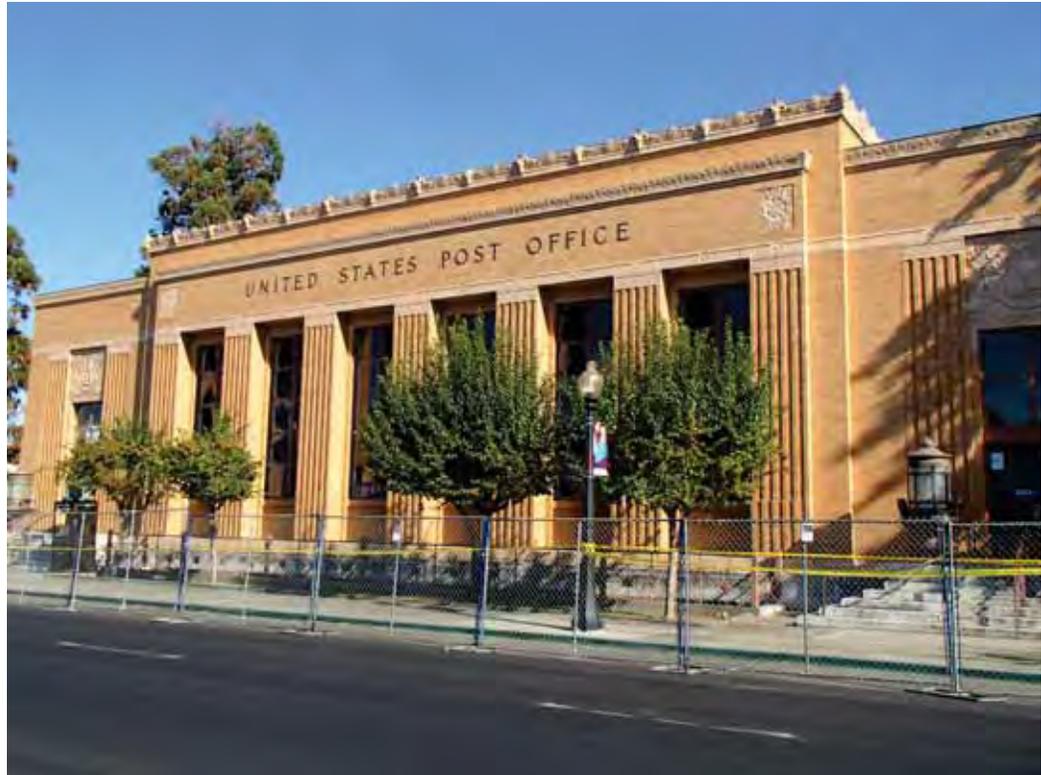
Figure 4-23 Exterior view of building.

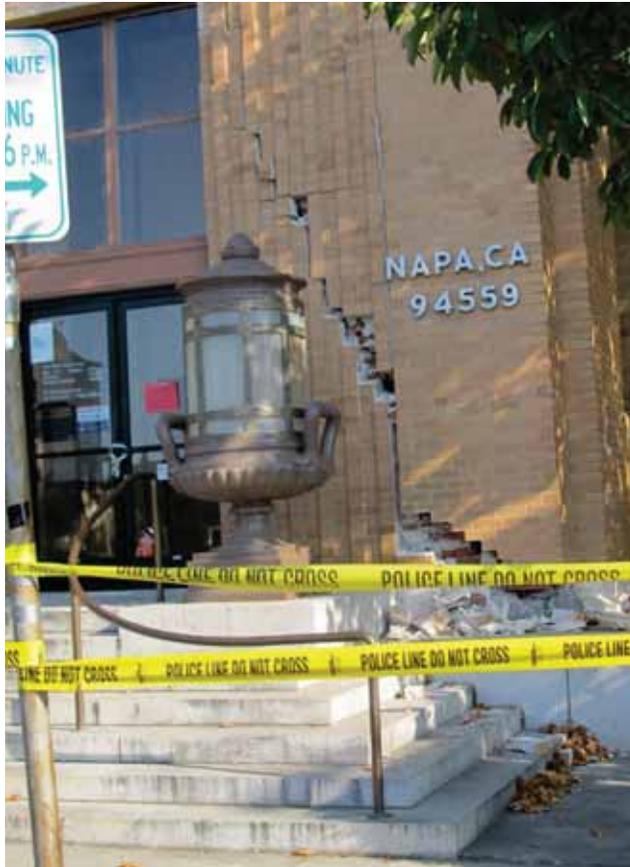
Figure 4-24 Damage to corner pier.

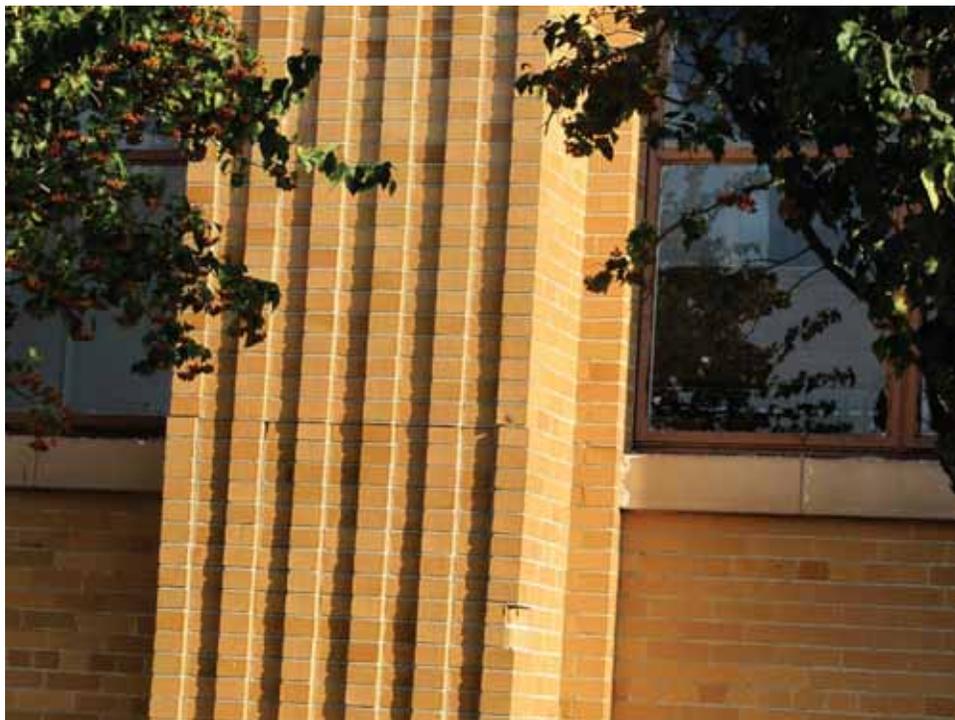
Figure 4-25 Lateral shifting at sill line.

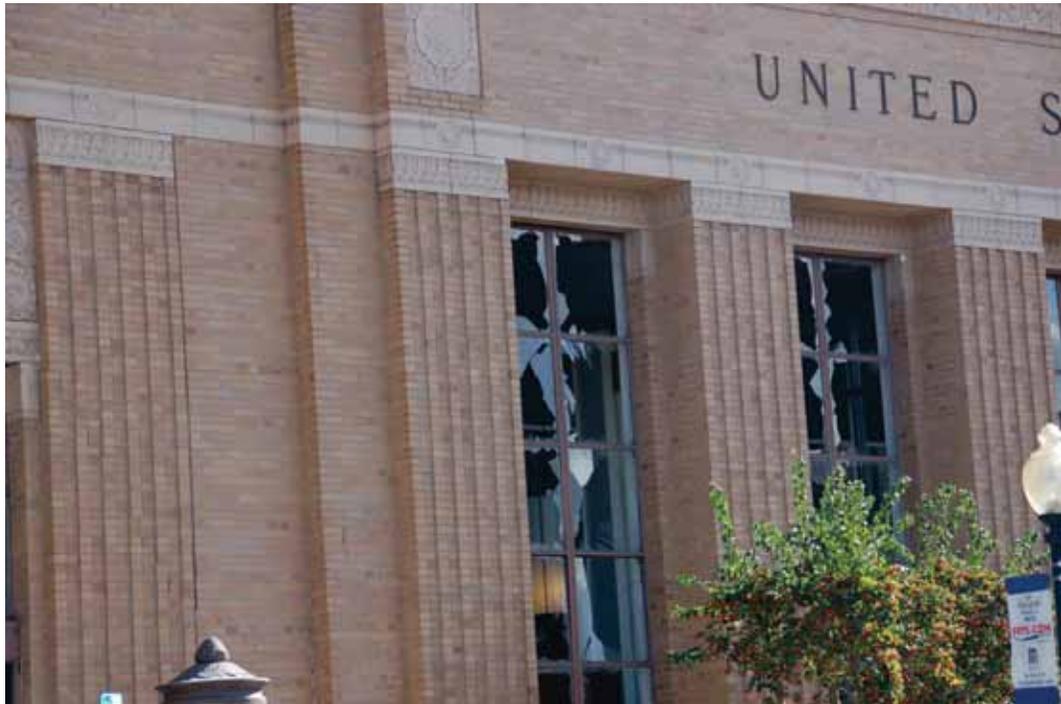
Figure 4-26 Glazing damage.

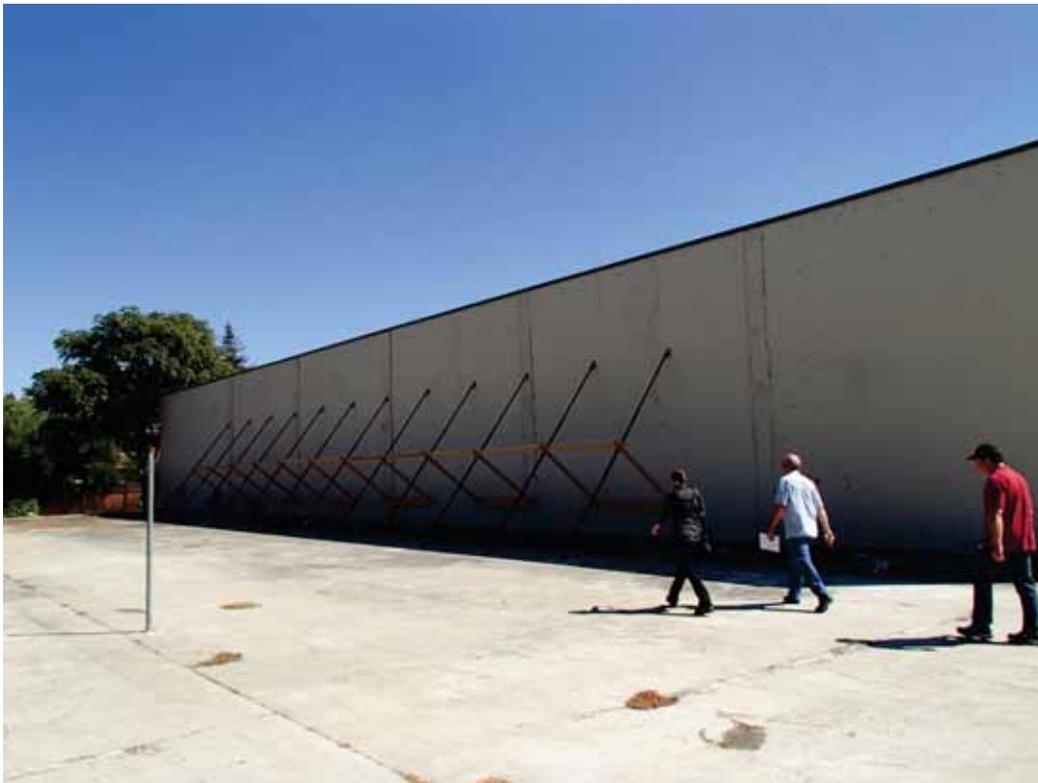
Figure 4-27 Shoring of wall with damaged pilasters.

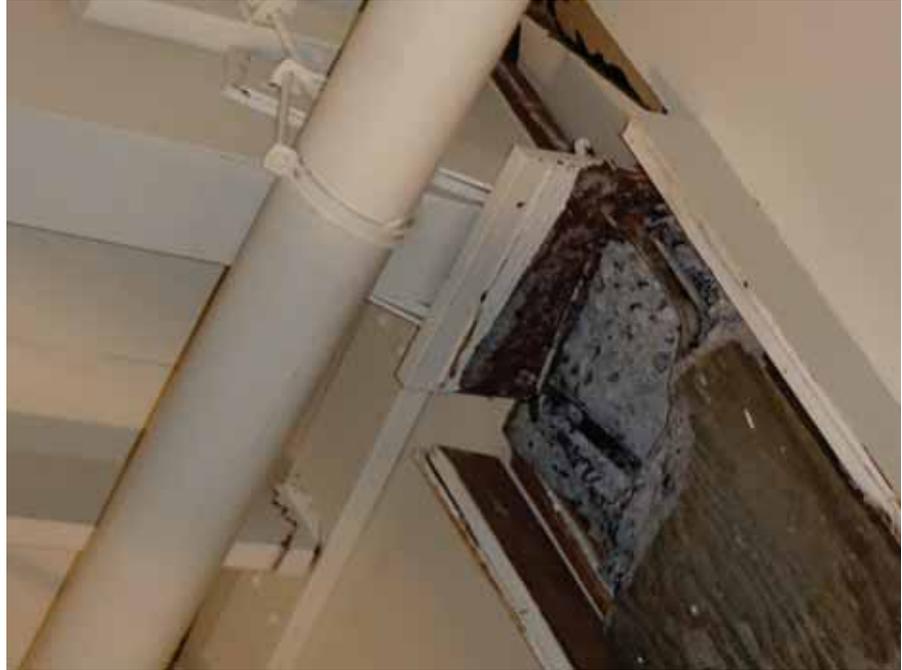
Figure 4-28 Damaged pilaster-to-roof beam connection.

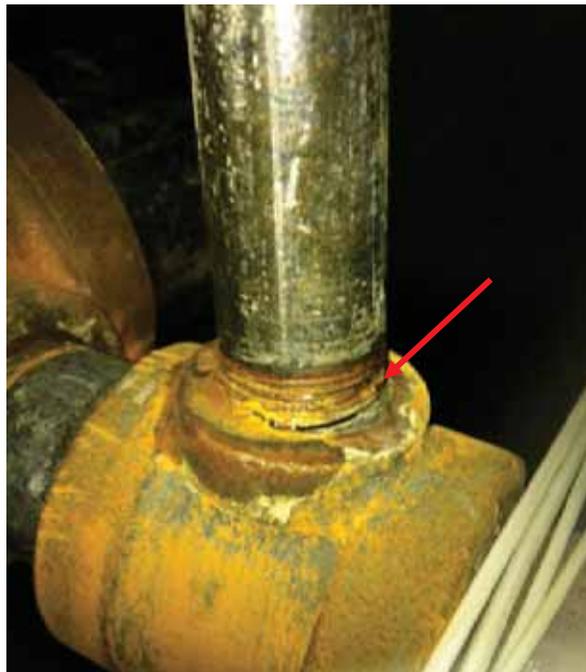
Figure 4-29 Cracked sprinkler pipe.

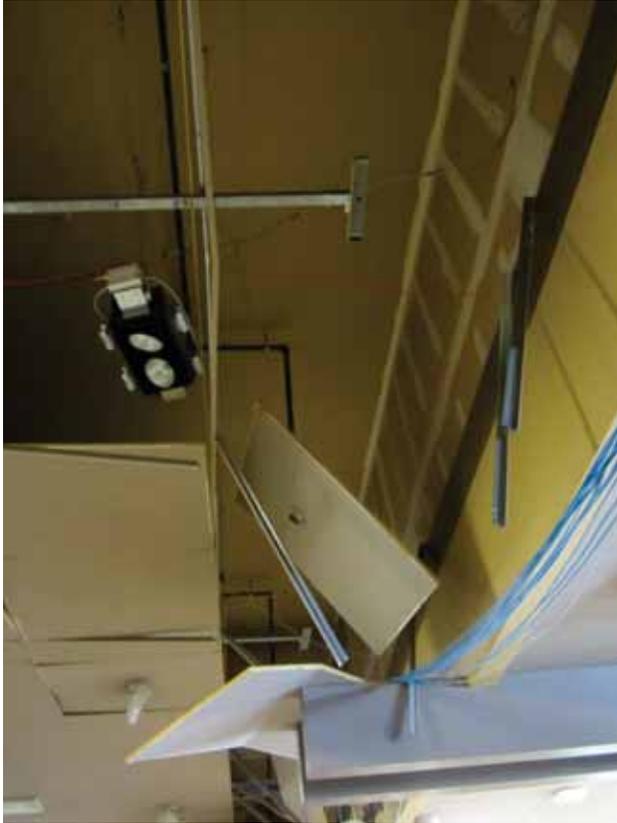
Figure 4-30 Suspended ceiling damage.

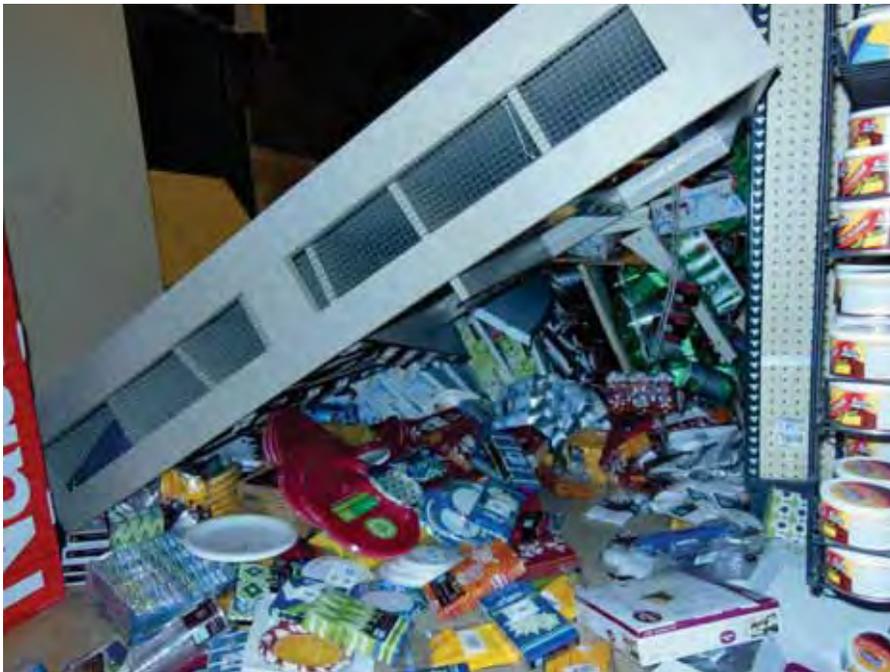
Figure 4-31 Overturned store fixture, loss of contents.

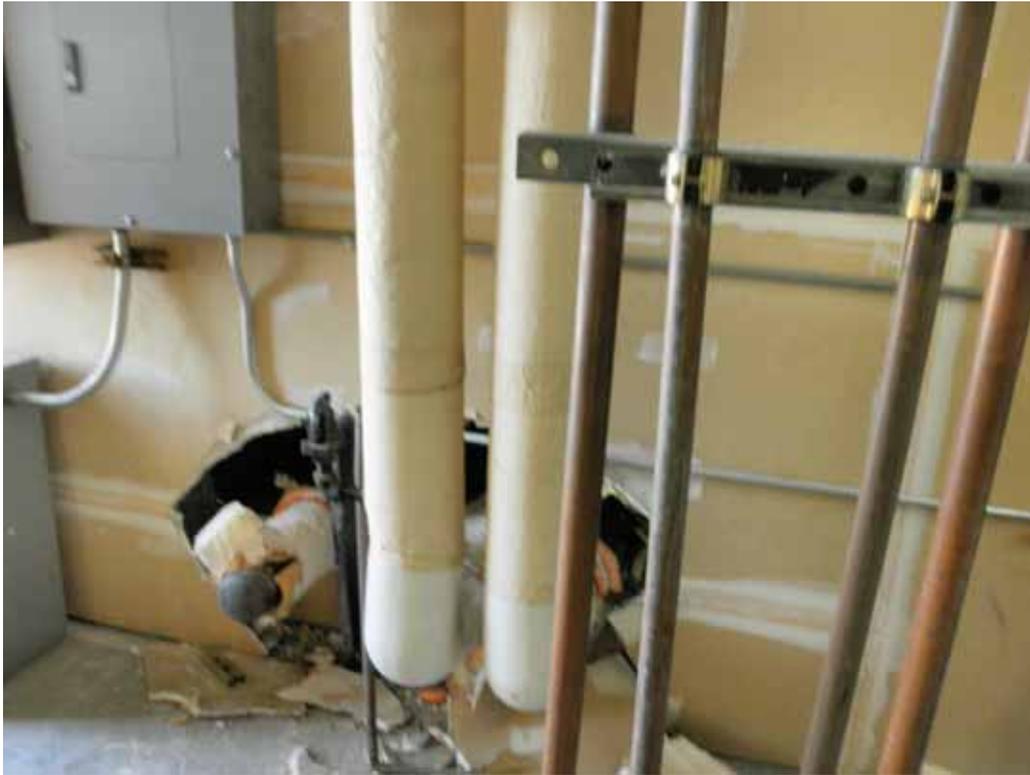
Figure 4-32 Evidence of pipe motion in penthouse partition wall.

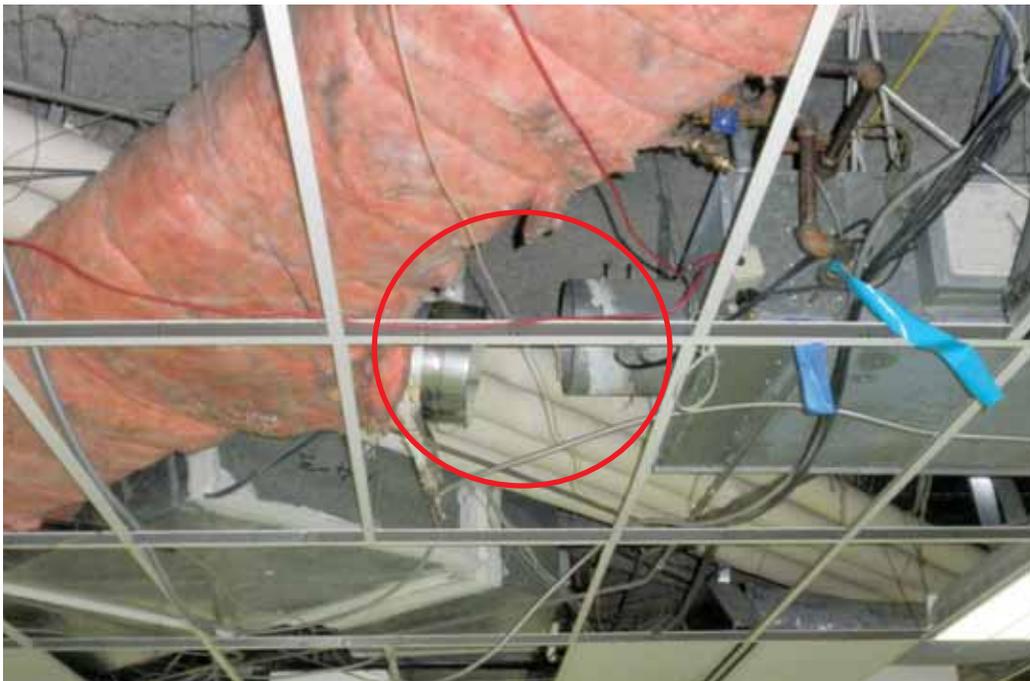
Figure 4-33 Ceiling and duct damage. The duct separated from the in-line HVAC unit to the right.

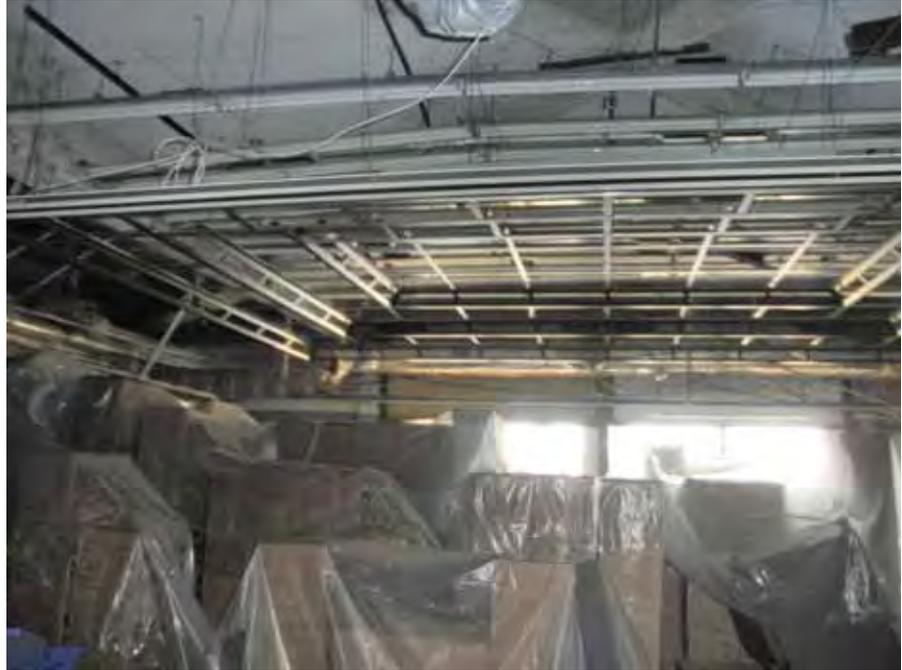
Figure 4-34 Ceiling removed due to water damage, third floor.

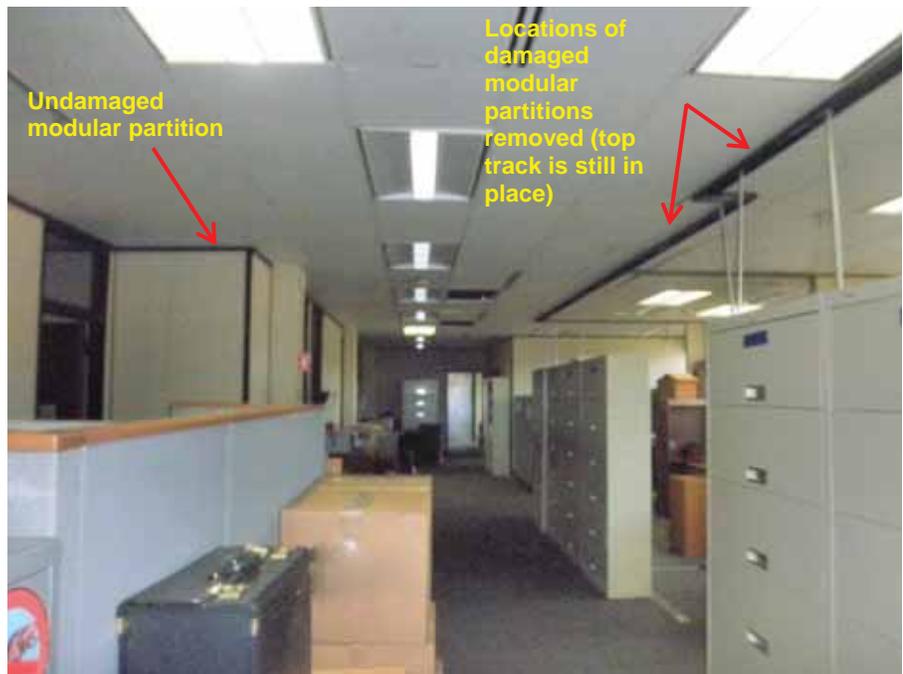
Figure 4-35 Third floor of building after the earthquake. Modular partitions similar to those at the left were damaged and removed.

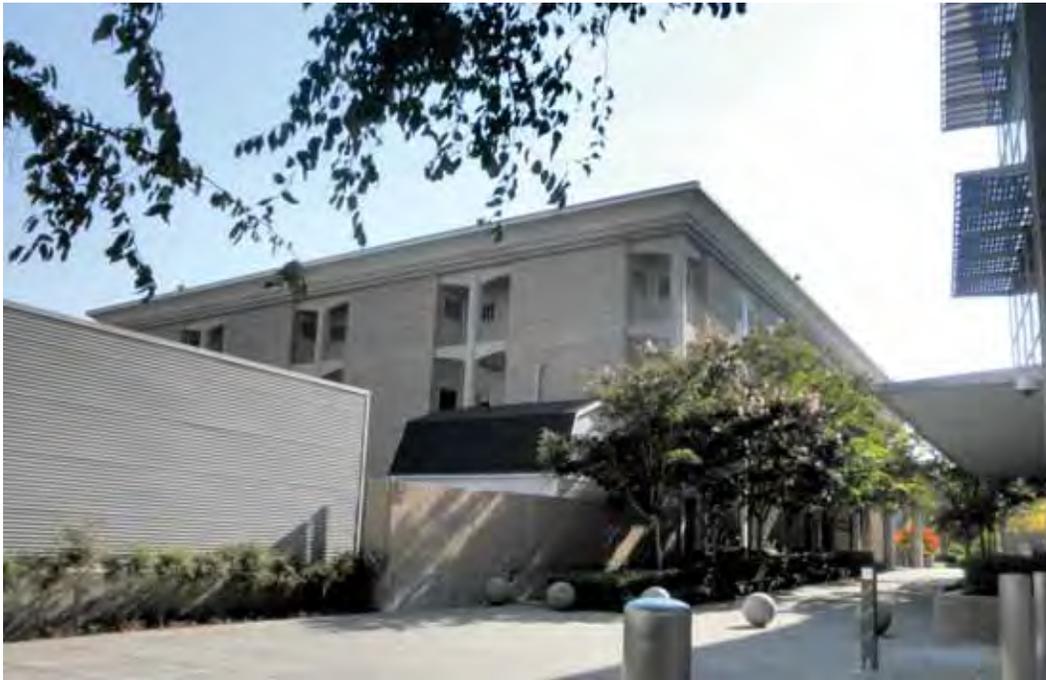
Figure 4-36 Exterior view, 1974 wing.

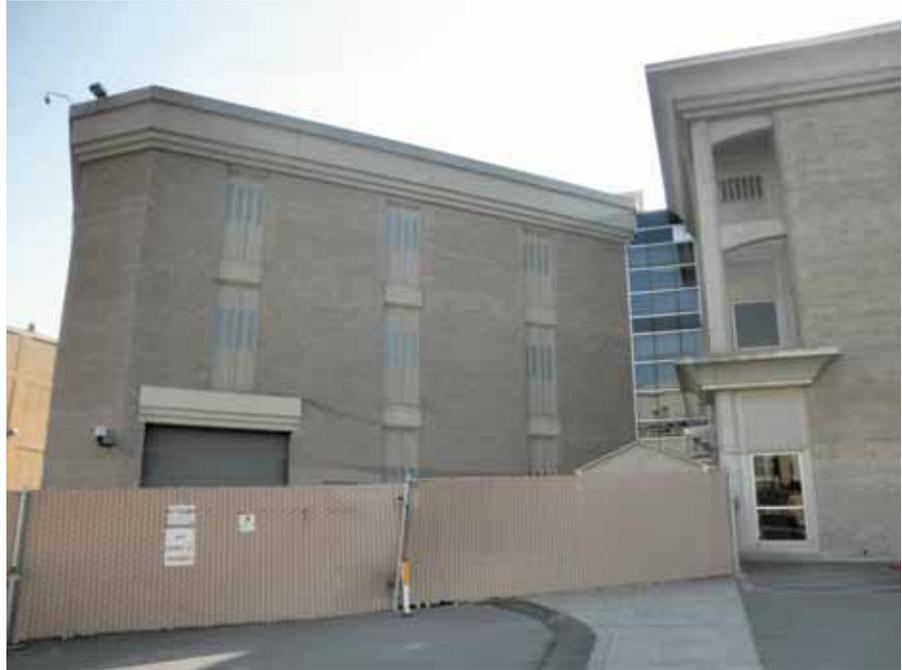
Figure 4-37 Exterior view, 1989 wing.

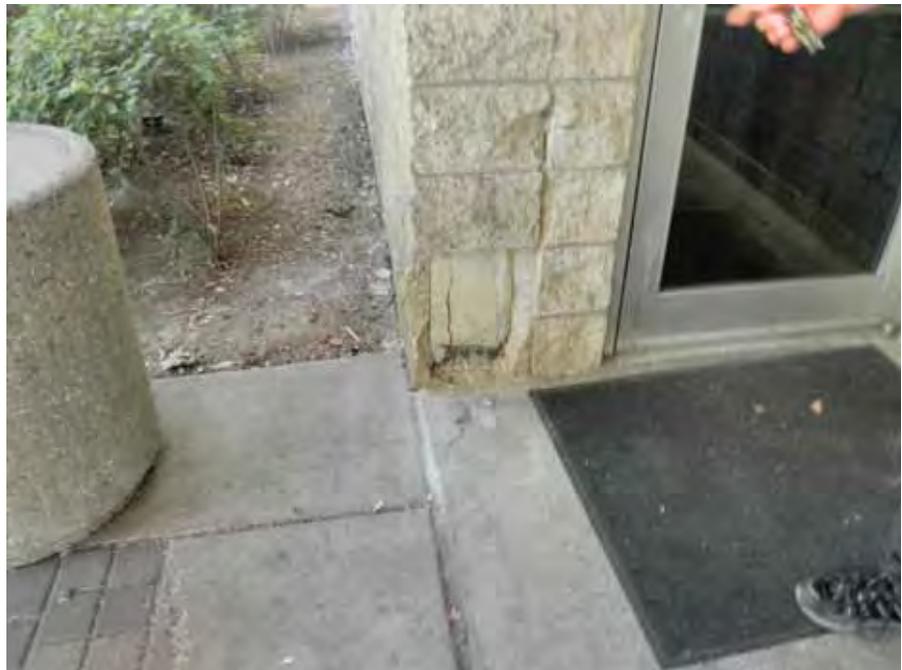
Figure 4-38 CMU face shell spalling, typical at base of walls.

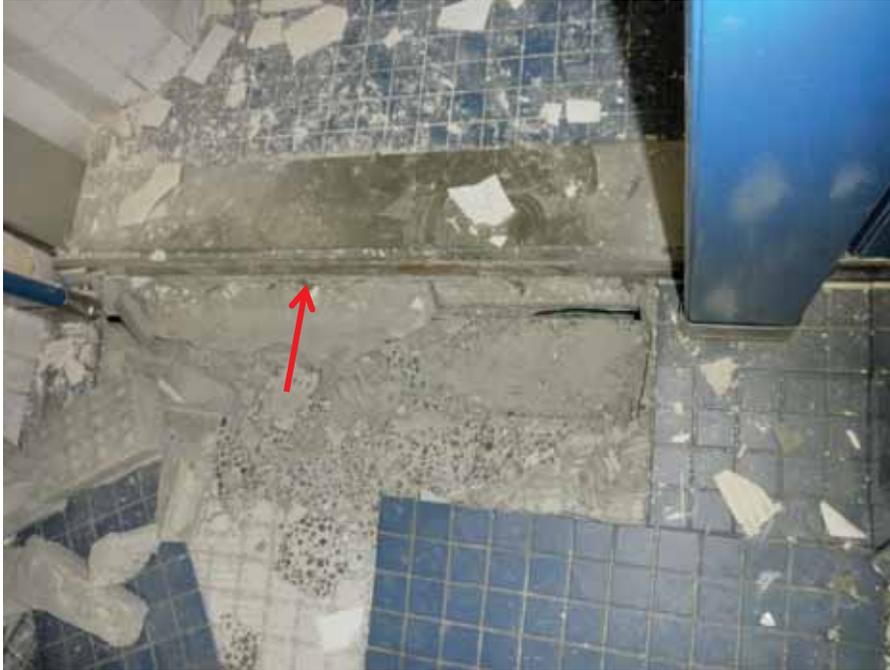
Figure 4-39 Floor finish damage due to pounding at the seismic joint indicated by the arrow.

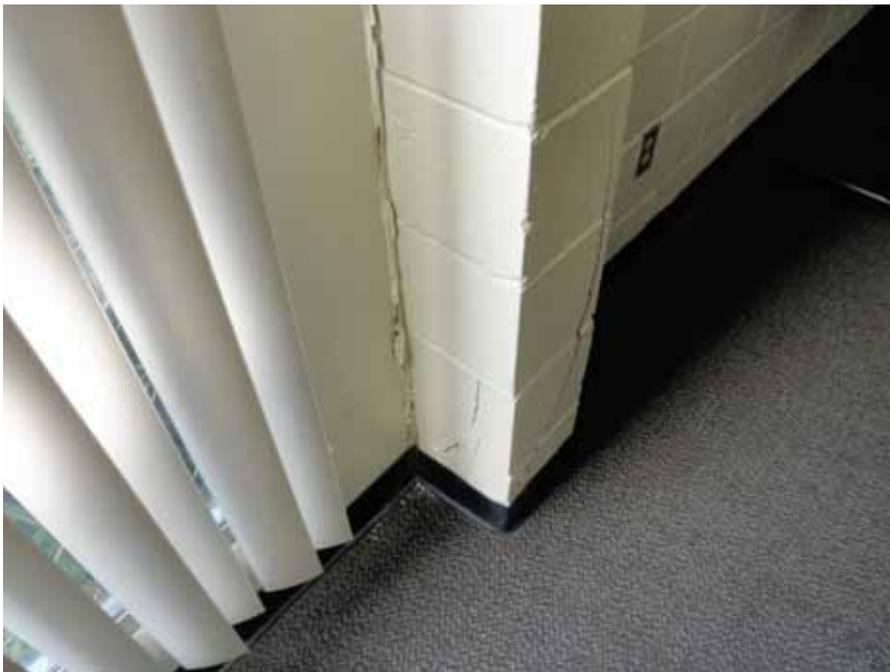
Figure 4-40 CMU damage at precast concrete panels containing the window.

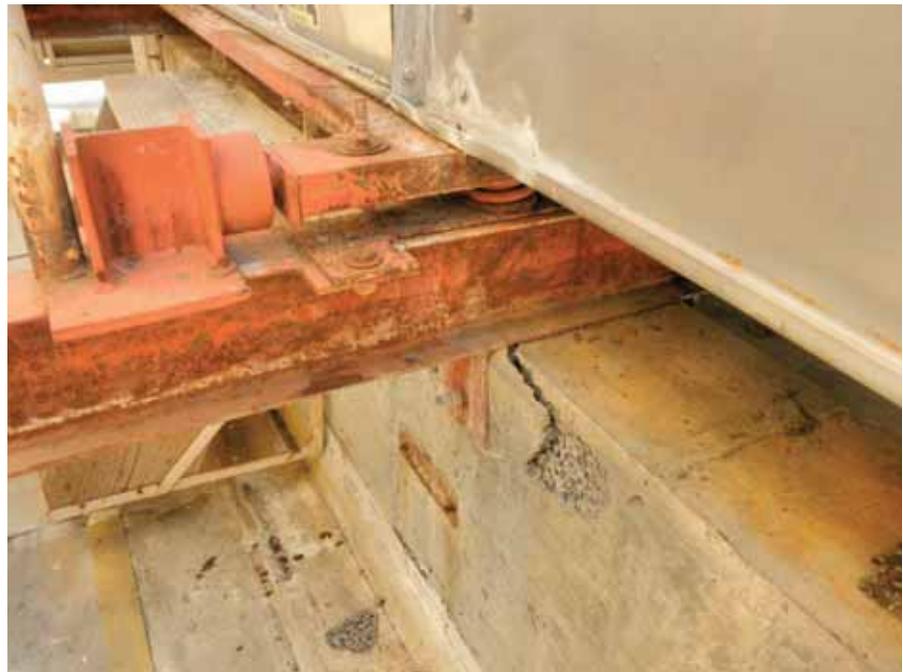
Figure 4-41 Anchor failure, rooftop cooling tower 1974 wing.

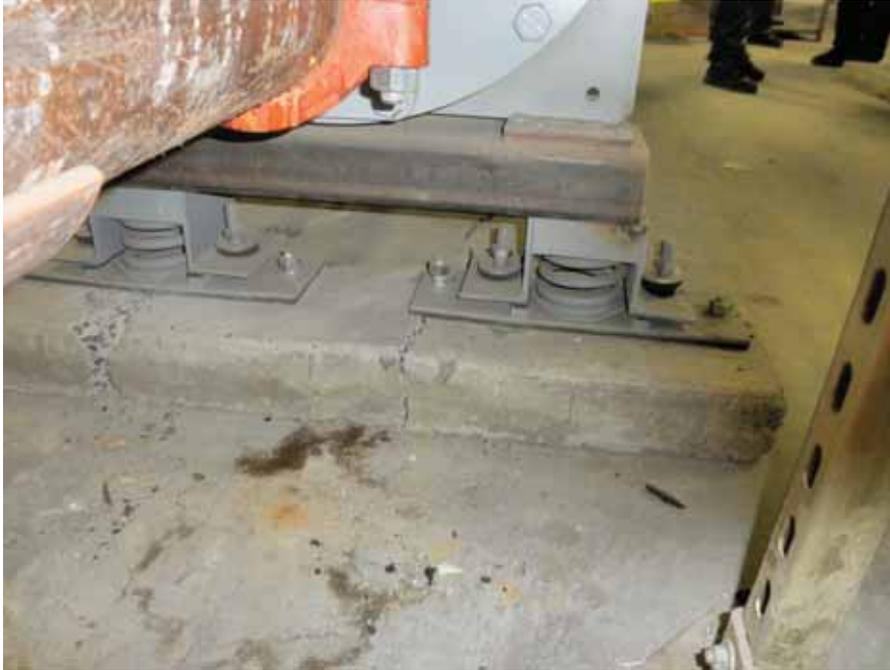
Figure 4-42 Housekeeping slab failure, chiller in 1974 wing penthouse.

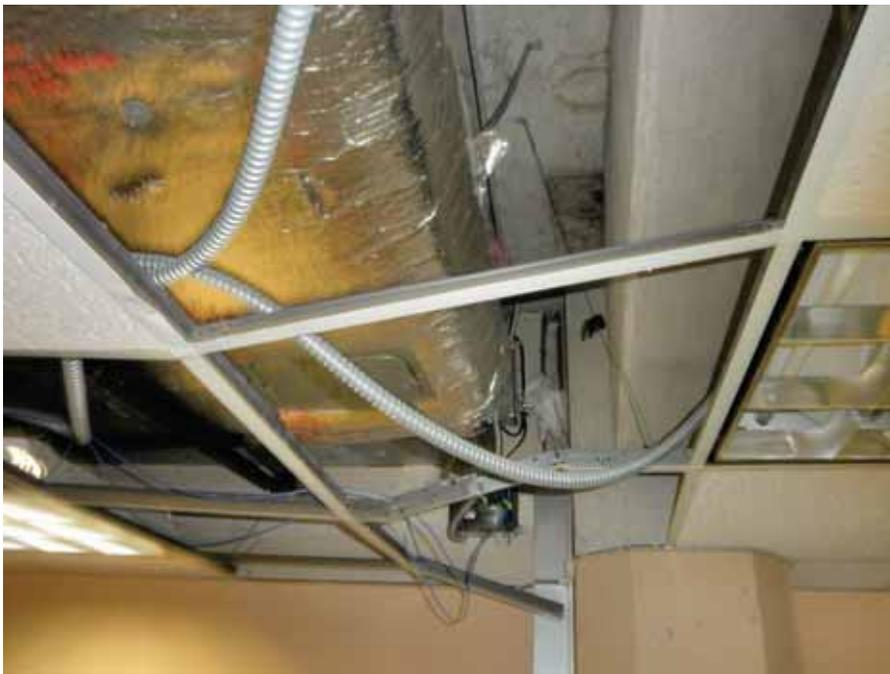
Figure 4-43 Ceiling damage at seismic joint.

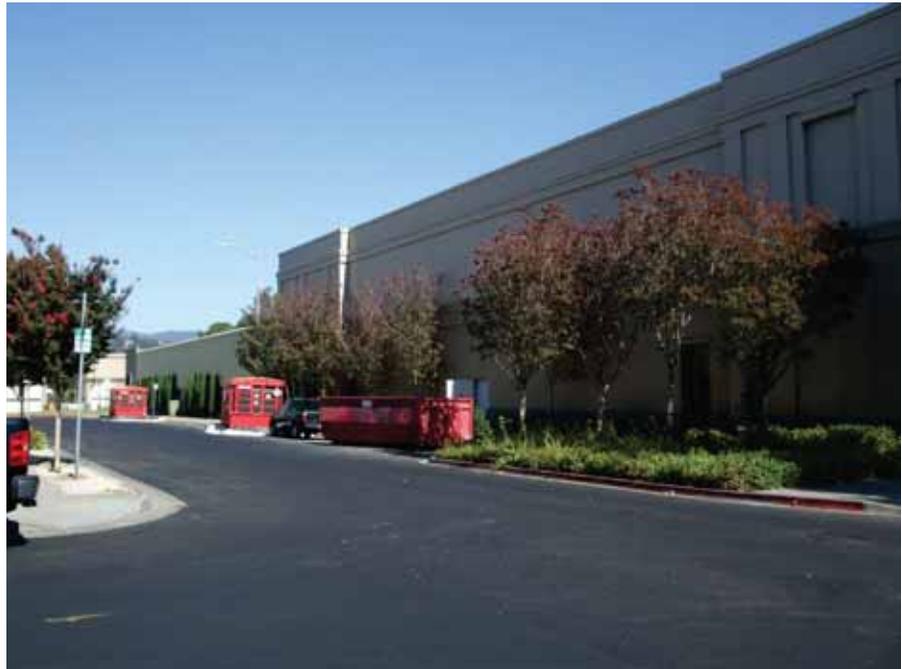
Figure 4-44 Exterior view of building.

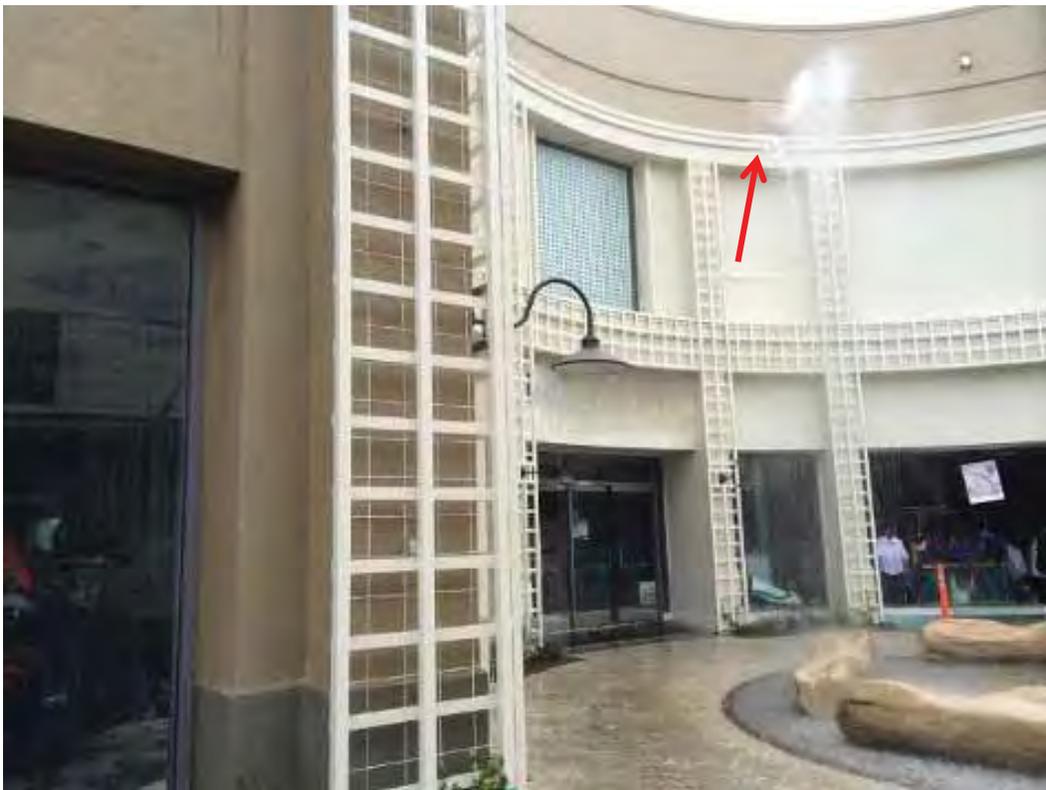
Figure 4-45 Water pressure from broken sprinkler line created a hole in the exterior cladding (photo by KCRA.com).

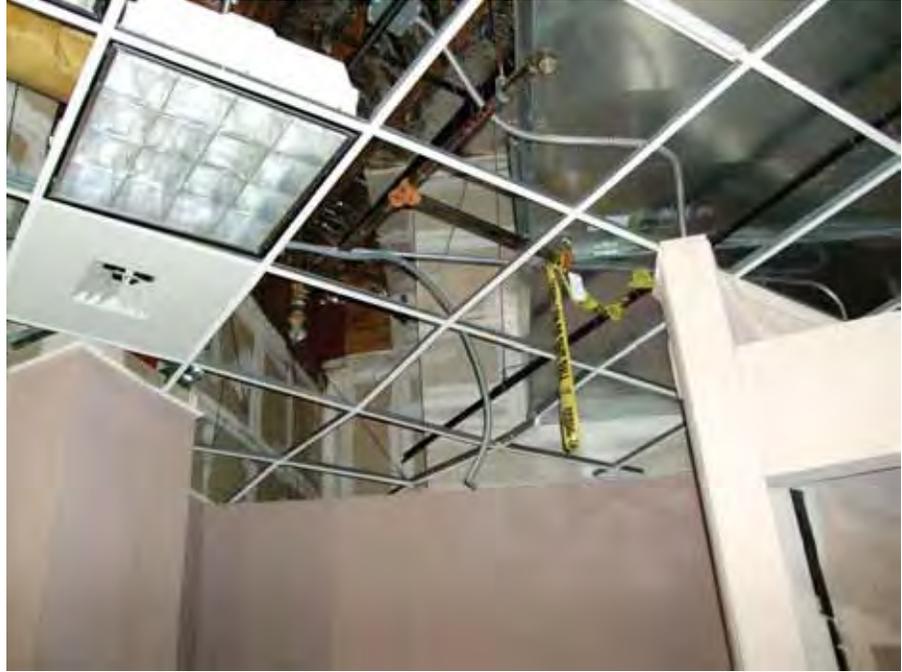
Figure 4-46 Damaged sprinkler pipe. Damage believed to have been caused by interaction with adjacent air handler.

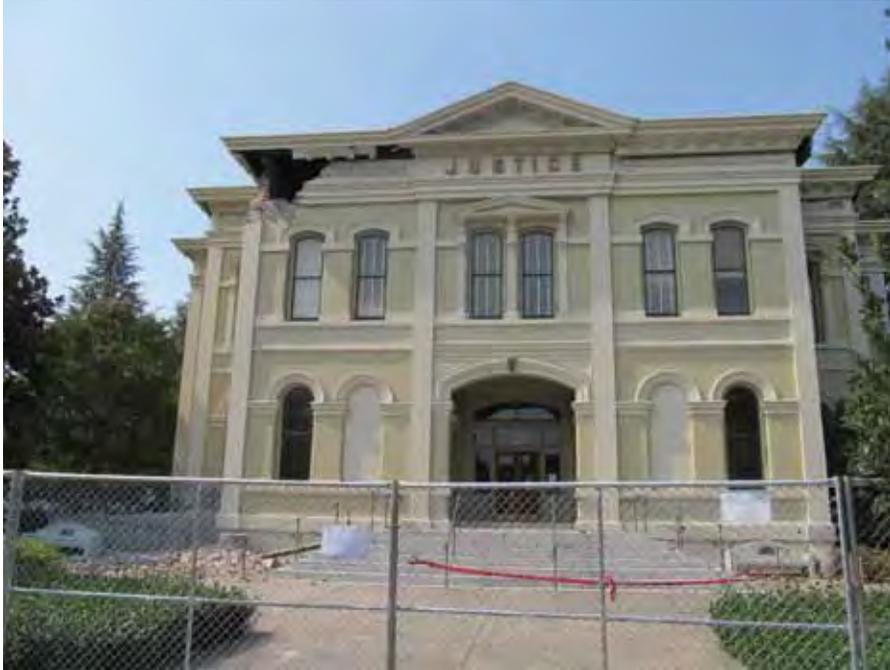
Figure 4-47 East façade of historic URM courthouse. Note fallen bricks below the damaged portion at the top of the wall.

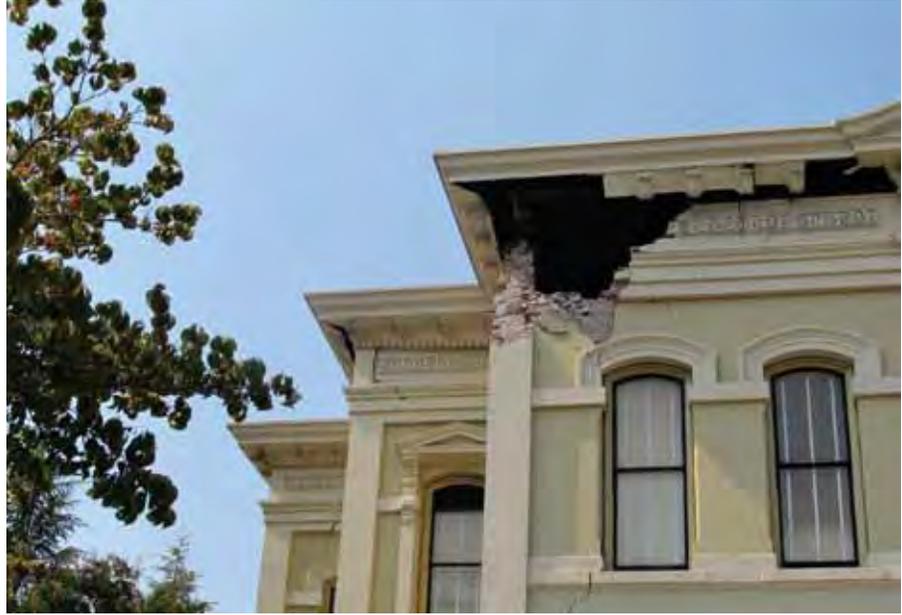
Figure 4-48 Close-up of damage at top of the wall.

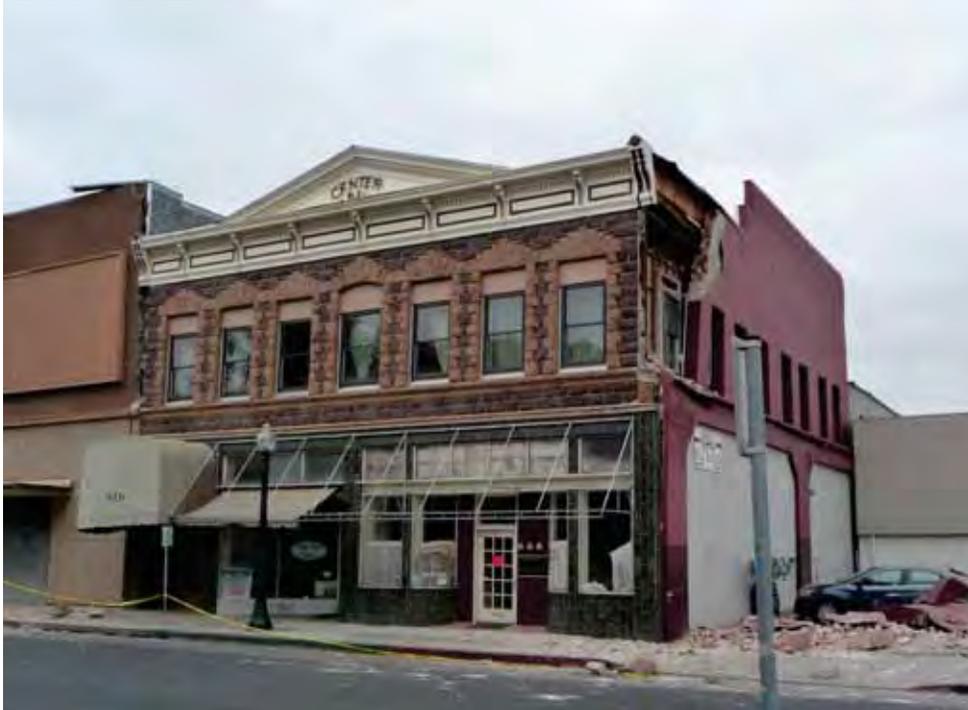
Figure 4-49 Failure of URM south wall (photo courtesy of Marko Schotanus).

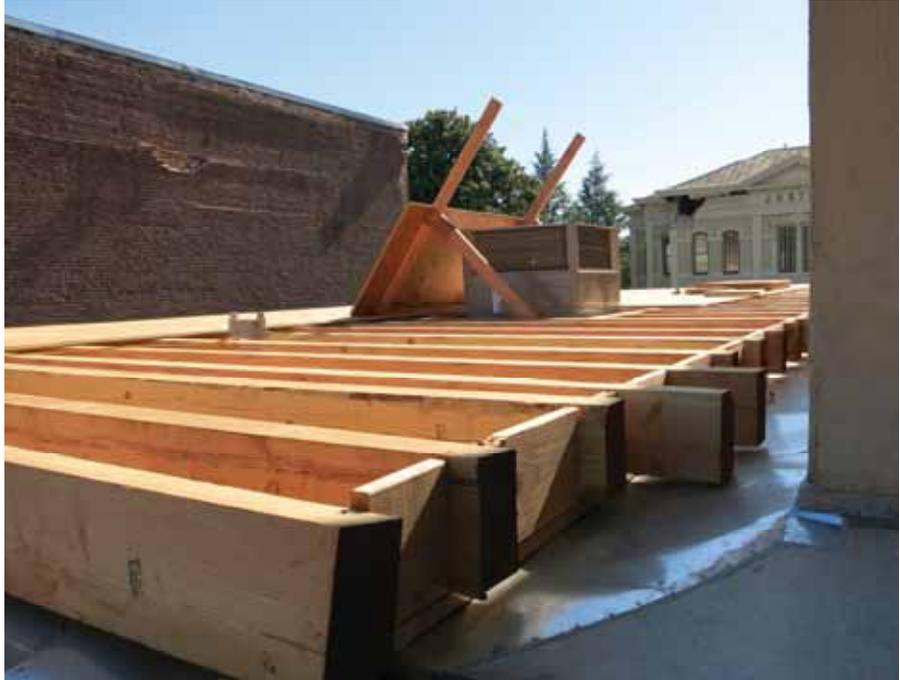
Figure 4-50 Wooden barrier constructed on the roof a building neighboring a masonry wall at risk of collapse.

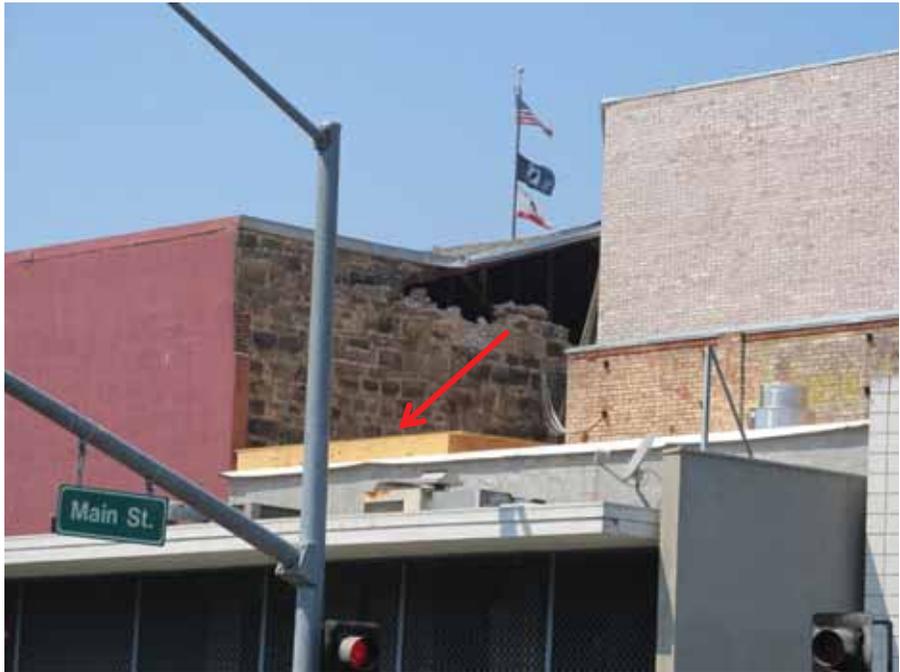
Figure 4-51 Failure of stone masonry east wall. Red arrow indicates wood barrier protecting adjacent property from falling stones.

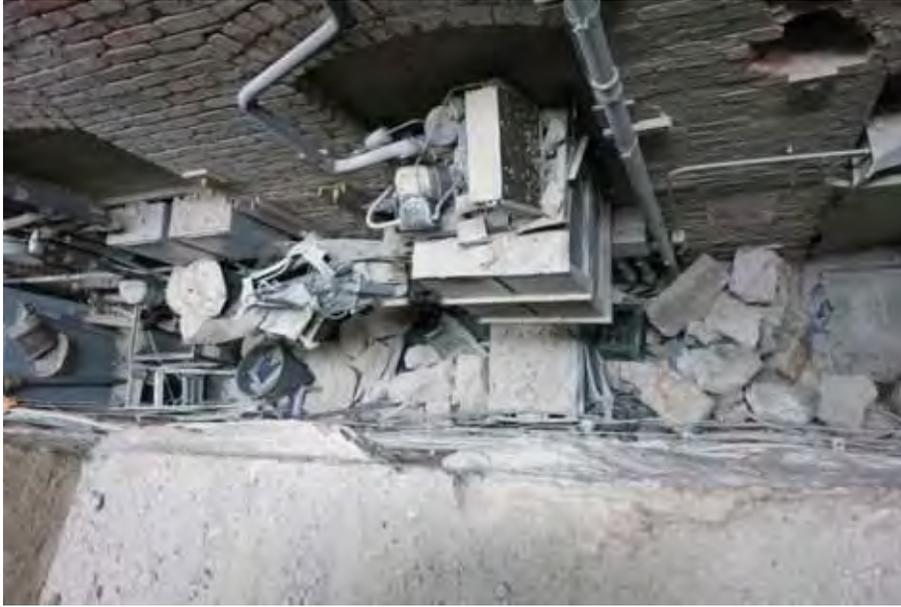
Figure 4-52 HVAC equipment damaged by falling stones.

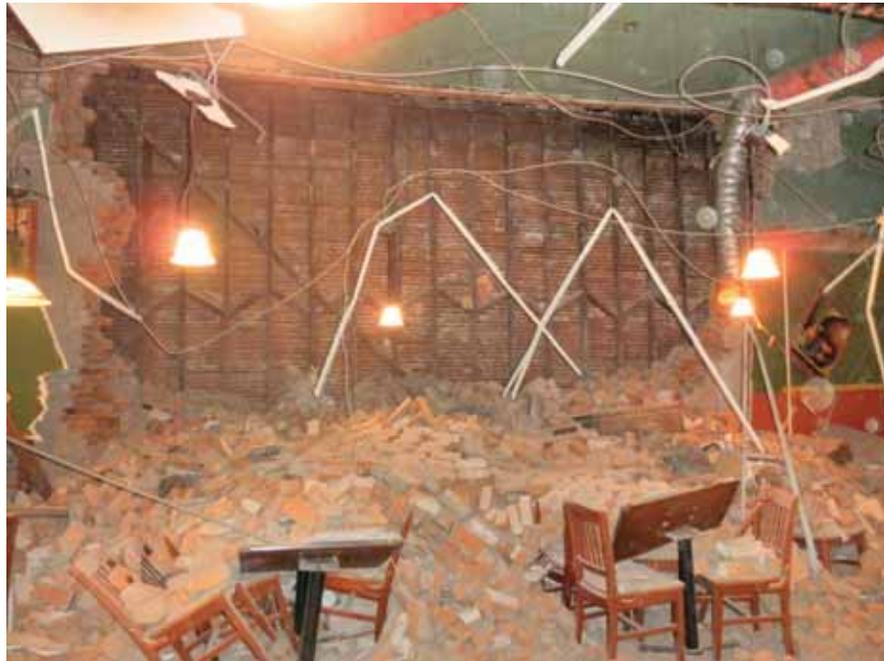
Figure 4-54 Collapsed URM wall and ceiling in dining area.

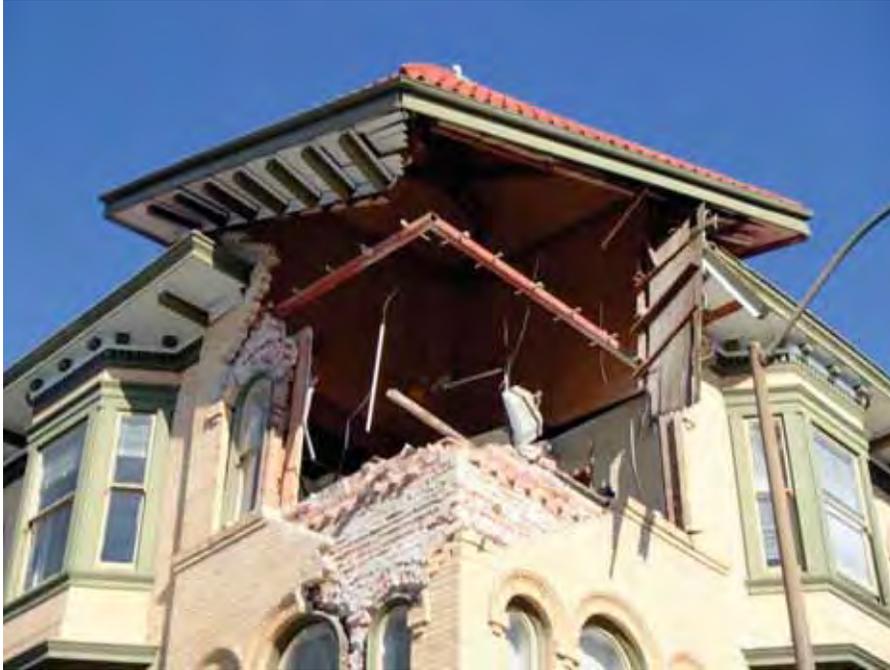
Figure 4-56 Collapse of URM walls supporting a corner cupola.

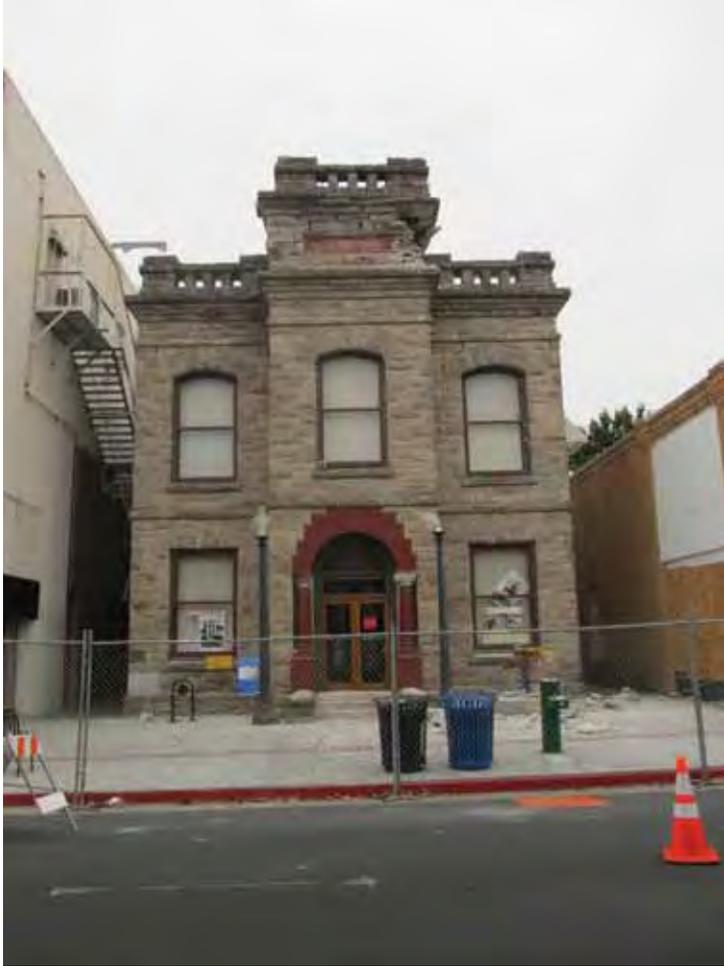
Figure 4-59 Front façade showing damage and UNSAFE placard before scaffolding was installed.

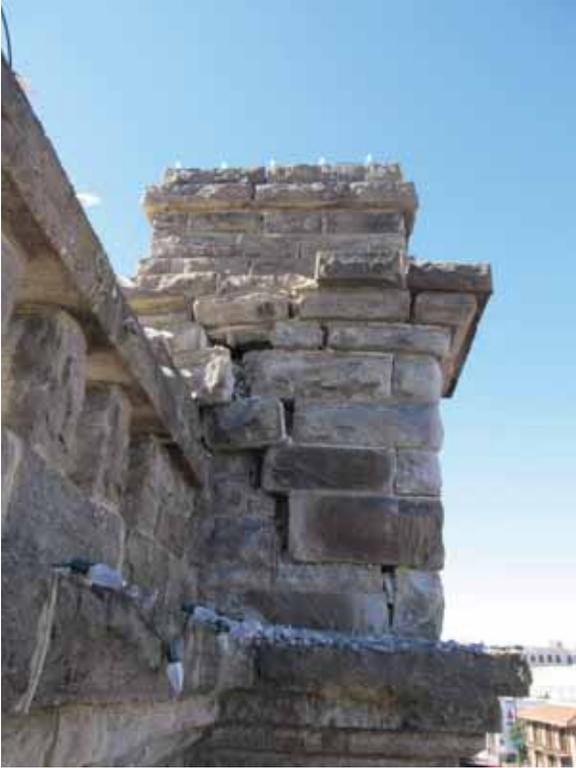
Figure 4-60 Cracking on east side of the tower feature.
