Performance of Buildings and Nonstructural Components in the 2014 South Napa Earthquake

FEMA P-1024 / February 2015

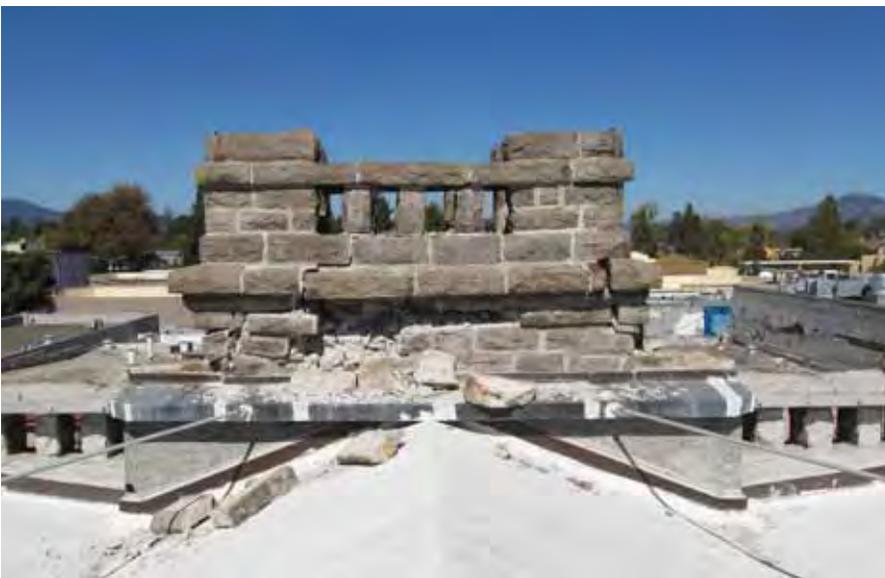
Figure 4-61 Top of concrete shear wall at roof level behind the tower feature.

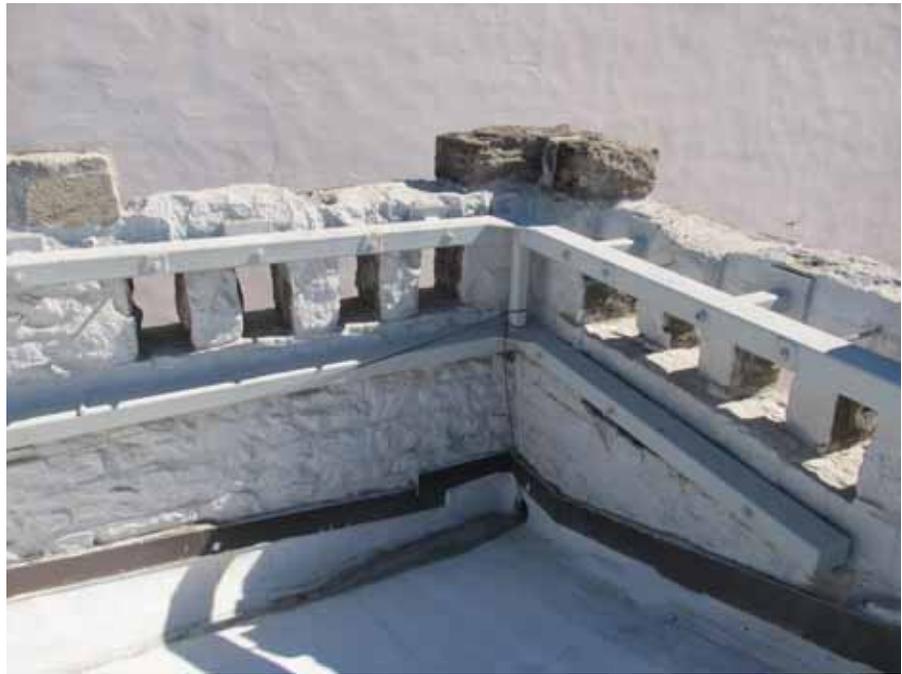
Figure 4-62 Steel tube bracing at parapet.

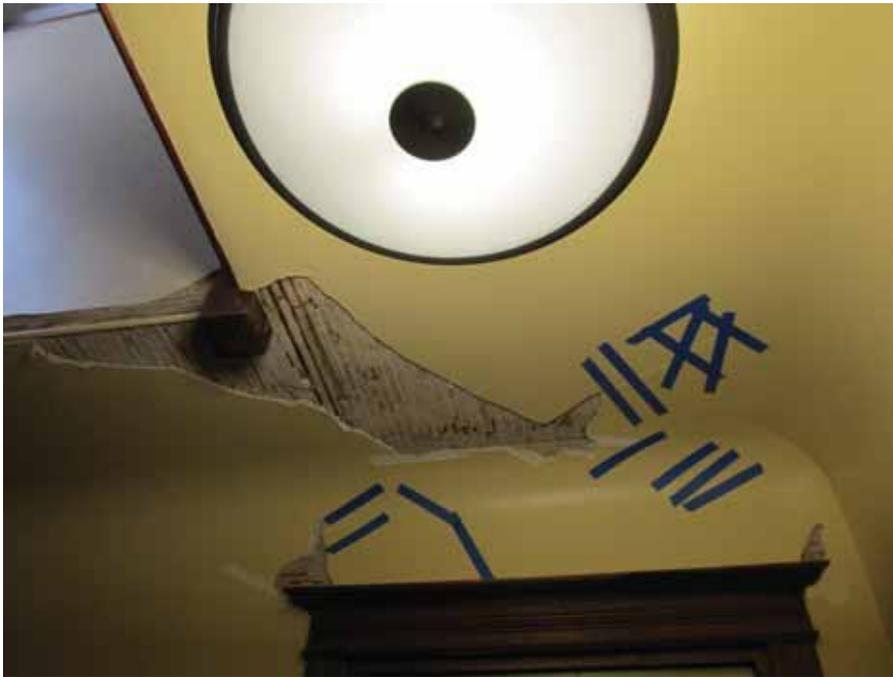
Figure 4-63 Lath and plaster ceiling damage and temporary taping at cracks and spalls.

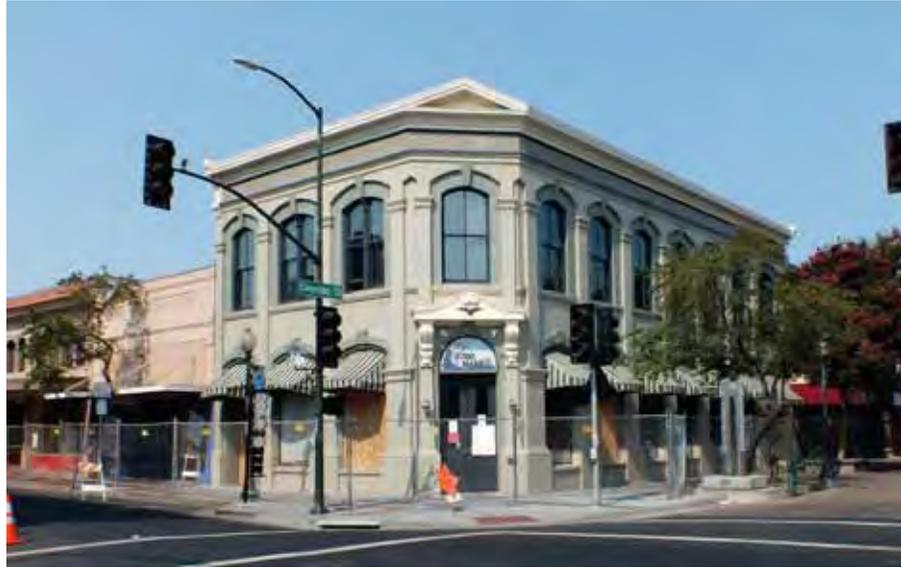
Figure 4-64 Exterior view of building.

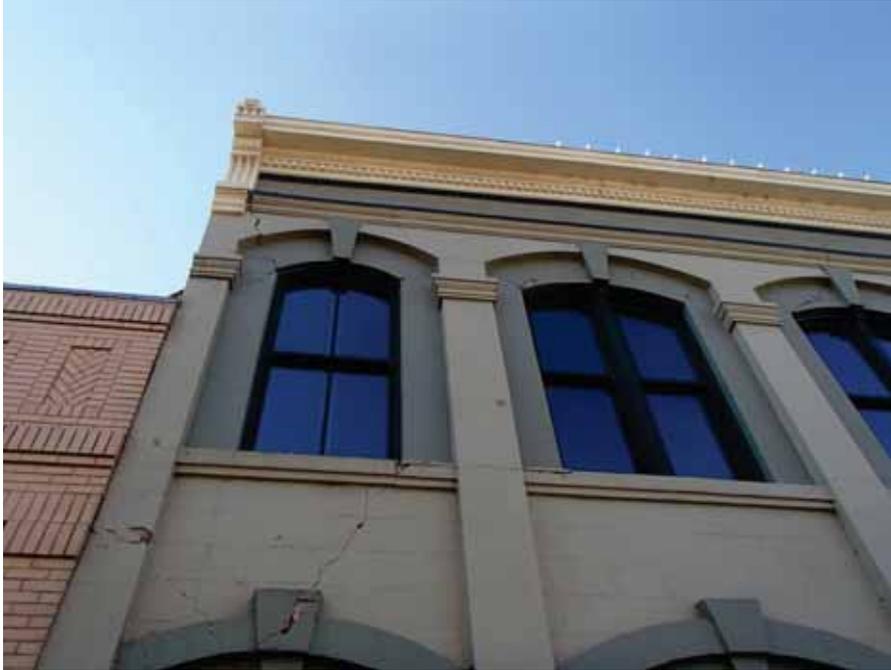
Figure 4-65 Cracking in URM on south façade.

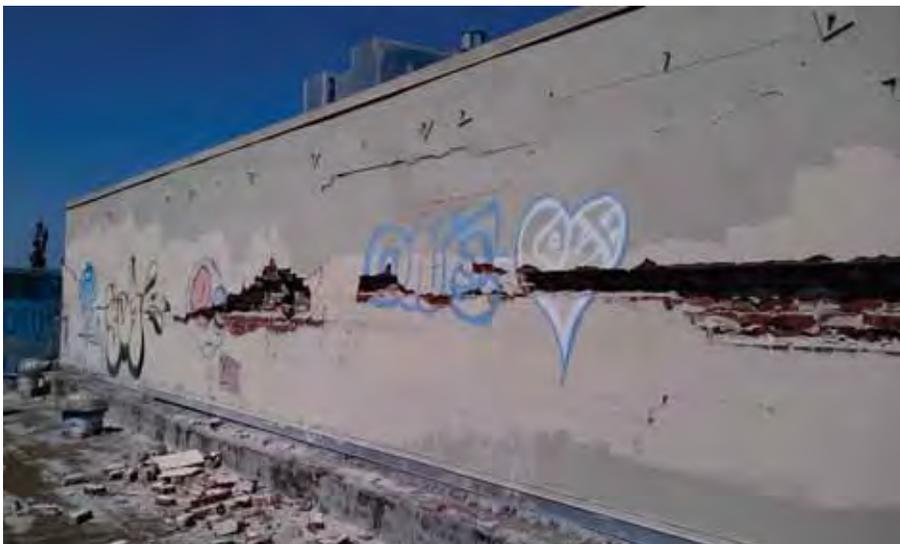
Figure 4-66 URM damage, west elevation (photo from Chris Jonas, ZFA Structural Engineers).

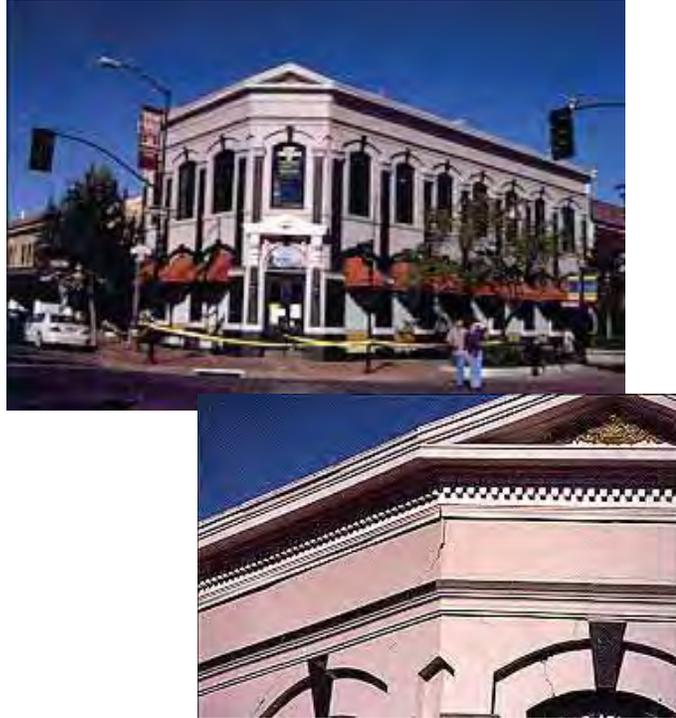
Figure 4-67 Photo of Building J4 and detail of damage after the 2000 Yountville earthquake (PEER, 2000).

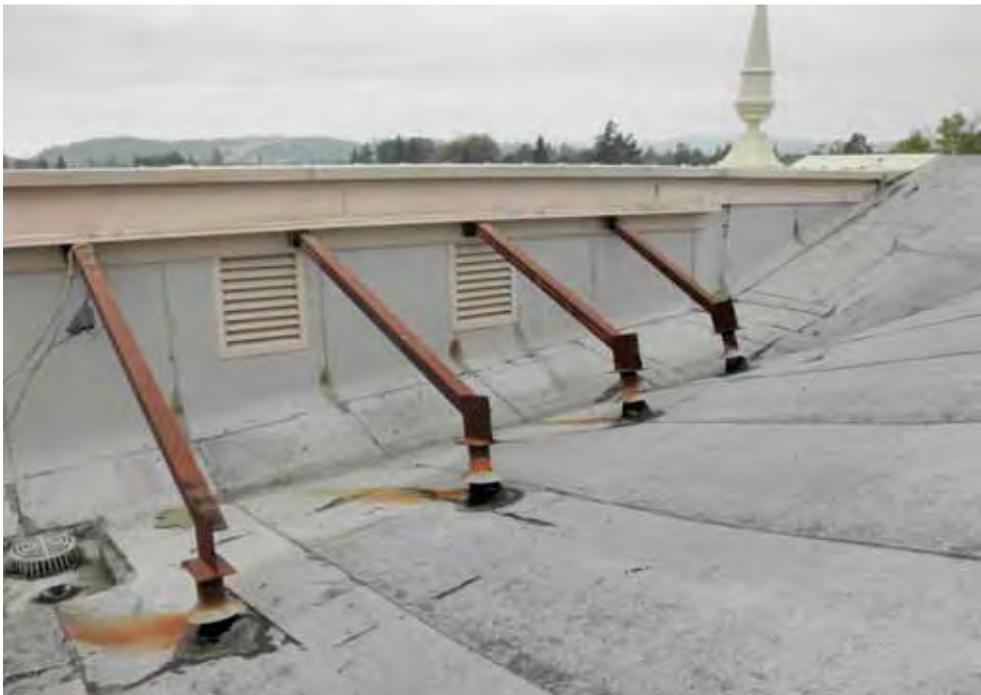
Figure 4-69 URM parapet bracing.

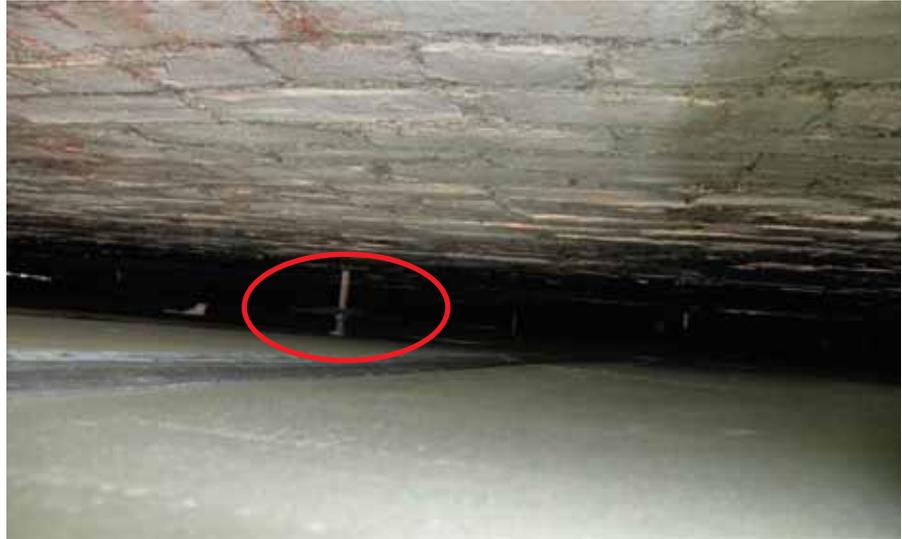
Figure 4-70 Loosened wall anchors on south wall, looking down.

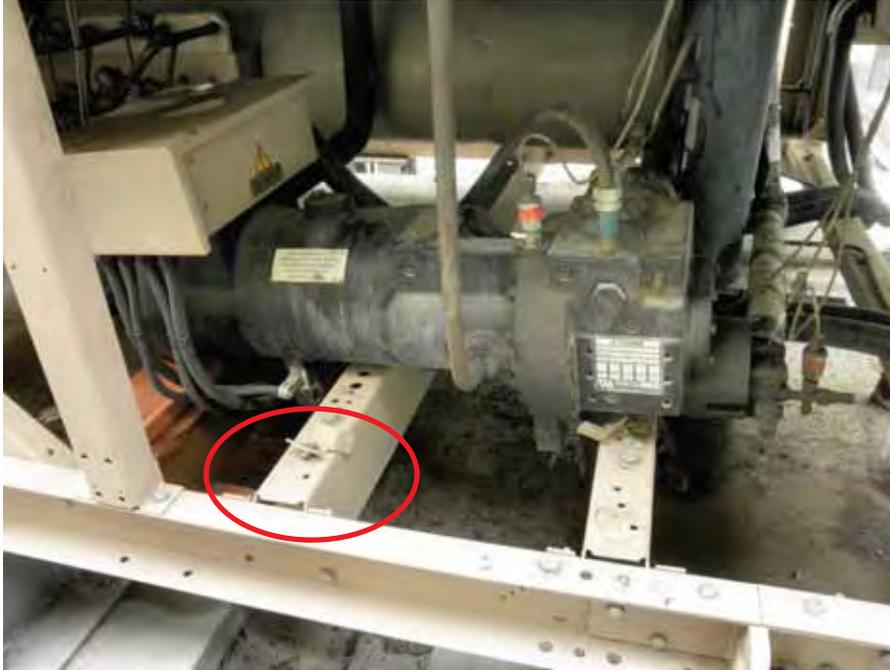
Figure 4-71 Connection failure at compressor.

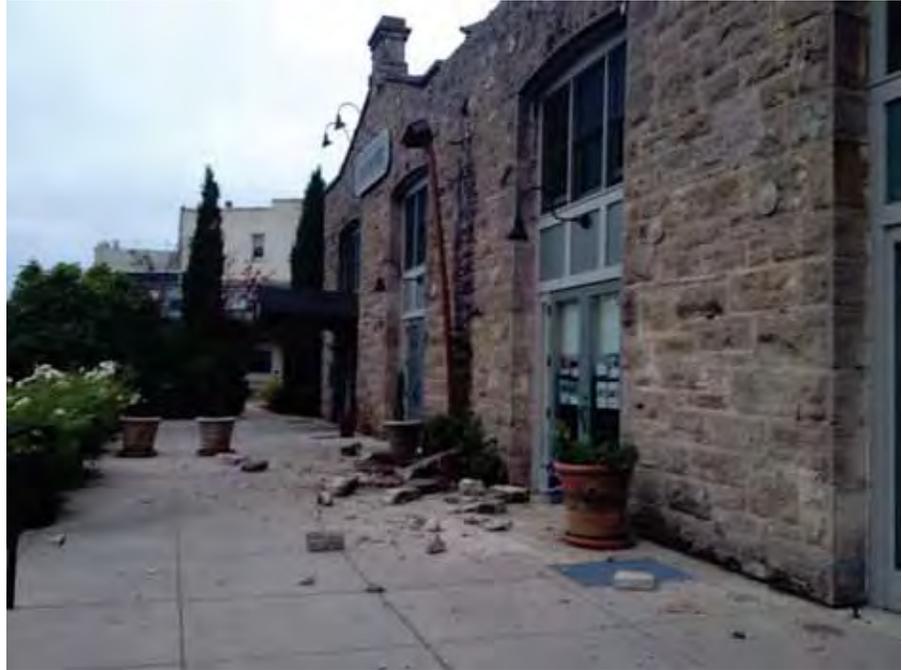
Figure 4-72 Exterior wall on day of earthquake.

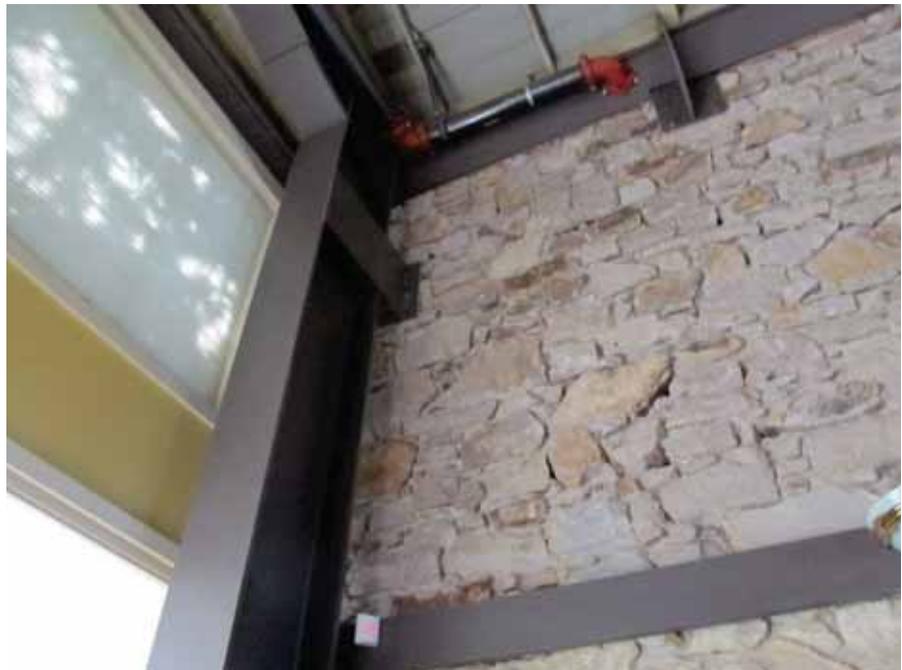
Figure 4-73 Diagonal cracks in stone wall.

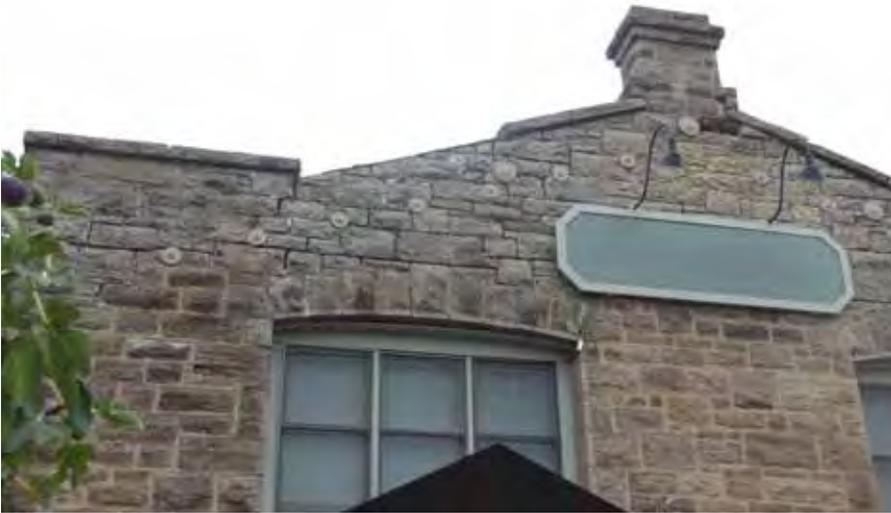
Figure 4-74 Exterior face of parapet wall.

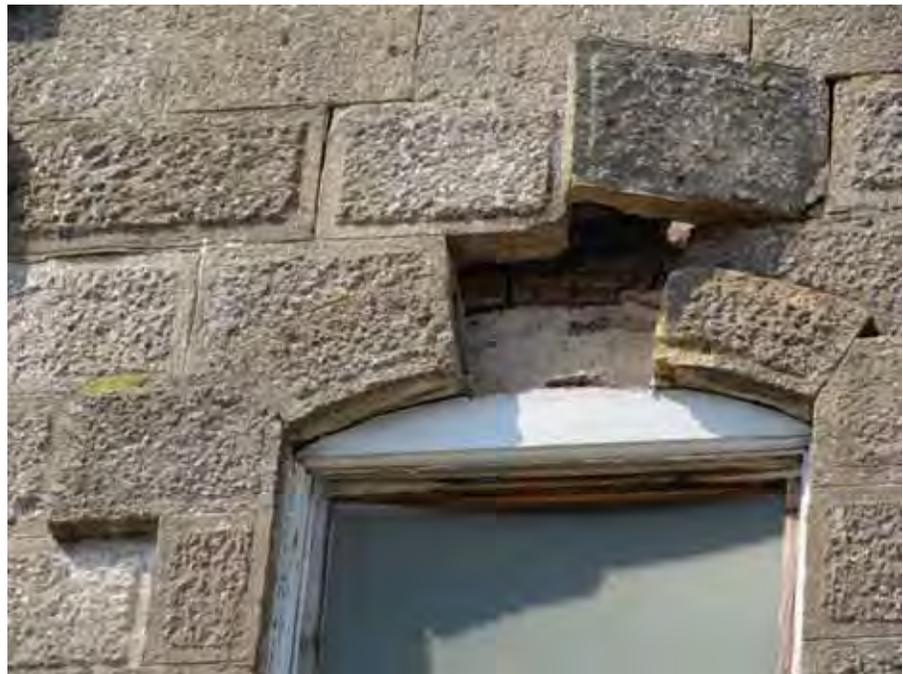
Figure 4-78 Loose stone cladding over window at front façade.

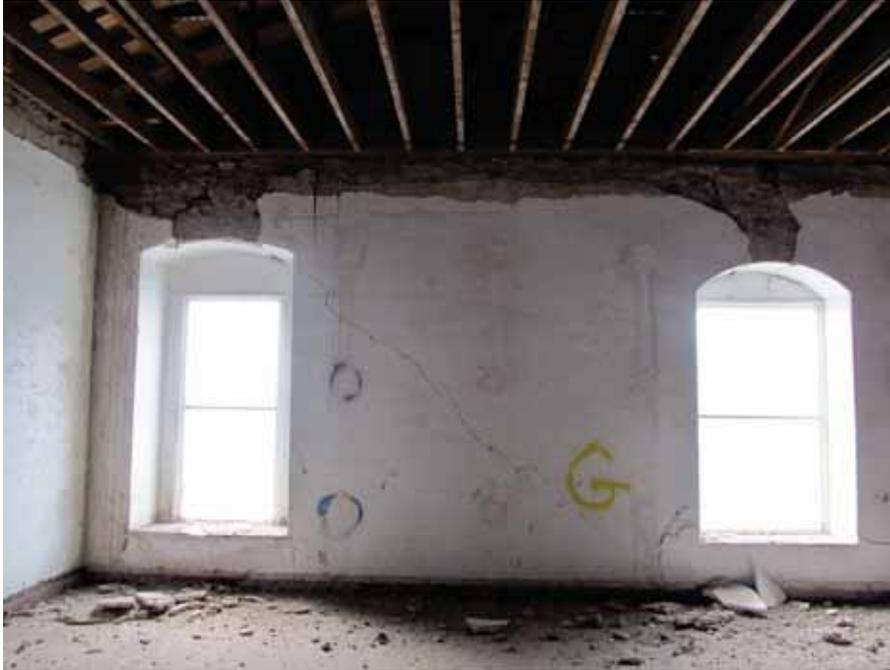
Figure 4-79 Diagonal cracking at inside face of second story pier at front façade.

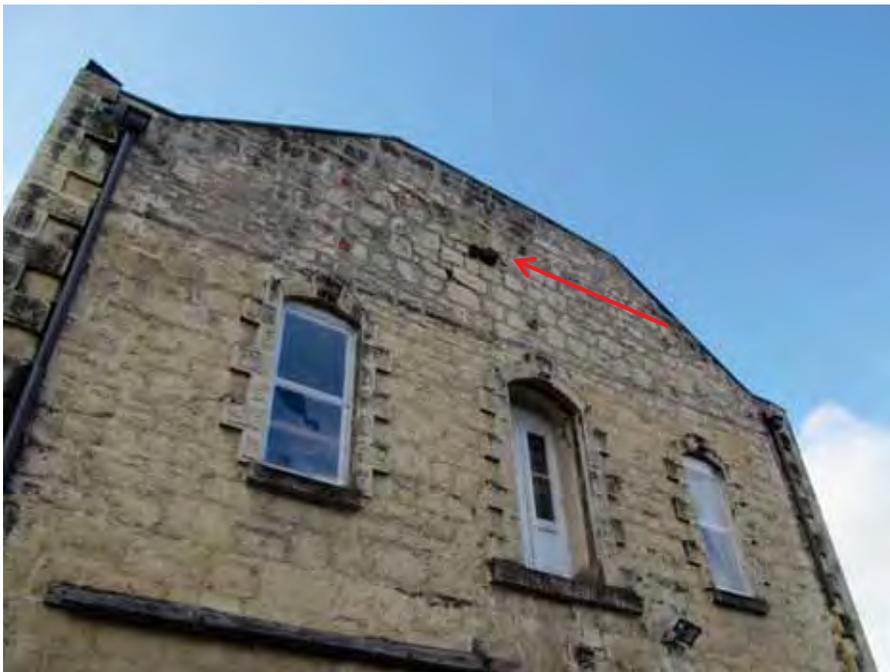
Figure 4-80 Rear façade elevation. Red arrow points to the location where the stone fell at the center of the gable.

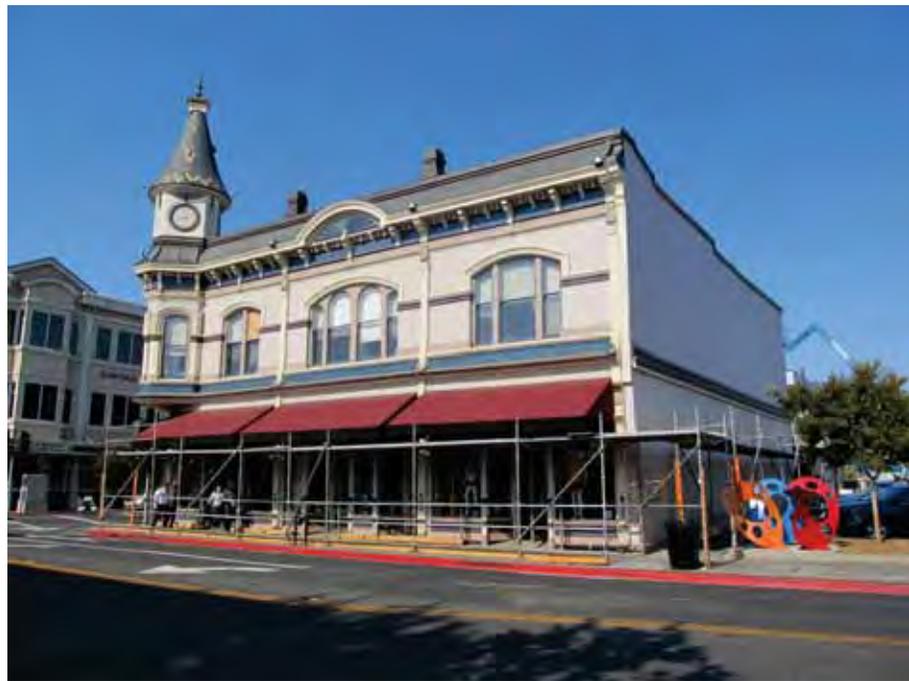
Figure 4-81 Exterior view of building.

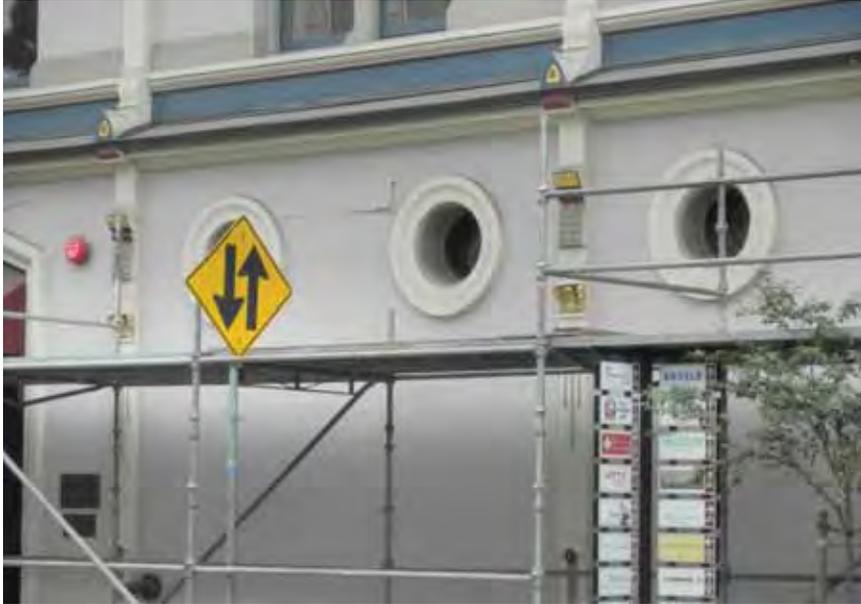
Figure 4-82 Minor cracking in URM wall, north elevation.

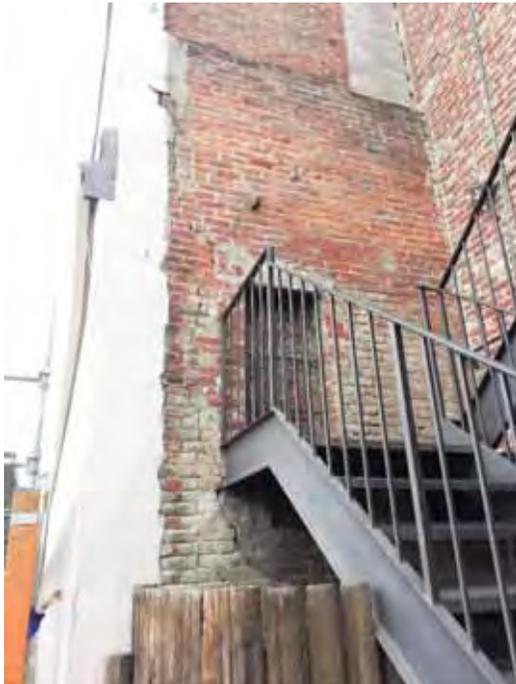
Figure 4-83 Southeast corner, damage to URM wall due to interaction with steel stair.

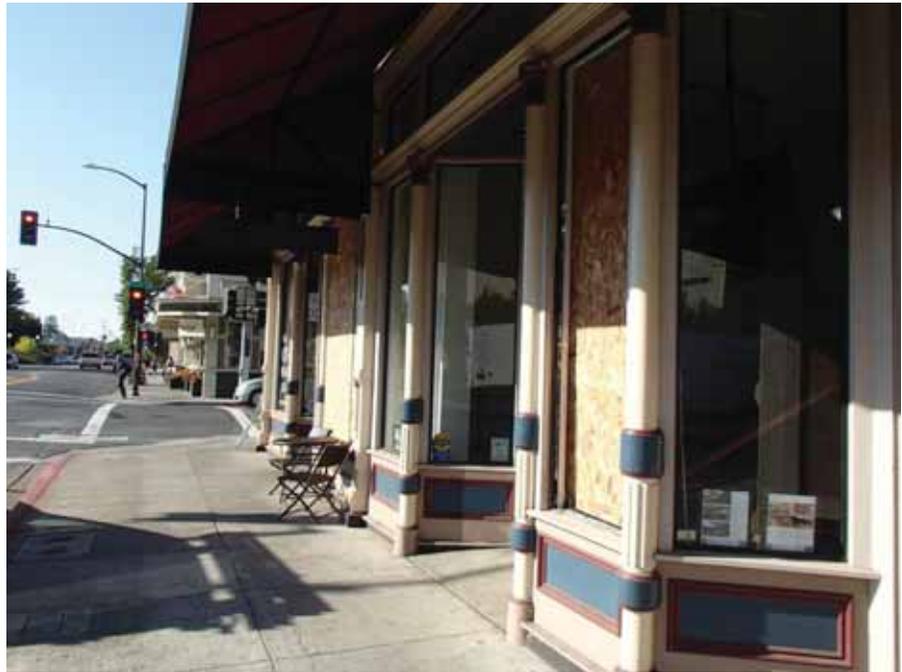
Figure 4-84 Damage to glazing, west elevation.

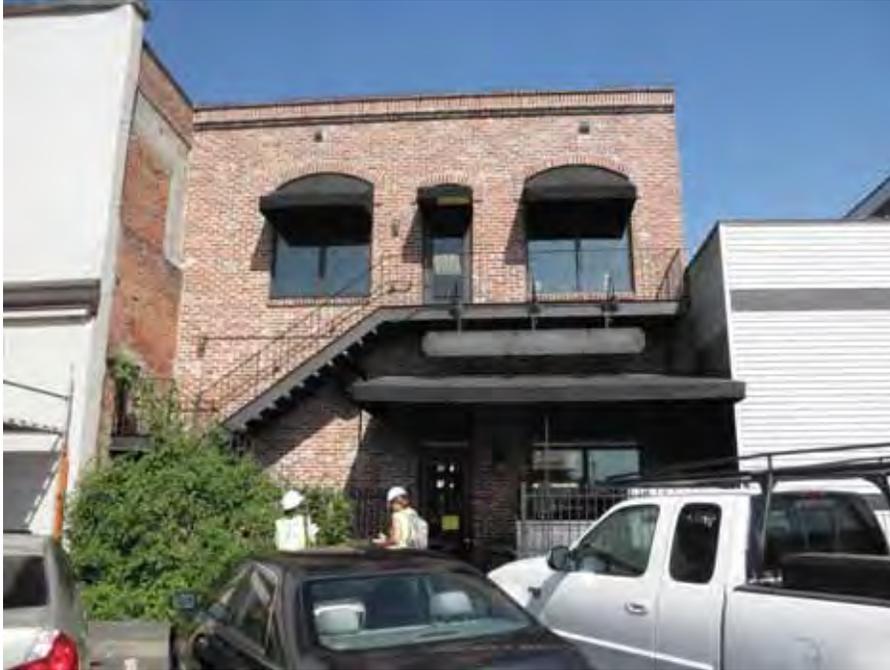
Figure 4-85 Exterior view of building.

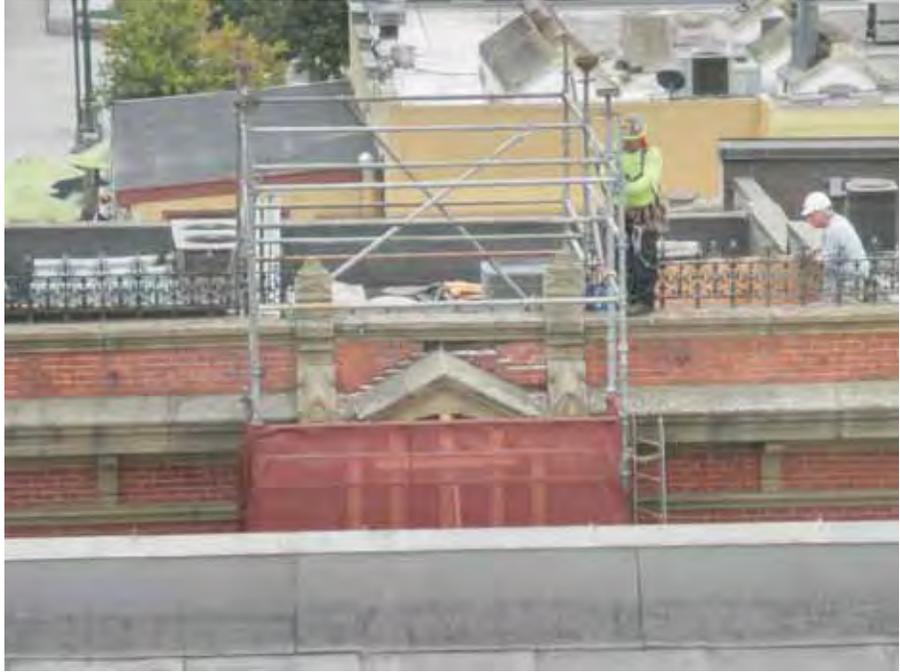
Figure 4-86 Damage to stonework above main entrance.

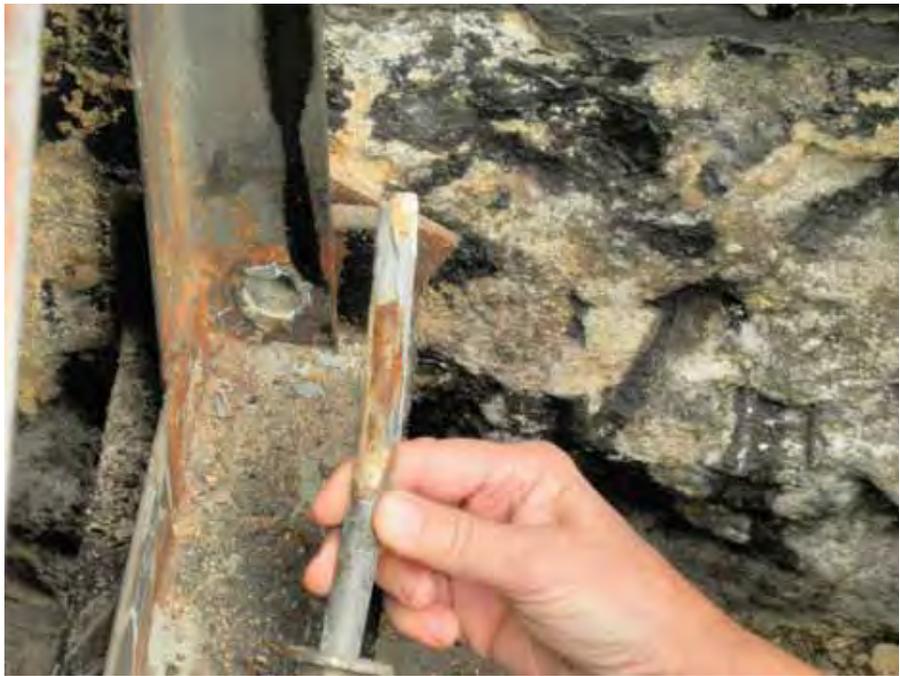
Figure 4-87 Failed wall anchor, north elevation.

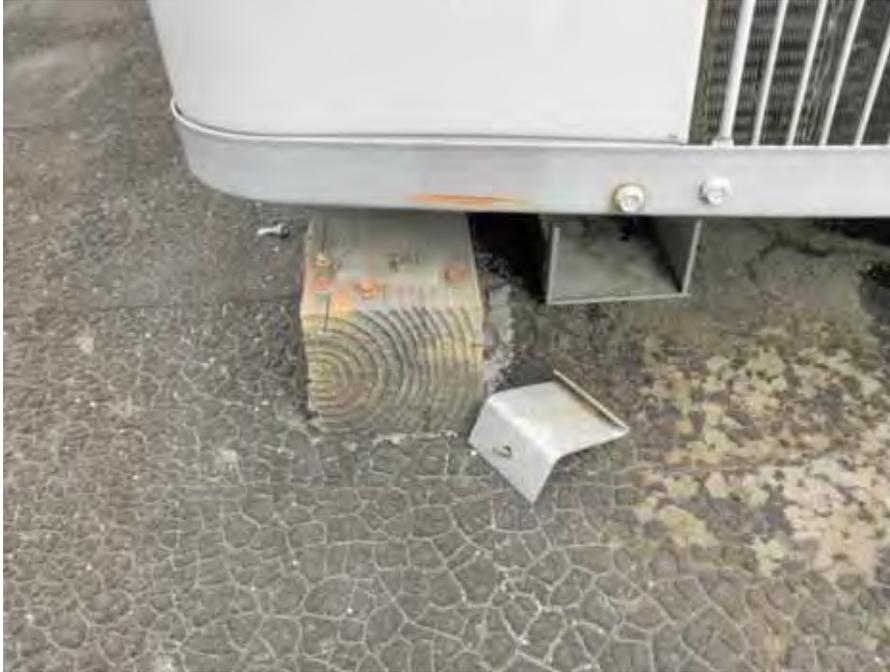
Figure 4-88 Failure of air handler unit anchor, screws pulled out of sleeper.

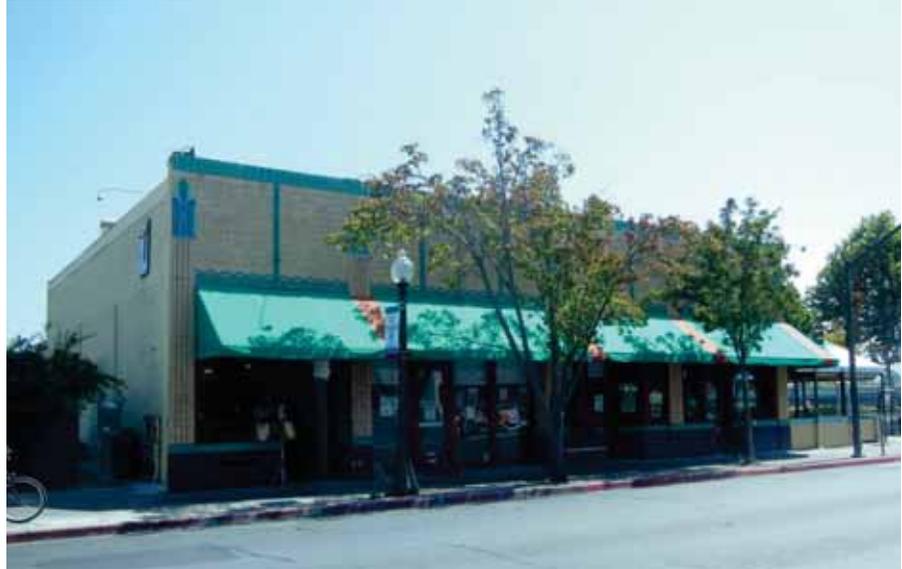
Figure 4-89 Building elevation from Main Street.

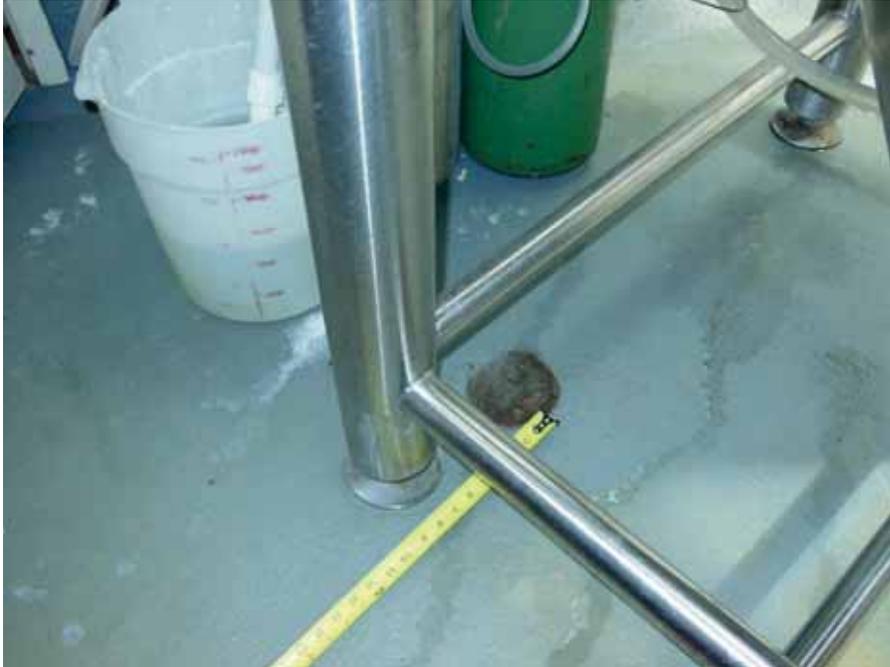
Figure 4-90 Unanchored tank shifted approximately 8 inches.

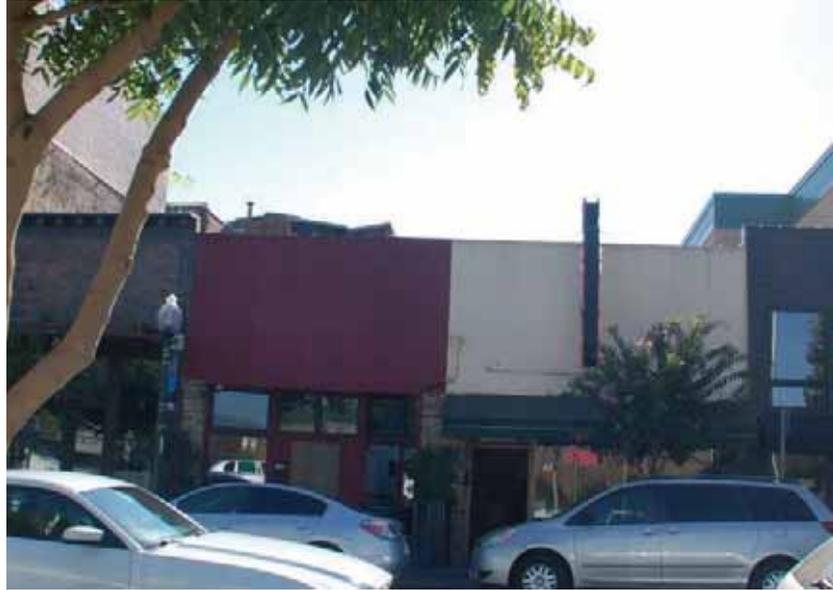
Figure 4-92 East elevation.

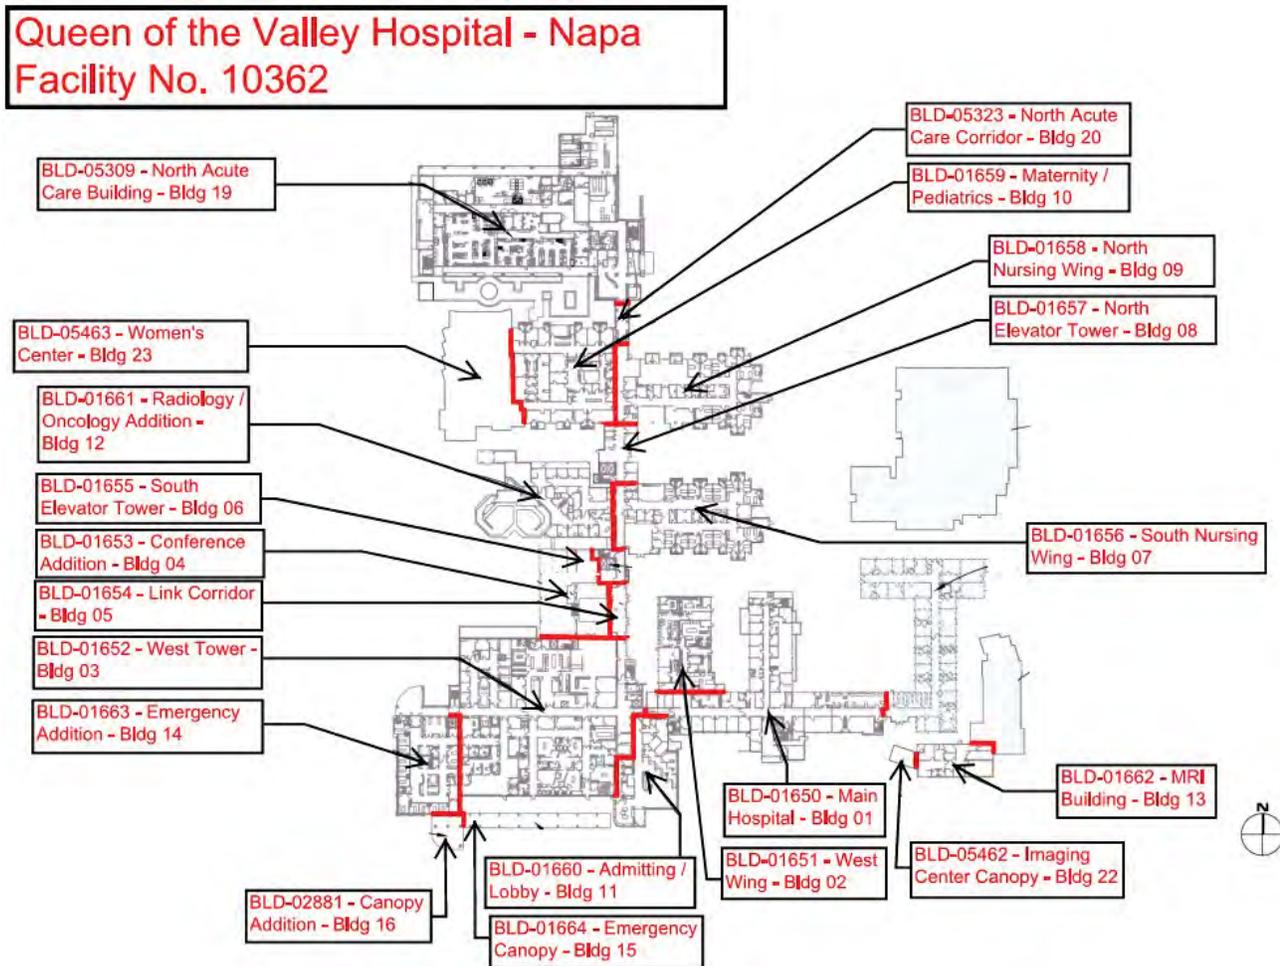
Figure 5-2 Queen of the Valley Hospital site plan indicating building numbers. Red lines indicate structural building separations.

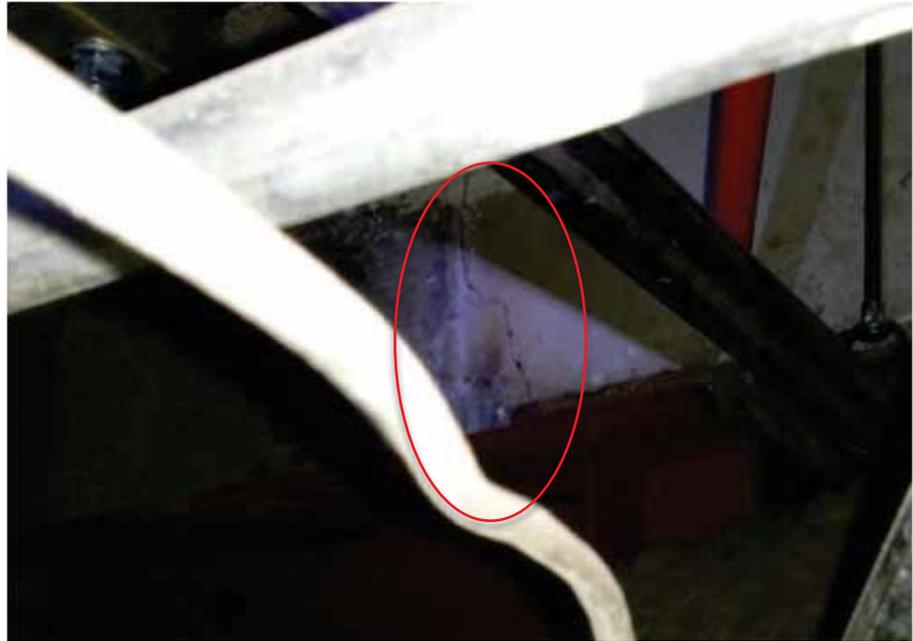
Figure 5-3 Damaged concrete beam at the third floor of BLD-01650.

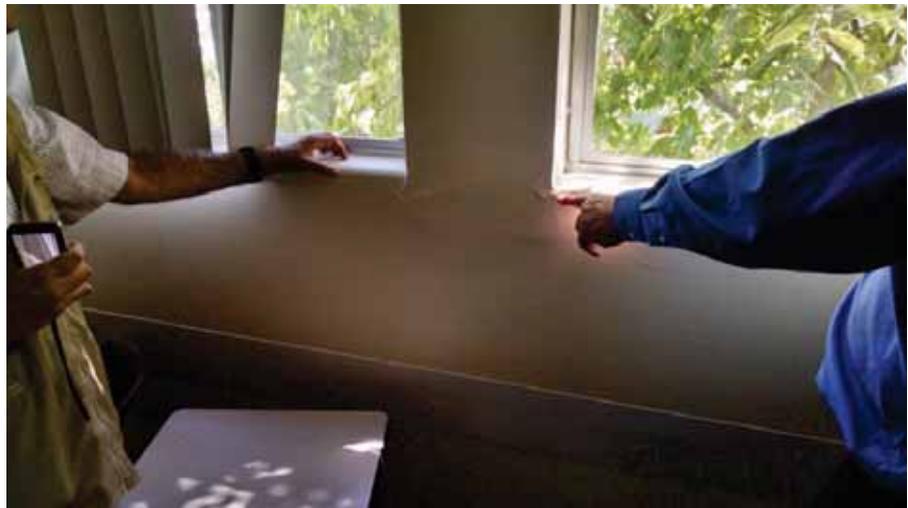
Figure 5-4 Cracked concrete wall piers in BLD-01650.

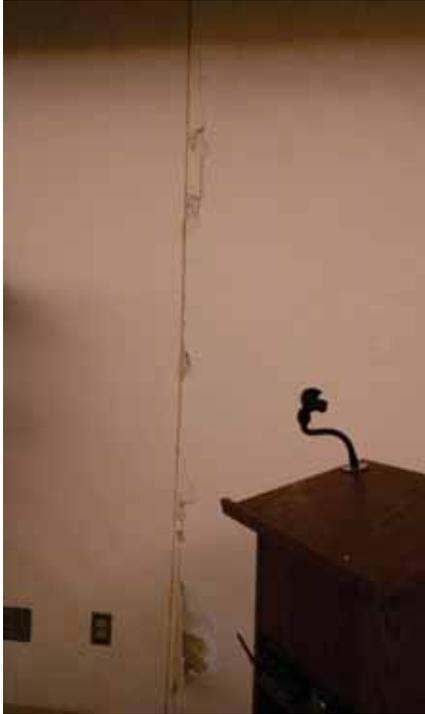
Figure 5-5 Cracked precast concrete panel in BLD-01653.

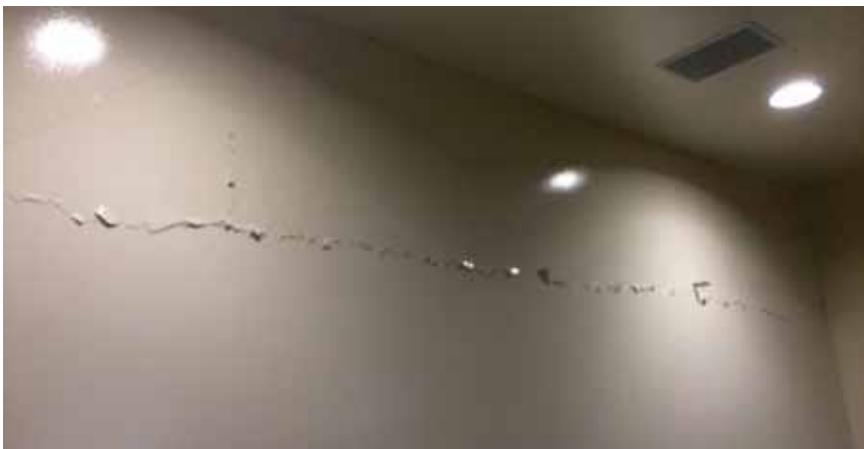
Figure 5-6 Cracked gypsum board wall in BLD-05309.

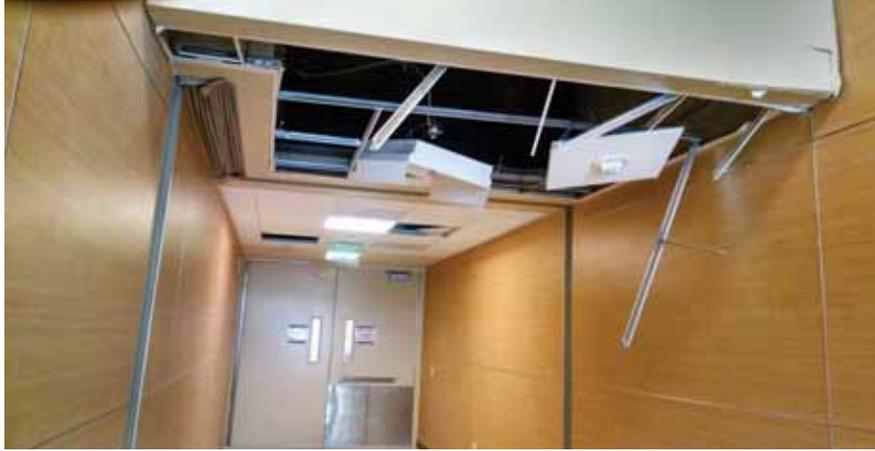
Figure 5-7 Third floor ceiling damage in BLD-05323 corridor link.

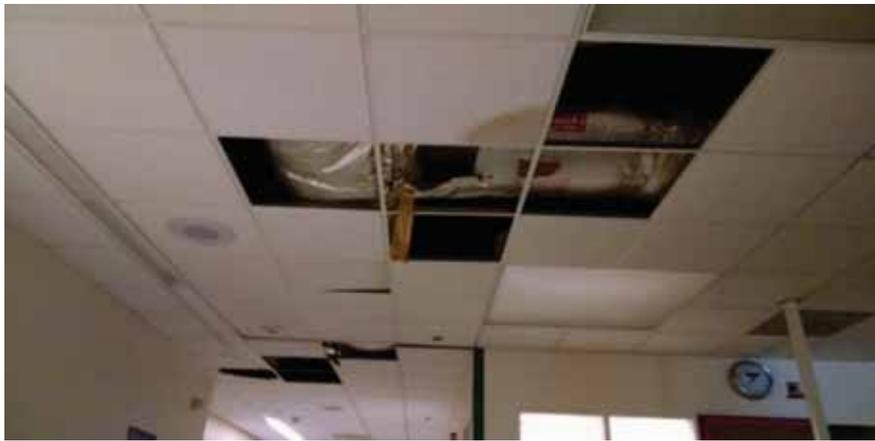
Figure 5-8 Third floor ceiling damage in BLD-01656.

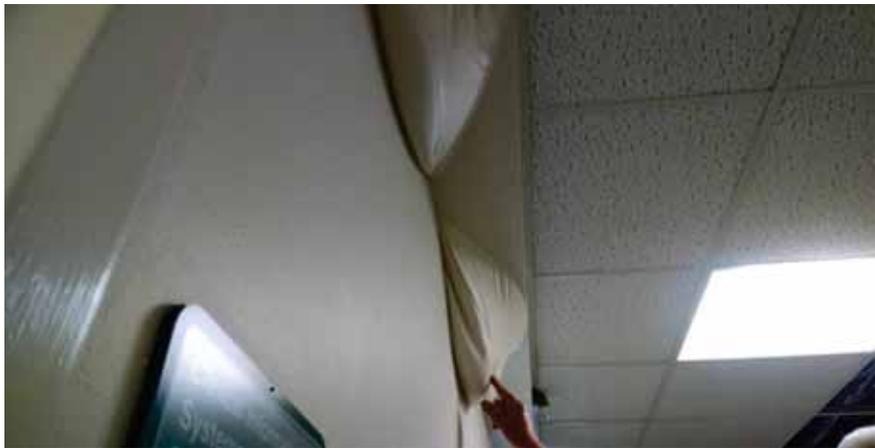
Figure 5-9 Evidence of water leak in corridor of BLD-01650 (paint stretched to contain water).

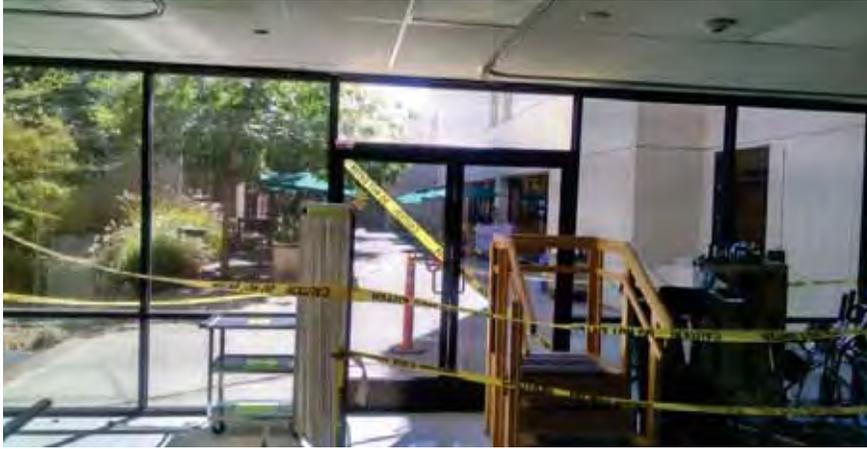
Figure 5-10 South Nursing Wing storefront glazing damage leading to entrance posted RESTRICTED USE at BLD-01656.

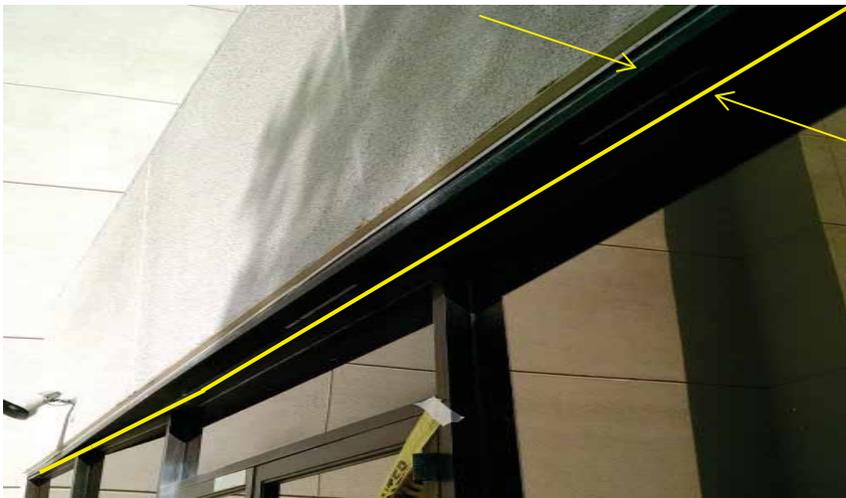
Figure 5-11 South Nursing Wing storefront glazing damage leading to RESTRICTED USE posting at BLD-01656. Yellow line indicates amount of movement in the top track.

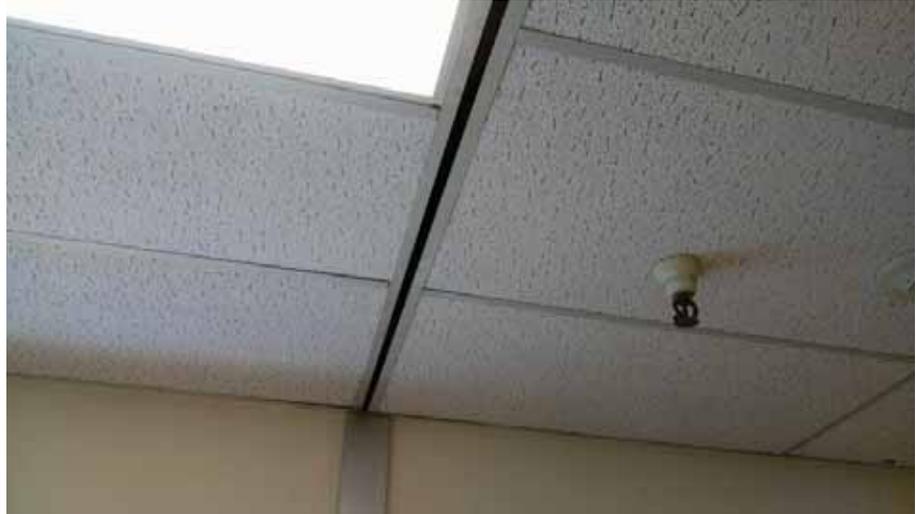
Figure 5-12 Movement at seismic joint between BLD-01652 and BLD-01650 Main Hospital.

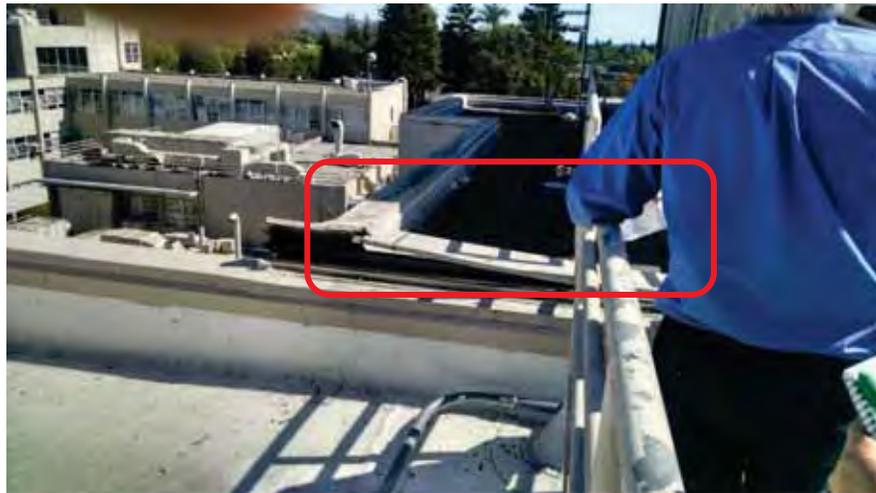
Figure 5-13 Damage to seismic joint flashing between BLD-01654 and BLD-01655.

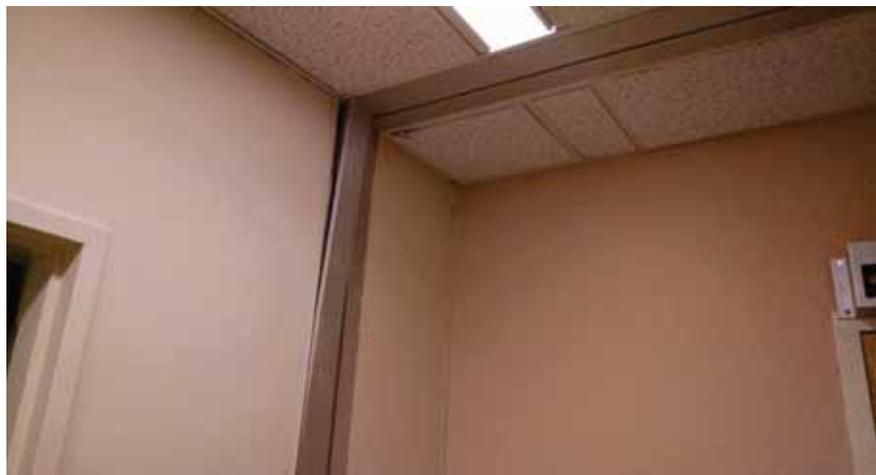
Figure 5-14 Damage to seismic joint cover at second floor of BLD-01659.

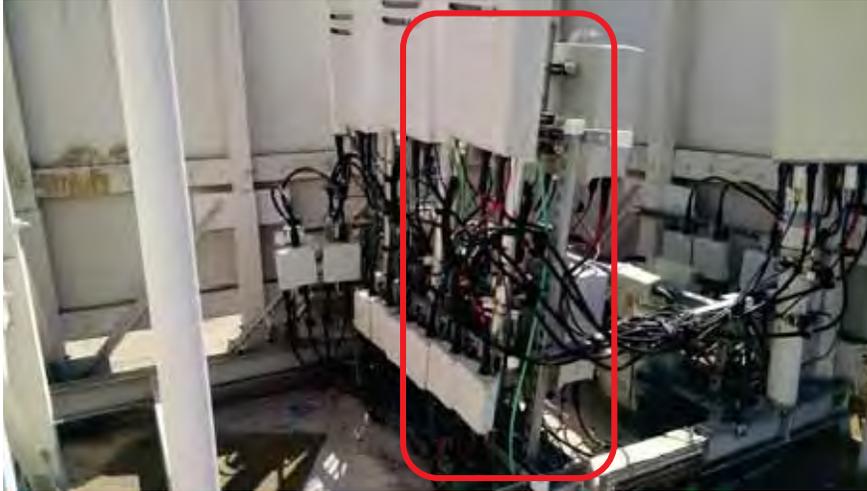
Figure 5-15 Telephone rack on cantilevered supporting frame at roof of BLD-01650 severely out of plumb.

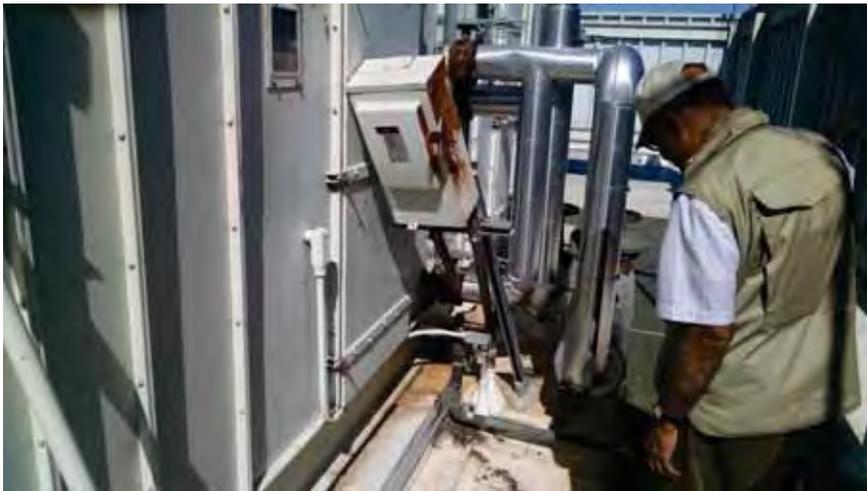
Figure 5-16 Electrical panel on cantilevered supports damaged at roof of BLD-01656.
