Performance of Buildings and Nonstructural Components in the 2014 South Napa Earthquake

FEMA P-1024 / February 2015

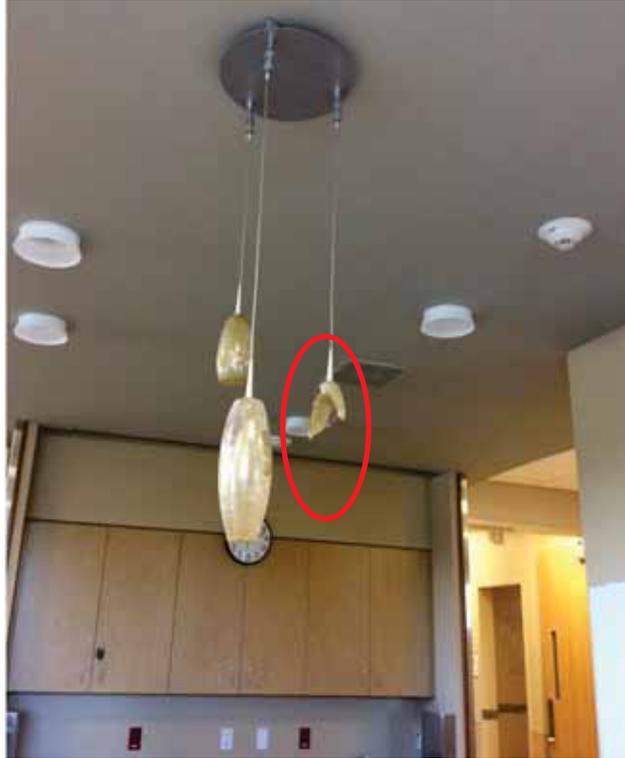
Figure 5-17 Damaged light fixture in BLD-05309.

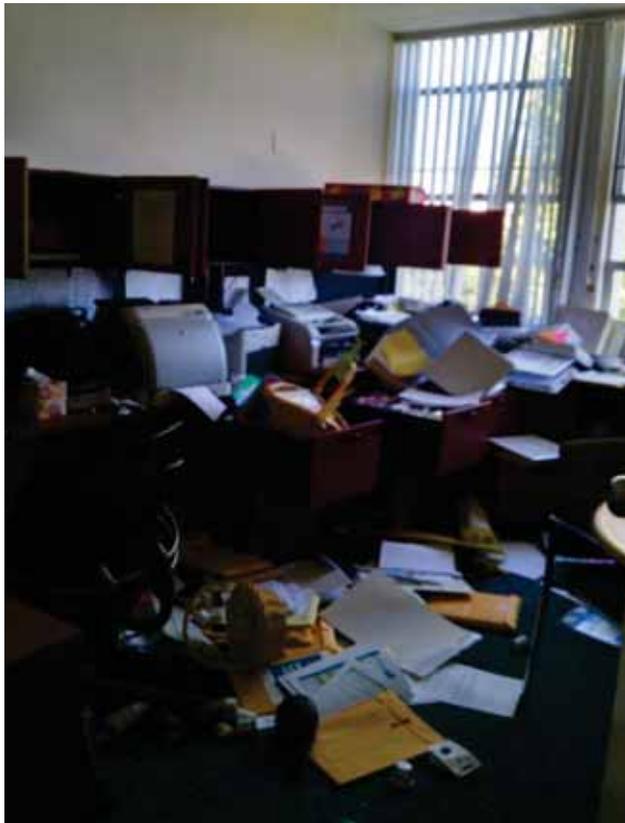
Figure 5-18 Contents damage in BLD-01650.

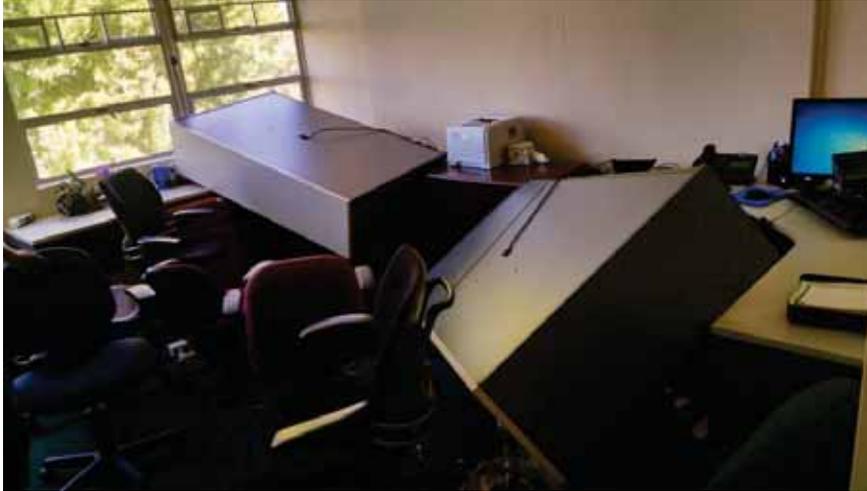
Figure 5-19 Contents damage in BLD-01650.

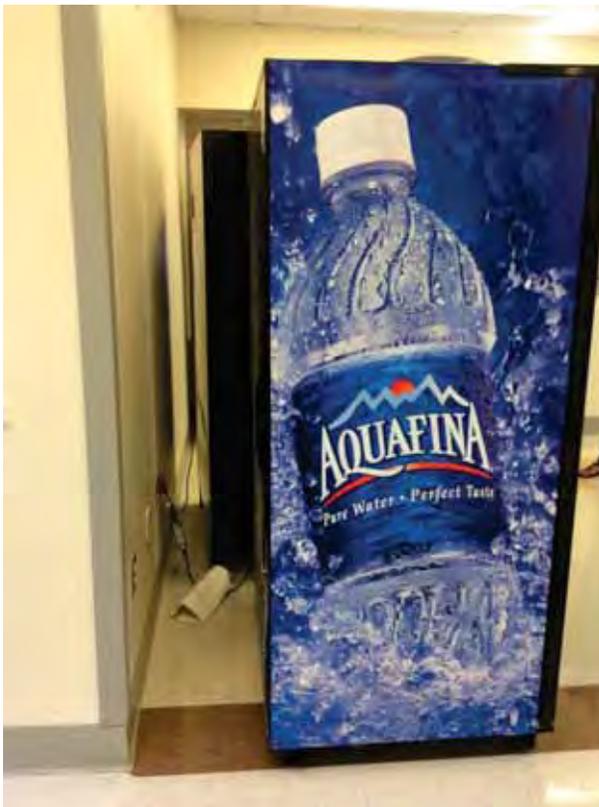
Figure 5-20 Unanchored vending machine in BLD-01656 shifted over 12 inches.

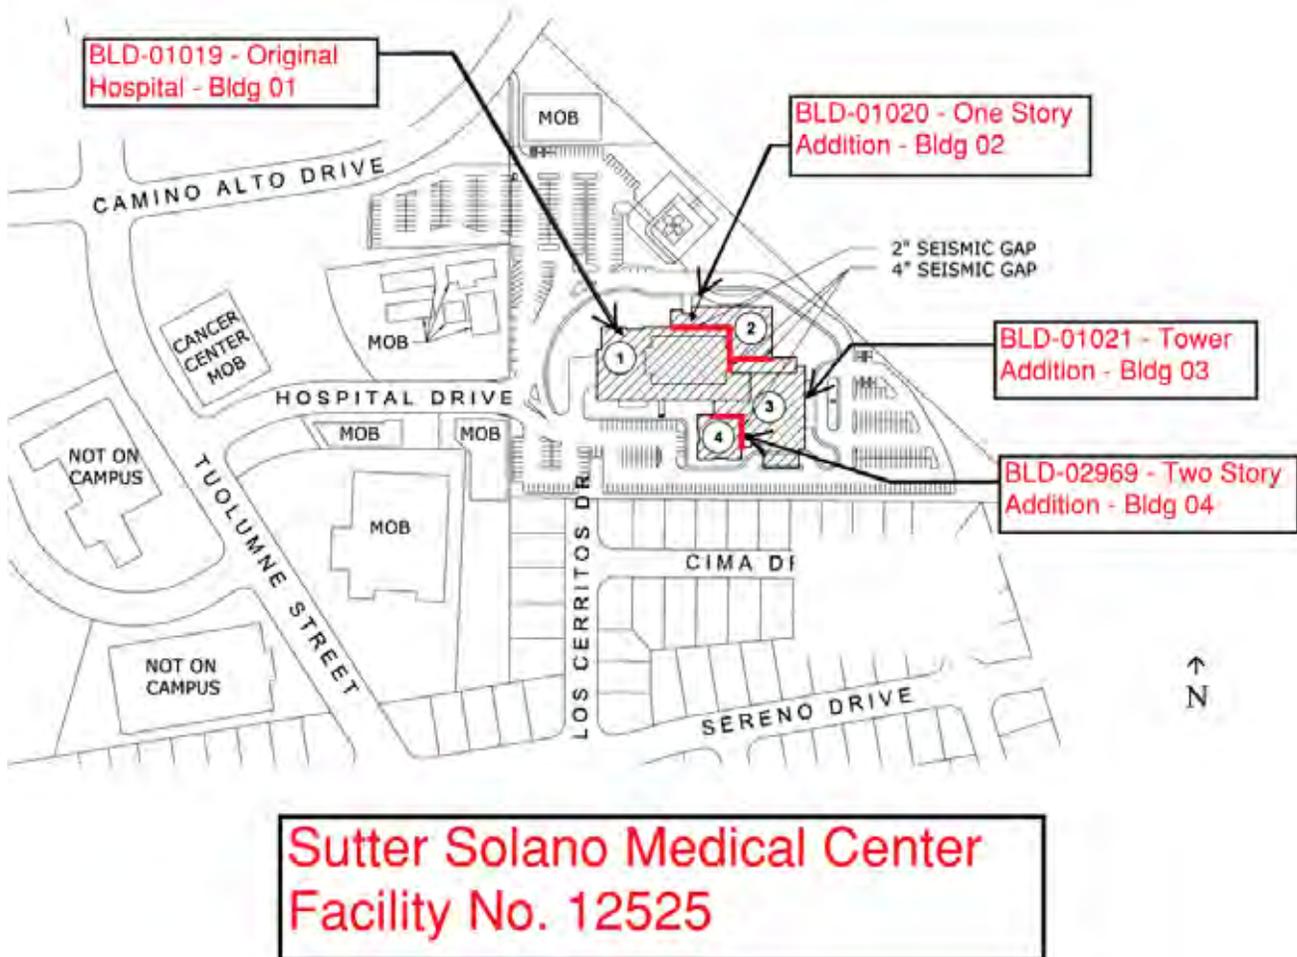
Figure 5-21 Sutter Solano Medical Center site plan.

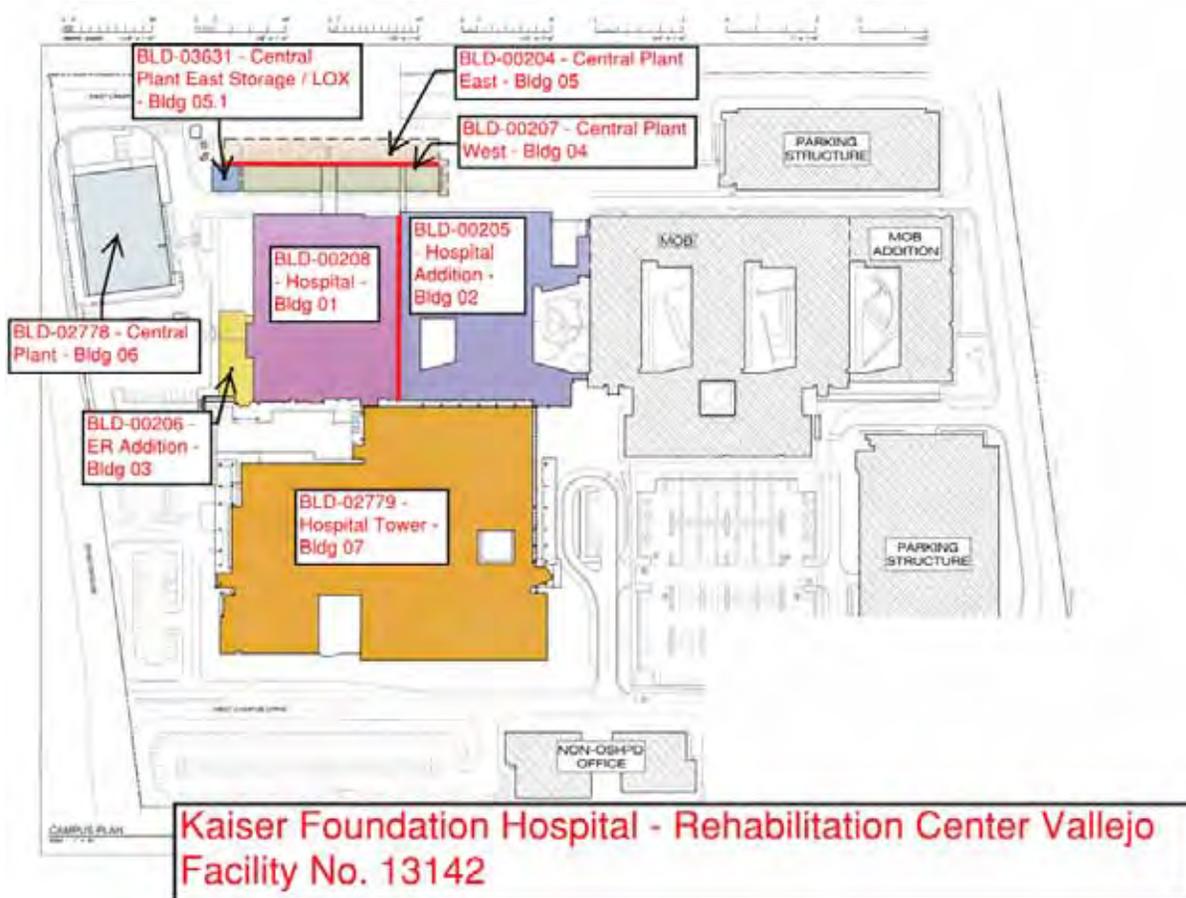
Figure 5-22 The Kaiser Foundation Hospital – Rehabilitation Center Vallejo site plan.

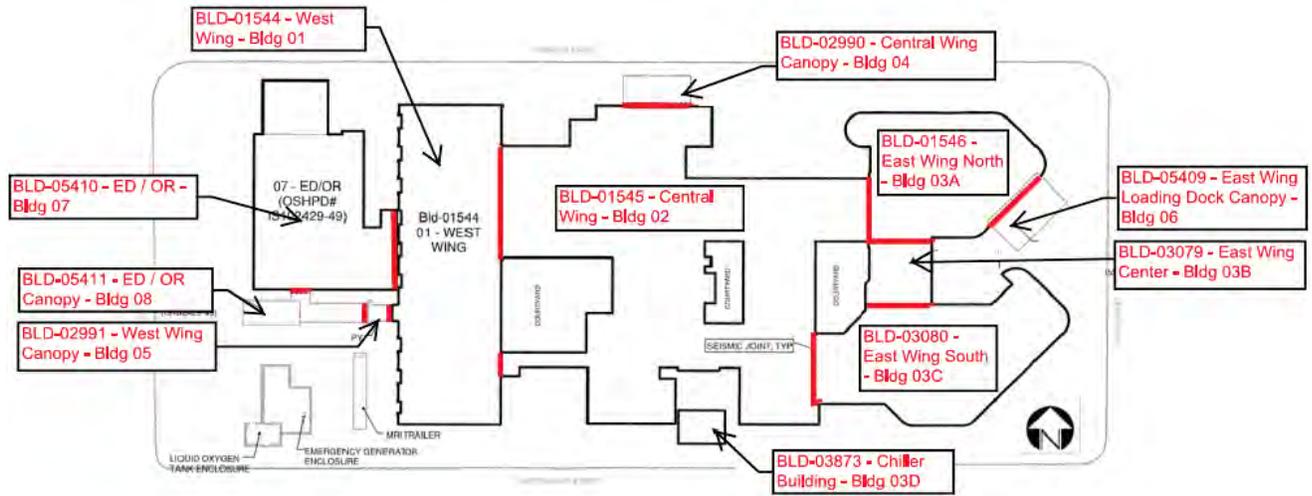
**Sonoma Valley Hospital
Facility No. 11064**

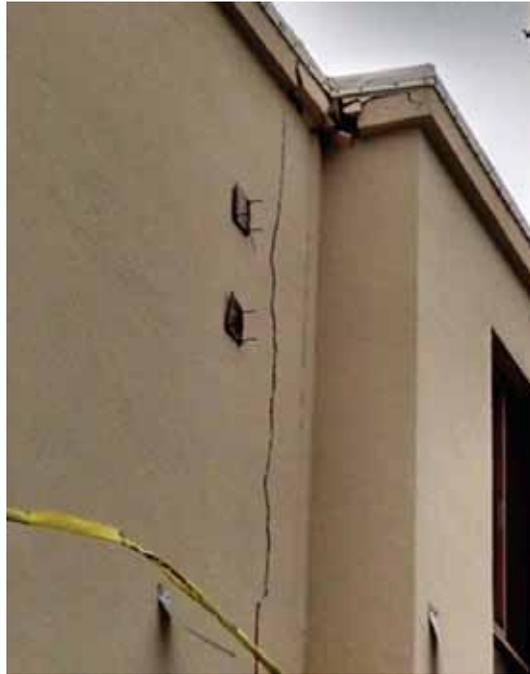
Figure 5-26 Cracking along the separation joint between BLD-01666 and BLD-01667 at the roof penthouse.

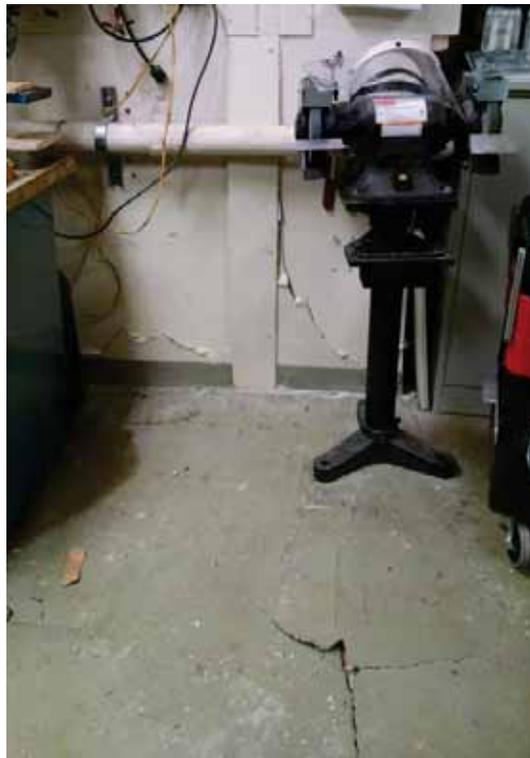
Figure 5-27 Cracking of the 1/2 inch to 1 inch thick topping slab over original roof slab inside the roof penthouse along the separation joint.

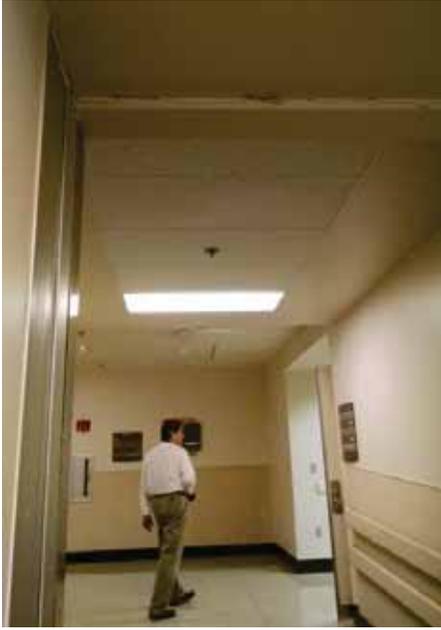
Figure 5-28 Evidence of movement along the separation joint at the fourth floor between BLD-01668 and BLD-01666.

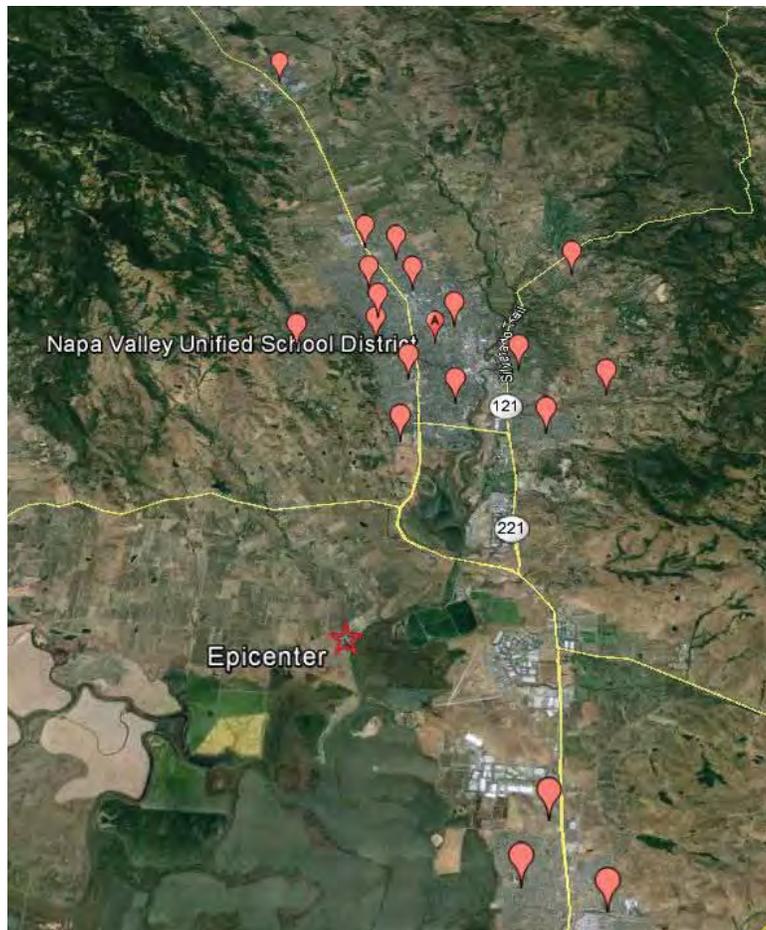
Figure 6-1 Map showing the locations of all schools in the Napa Valley Unified School District (image source: Google Maps).

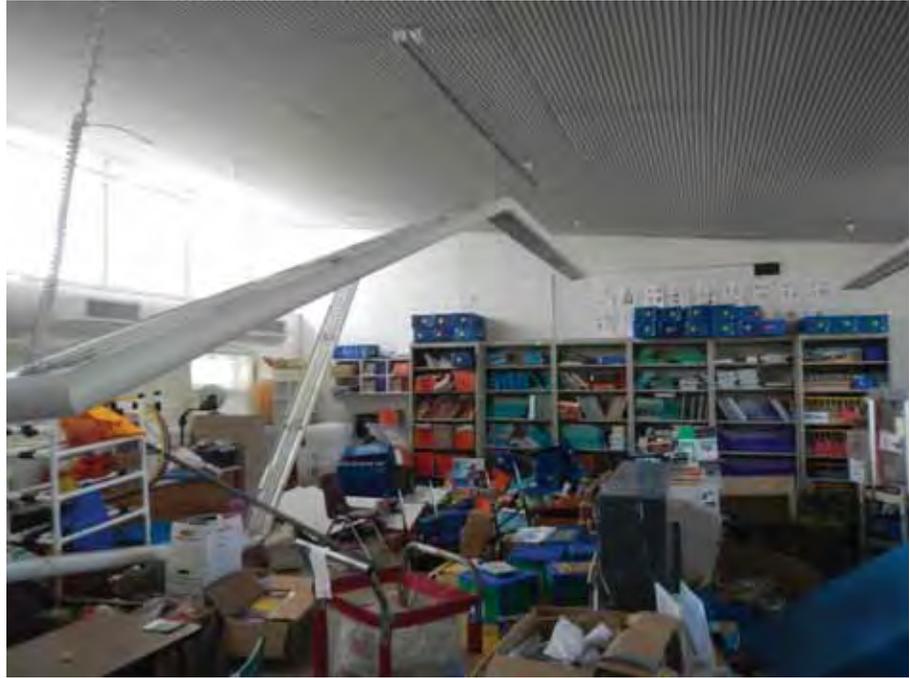
Figure 6-2 Damaged light fixtures in classroom at Pueblo Vista Elementary School (photo by Quattrocchi Kwok Architects).

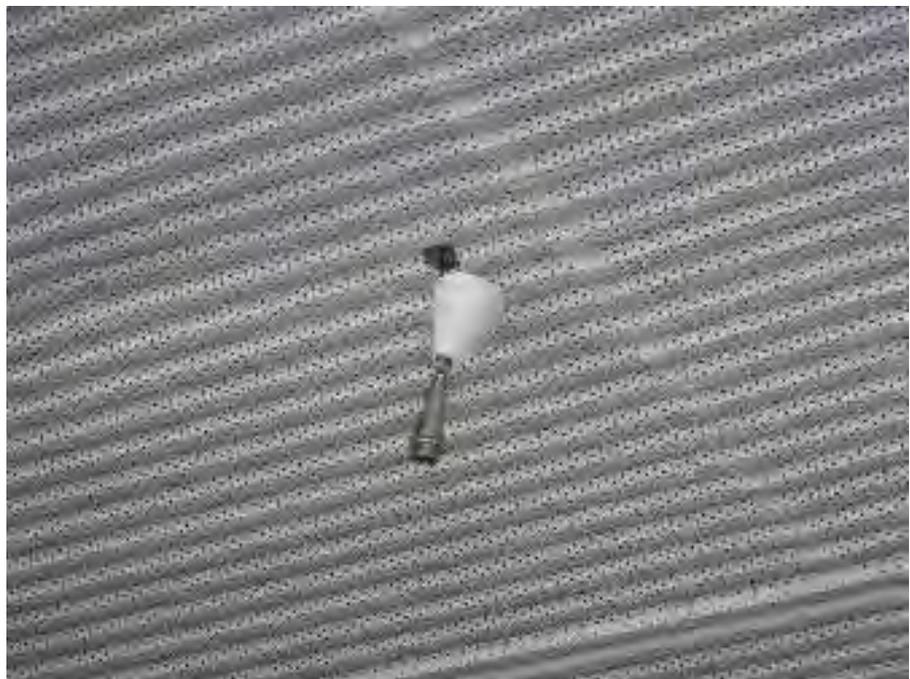
Figure 6-3 Aircraft cable slipped out of the cable gripping support fixture at Pueblo Vista Elementary School (photo by Quattrocchi Kwok Architects).

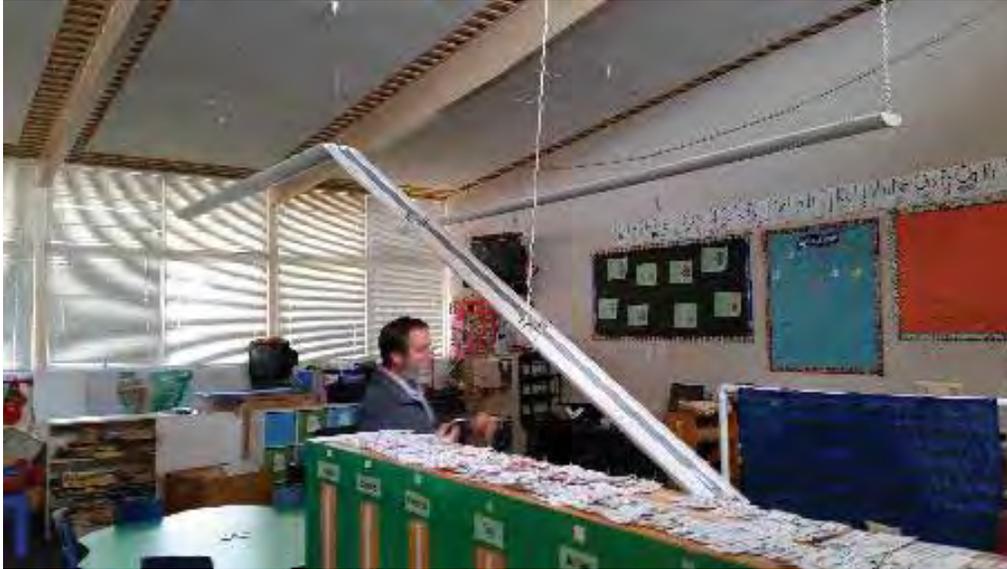
Figure 6-4 Damaged light fixtures in Irene M. Snow Elementary School (photo by Quattrocchi Kwok Architects).

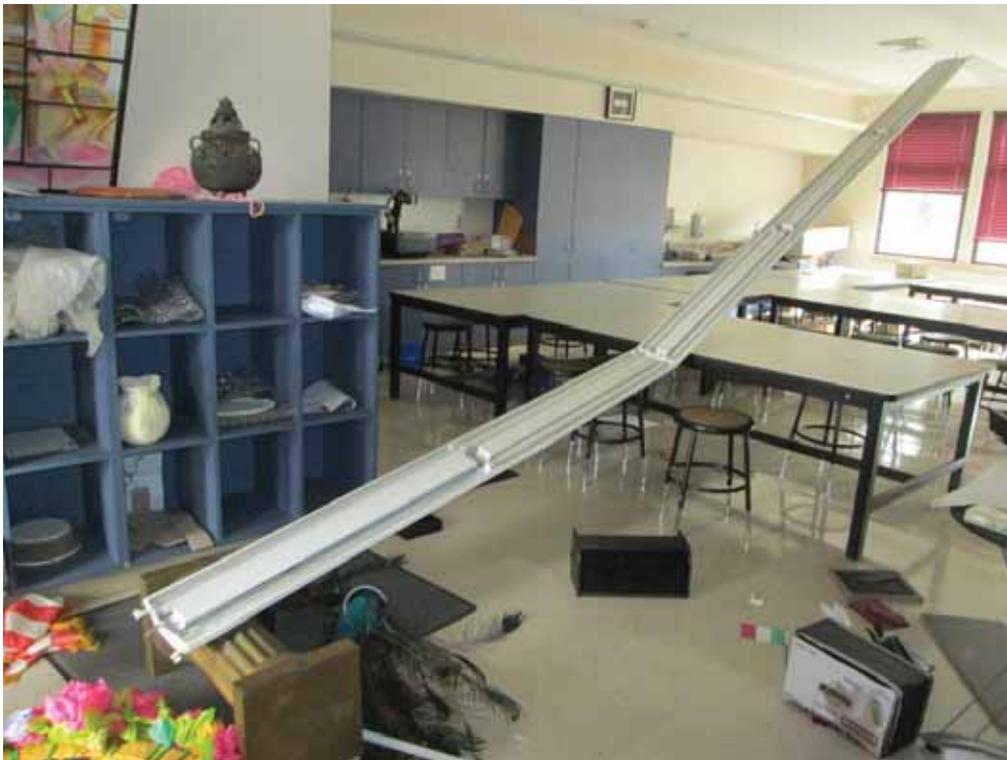
Figure 6-5 Damaged light fixtures in Napa Valley Language Academy (photo by Quattrocchi Kwok Architects).

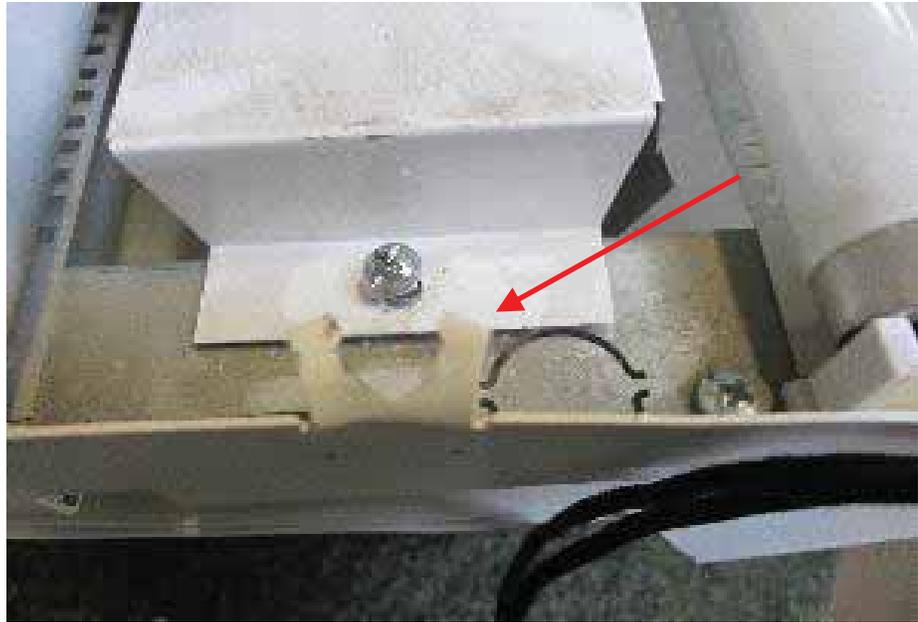
Figure 6-6 Failed connection at light fixture in Napa Valley Language Academy (photo by Quattrocchi Kwok Architects).

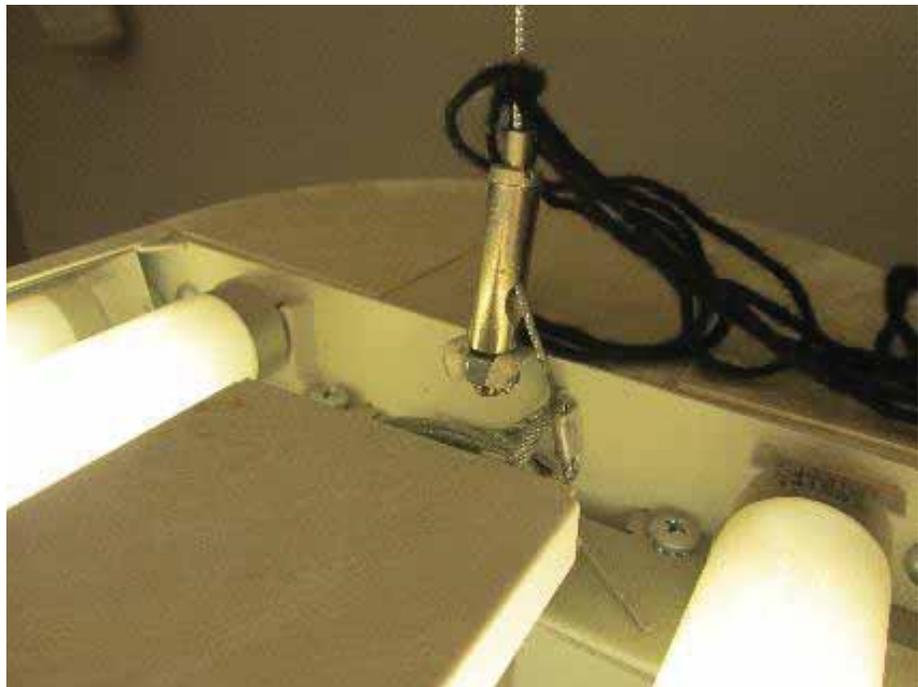
Figure 6-7 Undamaged connection to light fixture in Napa Valley Language Academy (photo by Quattrocchi Kwok Architects).

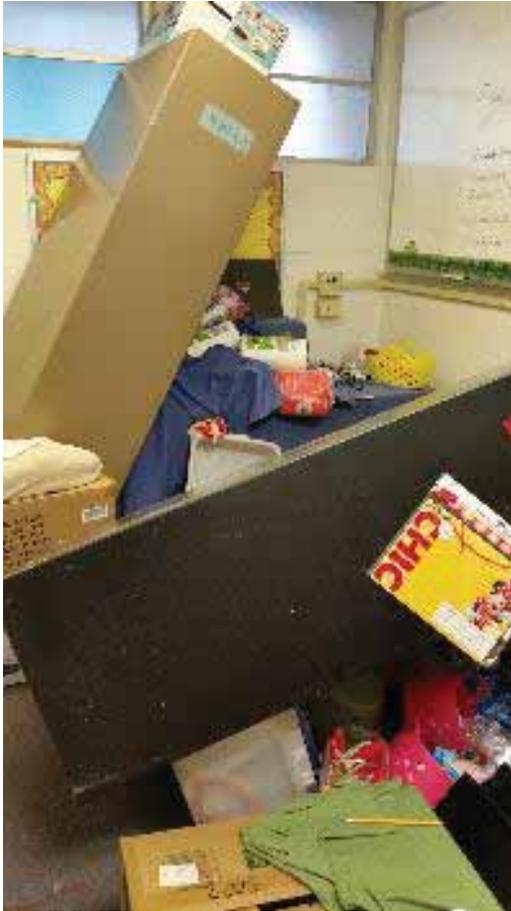
Figure 6-11 Overturned cabinets in Irene M. Snow Elementary School (photo by Quattrocchi Kwok Architects).

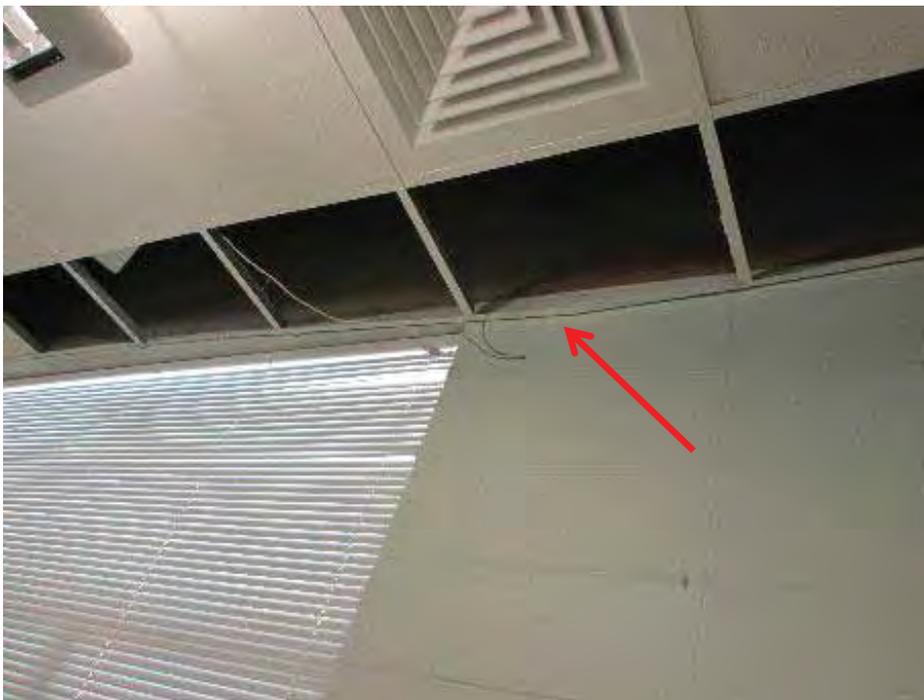
Figure 6-18 Dislodged tiles and bent edge angle in a Silverado Middle School classroom (photo by Quattrocchi Kwok Architects).

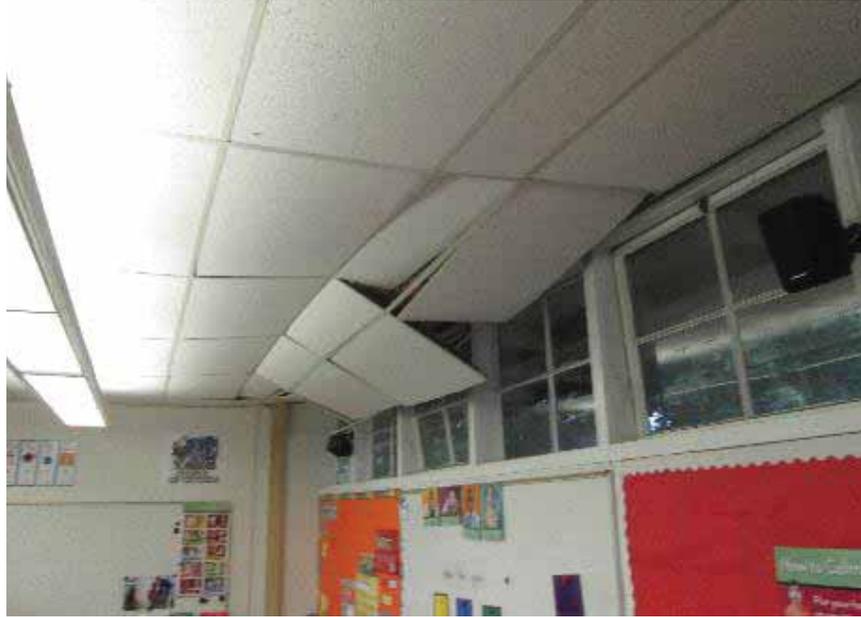
Figure 6-19 Damage to suspended acoustic tile ceiling in Napa Junction Elementary School (photo by Quattrocchi Kwok Architects).

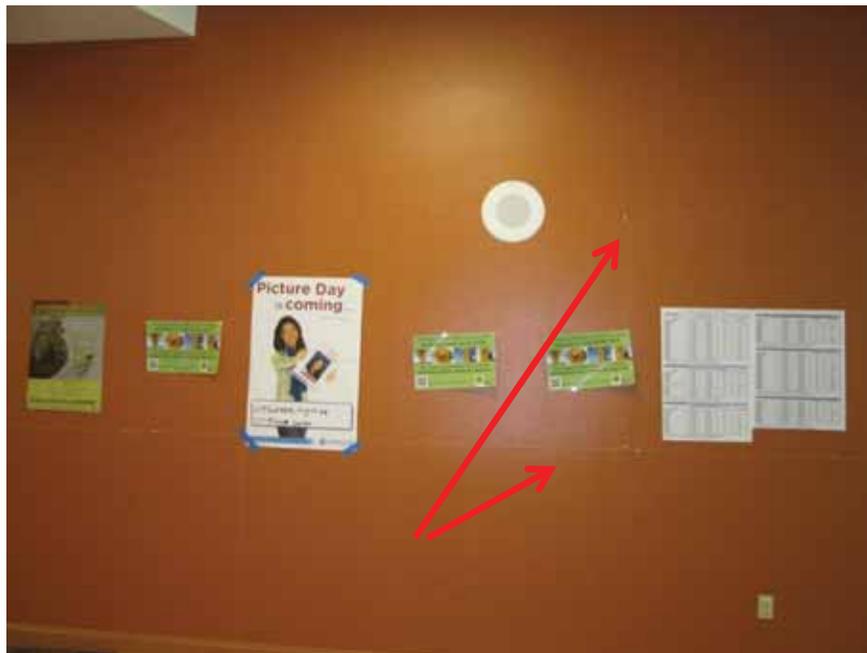
Figure 6-20 Gypsum wallboard cracking in New Technology High School (photo by Quattrocchi Kwok Architects).

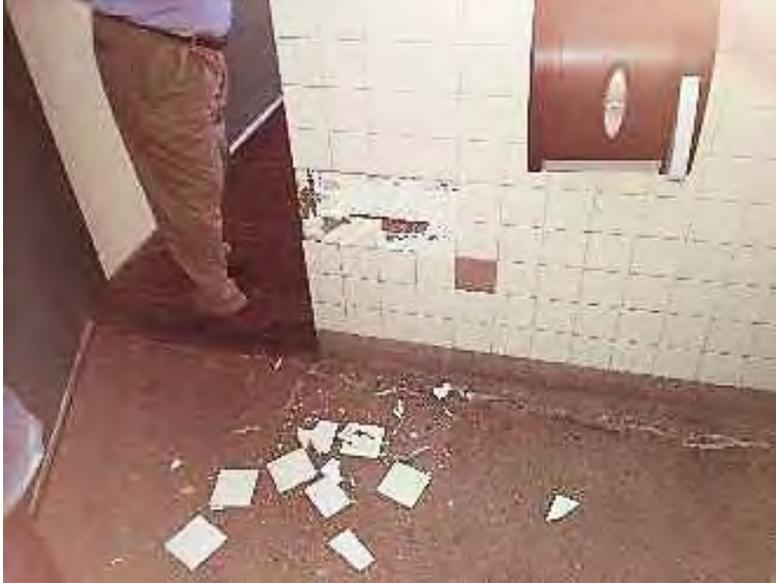
Figure 6-21 Dislodged adhered tile in Harvest Middle School (photo by Quattrocchi Kwok Architects).

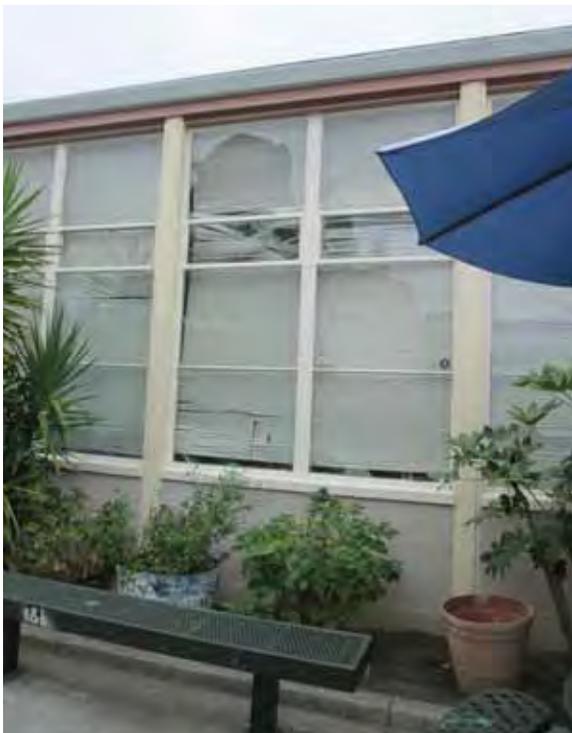
Figure 6-22 Broken window at Harvest Middle School (photo by Quattrocchi Kwok Architects).

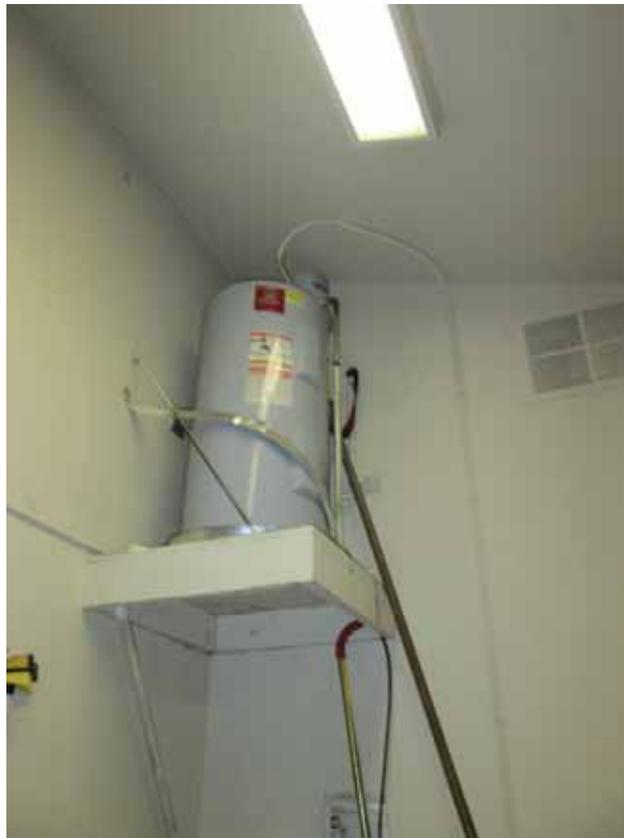
Figure 6-23 Failed earthquake restraining strap on water heater (photo by Quattrocchi Kwok Architects).

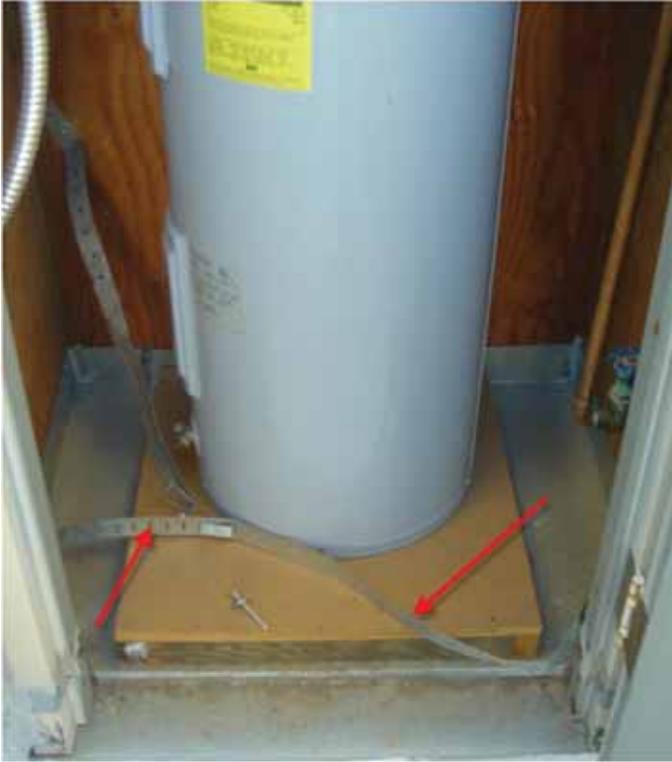
Figure 6-24 Failed earthquake restraining strap at Shearer Elementary School (photo by Quattrocchi Kwok Architects).

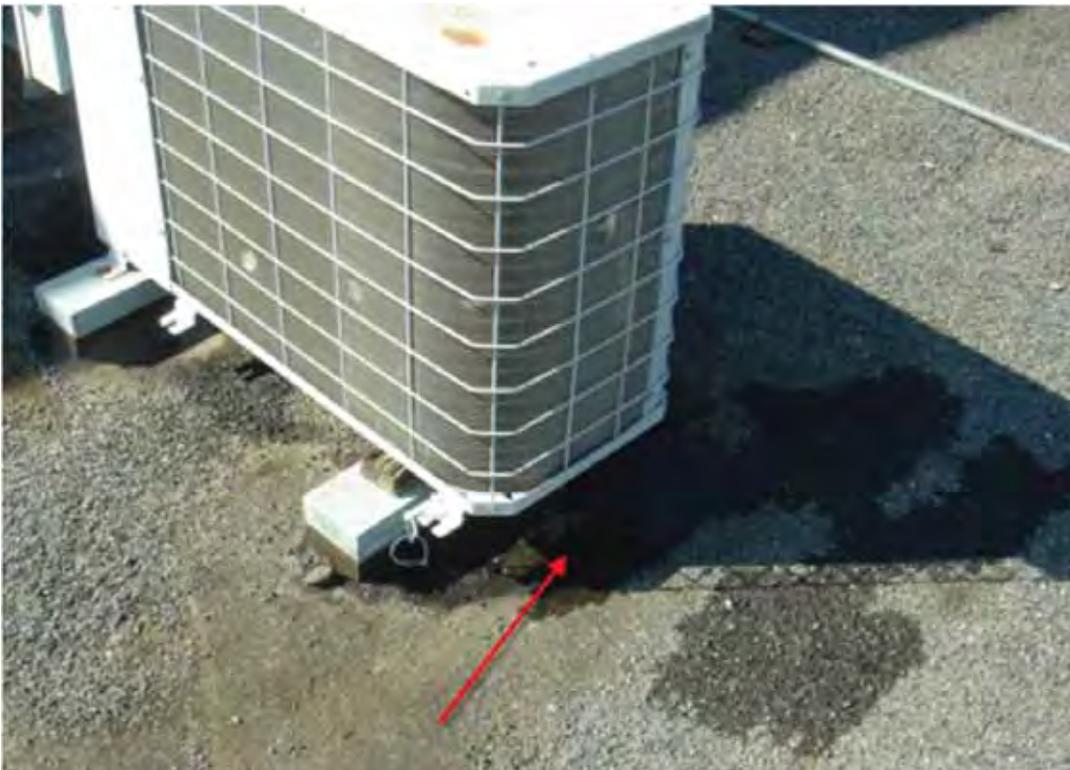
Figure 6-25 Shifted rooftop condensate unit at Redwood Middle School (photo by Quattrocchi Kwok Architects).

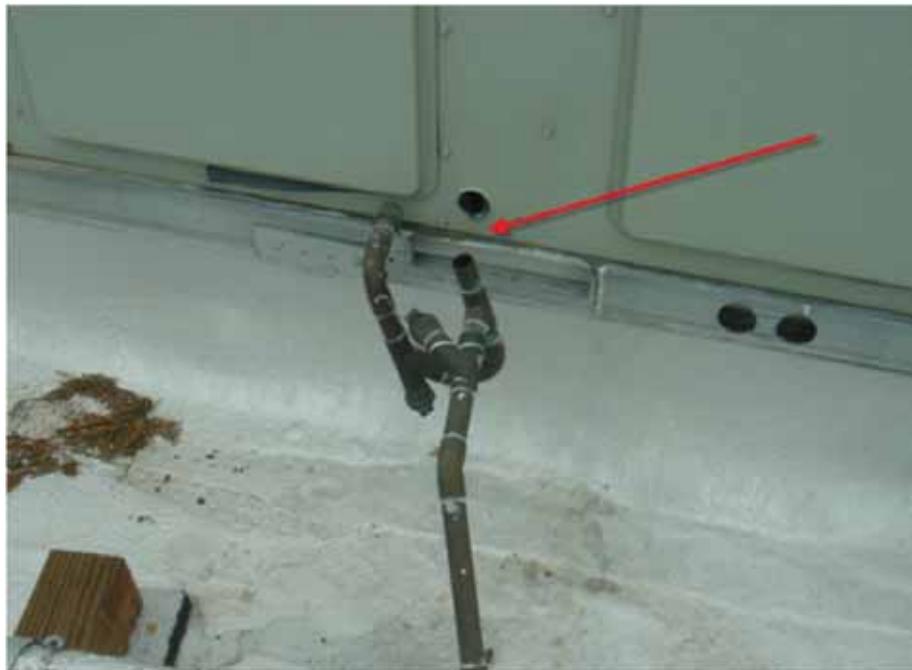
Figure 6-27 Broken condensate connection at air conditioning unit, Redwood Middle School (photo by Quattrocchi Kwok Architects).

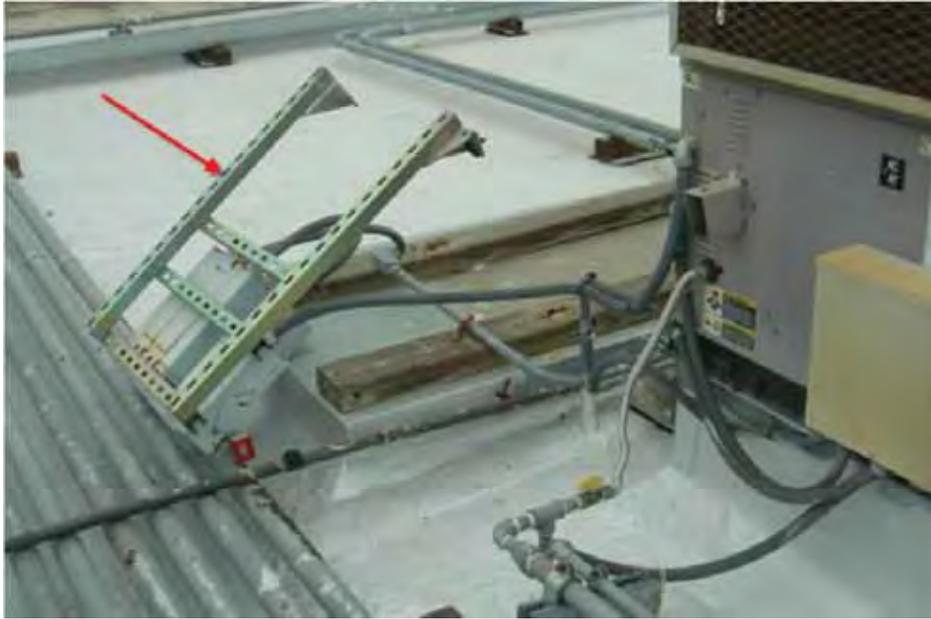
Figure 6-28 Toppled disconnect for rooftop air handler at Napa High School (photo by Quattrocchi Kwok Architects).

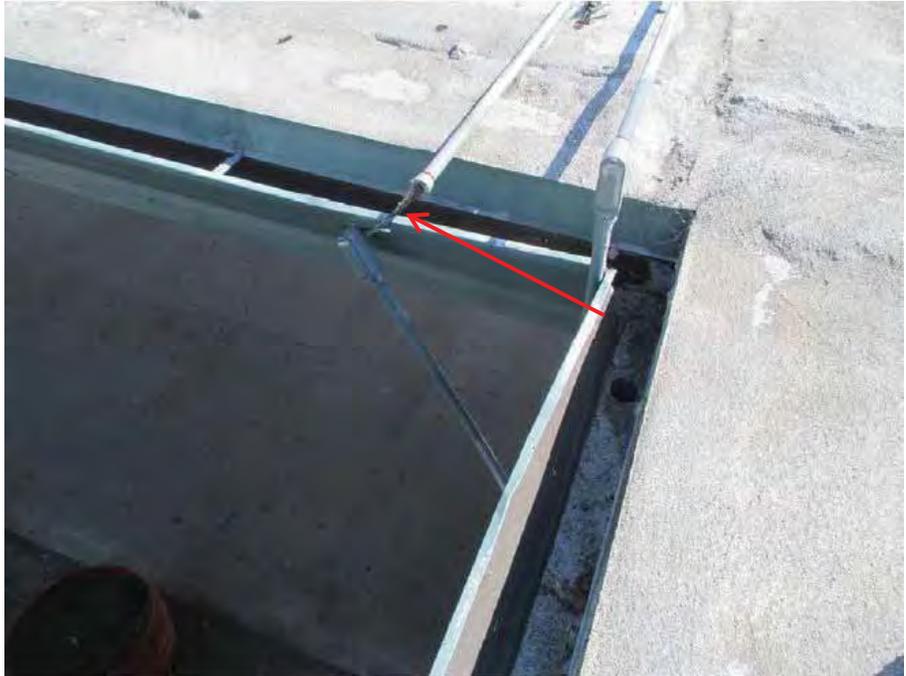
Figure 6-30 Exposed wires at failed conduit fitting, Harvest Middle School (photo by Quattrocchi Kwok Architects).

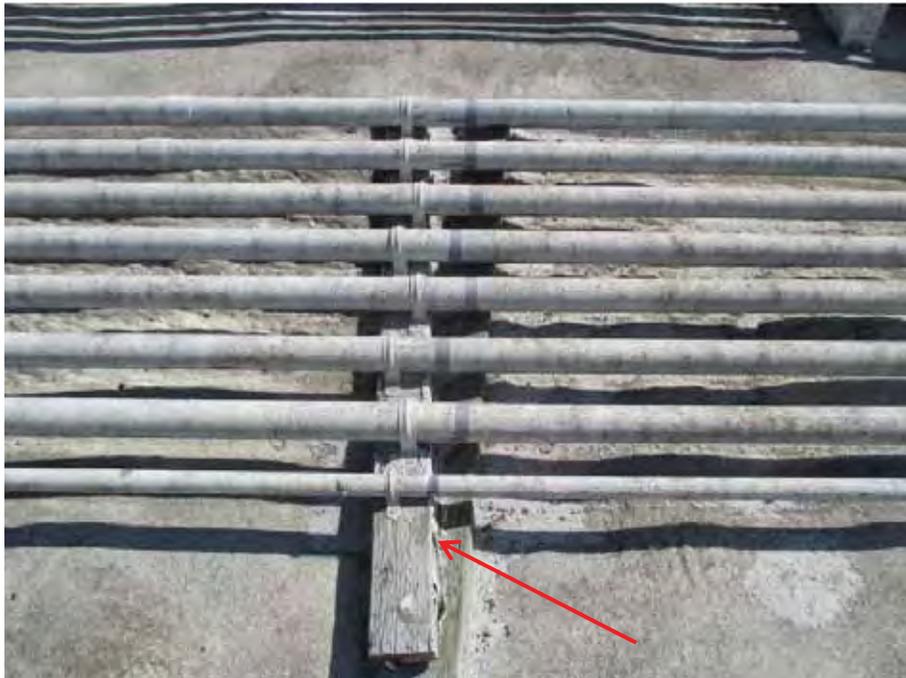
Figure 6-31 Shifted conduit at sleeper support, Harvest Middle School (photo by Quattrocchi Kwok Architects).

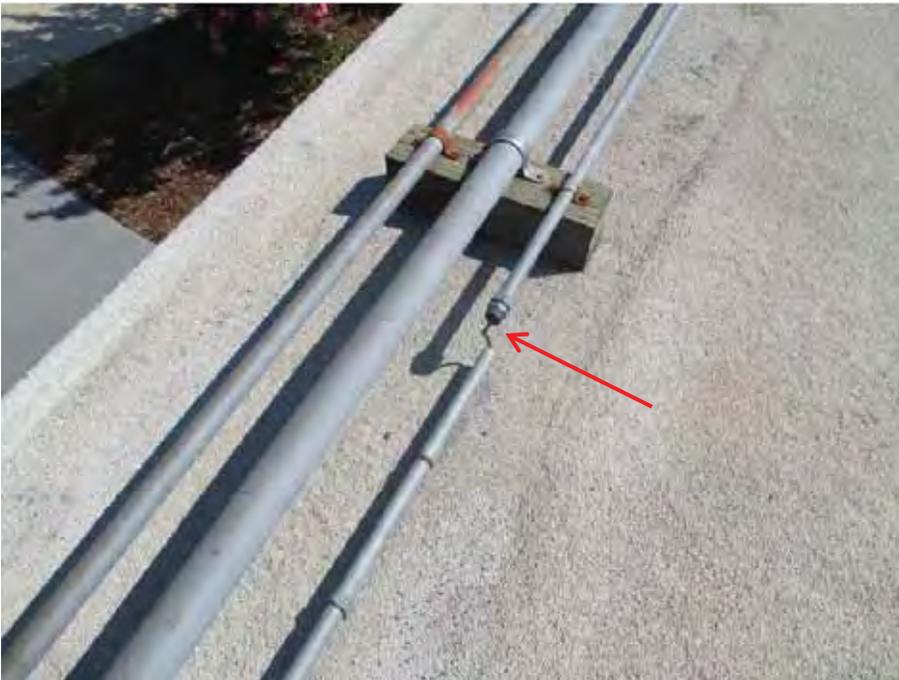
Figure 6-33 Broken low voltage conduit coupling at Redwood Middle School (photo by Quattrocchi Kwok Architects).

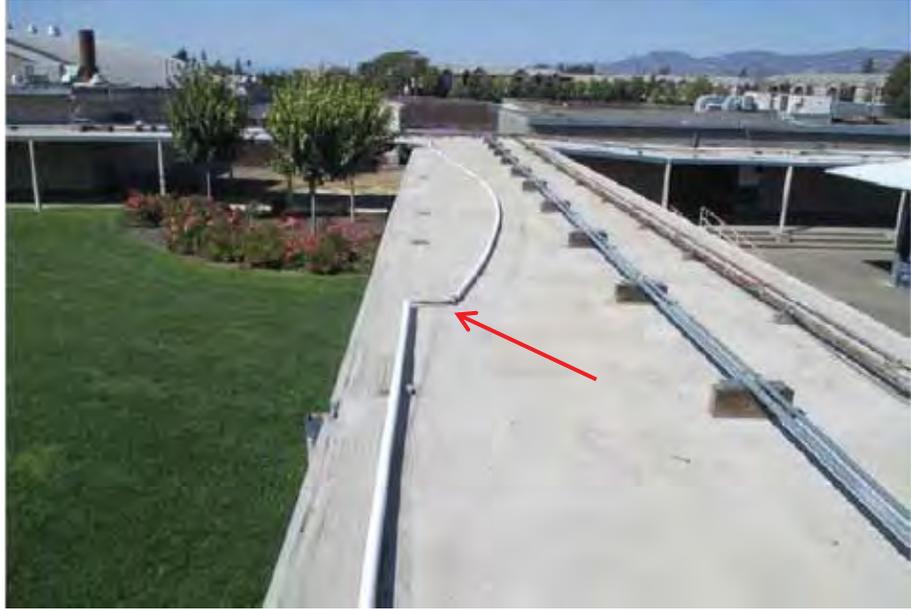
Figure 6-34 Broken PVC conduit at Redwood Middle School (photo by Quattrocchi Kwok Architects).

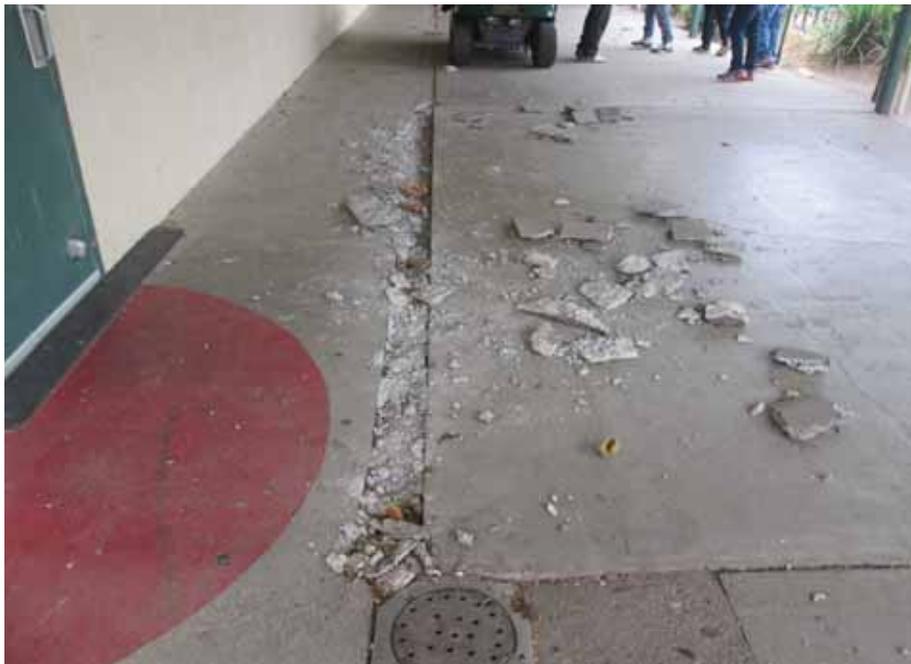
Figure 6-35 Cracking at slab joint in walkway at Harvest Middle School (photo by Quattrocchi Kwok Architects).

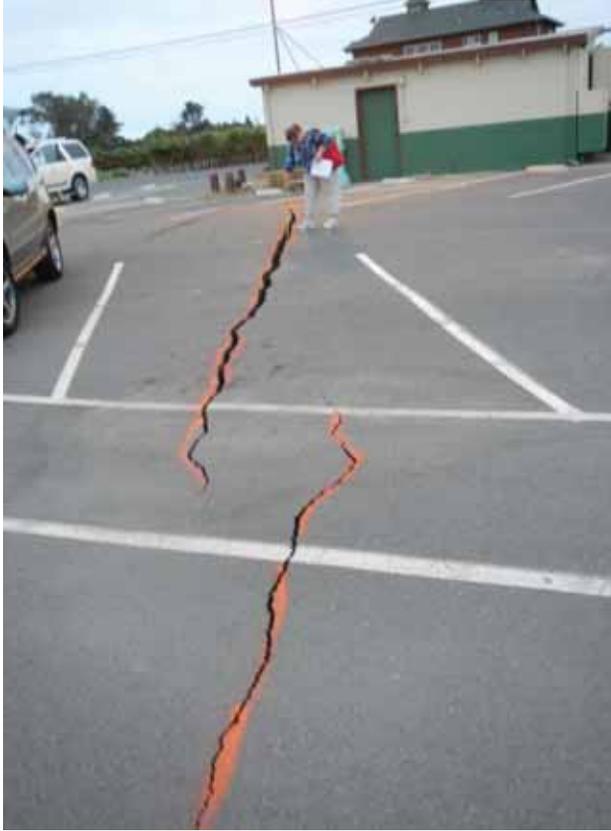
Figure 6-36 Cracks in asphalt parking lot at Stone Bridge School (photo by Quattrocchi Kwok Architects).

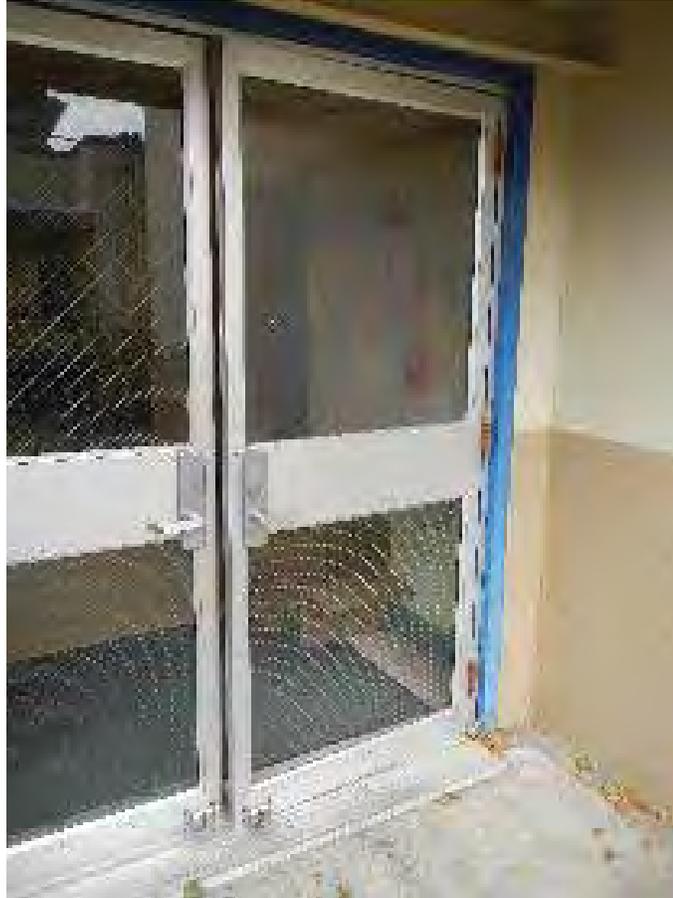
Figure 6-37 Damaged door at Browns Valley Elementary School (photo by Quattrocchi Kwok Architects).

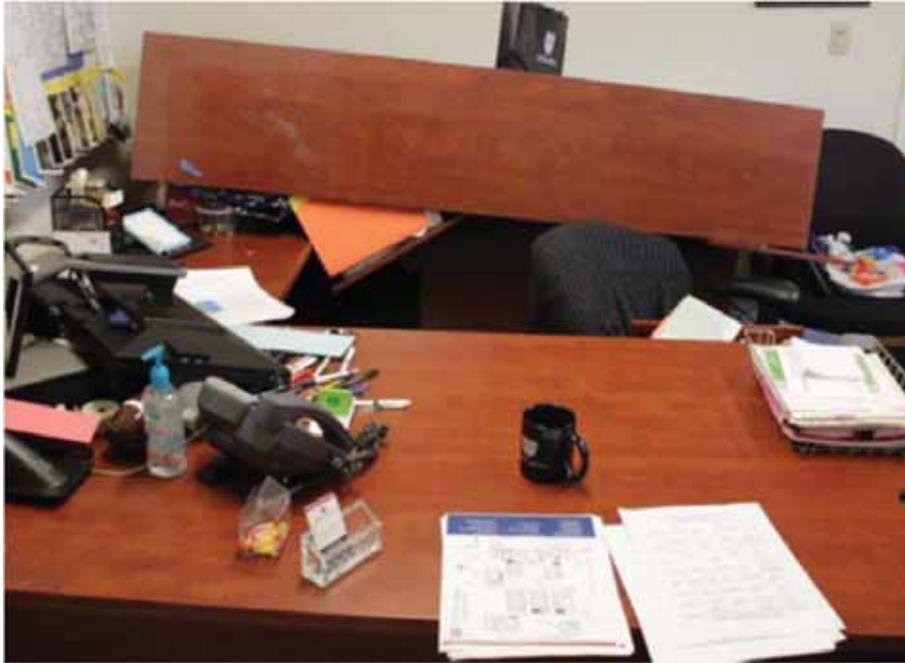
Figure 6-38 Unrestrained bookshelf overturned in office (photo by Quattrocchi Kwok Architects).

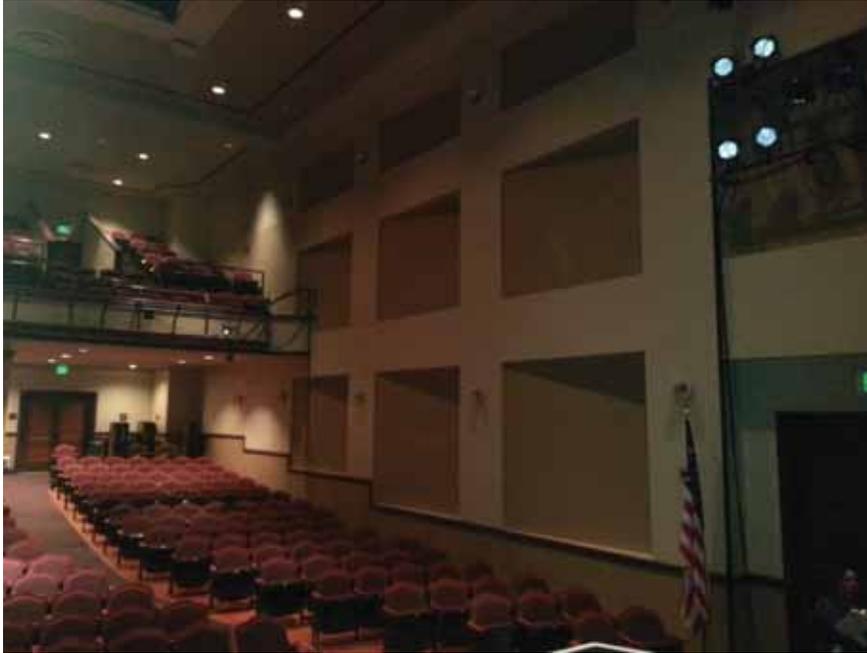
Figure 6-41 Interior view of auditorium walls.
