Performance of Buildings and Nonstructural Components in the 2014 South Napa Earthquake

FEMA P-1024 / February 2015

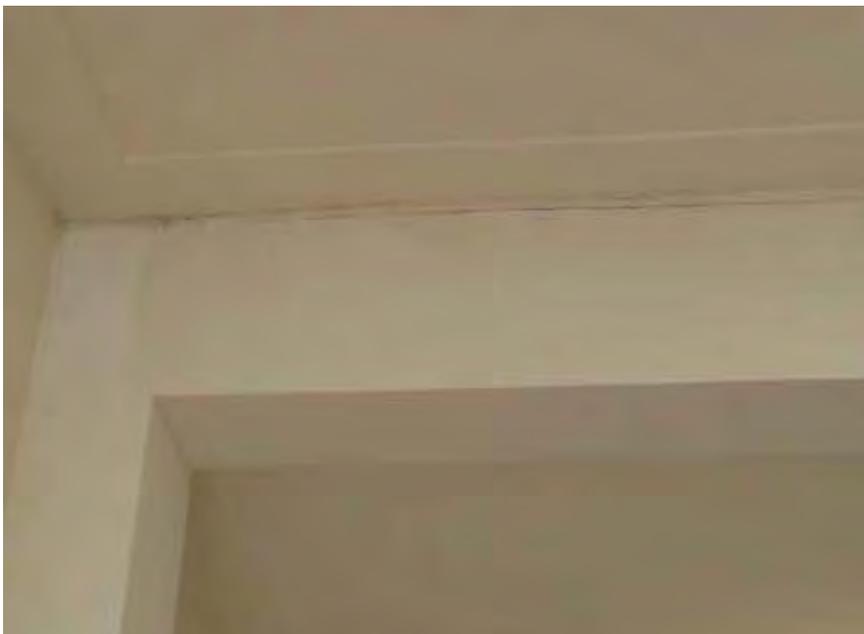
Figure 6-42 Minor wall cracking.

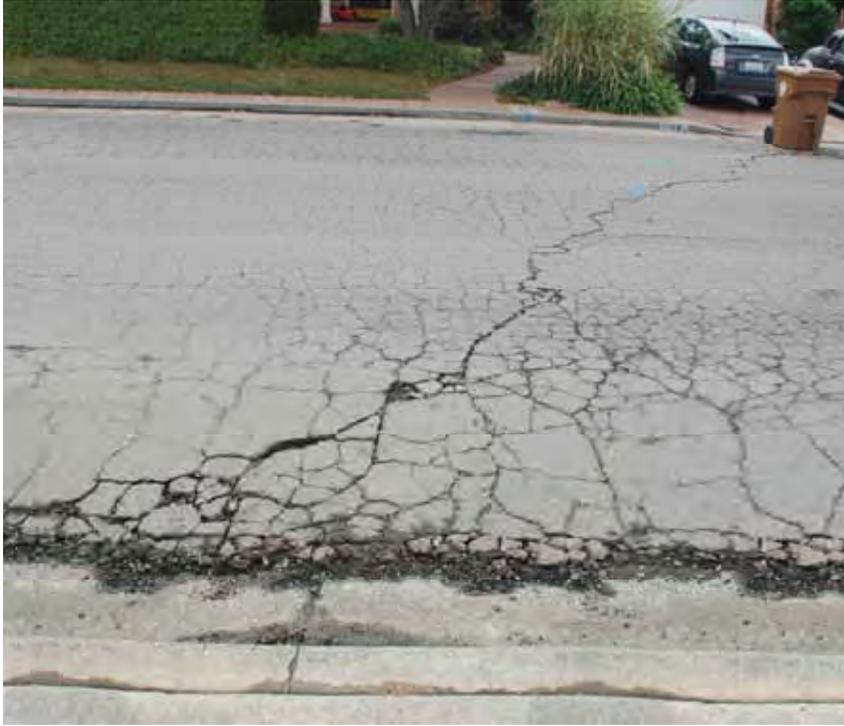
Figure 7-2 Surface feature of fault rupture observed on street.

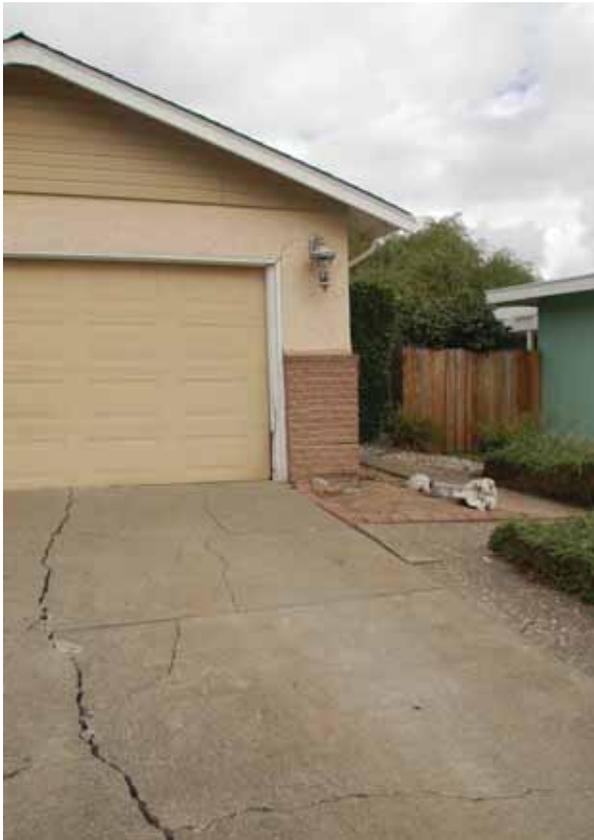
Figure 7-3 Crack running through the street and up the driveway.

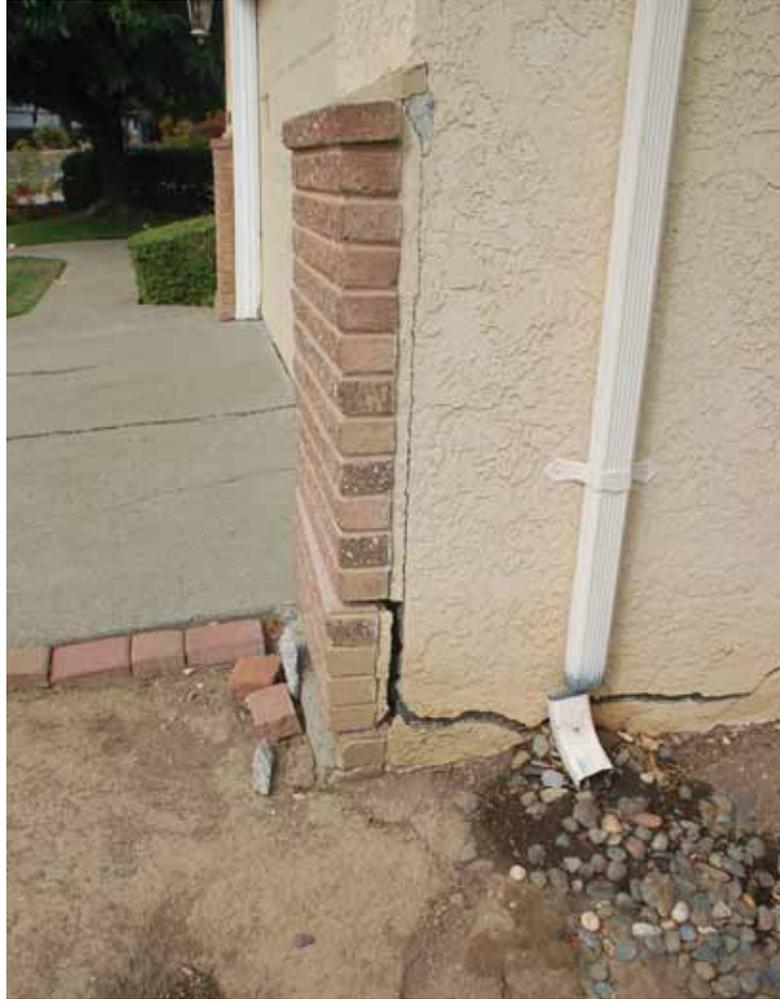
Figure 7-4 Crack continuing around the base of structure.

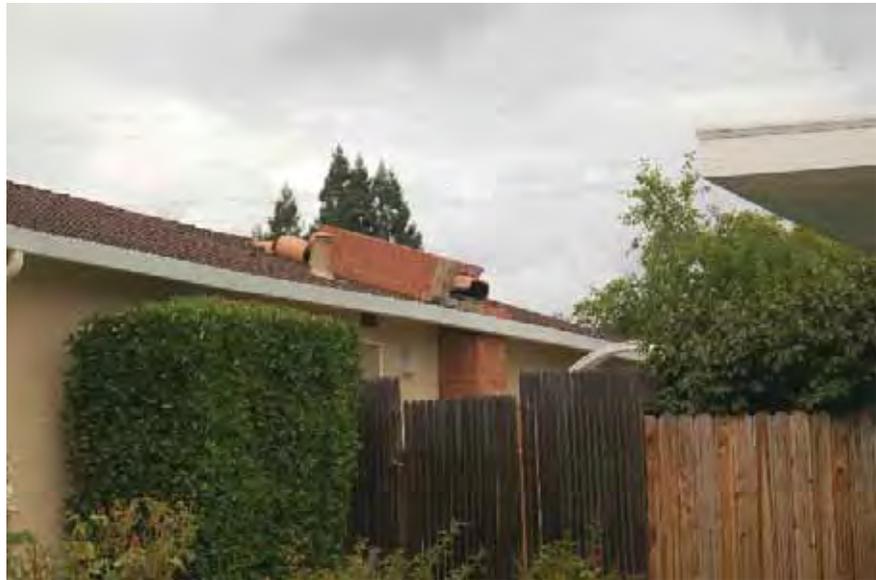
Figure 7-5 Brick chimney collapse on to the roof.

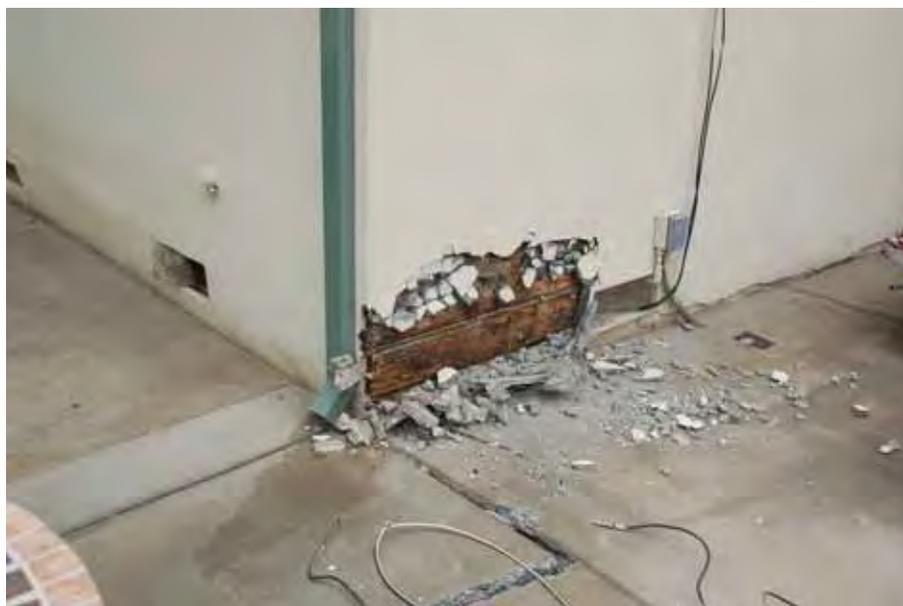
Figure 7-6 Cracks in the pavement of the backyard and damage to stucco wall.

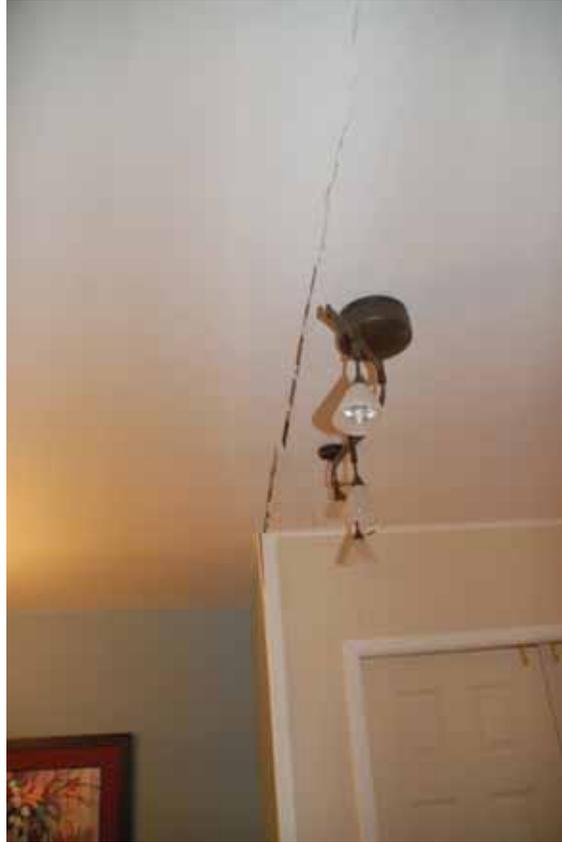
Figure 7-7 Ceiling crack.

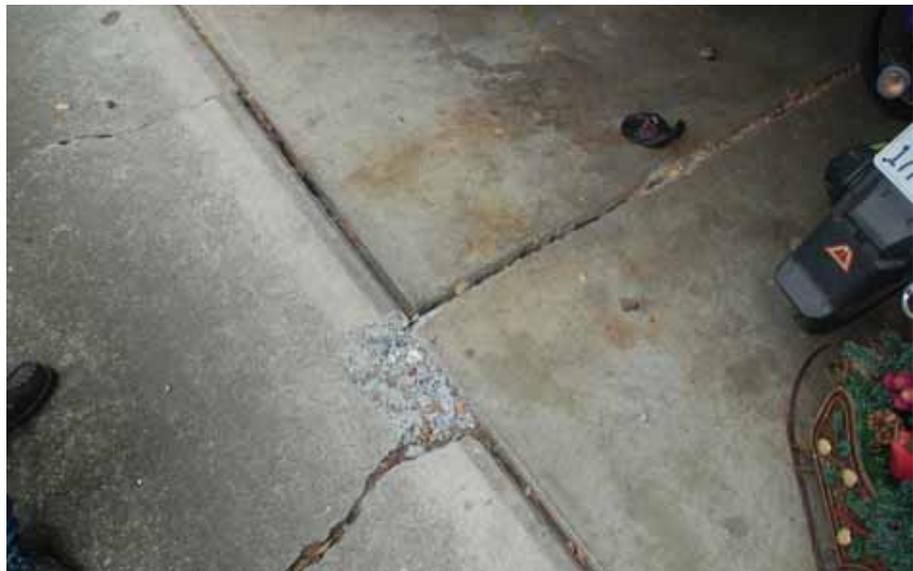
Figure 7-8 Damage caused due to differential movement of floor slabs in garage and driveway pavement.

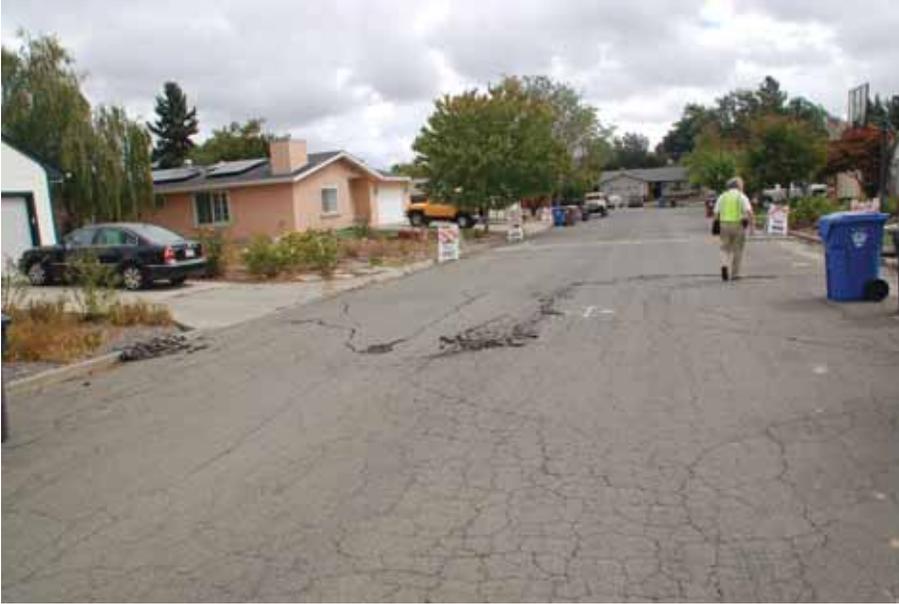
Figure 7-9 Surface rupture observed on street.

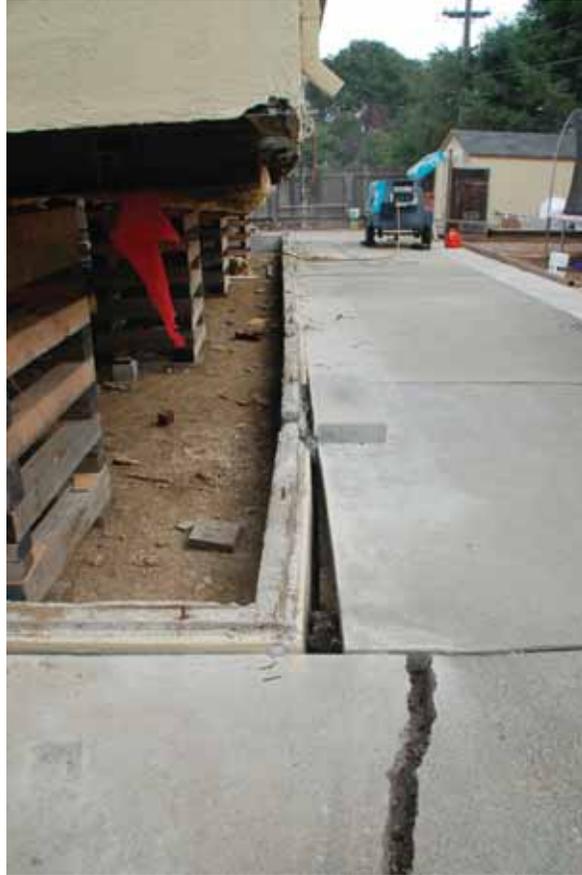
Figure 7-10 Photo showing demolished perimeter foundation and cracks in pavement.

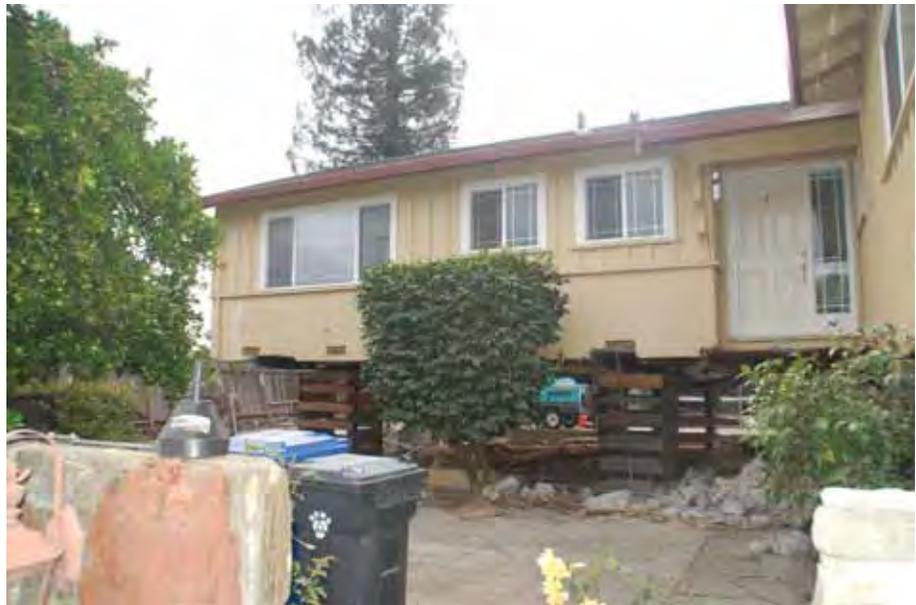
Figure 7-11 Structure raised for foundation repair.

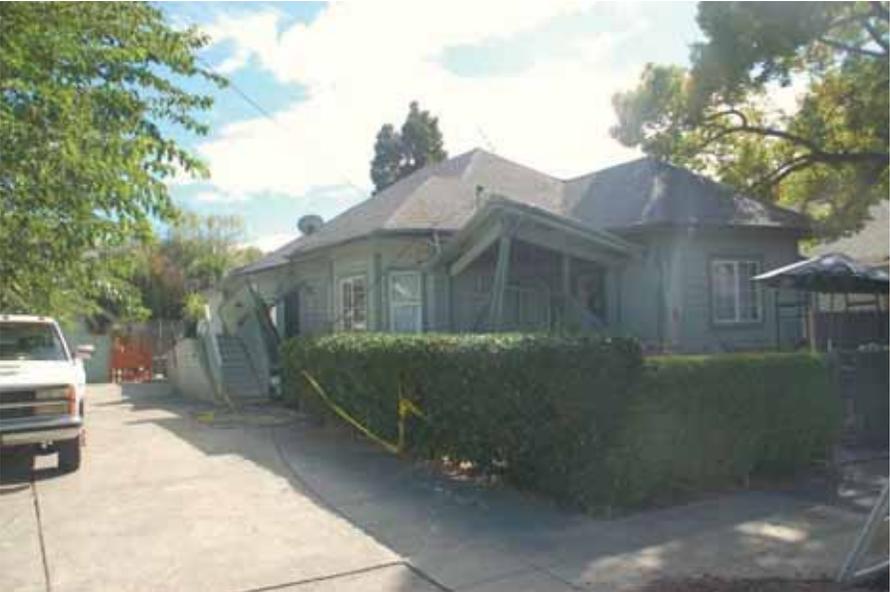
Figure 7-12 Home with collapsed cripple wall.

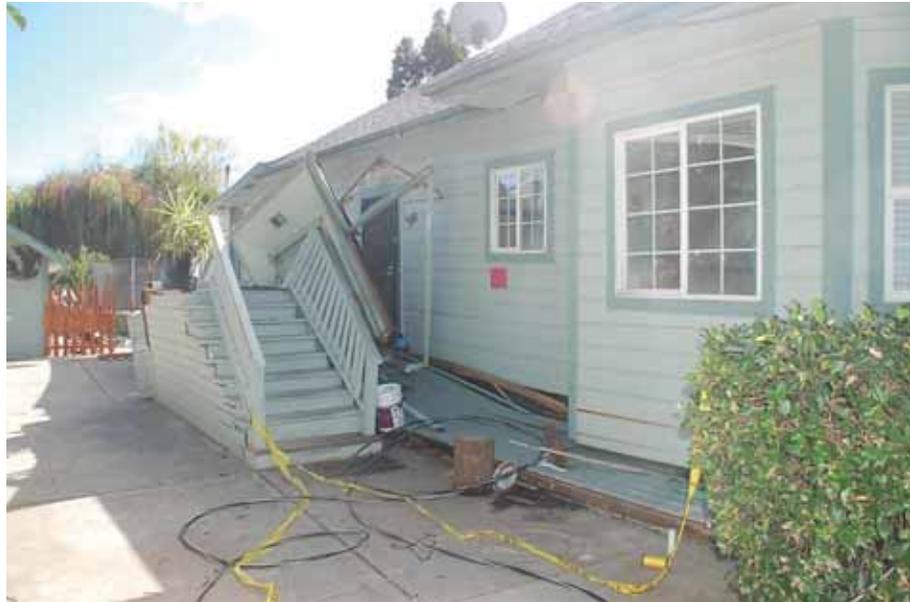
Figure 7-14 Failure of porch due to cripple wall collapse .

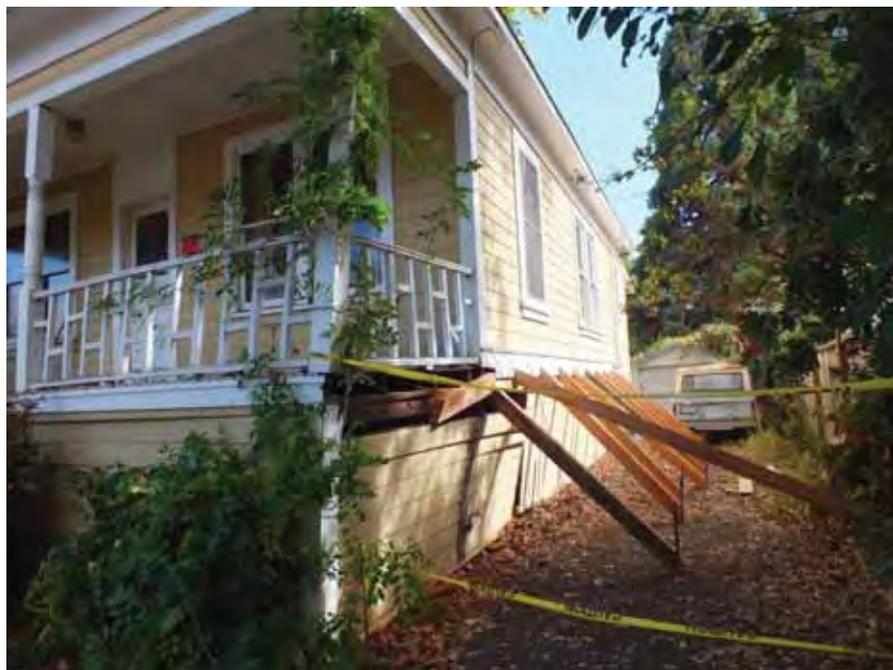
Figure 7-15 Temporary lateral bracing at cripple wall.

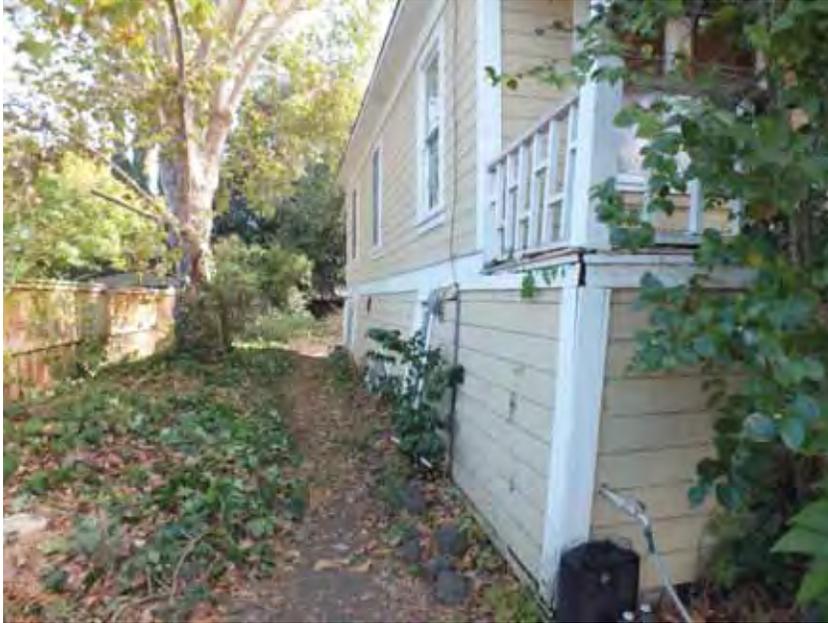
Figure 7-16 House shifted lateral at damaged cripple wall.

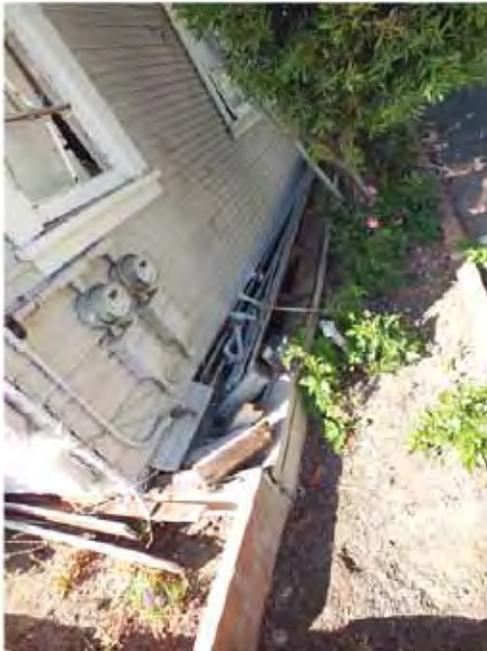
Figure 7-17 Collapsed cripple wall.

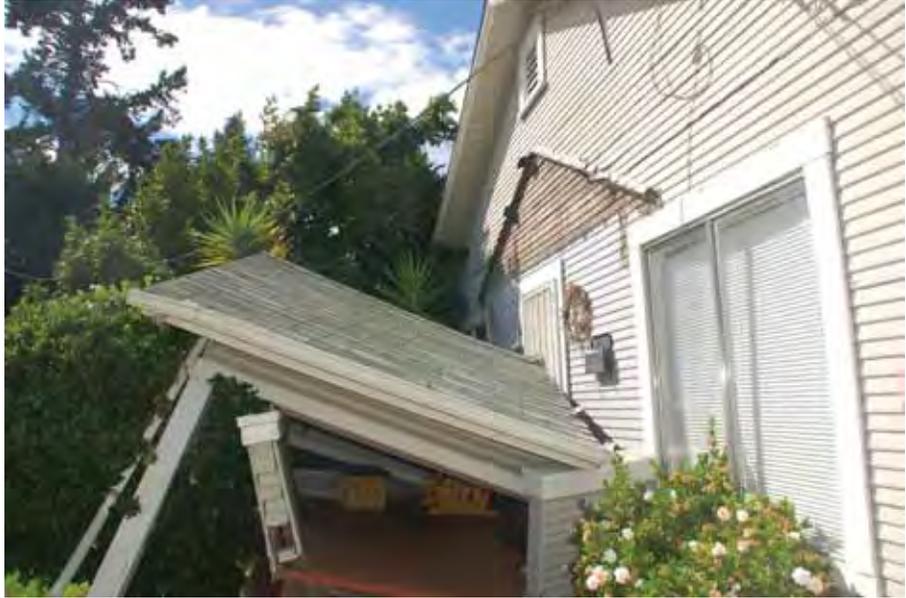
Figure 7-18 Failure of porch due to cripple wall collapse.

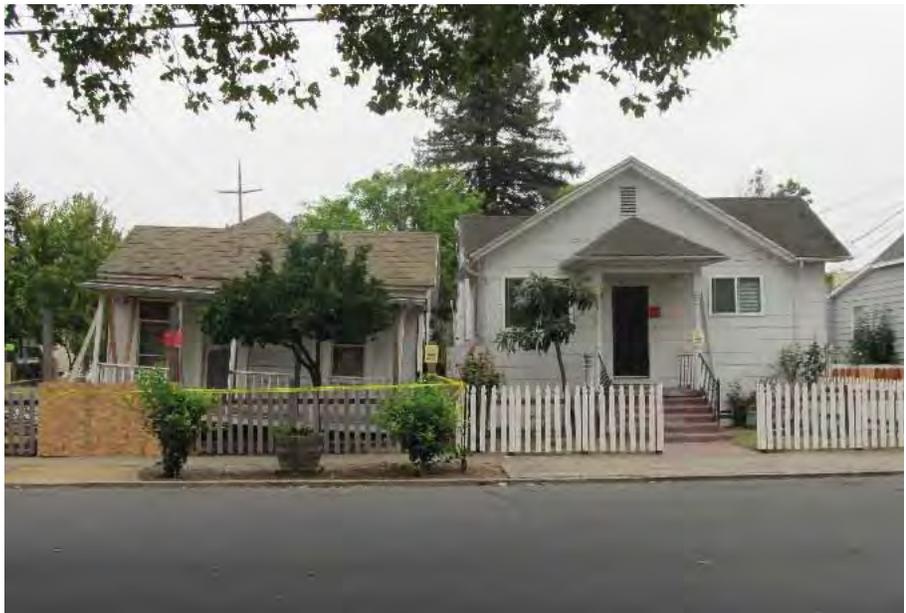
Figure 7-19 Undamaged residence on the right was posted UNSAFE due to risk posed by damaged residence on the left.

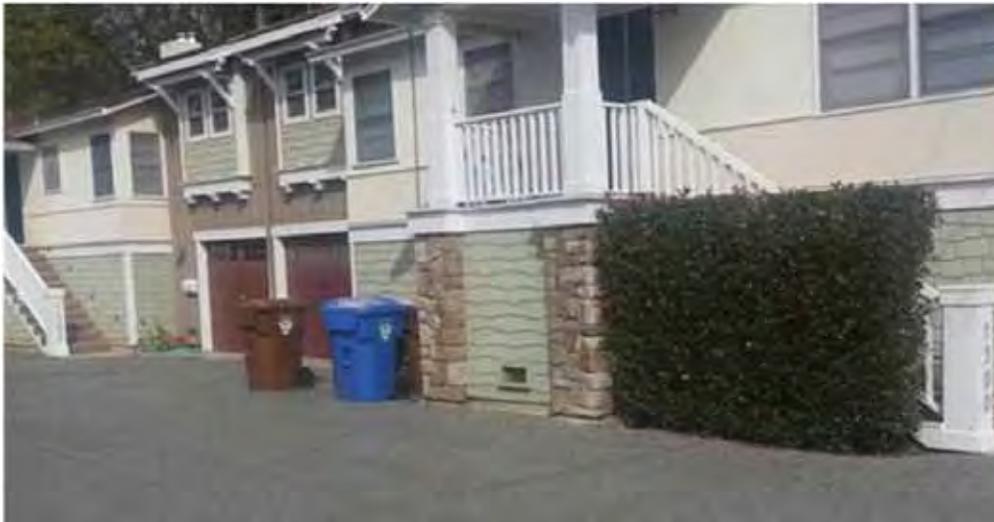
Figure 7-20 Elevated duplex homes.

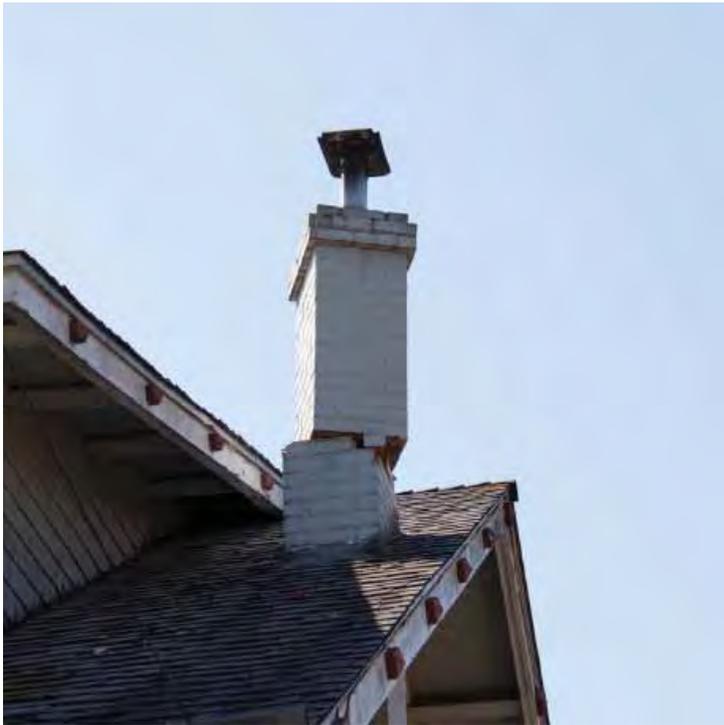
Figure 7-22 Dislodged unreinforced masonry chimney (photo from Janiele Maffei).

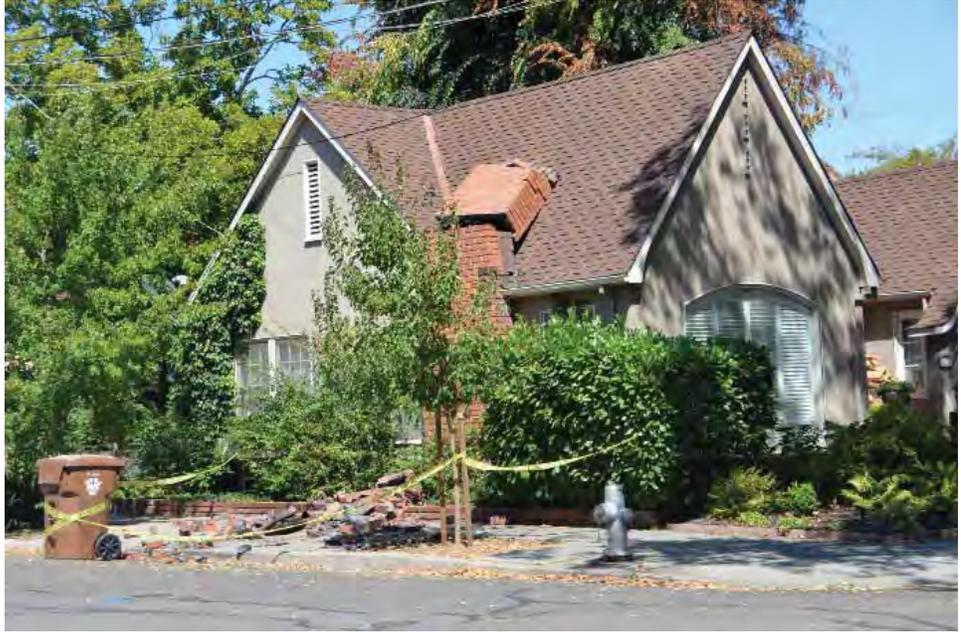
Figure 7-23 Photo of damaged chimney (photo from Janiele Maffei)

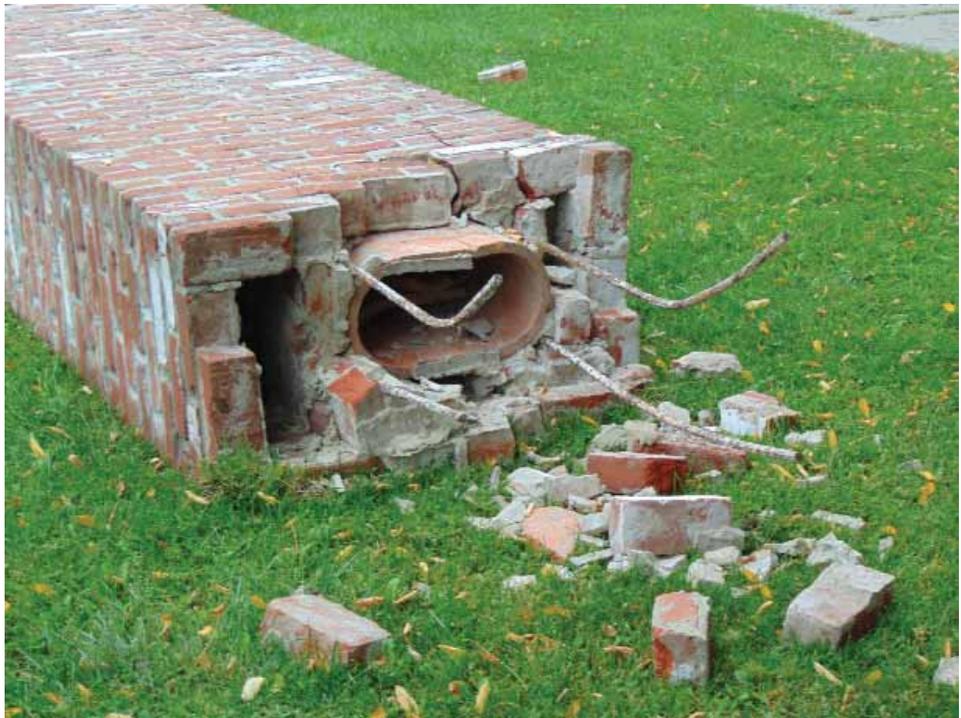
Figure 7-24 Photo of chimney laying on front yard of home (photo from Janiele Maffei).

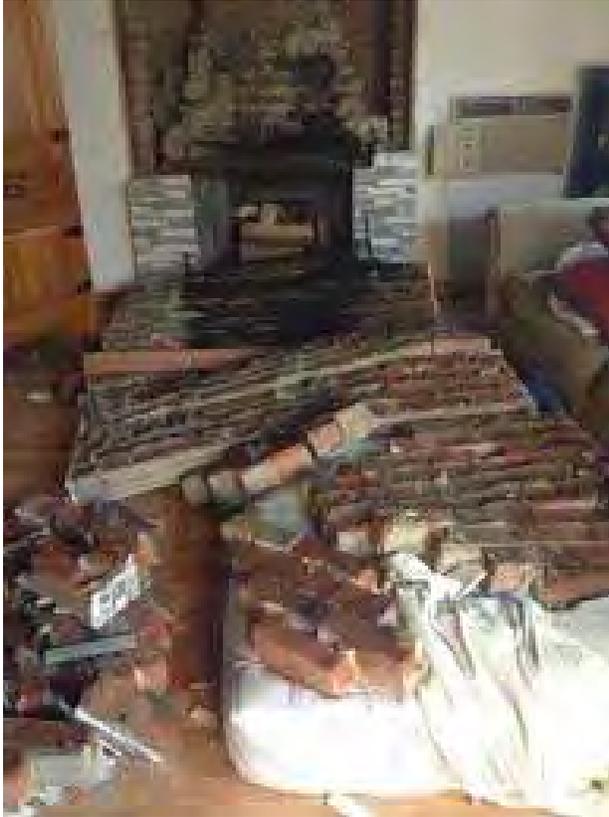
Figure 7-25 Photo of interior chimney collapse (photo from Janiele Maffei).

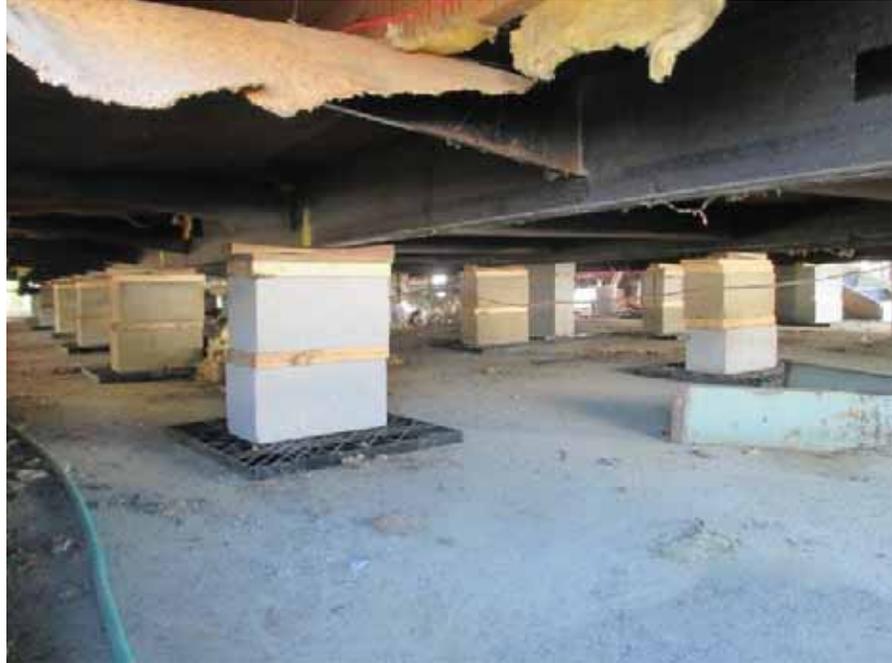
Figure 8-3 Typical dry-stacked masonry gravity piers, with interspersed wood blocks.

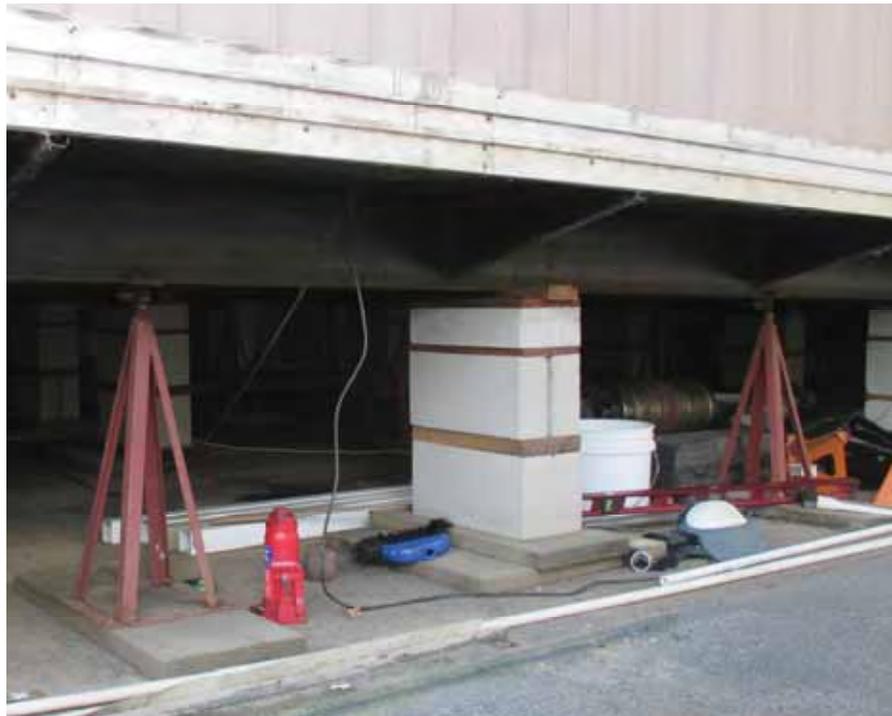
Figure 8-4 Steel gravity piers interspersed with masonry piers during home reinstallation.

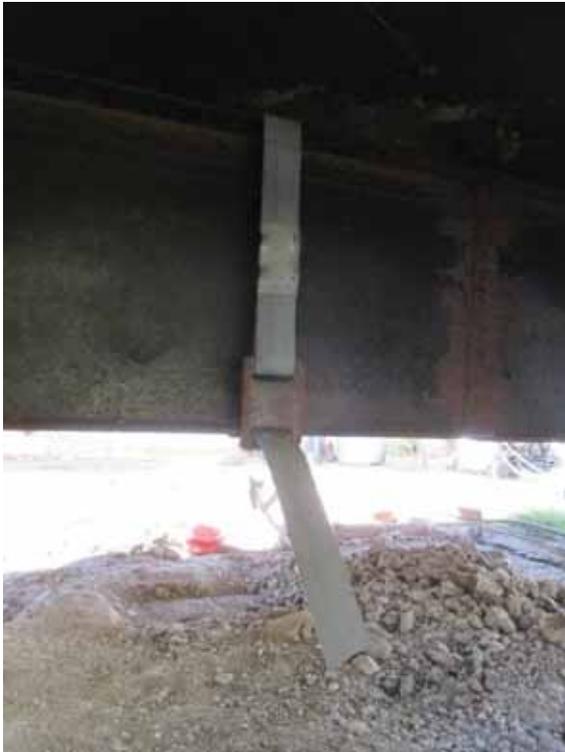
Figure 8-5 ETS strap connected to a home chassis beam, cut to allow home to be relocated.

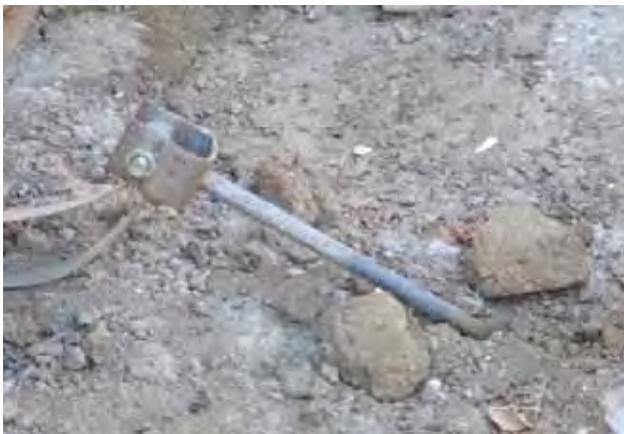
Figure 8-6 ETS ground anchor. The ground anchor bracket is typically attached to a helical soil anchor, embedded in the soil.

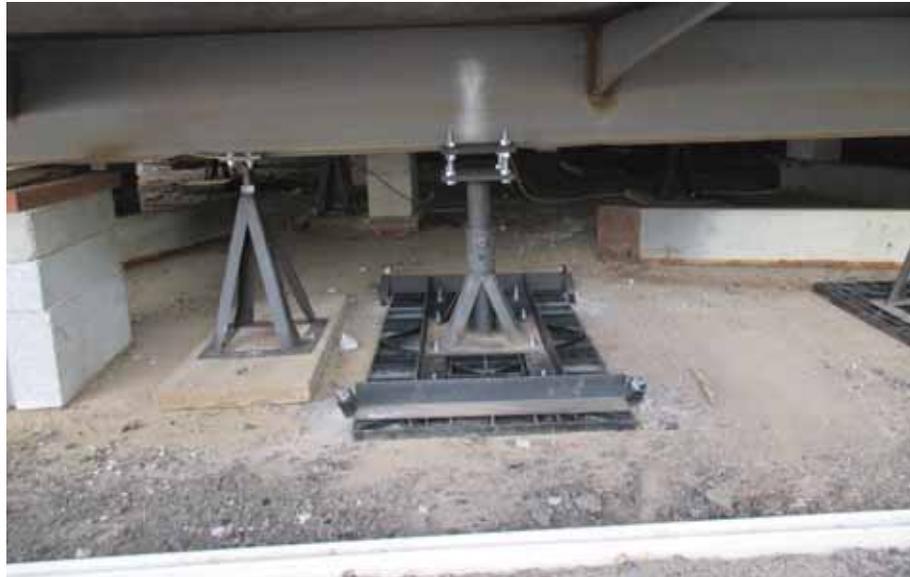
Figure 8-7 Steel pier system with anchor rods to the ground.

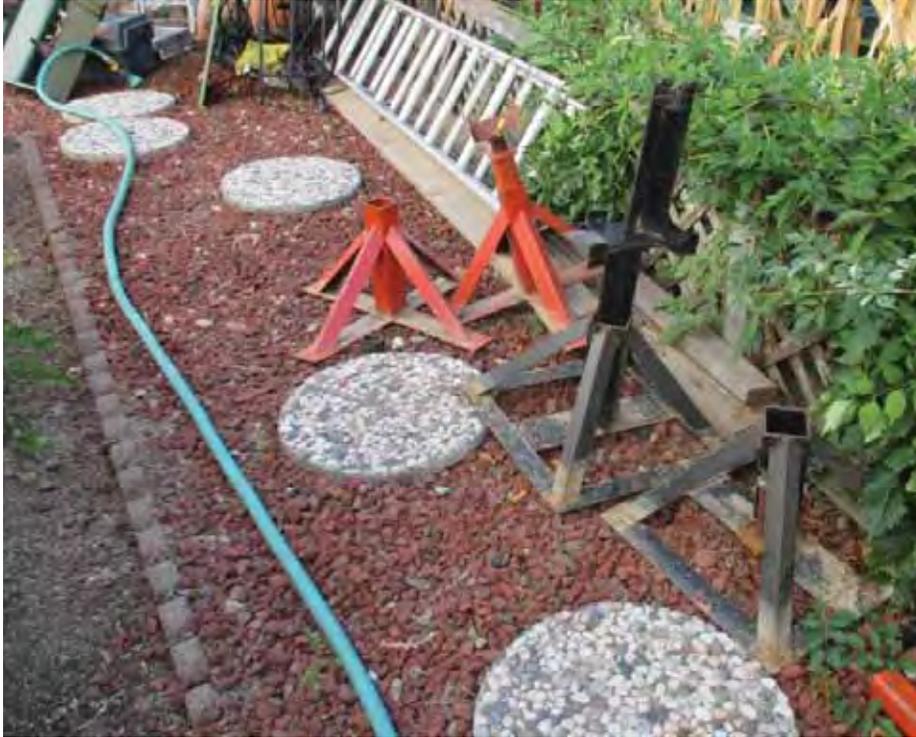
Figure 8-8 ETS removed from homes during reinstallation. These “cantilevered” piers had no allowance for anchorage to the supporting wood boards.

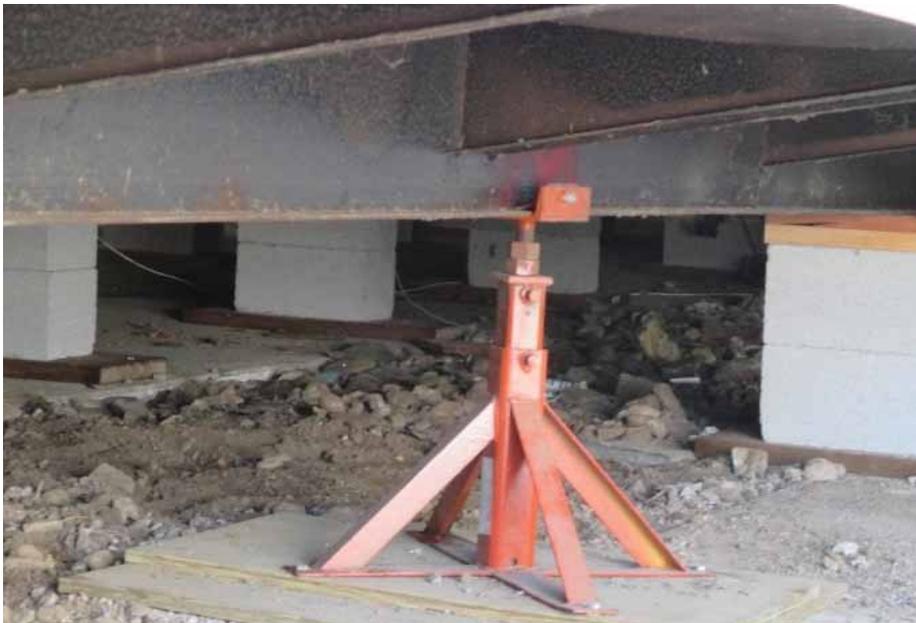
Figure 8-9 New “cantilevered” pier, anchored to supporting plywood panels.

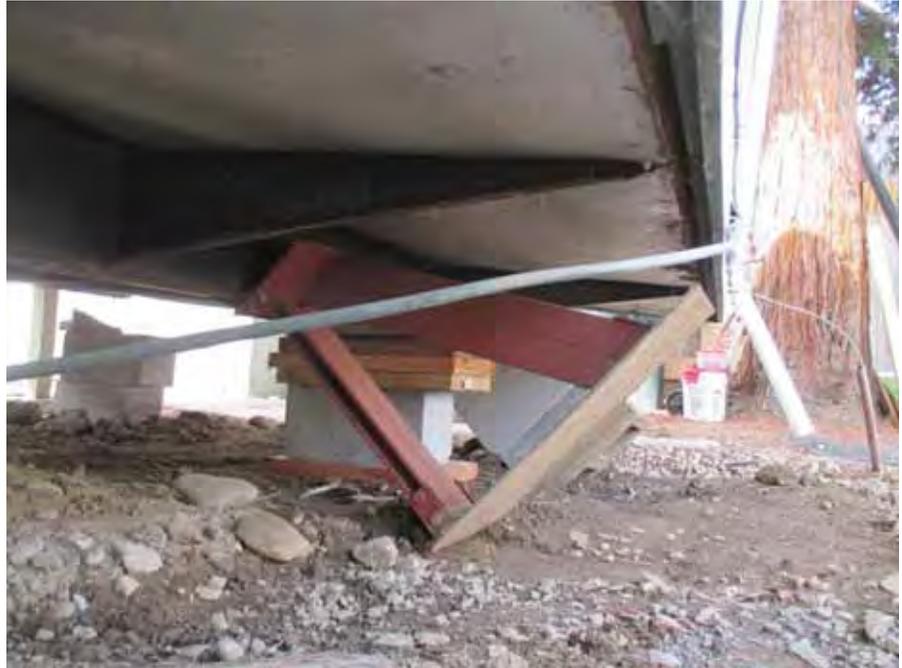
Figure 8-10 “Cantilevered” steel pier on home requiring reinstallation.

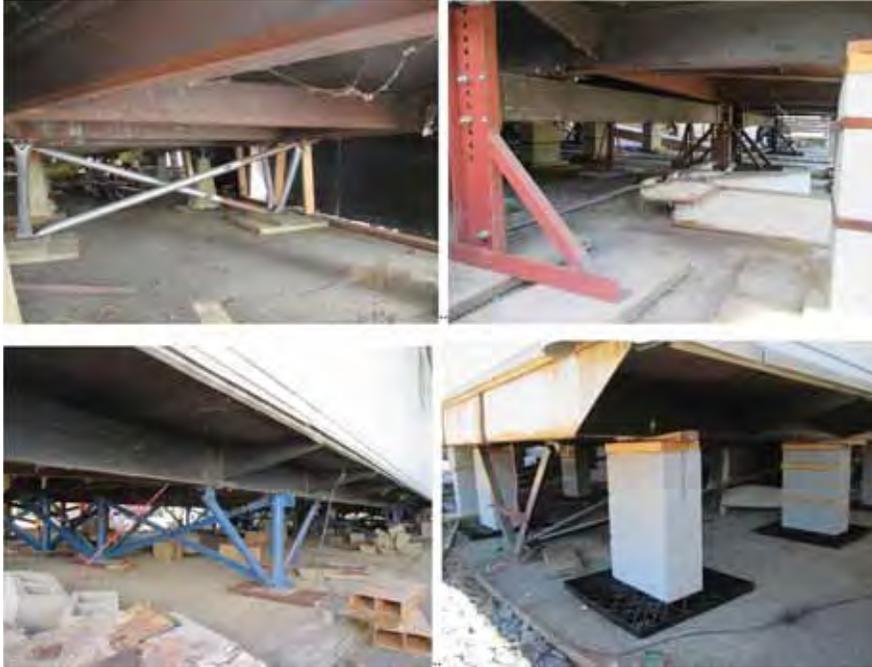
Figure 8-11 “Diagonally braced” ERBS on homes requiring reinstallation.

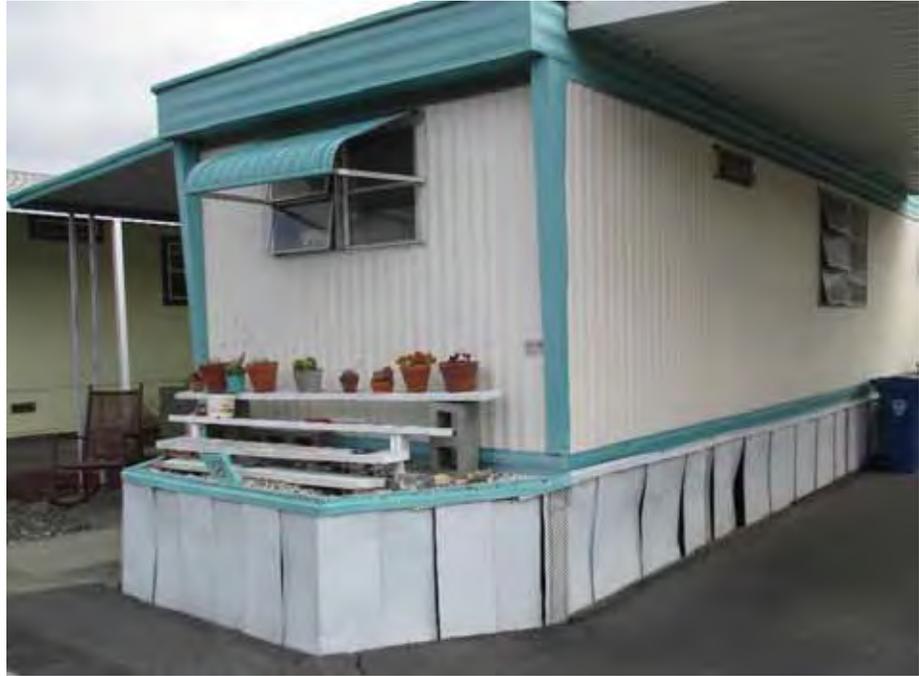
Figure 8-12 Damaged skirt on older home.

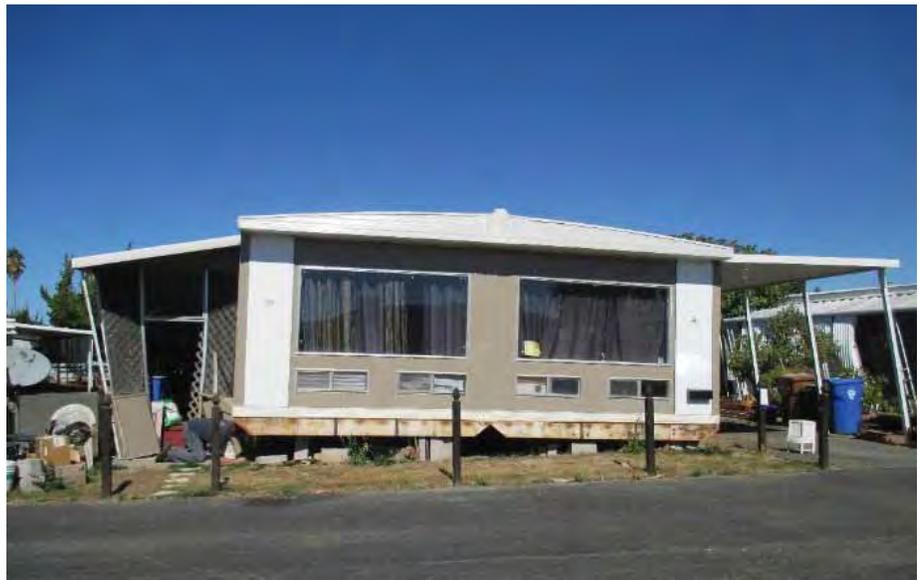
Figure 8-13 Home dropped from masonry gravity pier supports.

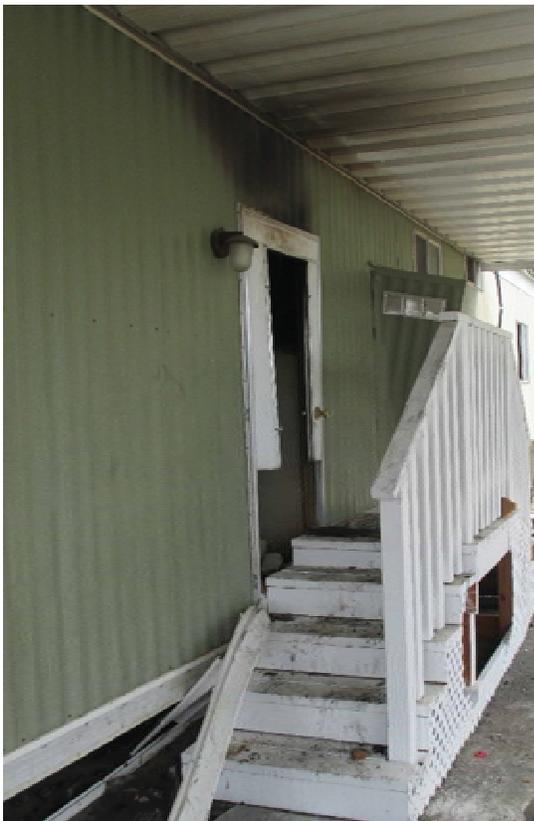
Figure 8-15 This door was blocked when the home dropped off of the gravity supports and had to be broken open by fire fighters.

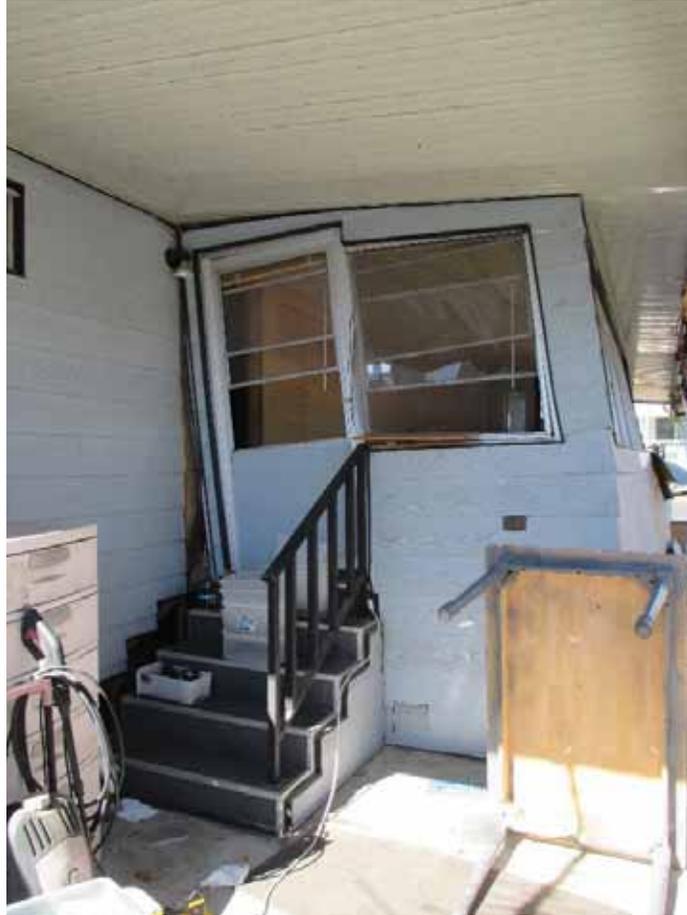
Figure 8-16 Add-on porch structure severely damaged by the earthquake.

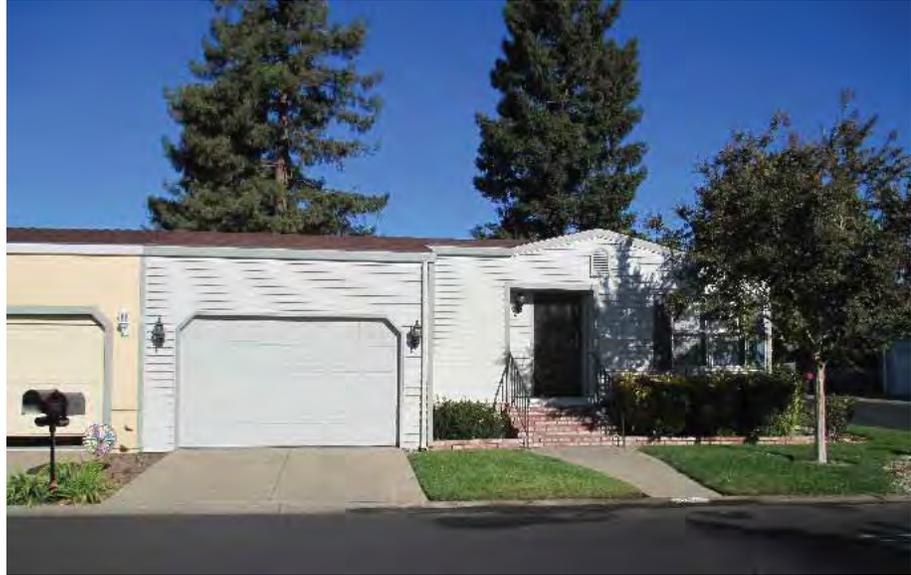
Figure 8-18 Oaktree Vineyard MHP typical home configuration.

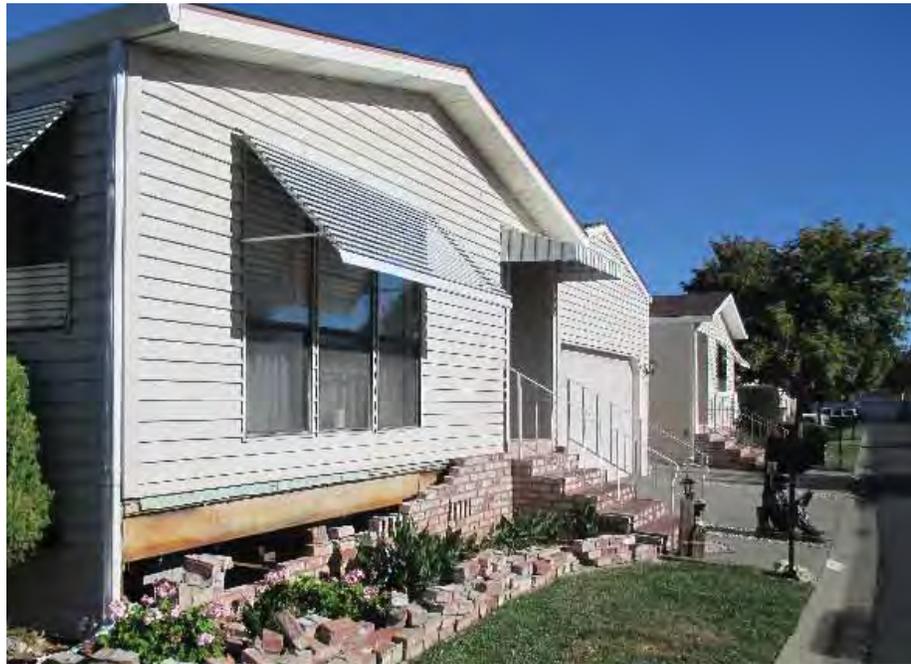
Figure 8-19 Damage to brick masonry skirt wall.

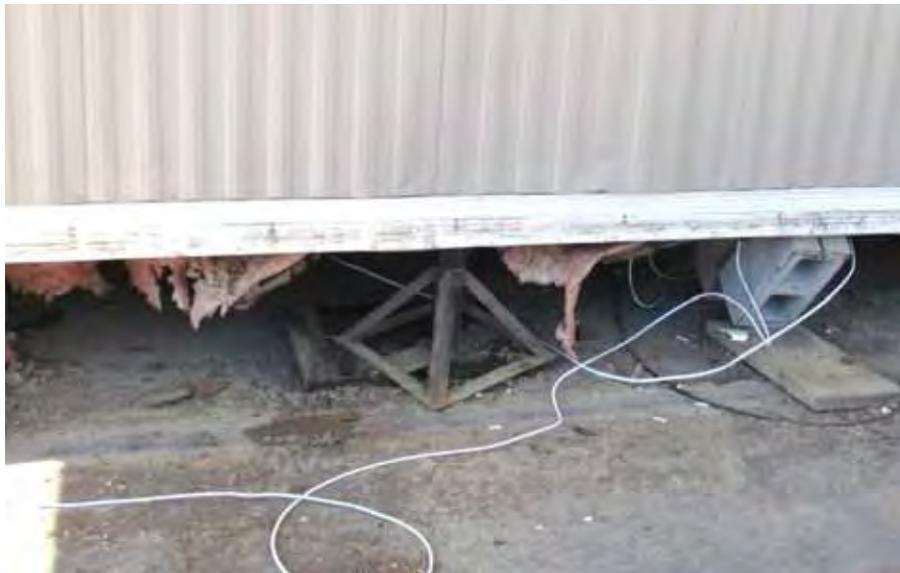
Figure 8-20 “Cantilevered” pier system that slid, adjacent to a masonry pier that has rolled over.

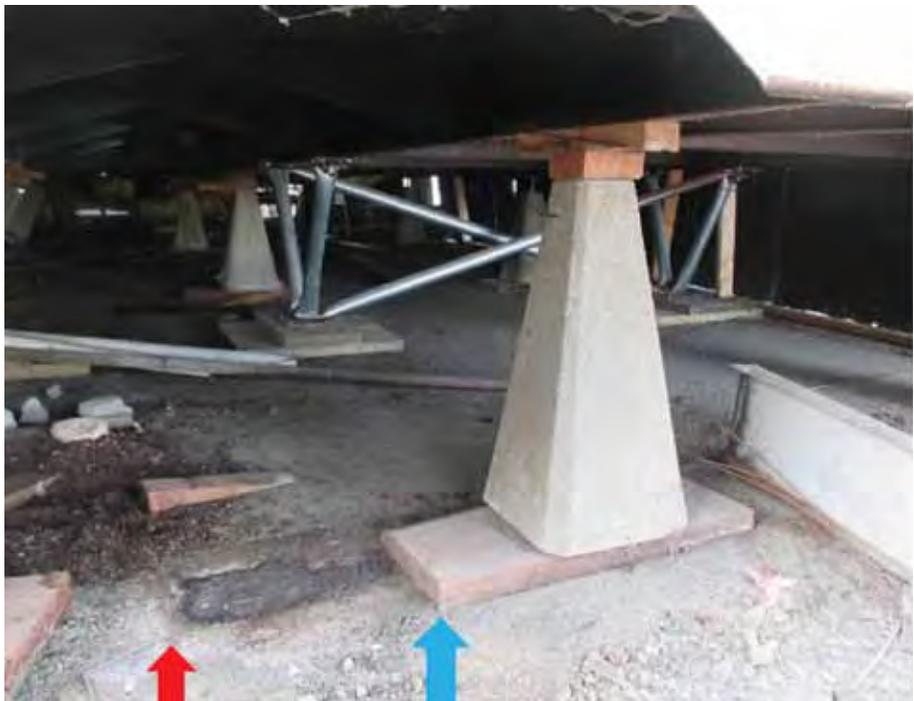
Figure 8-22 Extent of home sliding. Red arrow is initial wood board position, blue arrow is final position. ERBS can be observed in the background.
