Performance of Buildings and Nonstructural Components in the 2014 South Napa Earthquake

FEMA P-1024 / February 2015

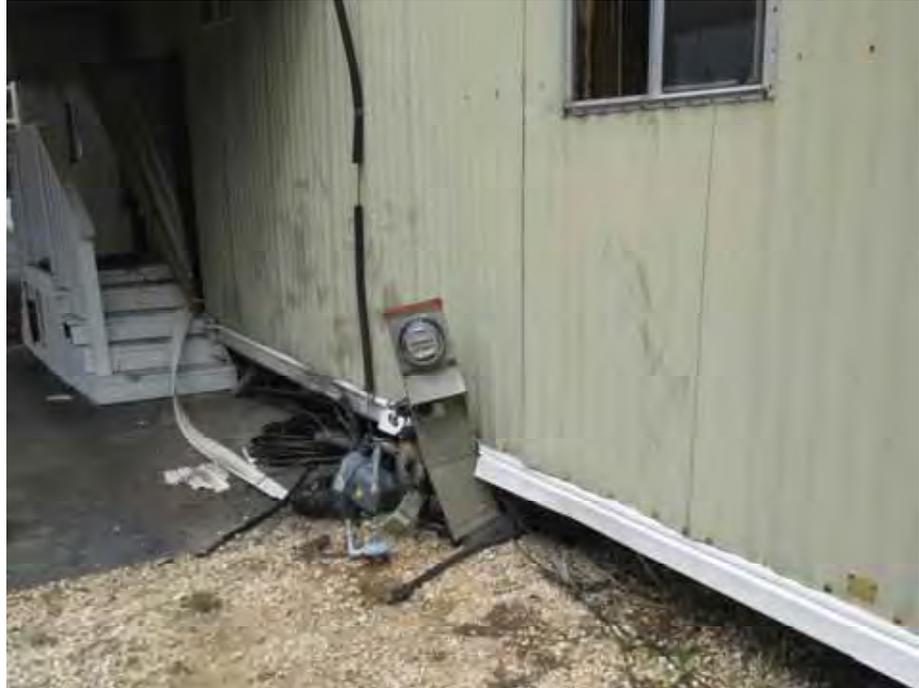
Figure 8-23 Manufactured home that slid and fell onto its utility hookup.

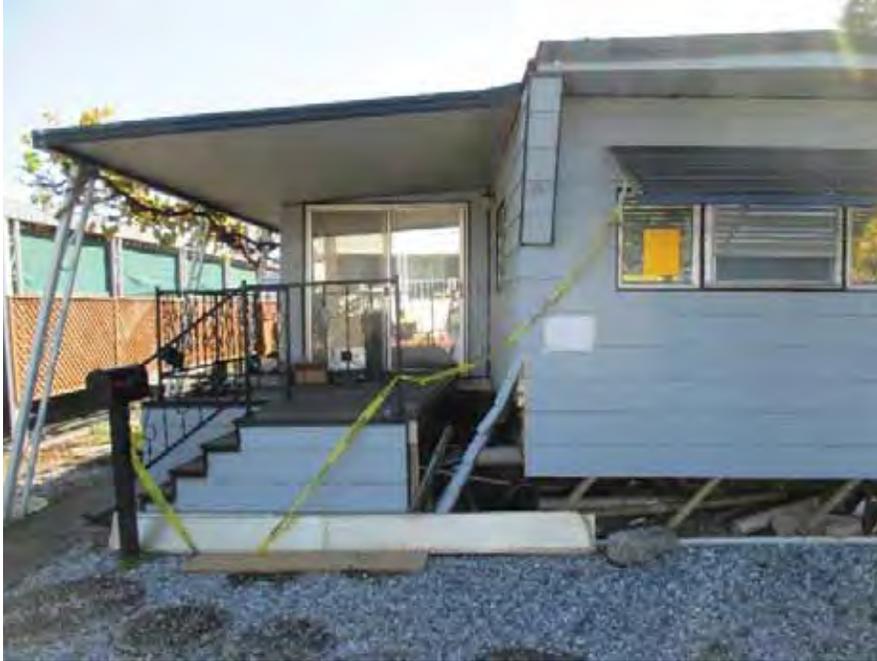
Figure 8-24 Napa Valley MHP home displaced significantly to the west.

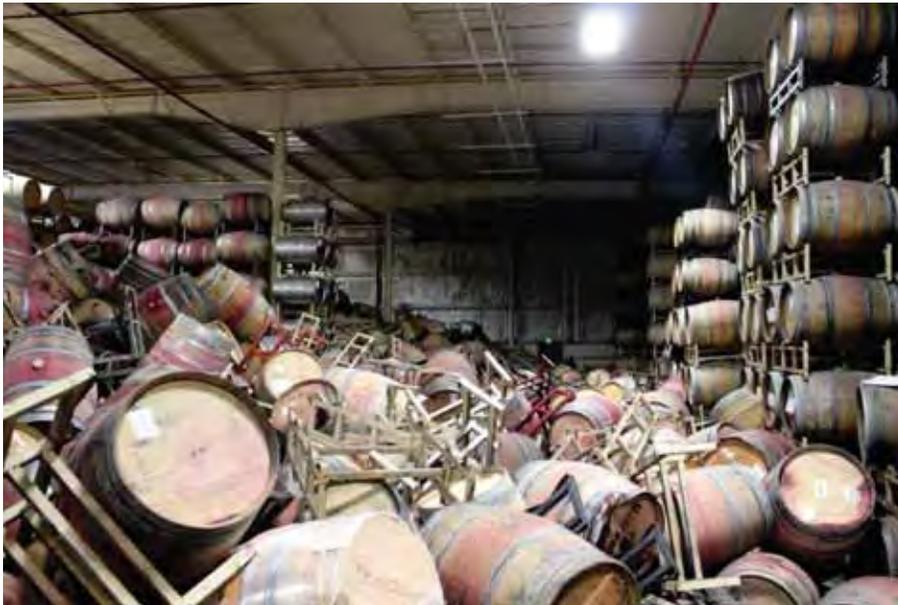
Figure 9-1 Collapsed barrel stacks.

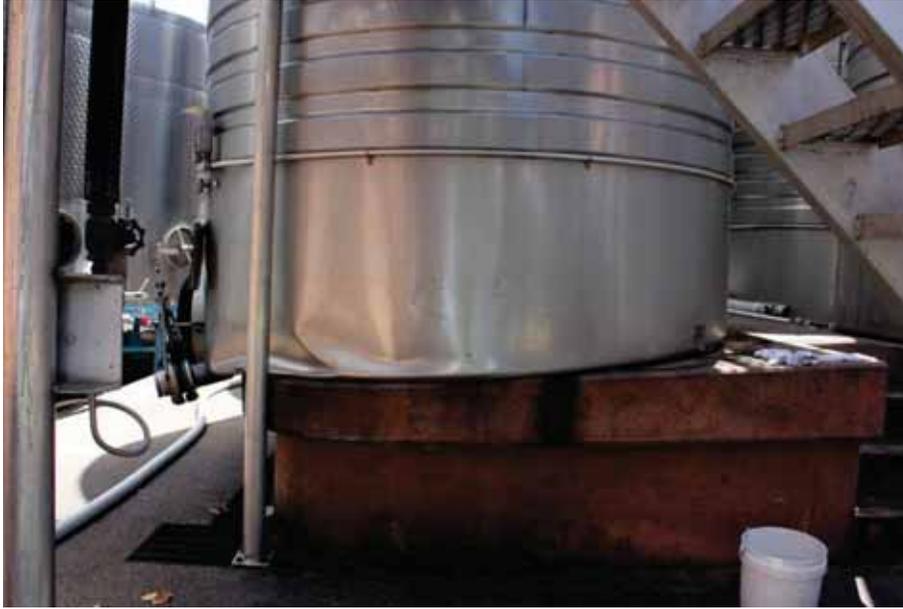
Figure 9-2 Anchorage failure allowed tank to shift on pedestal.

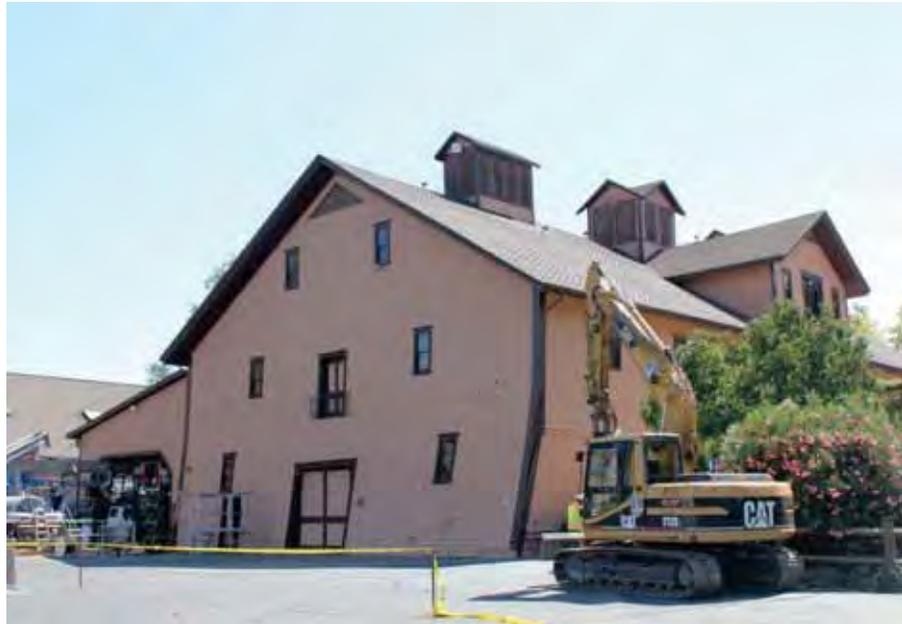
Figure 9-3 Historic timber-framed winery building with large residual drift at the ground floor.

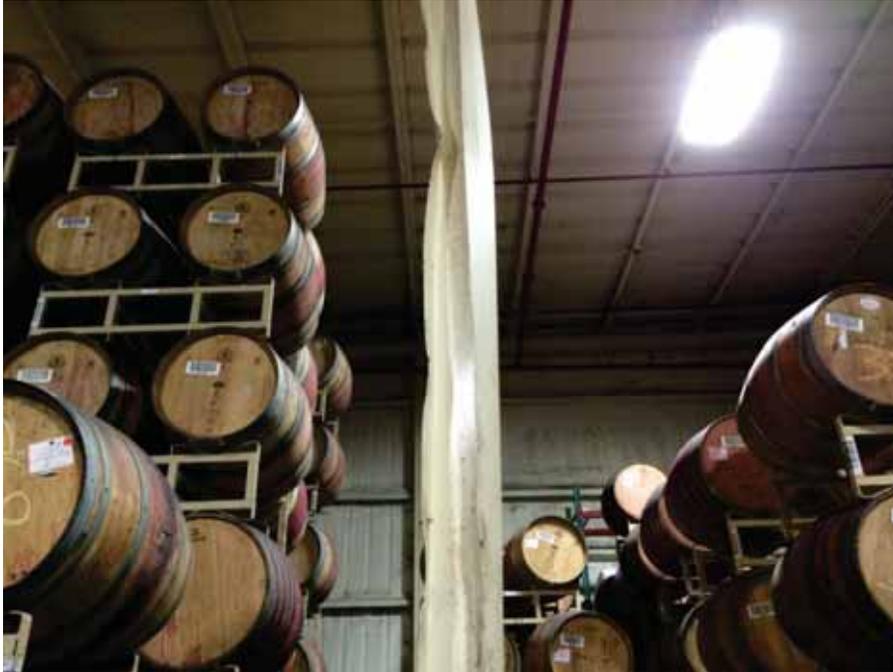
Figure 9-4 Steel columns damaged by impact of barrels.

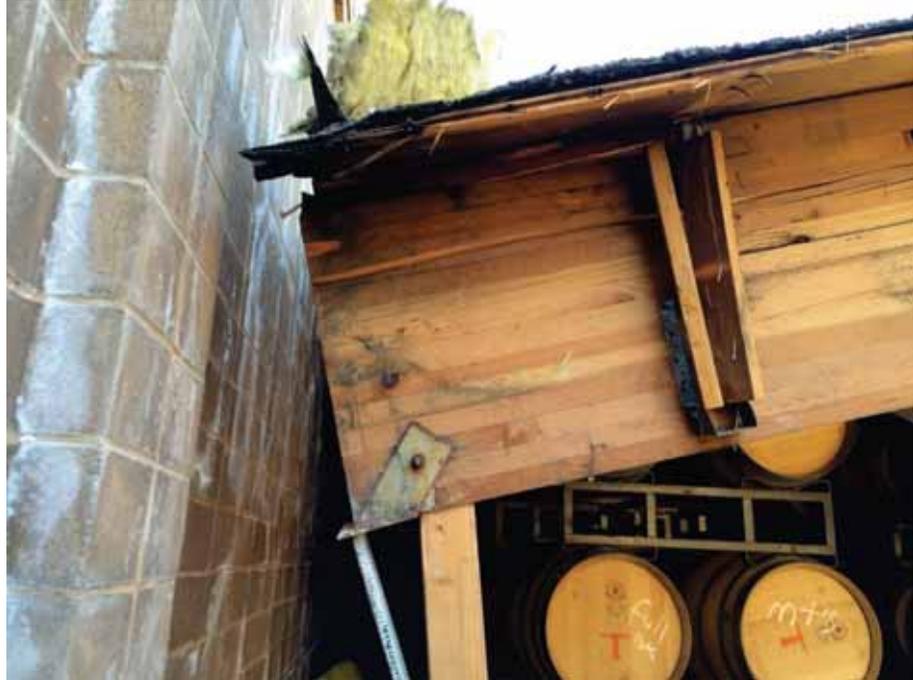
Figure 9-5 Failure of glulam beam to wall connection resulted in roof collapse.

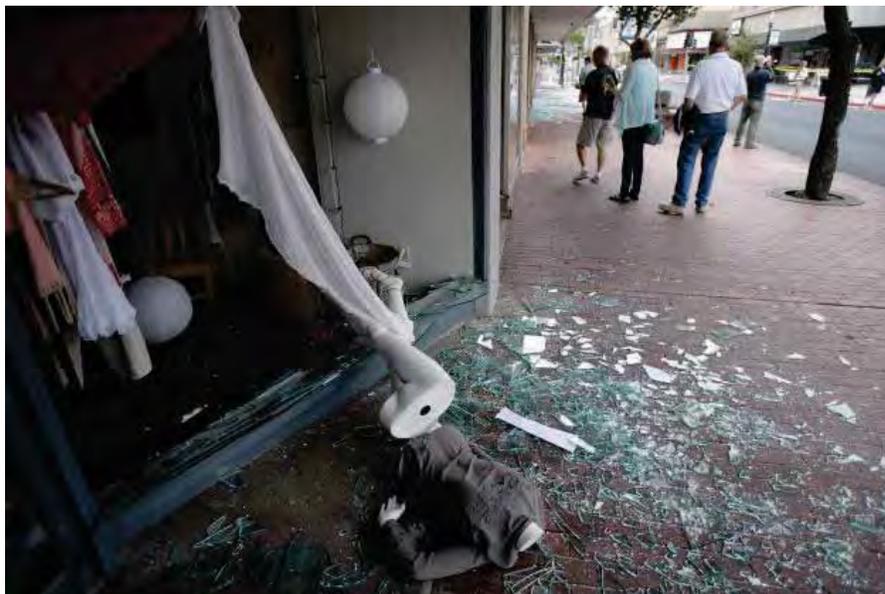
Figure 10-1 Broken glass at open storefront on an unreinforced masonry building.

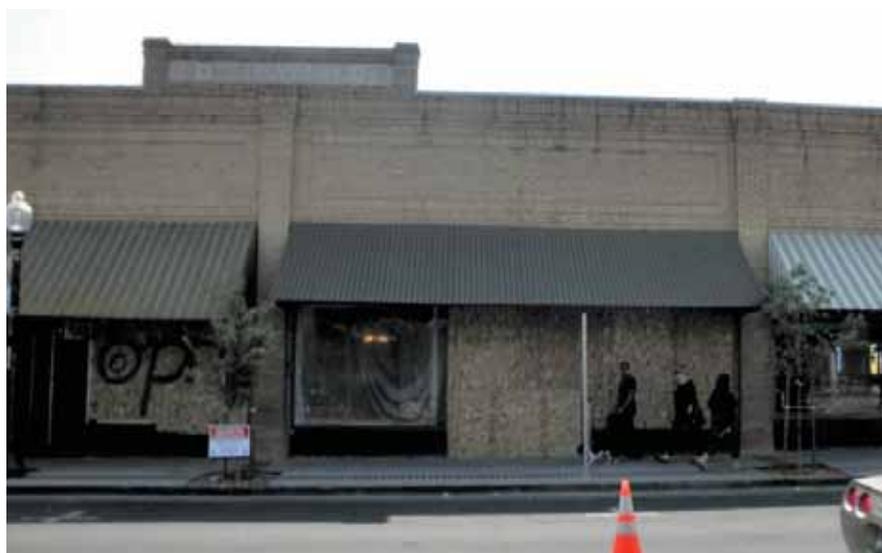
Figure 10-2 Typical condition showing temporary plywood barricades and plastic over openings where storefront glazing was damaged.

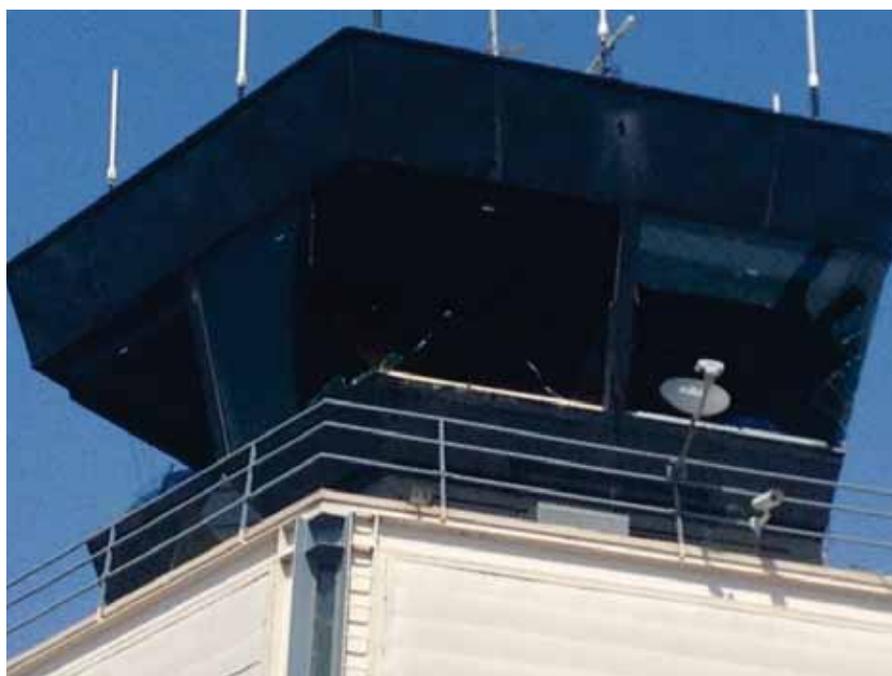
Figure 10-3 Broken glass in Napa County air traffic control tower (photo by J.L. Sousa/Napa Valley Register/ZUMAPress.com).

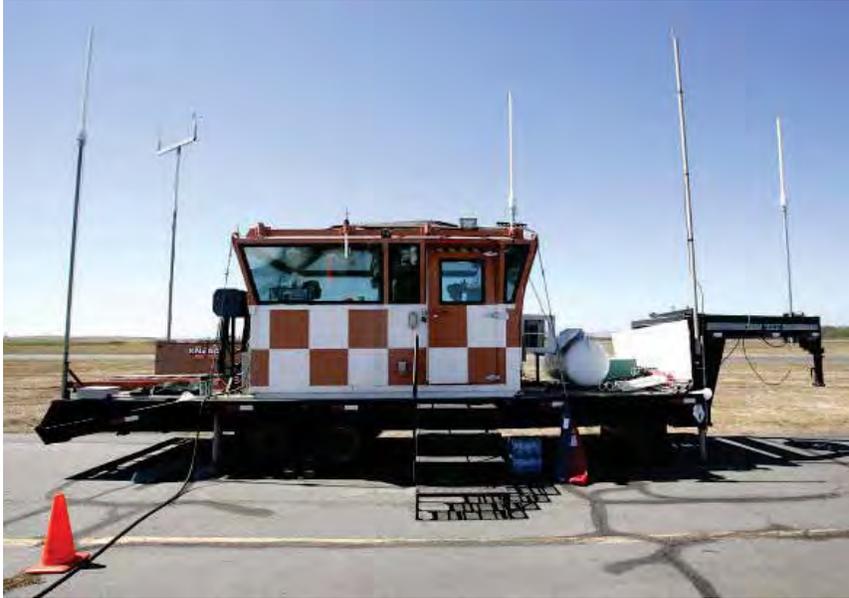
Figure 10-4 Temporary air traffic control tower.

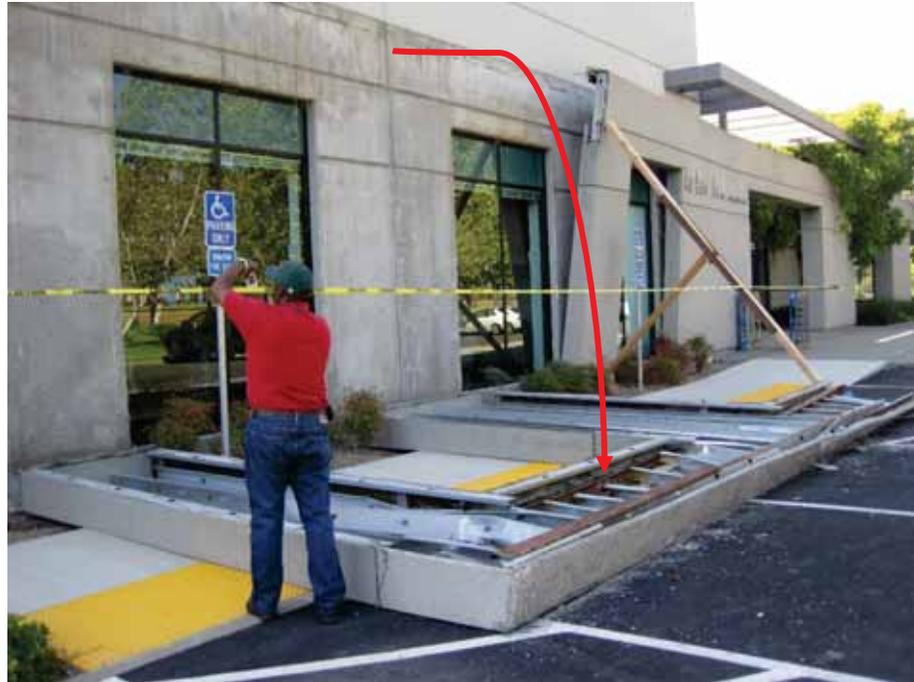
Figure 10-5 Metal stud and stucco framed cladding dislodged from concrete wall.

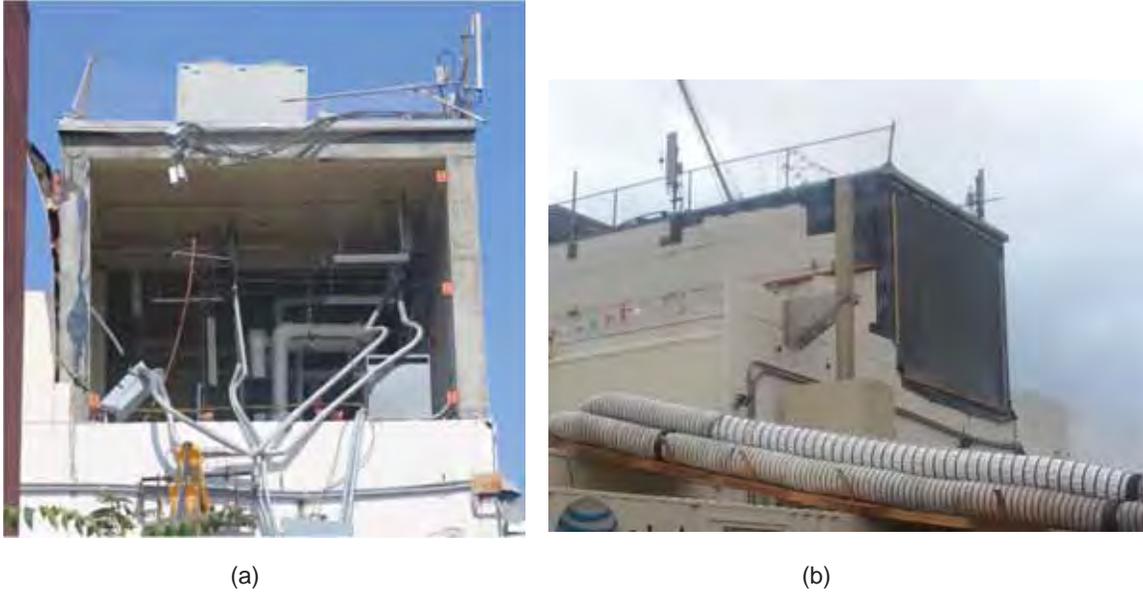
Figure 10-6 Dislodged precast panel in telephone operations facility: (a) missing panel with orange brackets remaining in place (photo from PEER (2014)); (b) temporary covering after the earthquake.

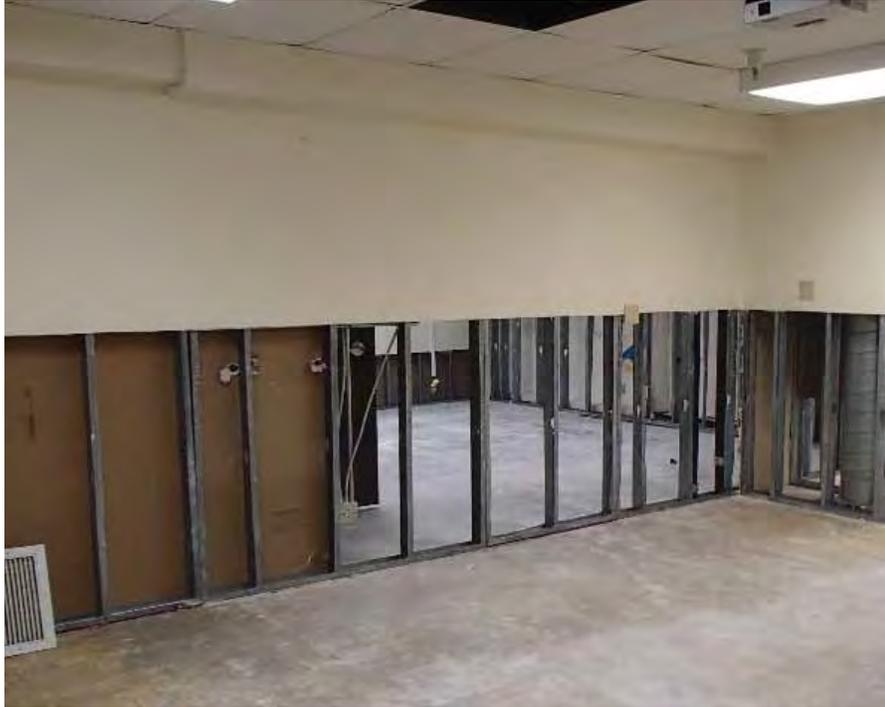
Figure 10-7 Gypsum wallboard was removed from partition walls where water damage from a broken sprinkler head occurred.

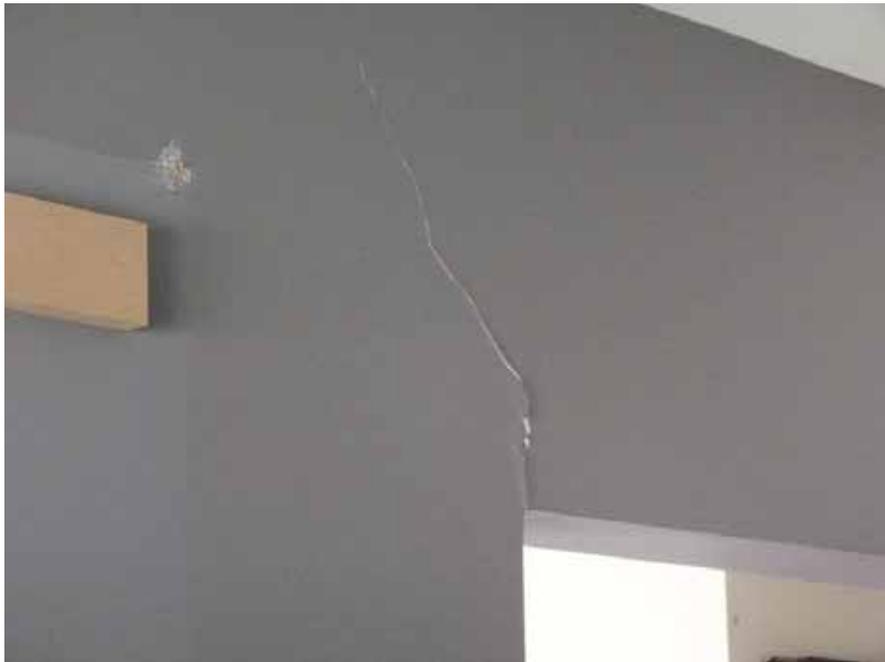
Figure 10-8 Typical damage to gypsum wallboard.

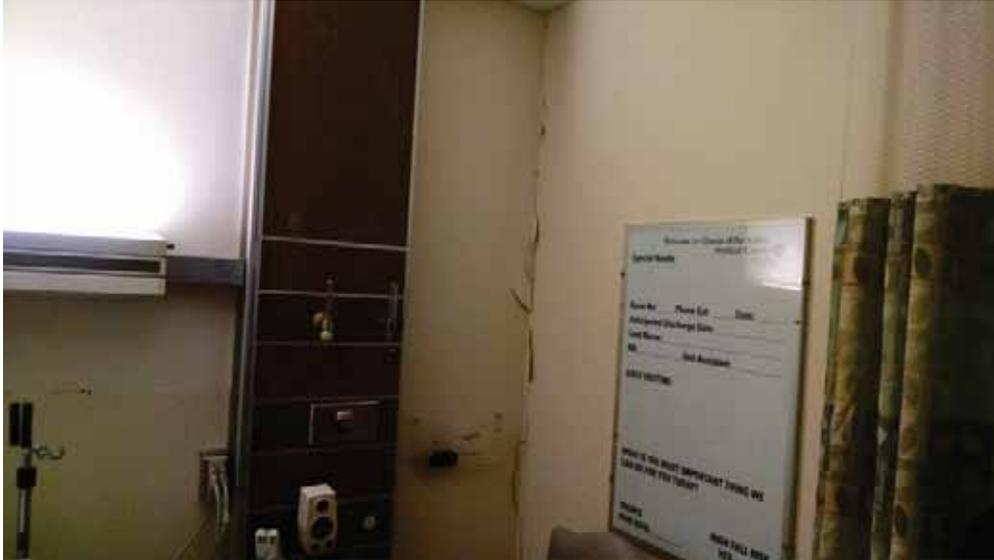
Figure 10-9 Damage to gypsum wallboard at corner (photo from OSHPD).

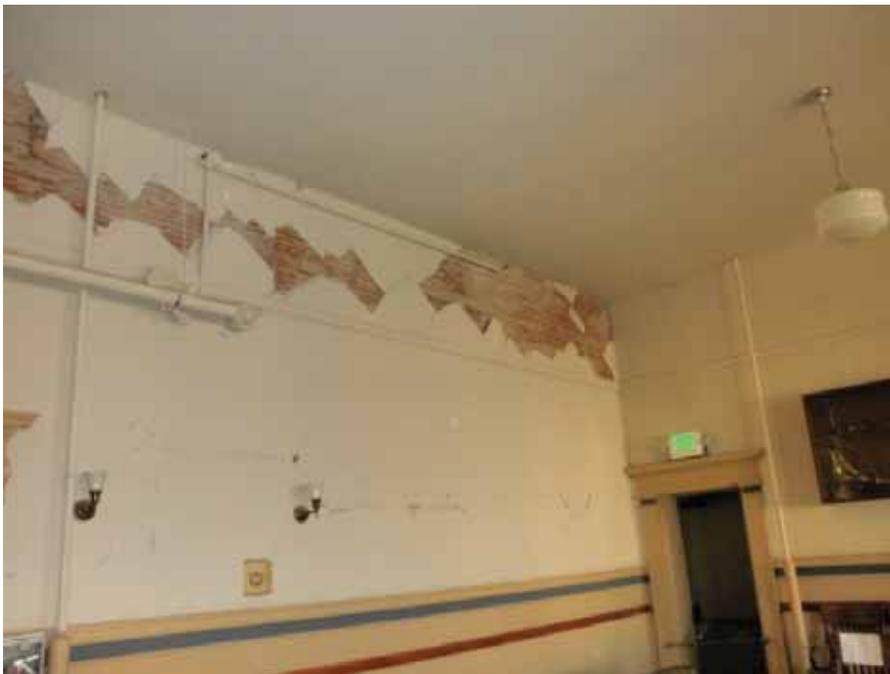
Figure 10-10 Cracked and spalled plaster on lath and plaster wall.

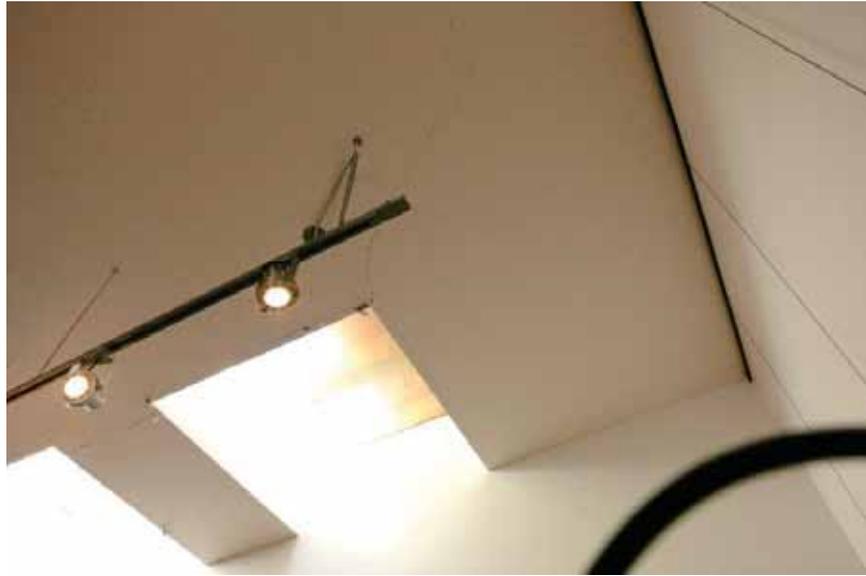
Figure 10-11 Cracking of gypsum wallboard ceiling.

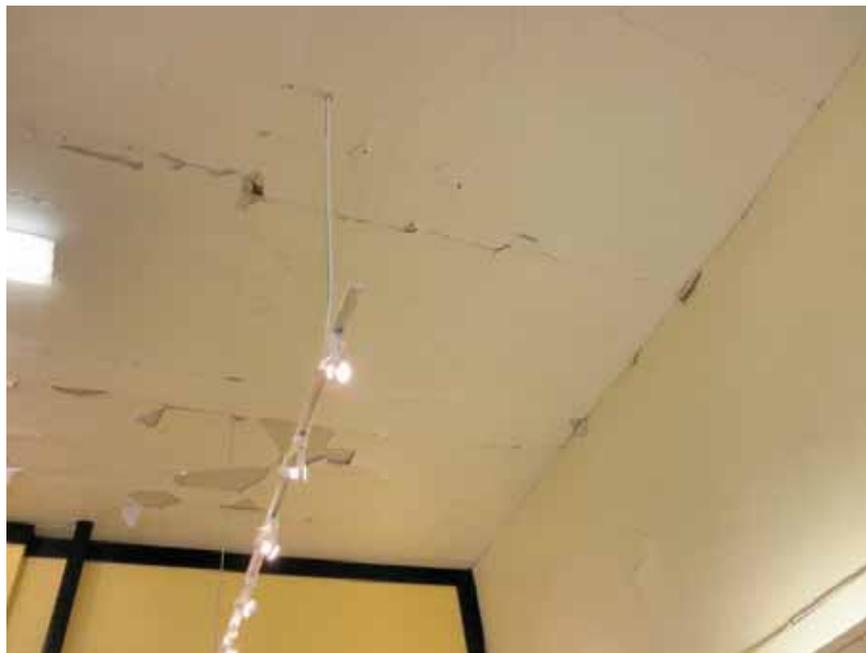
Figure 10-12 Cracking and spalling of a plaster ceiling in an older masonry building in downtown Napa.

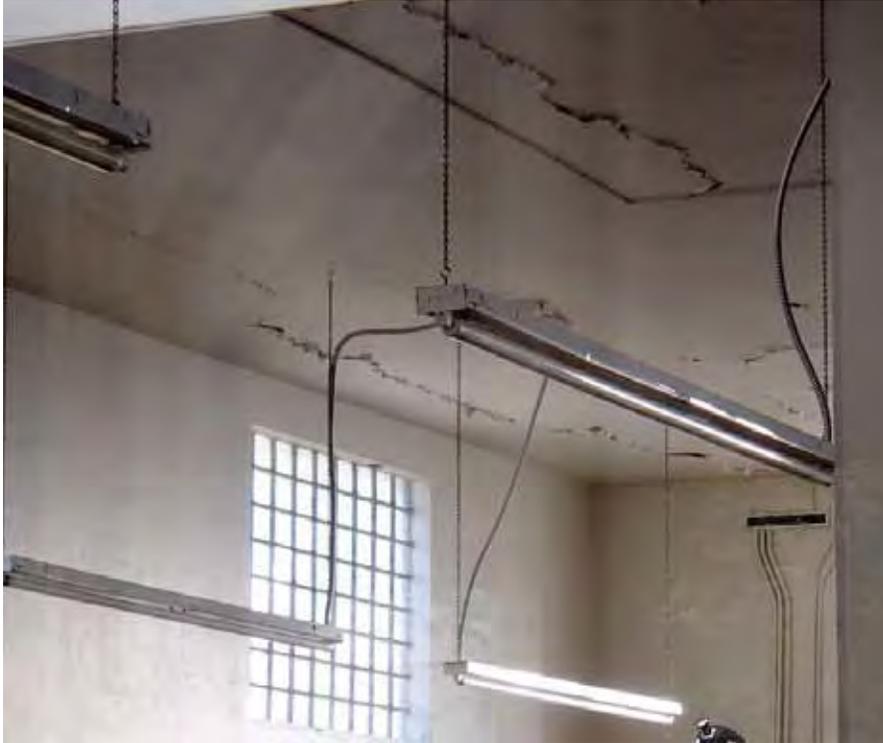
Figure 10-13 Cracking and spalling of a plaster ceiling in an older reinforced concrete building in downtown Napa.

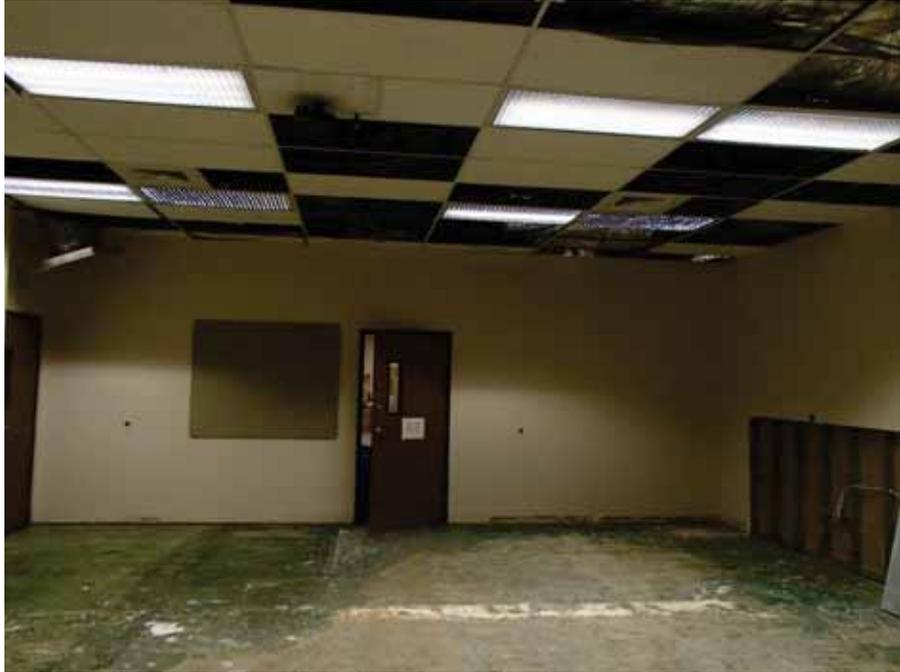
Figure 10-14 Acoustic ceiling where tiles fell in an office building.

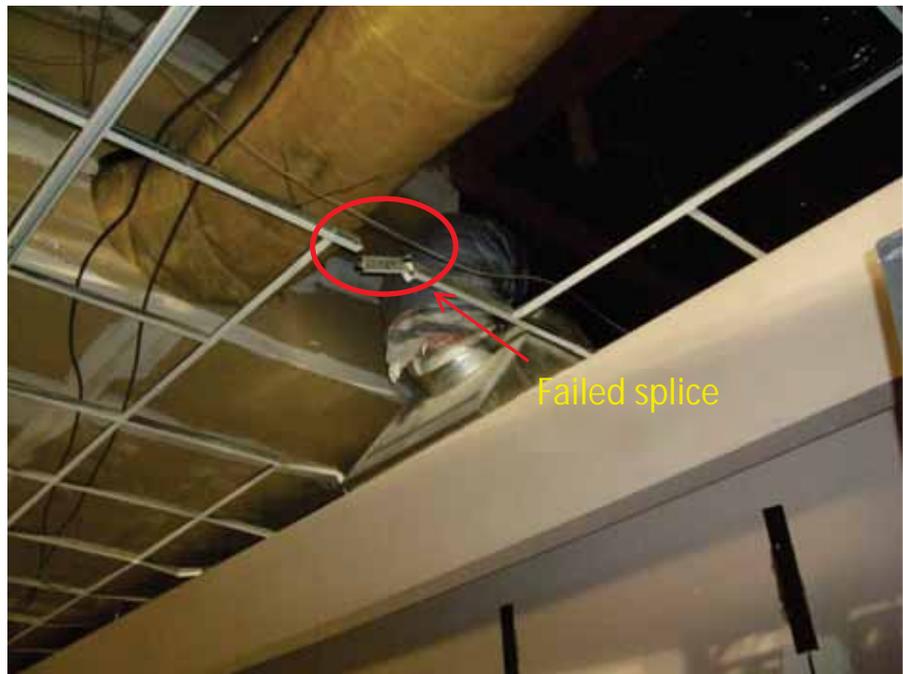
Figure 10-15 Failure of a splice of acoustical tile ceiling grid in a two-story retail store in downtown Napa.

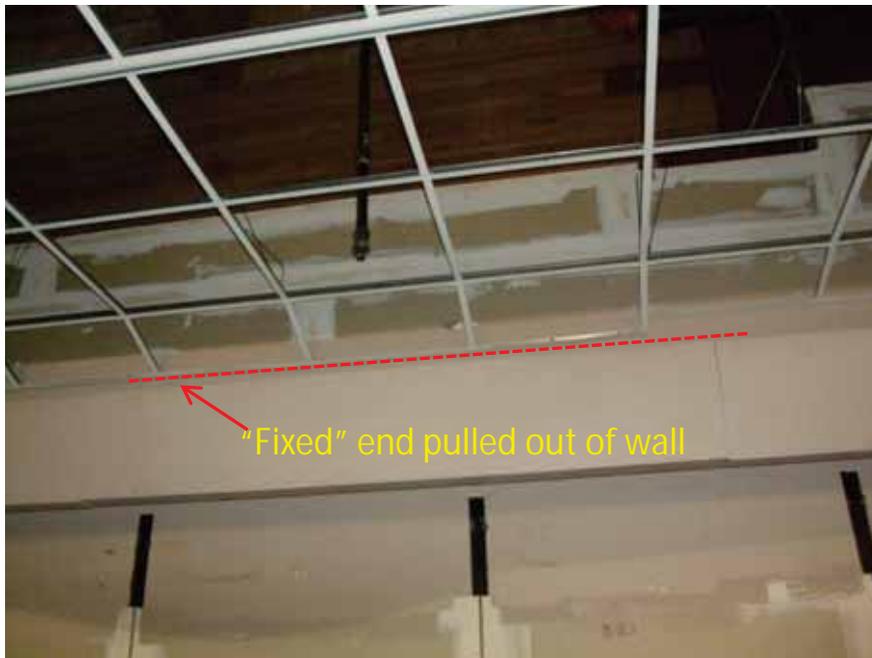
Figure 10-16 Failure of "fixed" end support of the acoustical tile ceiling grid in a two-story retail store in downtown Napa.

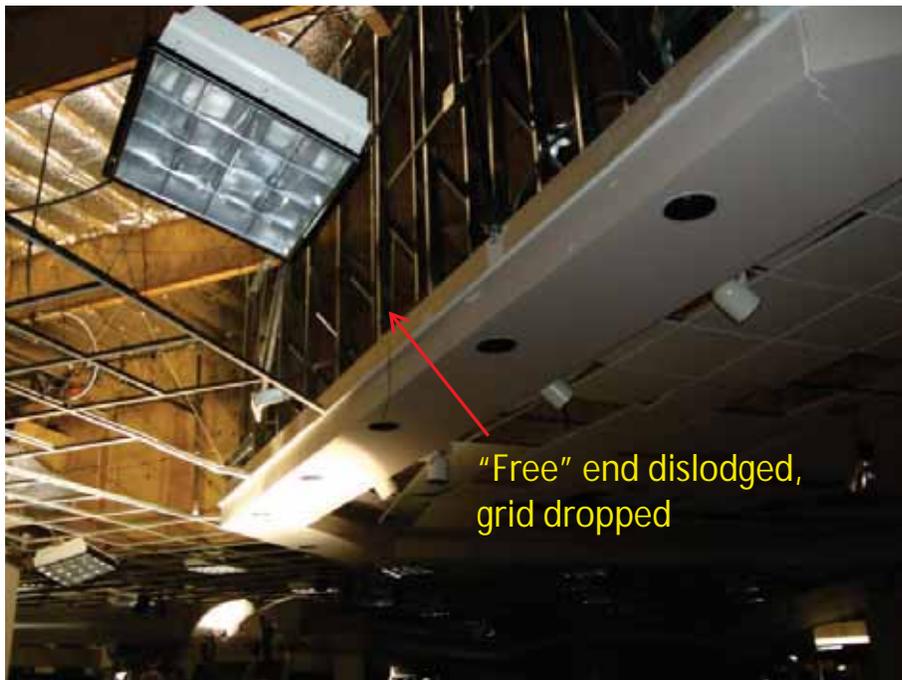
Figure 10-17 Failure of "free" end support of the acoustical tile ceiling grid in a two-story retail store in downtown Napa.

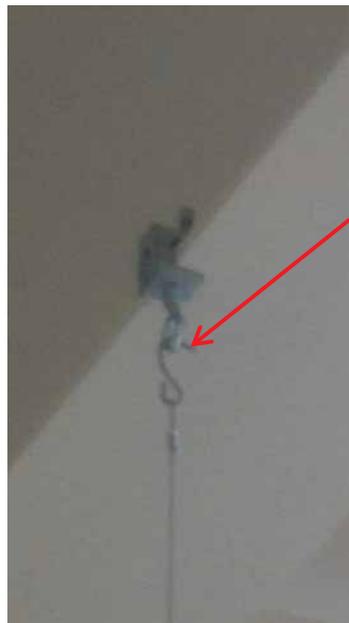
Figure 10-18 “S” hook opened during earthquake and caused fixtures to drop.

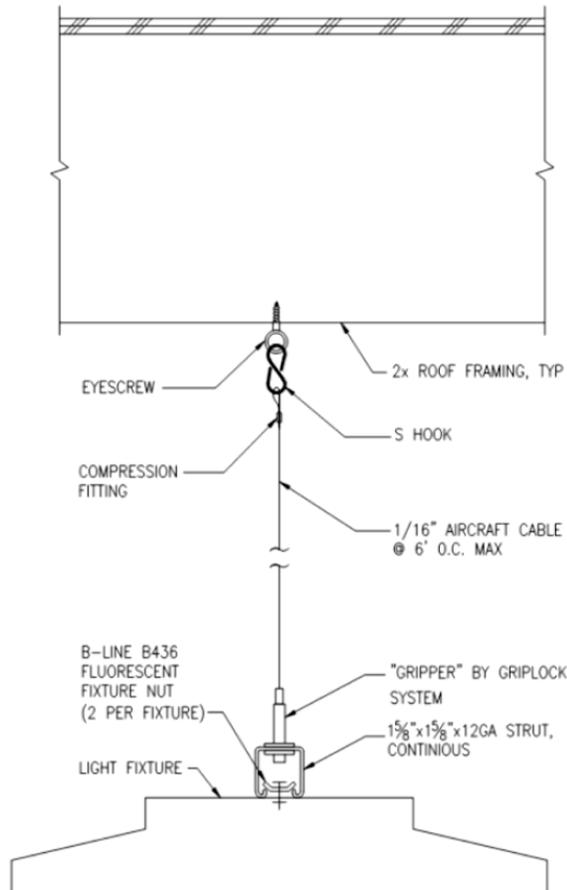
Figure 10-19 Pendant fixture support detail.

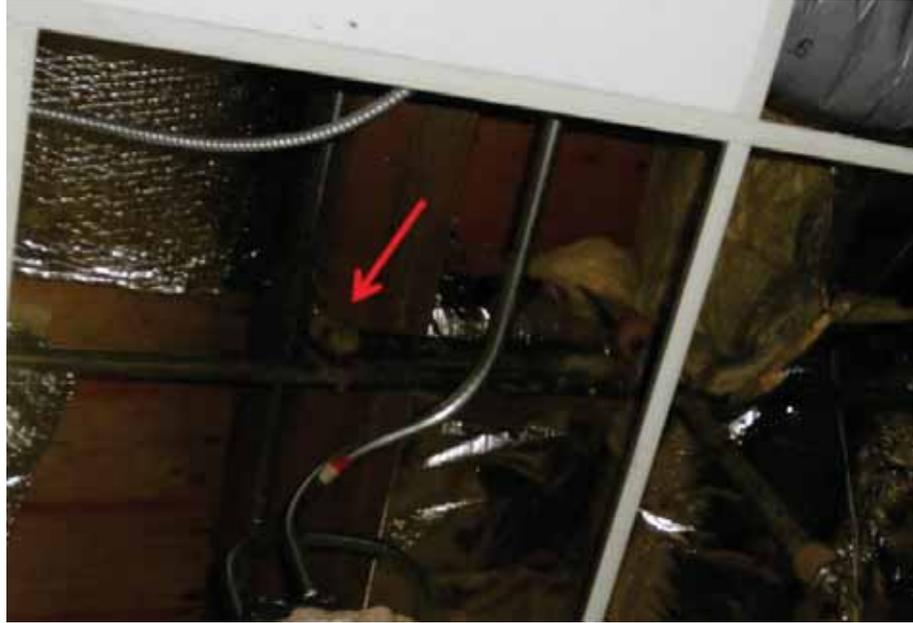
Figure 10-20 Sprinkler head interaction with adjacent components resulted in extensive flooding.

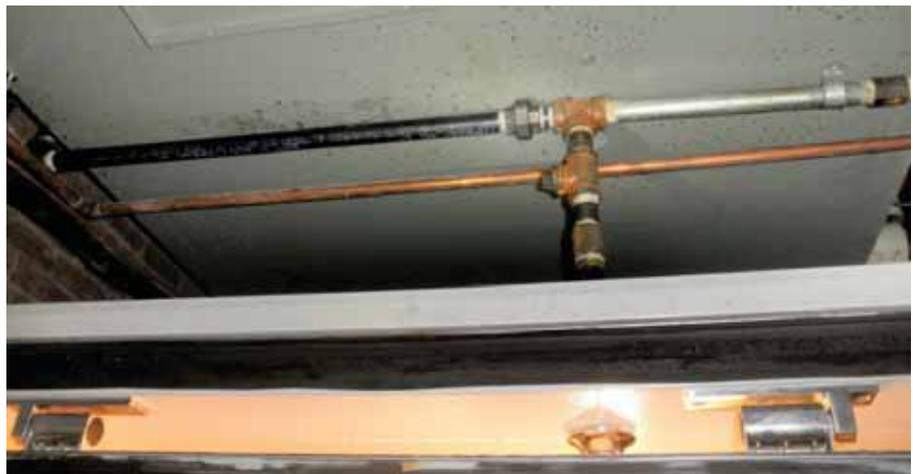
Figure 10-21 Repaired condition of a failed pipe at threaded connection that resulted in flooding of the first floor restaurant.

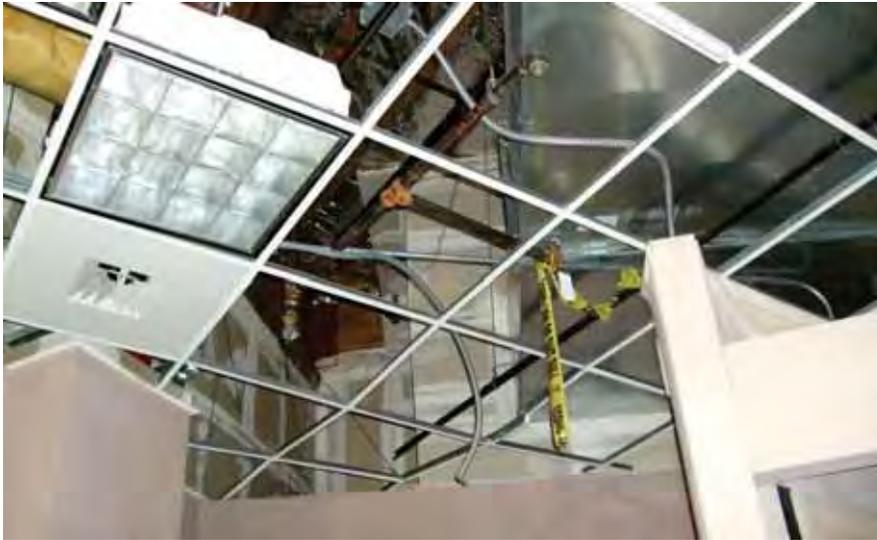
Figure 10-22 Sprinkler piping in close proximity to HVAC components.

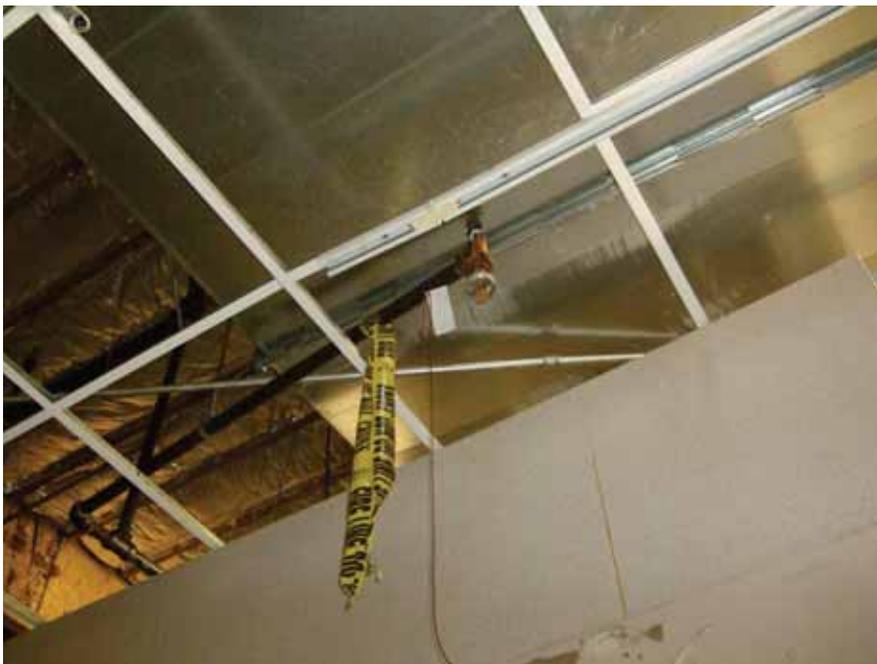
Figure 10-23 Sprinkler armover in close proximity to HVAC components.

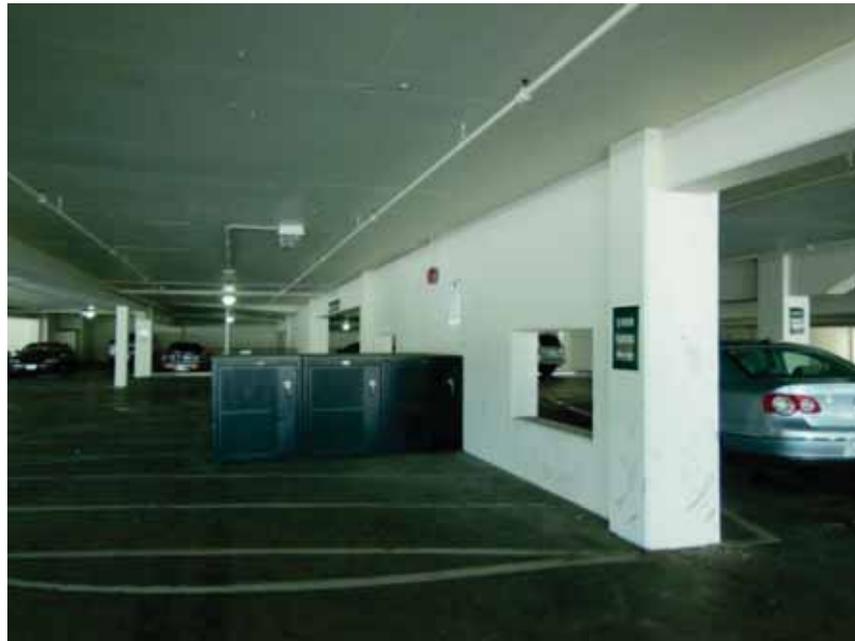
Figure 10-24 Sprinkler installation in parking garage.

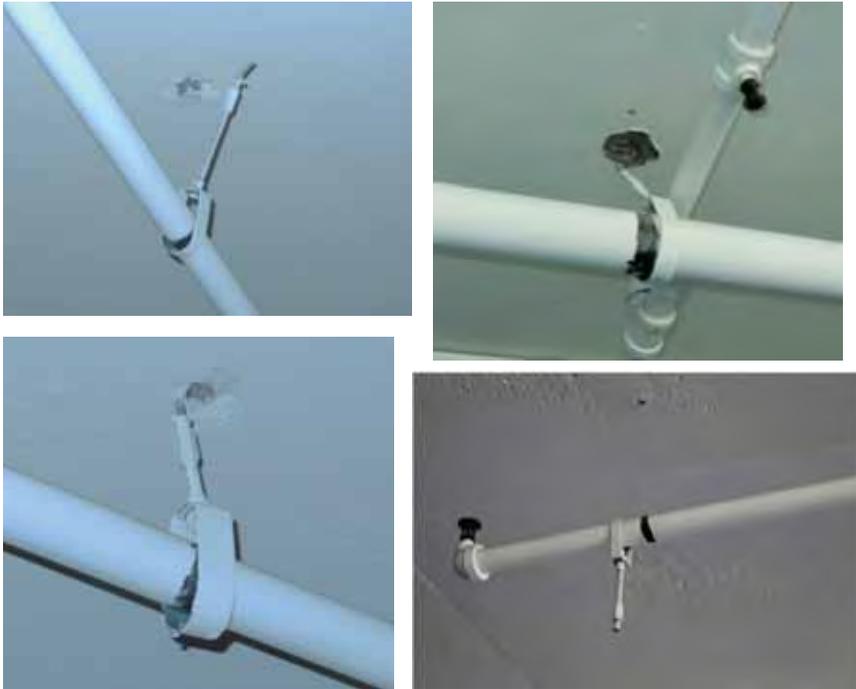
Figure 10-25 Failures of powder driven fasteners. Bottom right photo is from PEER (2014).

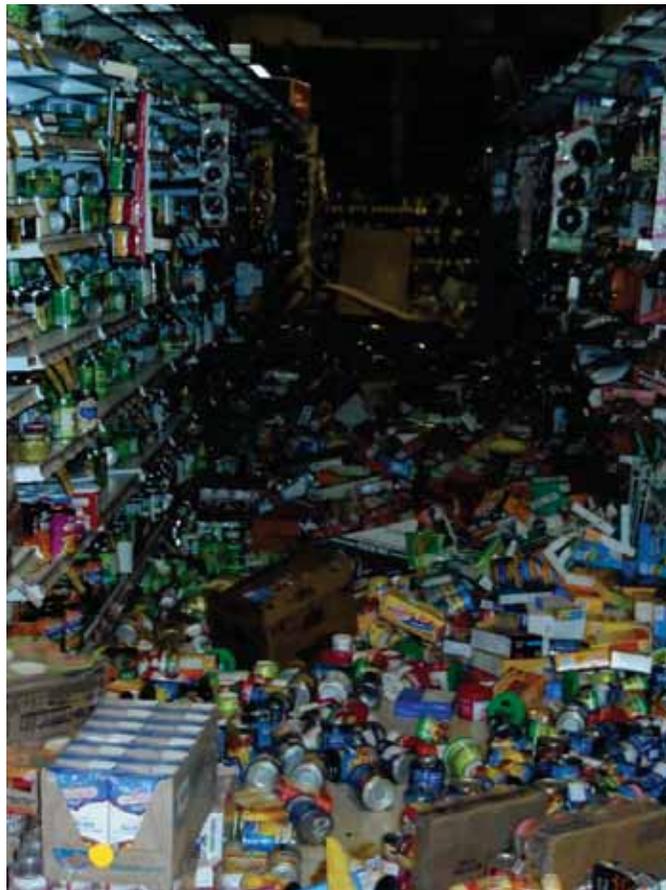
Figure 10-26 Contents dislodged from grocery store shelves.

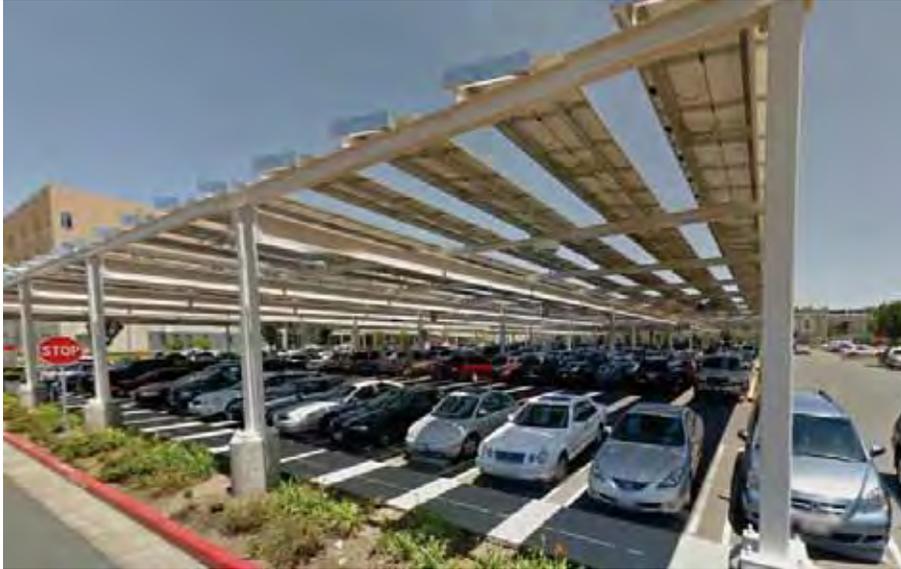
Figure 10-33 Ground-mounted solar canopy over parking lot (photo from Google Street View). No damage reported.

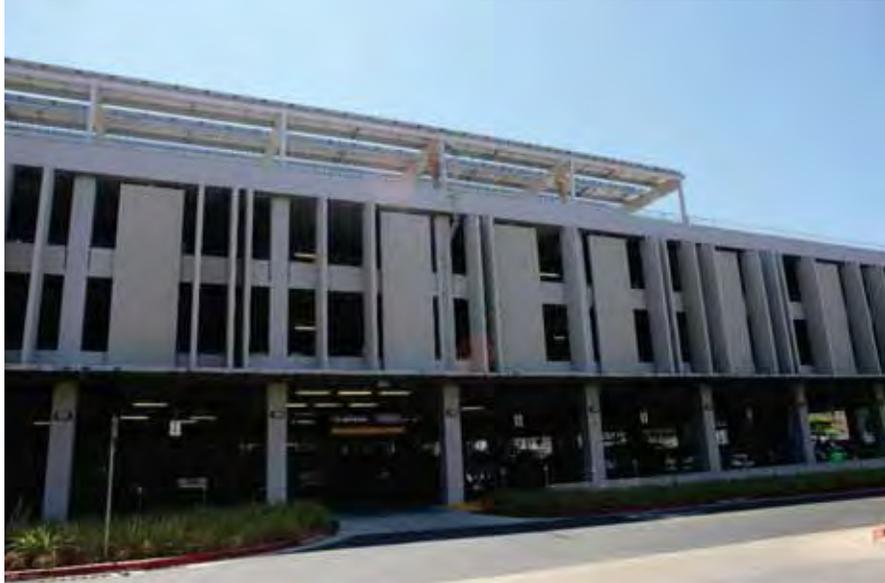
Figure 10-34 Parking garage with solar canopy structure on roof (photo by Jiun-Wei Lai).

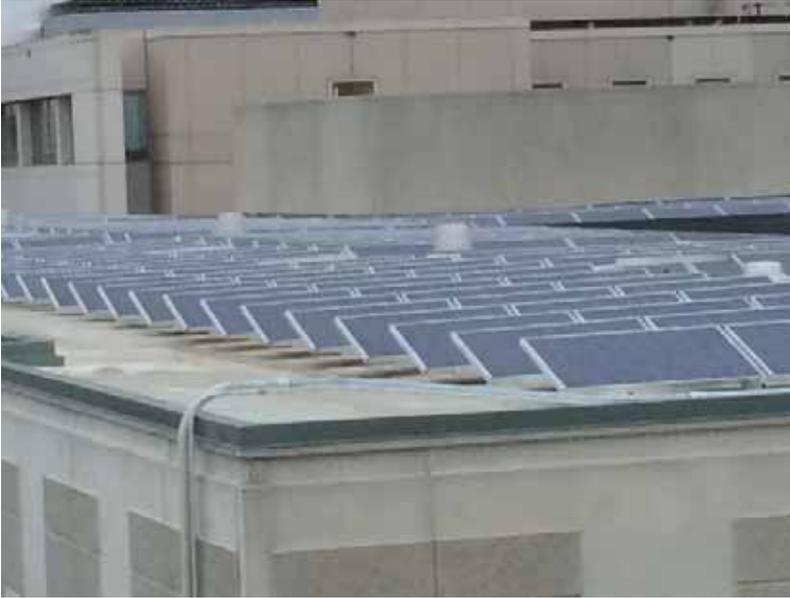
Figure 10-39 Low-profile unattached (ballast-only) solar array on roof of medical office building (photo from Kaiser Permanente). No damage was reported.

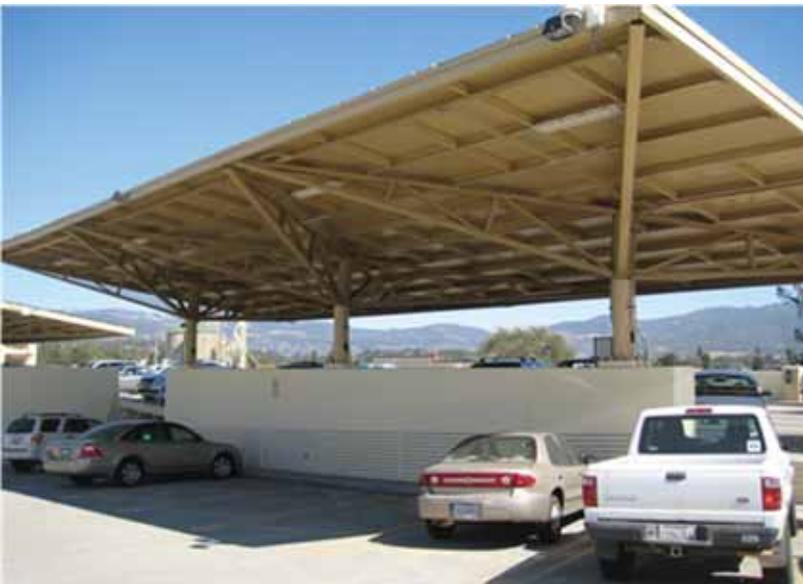
Figure 10-40 Roof-mounted solar canopy on top of parking garage structure. No damage was reported.

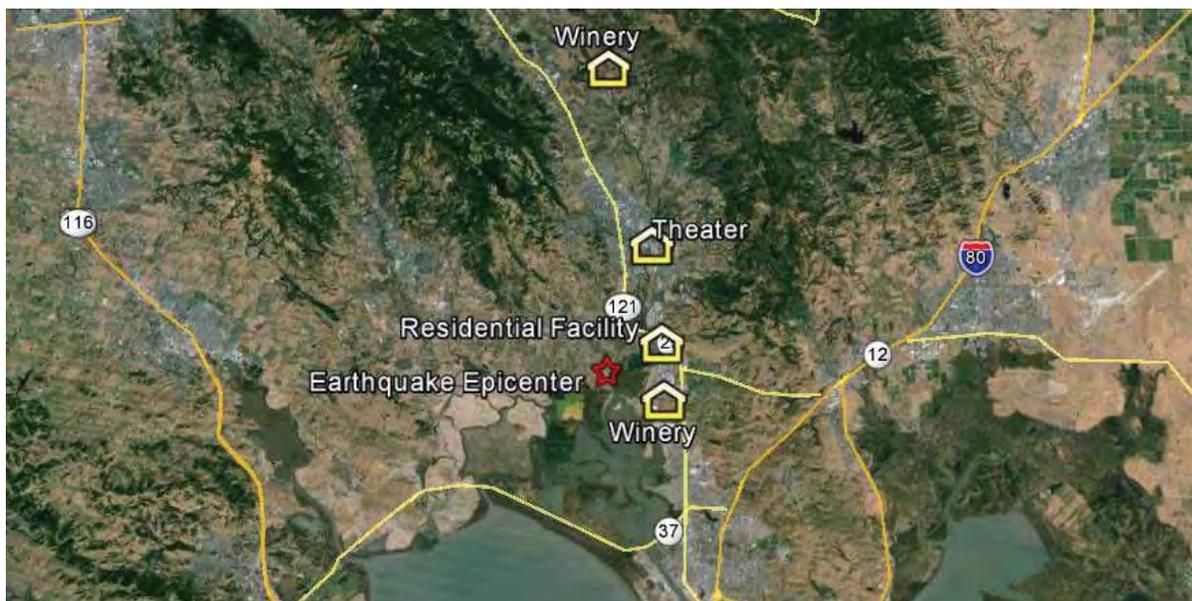
Figure 10-41 Locations of rooftop solar arrays inspected by manufacturer's engineers following the earthquake (Image from Google Earth.)

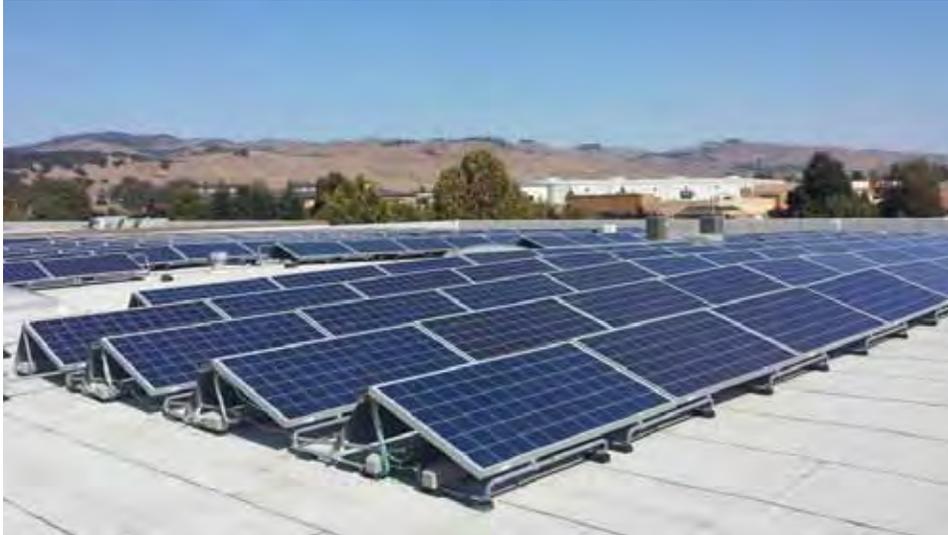
Figure 10-42 Solar array on the roof of an office and warehouse building two miles east of earthquake epicenter (photo from PanelClaw, Inc.). Array includes ballast and mechanical attachments to the building roof at selected locations. No damage reported.

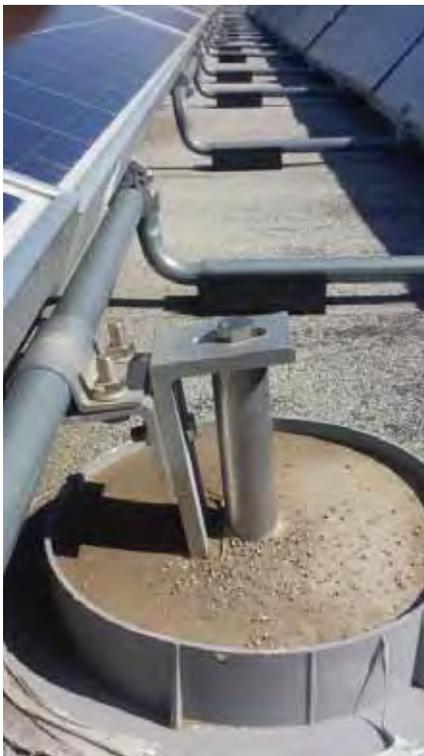
Figure 10-43 Mechanical attachment of solar array on the roof of an office/warehouse building two miles east of earthquake epicenter (photo from PanelClaw, Inc.). Array includes ballast and mechanical attachments to the building roof at selected locations. Mechanical attachments are evenly distributed throughout the array and typically showed similar evidence of possible movement.
