Performance of Buildings and Nonstructural Components in the 2014 South Napa Earthquake

FEMA P-1024 / February 2015

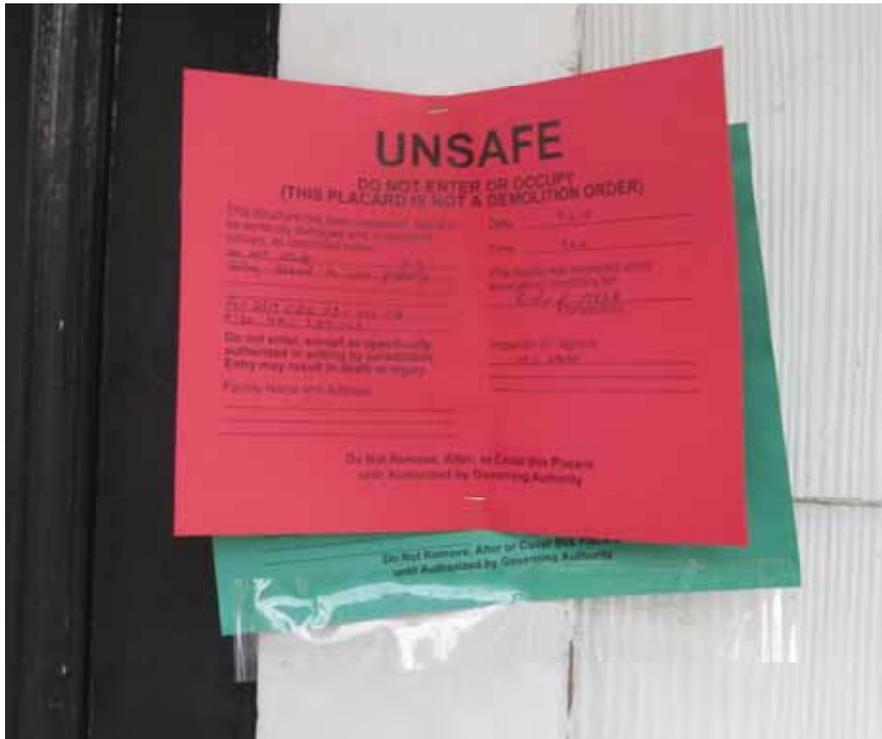
Figure 11-1 A building with multiple placards.

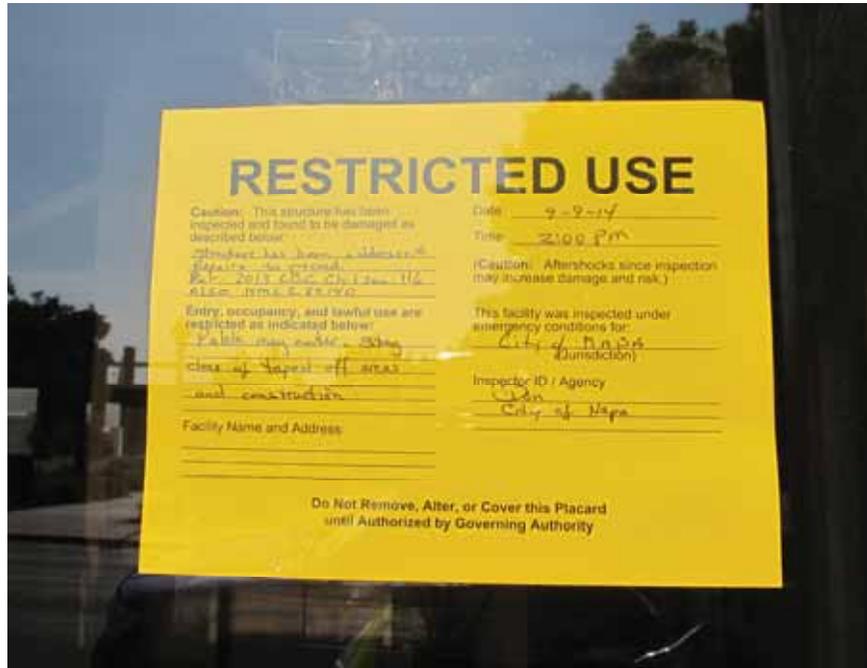
Figure 11-2 A RESTRICTED USE tag with restrictions noted as “Public may enter. Stay clear of taped off areas and construction.”

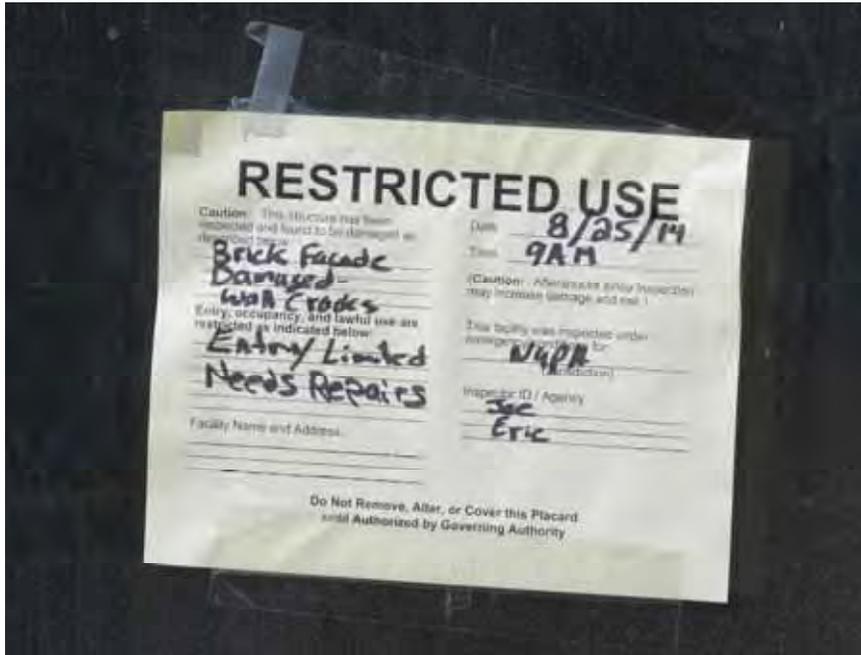
Figure 11-3 A RESTRICTED USE placard with no information on the restrictions.

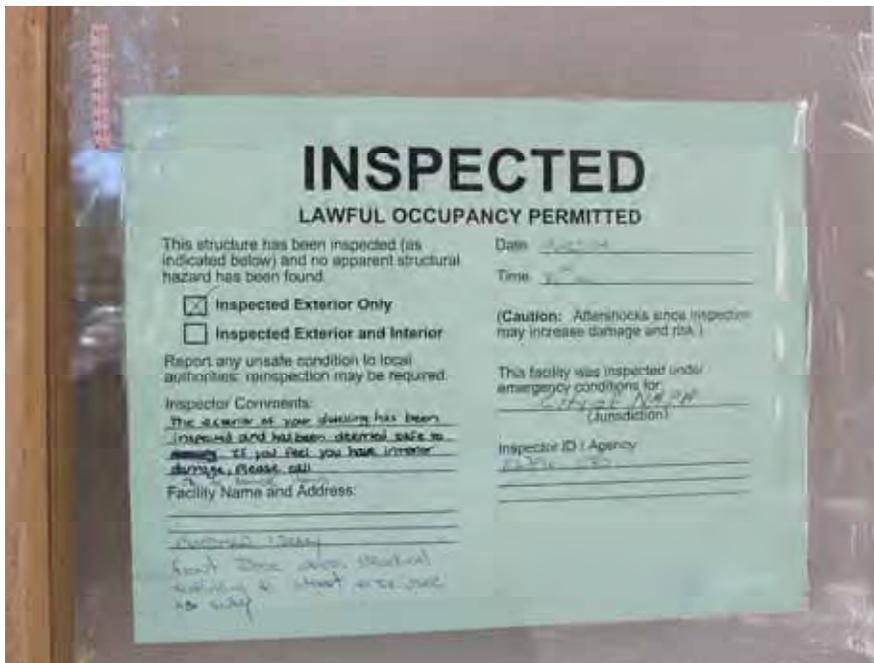
Figure 11-4 An INSPECTED placard on a building with another exit that is still restricted. A RESTRICTED USE placard should have been used.

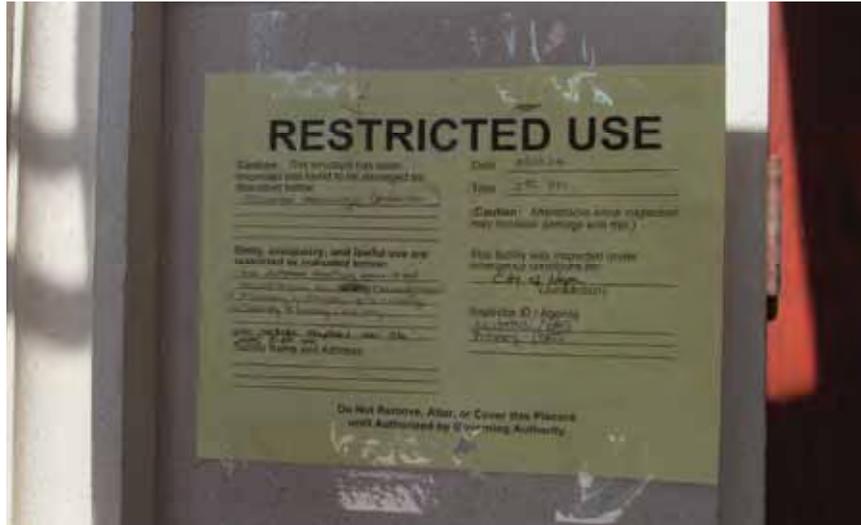
Figure 11-5 A RESTRICTED USE placard with exemptions permitting access while the restaurant is open.

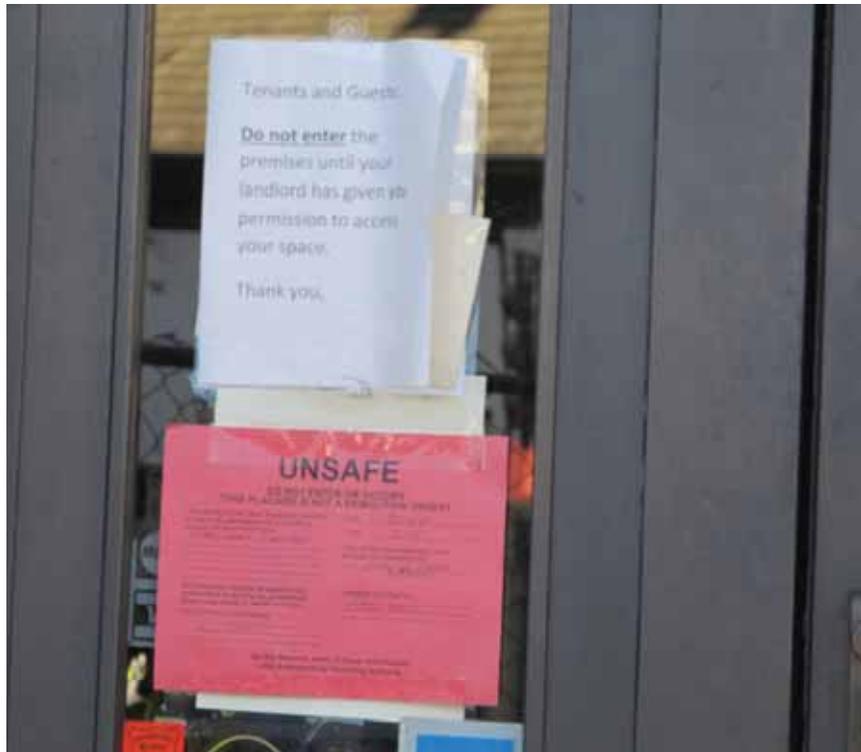
Figure 11-6 An UNSAFE placard with an adjacent inconsistent placard by the owner.

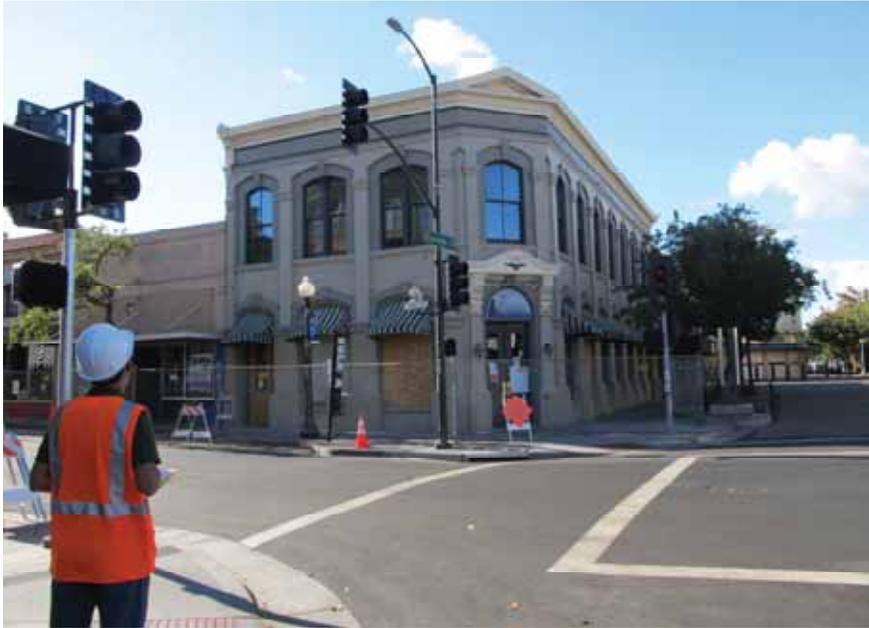
Figure 12-1 A building with an UNSAFE placard where the fence setback was much less than a 1.5H:1V setback distance.

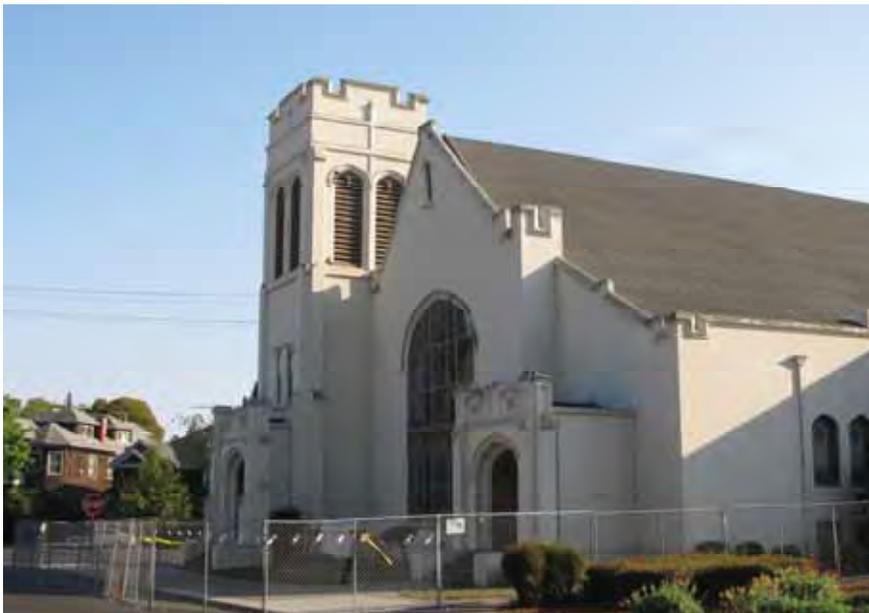
Figure 12-2 Church with damaged gable façade where the fence setback was less than a 1.5H:1V set back distance.

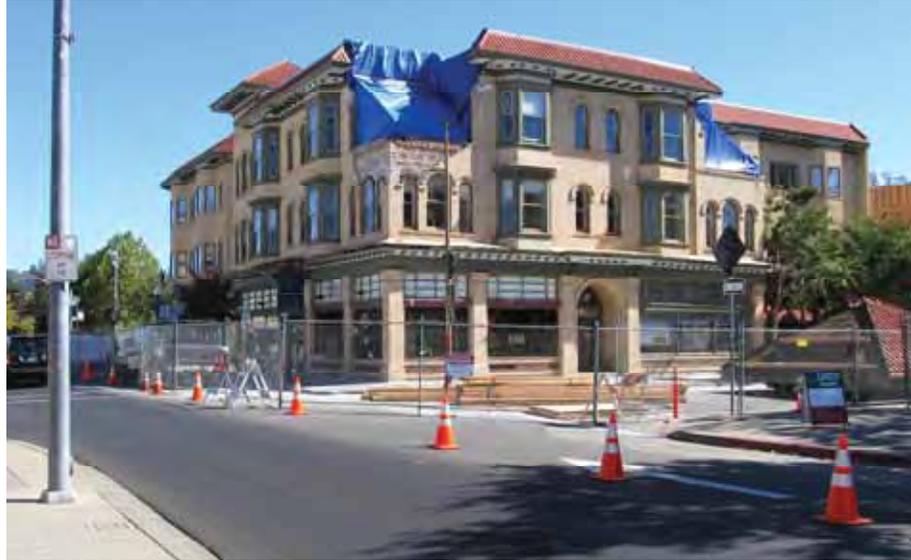
Figure 12-3 Partial street closure. Prior to removal of the damaged roof cupola, the entire street was closed.

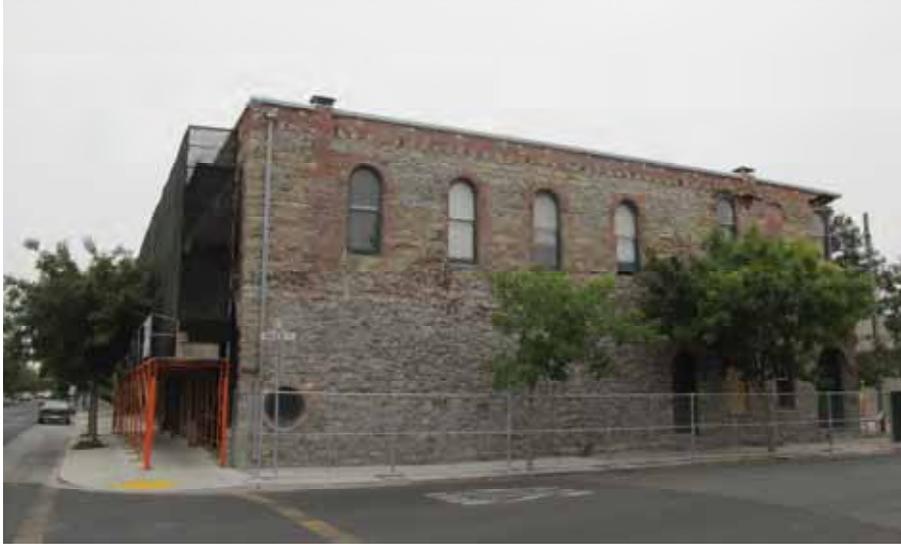
Figure 12-4 Scaffolding used as a barricade on damaged URM building.

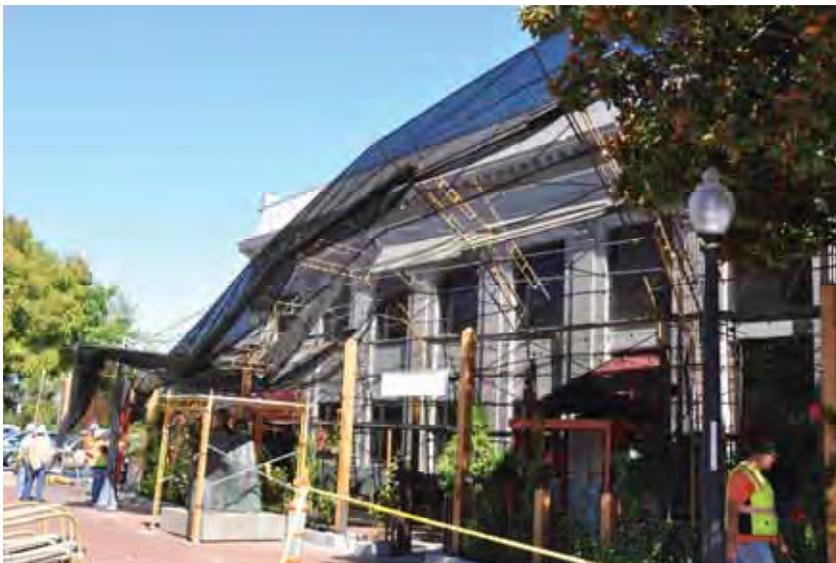
Figure 12-5 Scaffolding used as a barricade damaged in a windstorm (photo by Fred Turner).

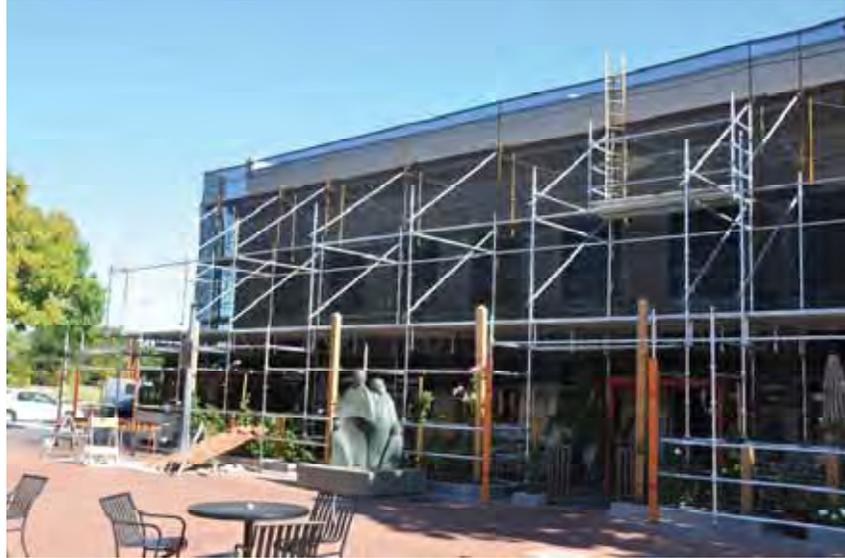
Figure 12-6 Replacement scaffolding following the windstorm (photo by Fred Turner).

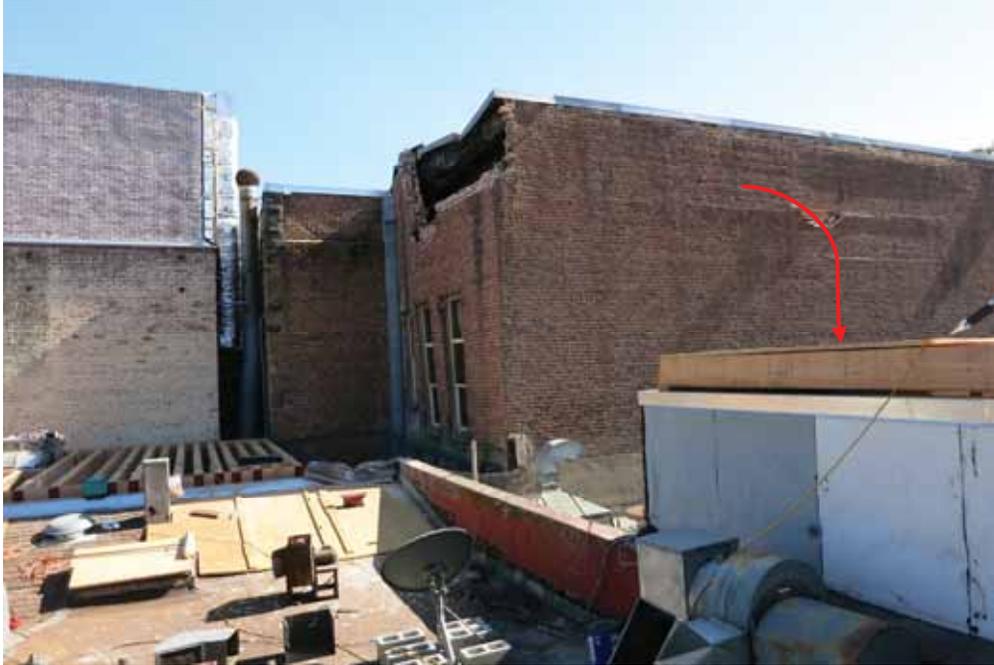
Figure 12-7 Protective barrier constructed over the rooftops of buildings to protect from falling brick.

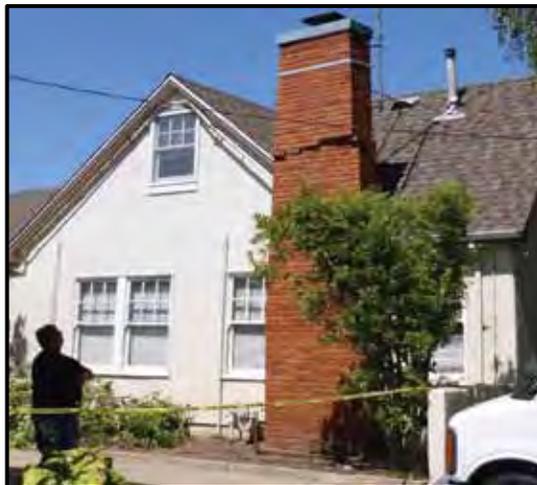
Figure 1: Chimney damaged in the South Napa Earthquake. Photo Credit: Exponent.

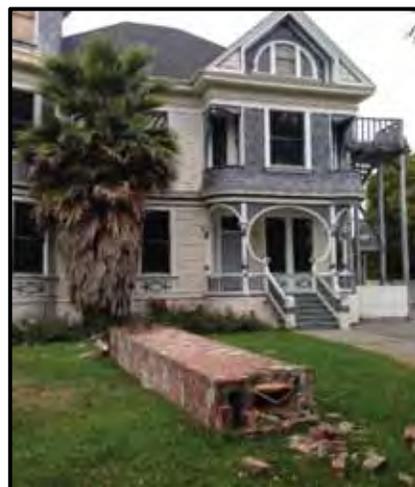
Figure 2: Chimney damaged in the South Napa Earthquake. Photo Credit: Janiele Maffei, CEA

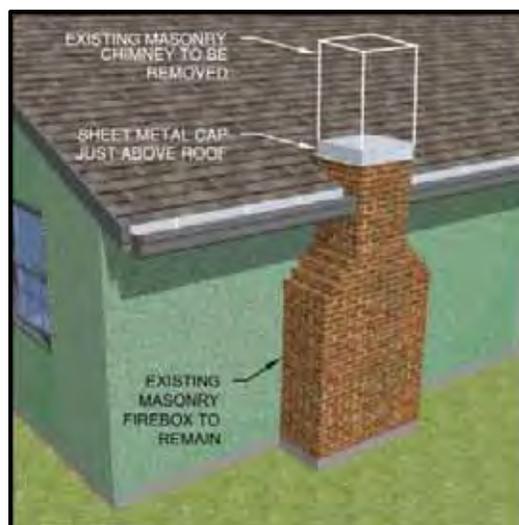
Figure 3: Dwelling with a chimney capped at the roof line.

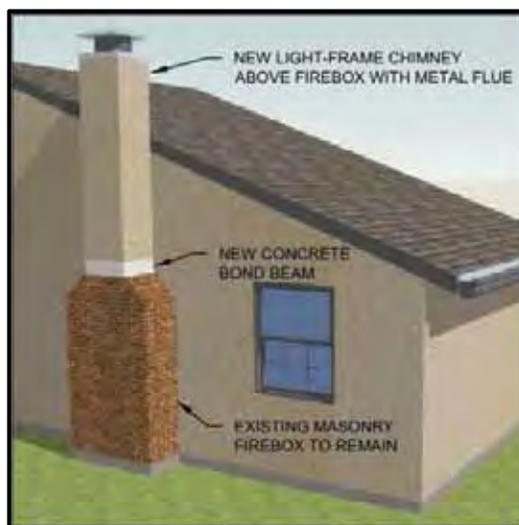
Figure 4: Dwelling with chimney reconstructed from the firebox up.

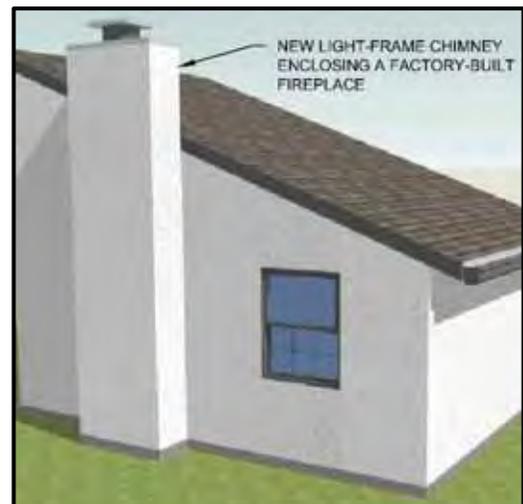
Figure 10: Replacement of entire firebox and chimney with light-frame construction.

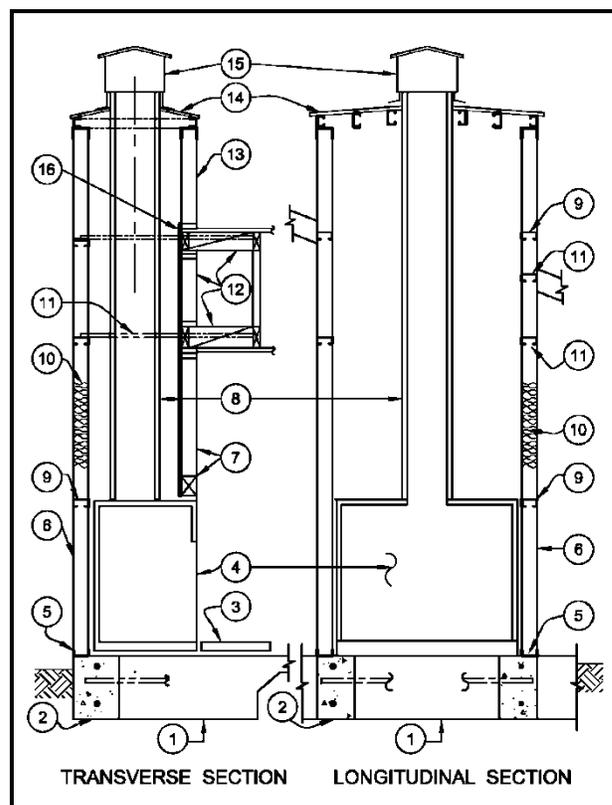
Figure 11: Components of a factory-built fireplace in light-frame chimney chase (Alternative D).
