# EARTHQUAKE PERFORMANCE OF A THREE STORY ACTUAL SUB-STANDARD BUILDING

Mustafa Comert<sup>1</sup>, Cem Demir<sup>1</sup>, Ali Osman Ates<sup>1</sup>, Kutay Orakcal<sup>2</sup> and Alper Ilki<sup>1</sup> Istanbul Technical University<sup>1</sup> and Bogazici University<sup>2</sup> Istanbul, Turkey

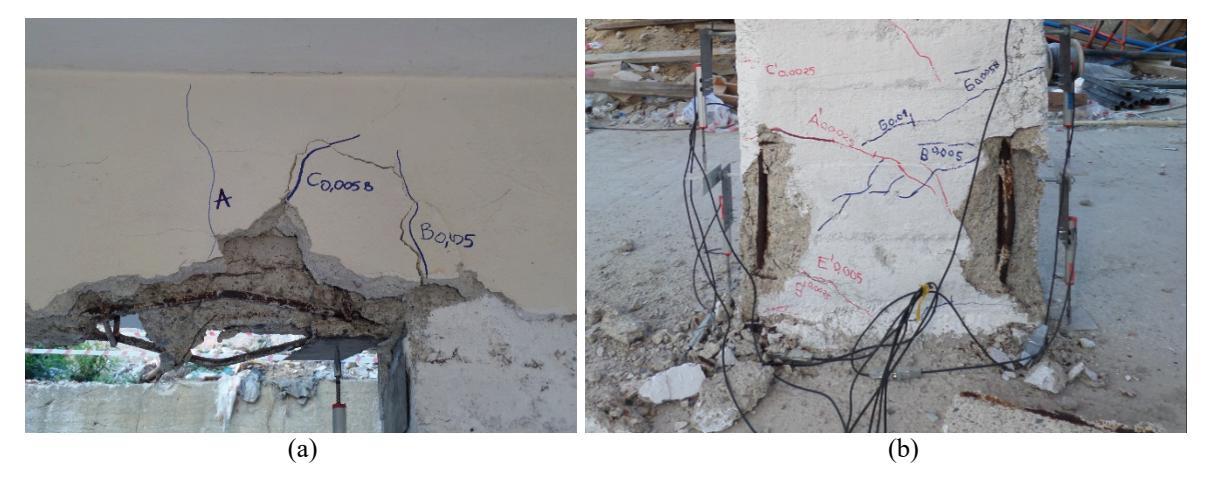
The test was performed on 26<sup>th</sup>-27<sup>th</sup> of July, 2014. The reversed cyclic loading pattern was applied up to a drift ratio of 1.50%. Since the building damage was severe at this drift ratio, the test was finalized for the sake of safety. The base shear vs. 1st story drift ratio response of the building is presented in Fig. 7. Marks on this figure indicate important stages of the test. Throughout the test, no significant shear damage was observed and the overall response was dominated by flexural behavior at the critical end regions of beams and columns. The damage was first seen (at 0.25% drift ratio) at the support regions of the first story beams and columns (K11 and K12 beams and S11 and S14 columns in Fig. 4), which were parallel to the loading direction. Then, the damage started to accumulate at the bottom ends of the first story S11 and S14 columns that were relatively stronger in the loading direction than the S12 and S13 columns. No significant damage was observed at weak columns (S12 and S13) of the first story and all of second and third story. In the following cycles, damages on the beams developed faster than the columns. Since concrete cover was thin (i.e. 5 mm), concrete spalling occurred at an early stage at beam end regions. The longitudinal bars of K12 beam started to buckle at 0.75% drift ratio cycles (Fig. 7a). Vertical cracks and cover crushing were seen at S11 and S14 columns at 1.0% drift ratio. The longitudinal bars of the S14 column buckled at 1.5% drift ratio (Fig.7b). Further details for test results can be found elsewhere (Comert et al. 2016).

Figure 7. The damage seen in (a) K12 beam at 0.75 % drift ratio and (b) S14 column at 1.50% drift ratio.

In order to compare theoretical and experimental responses at member level, observed damages and the damage limitations for S14 column and K12 beam determined by both approaches are presented in Tables 1 and 2. It should be noted that while TSDC (2007) defines member damage limits in terms of strains of concrete at ultimate compression fiber and reinforcing bars, ASCE 41-13 (2014) defines the limits in terms of plastic rotation of member. To compare results of both documents with the experimental ones, the code limitations were transformed to the total rotation of section by using cross section analyses. As seen in Table 1, for column S14, although the ASCE 41-13 (2014) procedure defines approximately 20% larger rotation limits compared to the TSDC (2007) method, both analysis procedures and damage limitations are in overall good correlation with the test data and observations. The rotation limits that define the member damage states in TSDC (2007) seem to be slightly more conservative than those specified in ASCE 41-13 (2014), when compared with each other and with the experimental observations presented in Table 1. For K12 beam, both procedures fail to estimate the observed level of damage (Table 2). The damage observed at this beam during the test, progressed much more rapidly than both TSDC (2007) and ASCE 41-13

(2014) predictions. For beams of the test building, the diameter of the beam longitudinal bars (d) is 12 mm and the spacing of stirrups (s) is approximately 300 mm. Together with the thin concrete cover, the s/d ratio that is in the order of 25 makes the beam longitudinal bars prone to buckling (as also observed during test). In predicting the beam damage state, both assessment approaches lack the consideration of buckling of the beam compression bar buckling, which leads to misprediction of the behavior, ductility, and damage state of the beam.

TSDC (2007) (Rotation)	ASCE 41-13 (2014) (Rotation)	Observed Damage	Damage Notes
ΙΟ	0.005	0.0061		(Measured Rotation is 0.0075) Distributed flexural cracks were observed. Maximum residual crack width is measured as 0.5 mm.
LS	0.0071	0.01		(Measured Rotation is 0.0085) Concrete spalling. Maximum residual crack width is measured as 1.1 mm.
СР	0.009	0.011		(Measured Rotation is 0.012) Buckling of longitudinal bars.

TSDC (2007) (Rotation)	ASCE 41-13 (2014) (Rotation)	Observed Damage	Damage Explanation
ΙΟ	0.006	0.005		(Measured Rotation is 0.012) Buckling of longitudinal bars under compression.
LS	0.024	0.019	Experimental rotation did not reach this level.	-
СР	0.028	0.029	Experimental rotation did not reach this level.	-

- At 0.75% drift ratio, the beam longitudinal bars buckled and at 1.50% drift ratio, the column longitudinal bars buckled. Thereafter, the test was terminated due to safety reasons.
