Seismic Retrofit Guidelines for Detached, Single-Family, Wood-Frame Dwellings

FEMA P-50-1 / June 2012

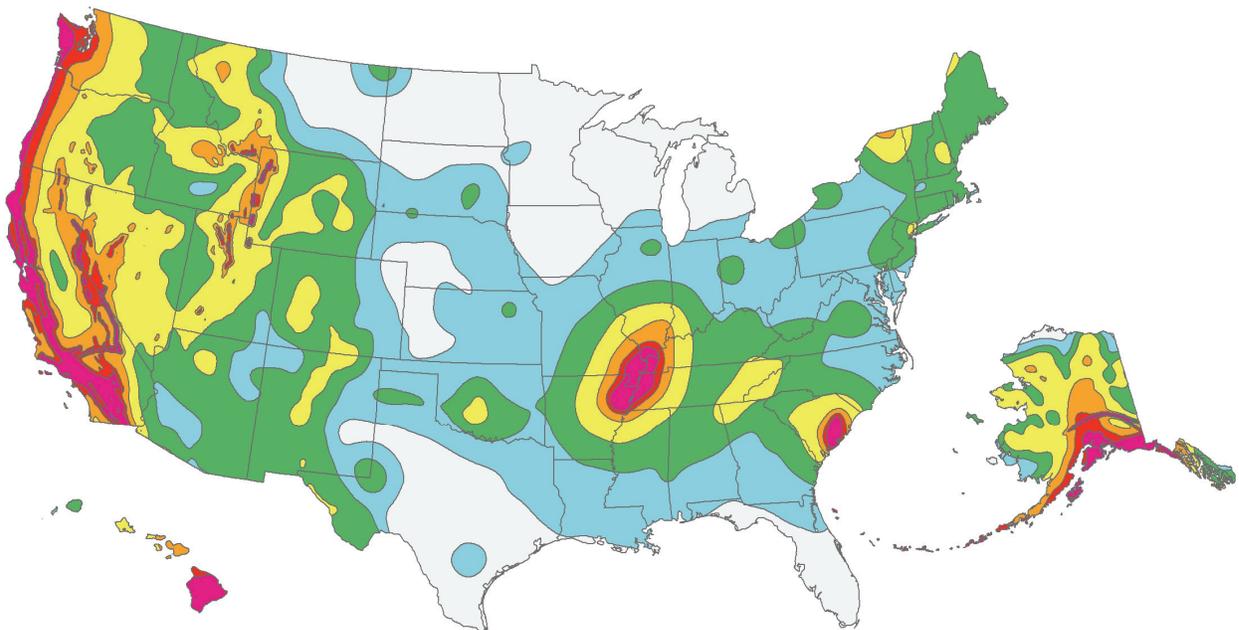
Figure 2-1 Seismic hazard map of the United States. Colors represent ranges of horizontal ground shaking, with grey representing the lowest hazard and pinkish-red representing the highest hazard. More detailed maps of acceleration response, S_{DS} , the parameter referred to in Table 1 of the Simplified Seismic Assessment Form, are provided in the companion FEMA P-50 report. (Source: U. S. Geological Survey.)

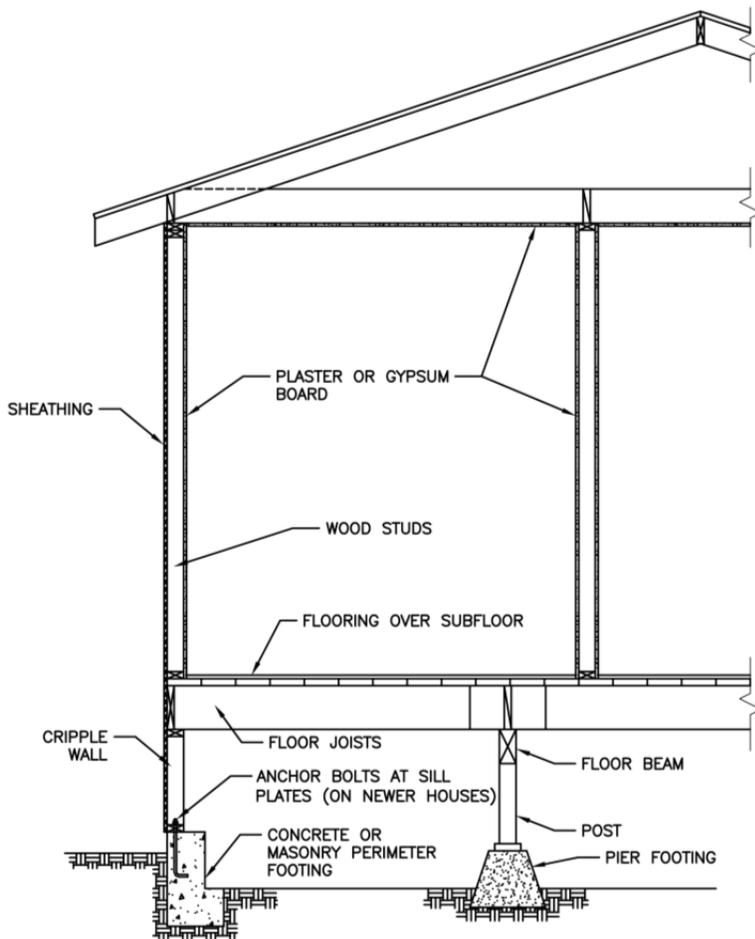
Figure 2-2 Section through typical cripple-wall crawl-space house (from ATC, 2002).

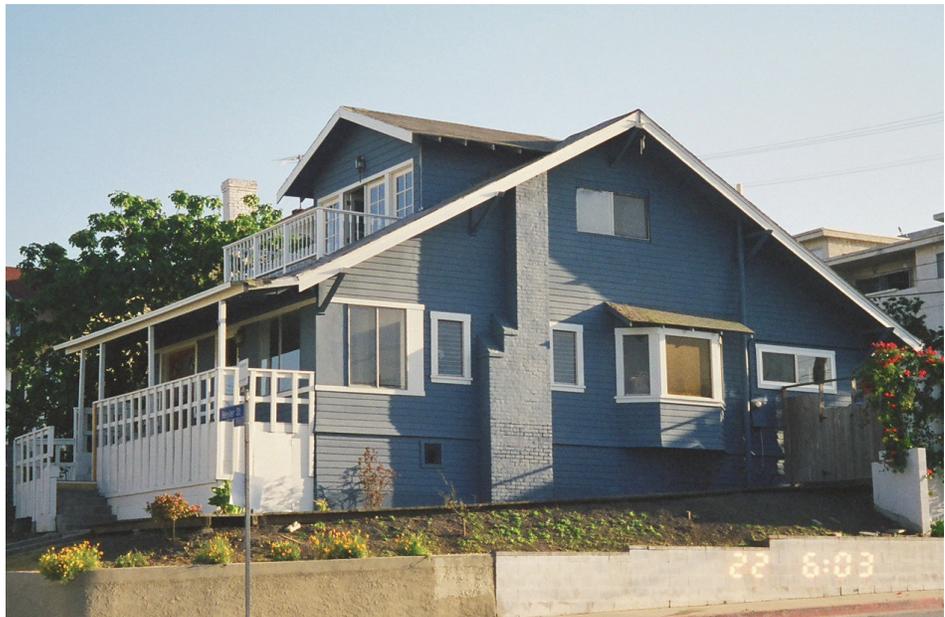
Figure 2-4 Typical older one and one-half-story cripple-wall crawlspace house (from ATC, 2002).

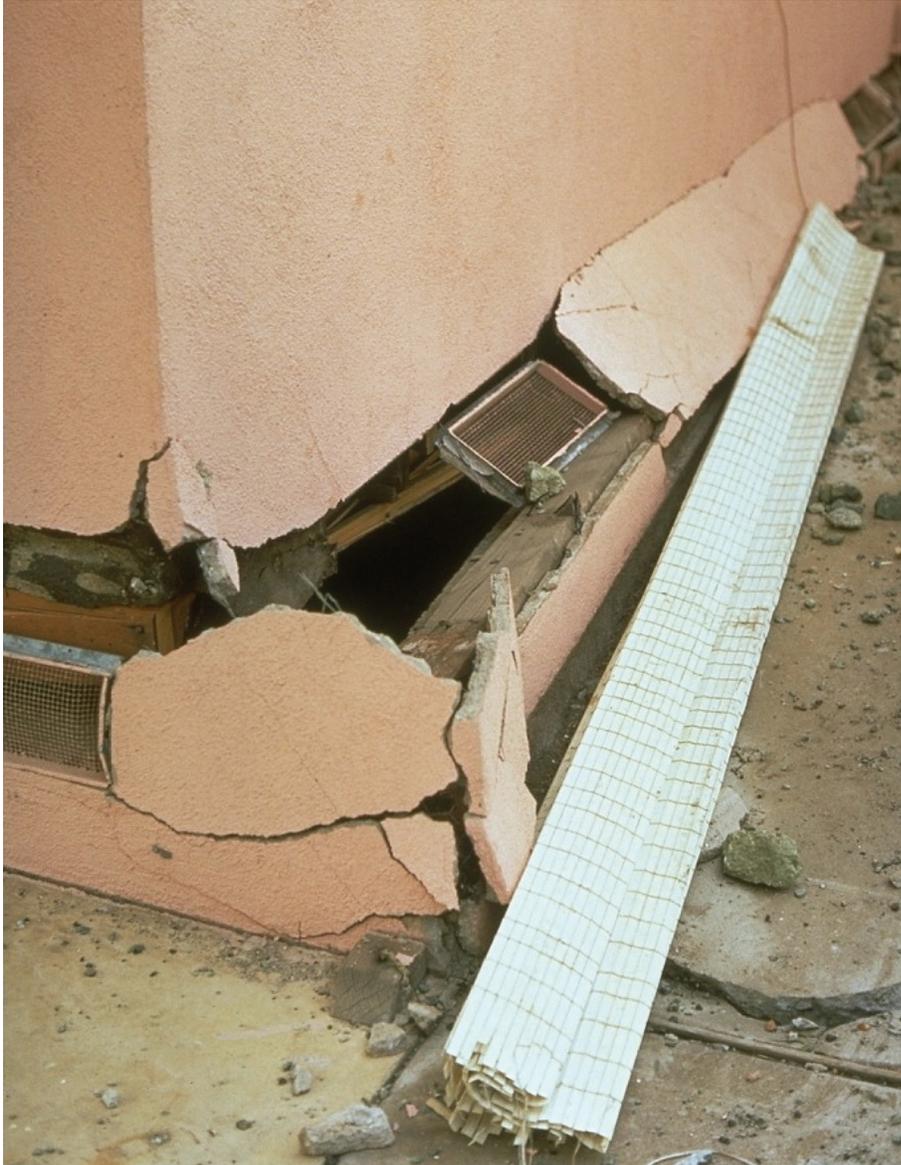
Figure 2-5 Typical earthquake damage to a cripple-wall house (from ATC, 2002).

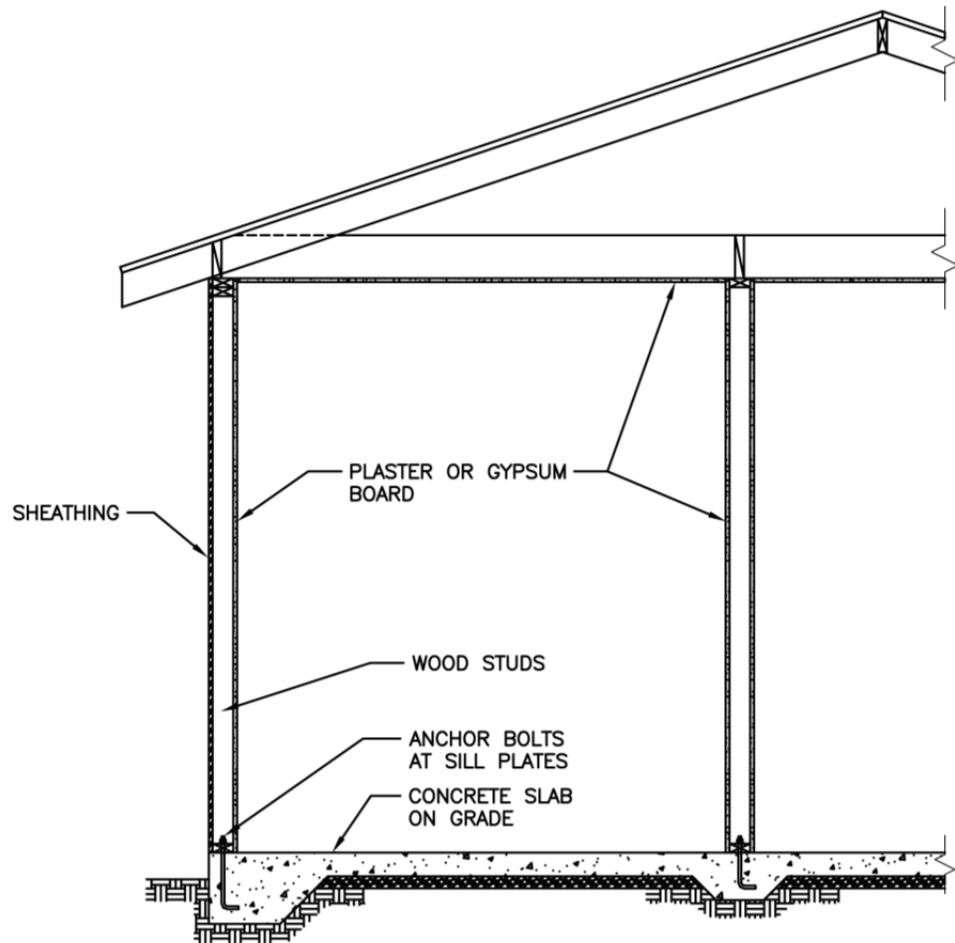
Figure 2-6 Section through typical one-story slab-on-grade house (from ATC, 2002).

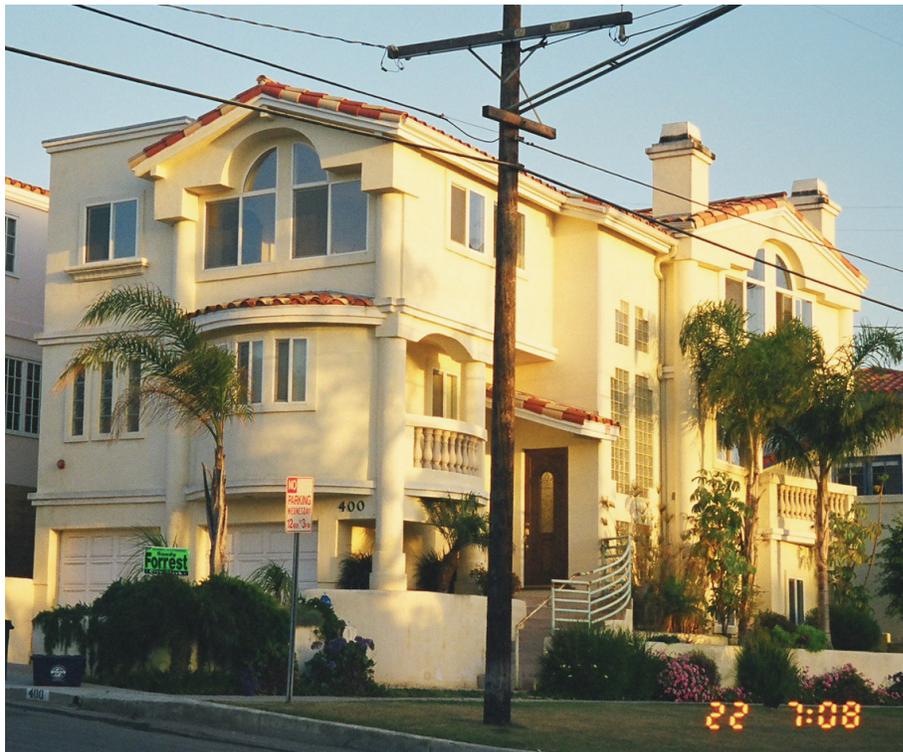
Figure 2-8 Typical three-story slab-on-grade house (from ATC, 2002).

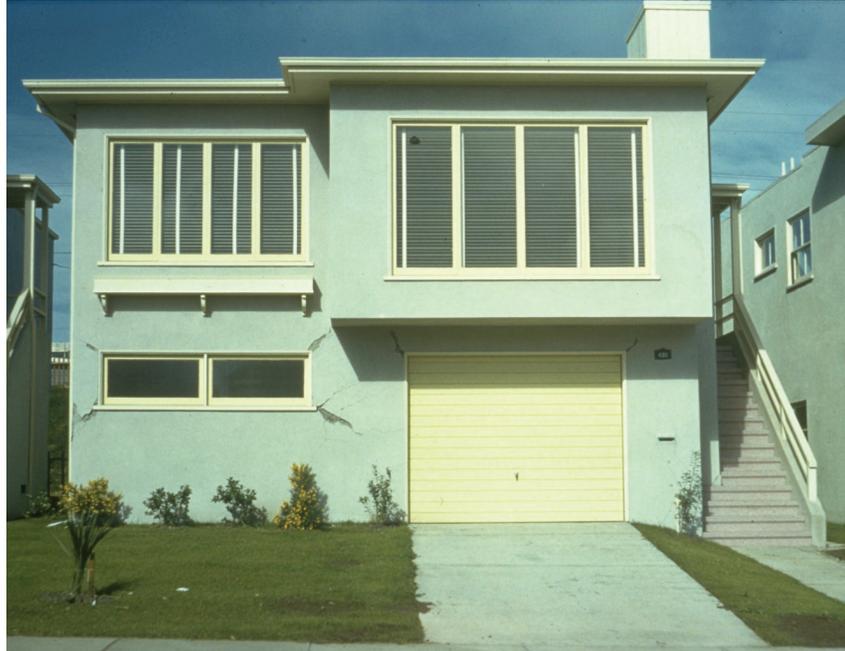
Figure 2-9 Cracking damage at the window to stucco first-floor walls of a two-story slab-on-grade house (from ATC, 2002).

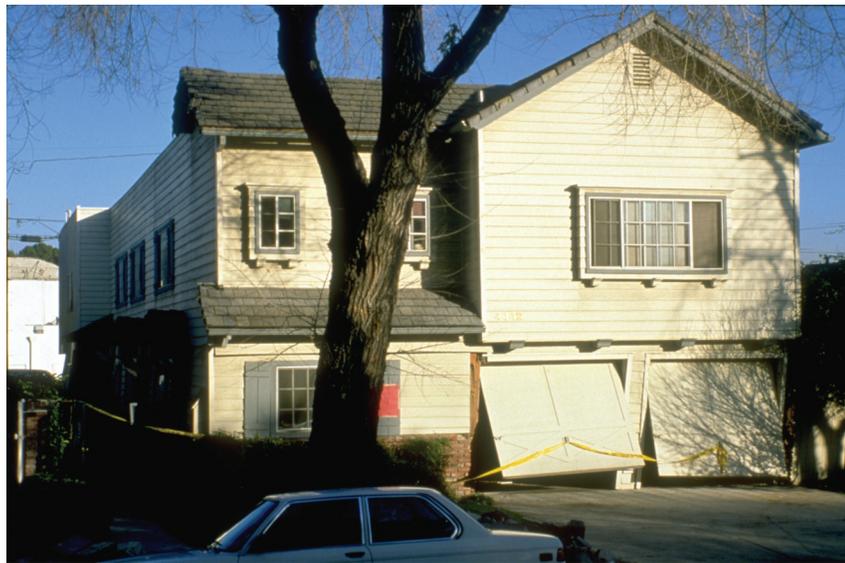
Figure 2-10 Damage and racking displacement to the right in the first floor walls of a two-story slab-on-grade house (from ATC, 2002).

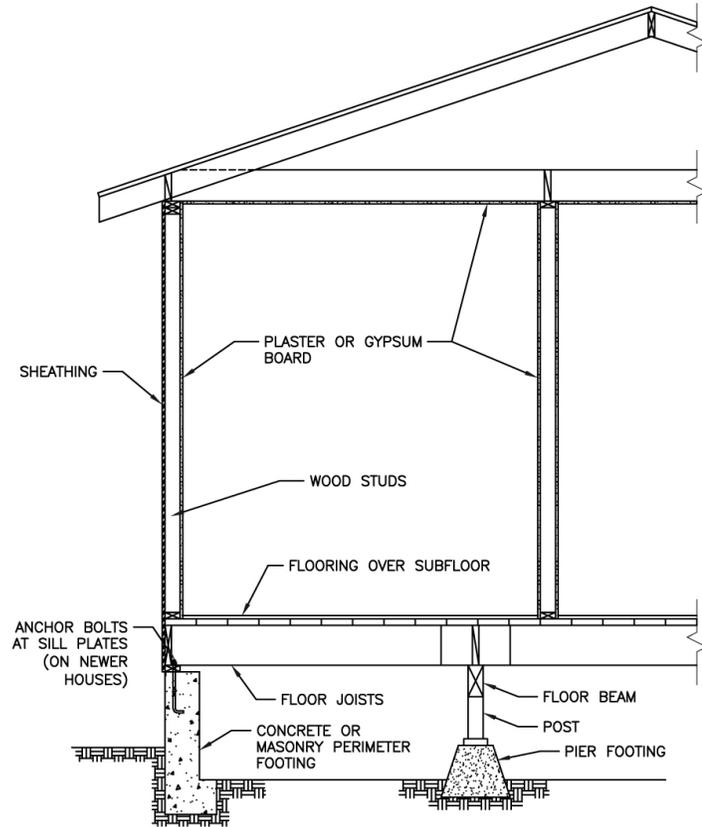
Figure 2-12 Section through a variation of the basement house where the perimeter foundation walls enclose a crawl space (from ATC, 2002).

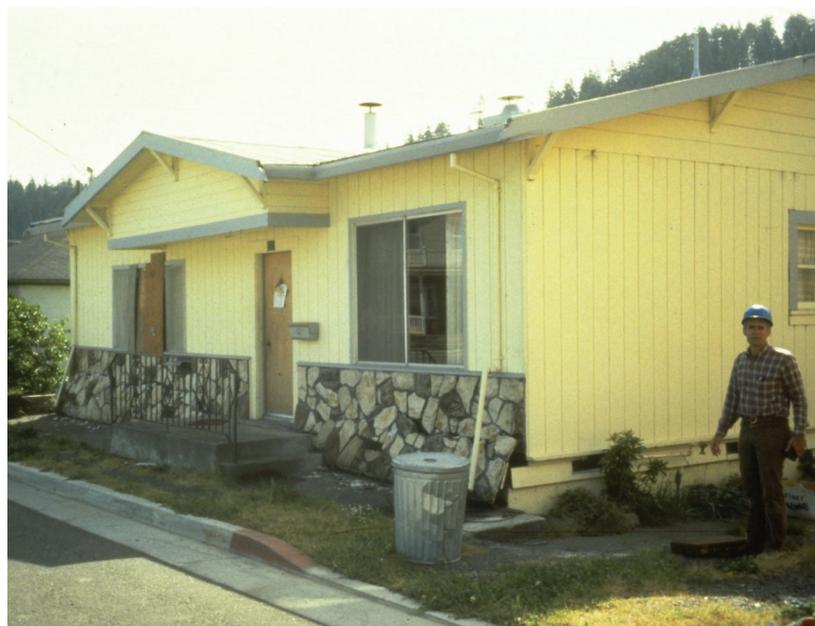
Figure 2-13 Damage to a basement-type house where the sill plate slid on the top of the foundation wall (from ATC, 2002).

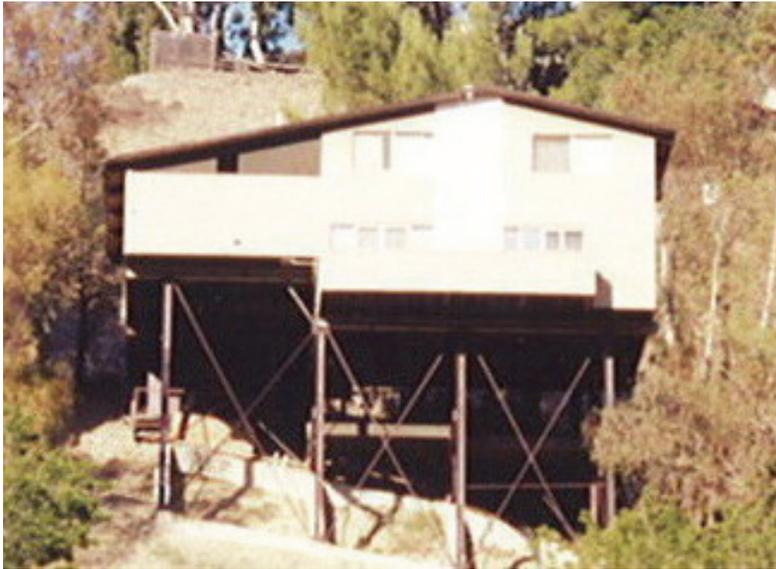
Figure 2-14 Steel post-and-pier foundation house on sloping site (from ATC, 2002).

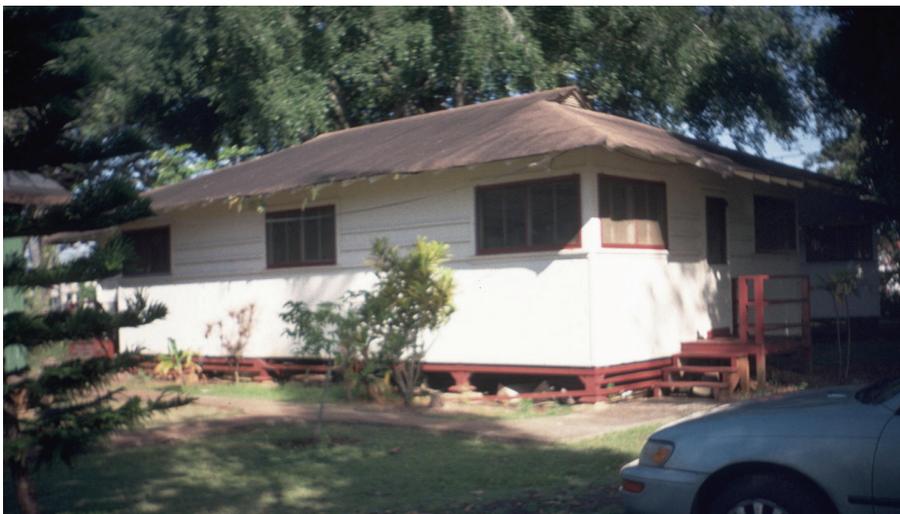
Figure 2-15 Wood post-and-pier house on flat site (from ATC, 2002).

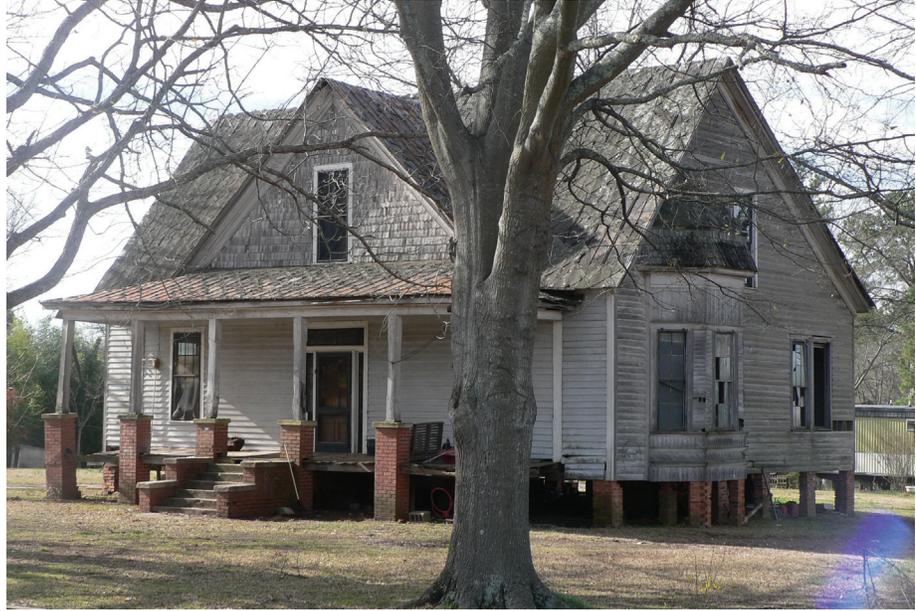
Figure 2-16 Masonry pier house on flat site (from ATC, 2002).

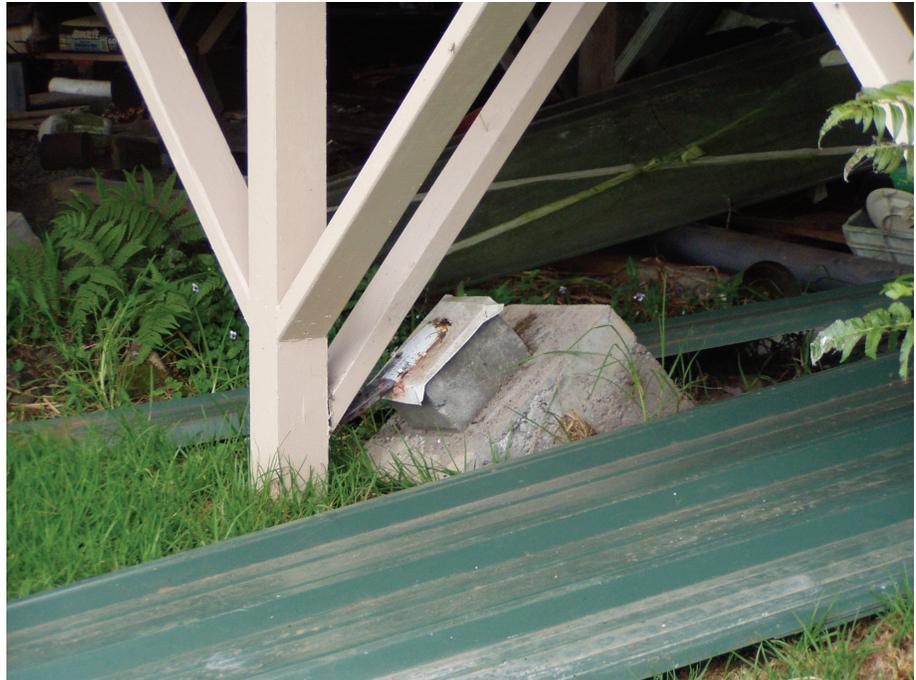
Figure 2-17 Earthquake-damaged perimeter post-and-pier foundation. The diagonally-braced post has overturned the shallow-founded concrete pier footing (from ATC, 2002).

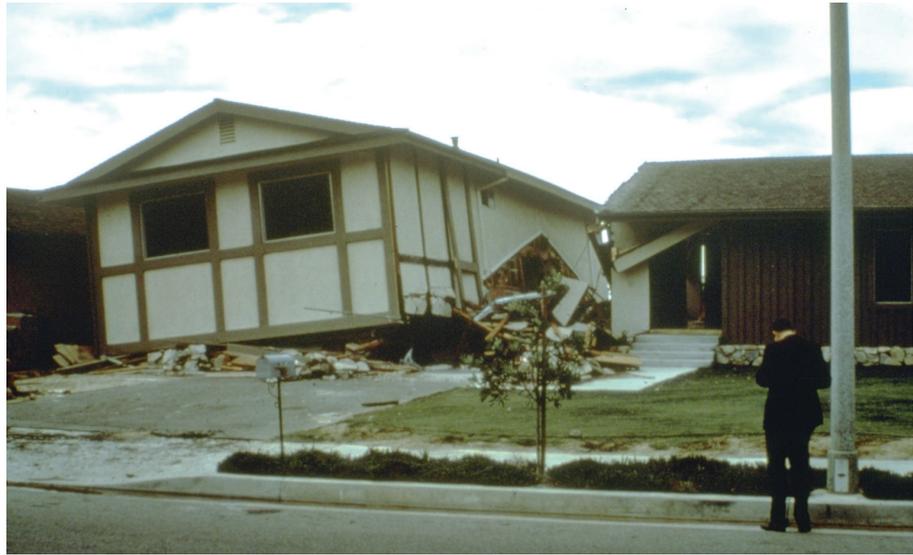
Figure 2-19 Split-level house with damage and collapse at the garage-level walls at two-story portion (from ATC, 2002).

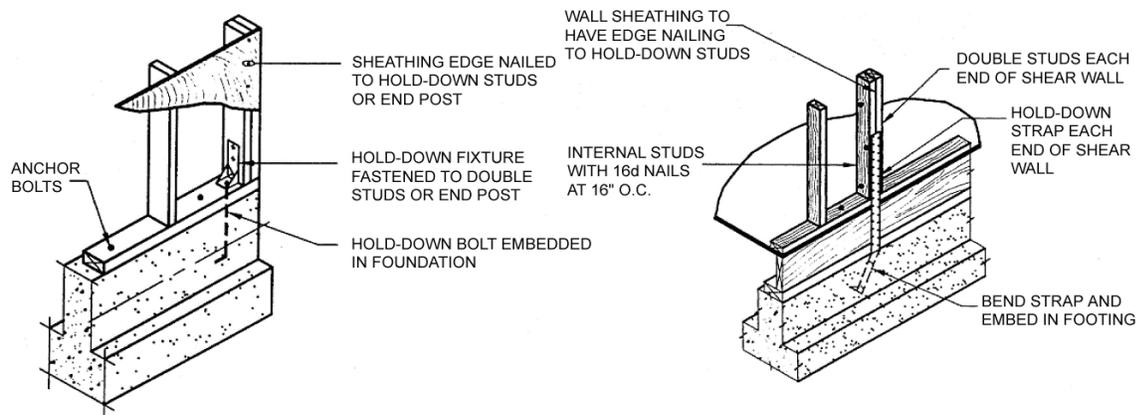
Figure 2-22 Typical commercially available tiedowns (from ATC, 2002).

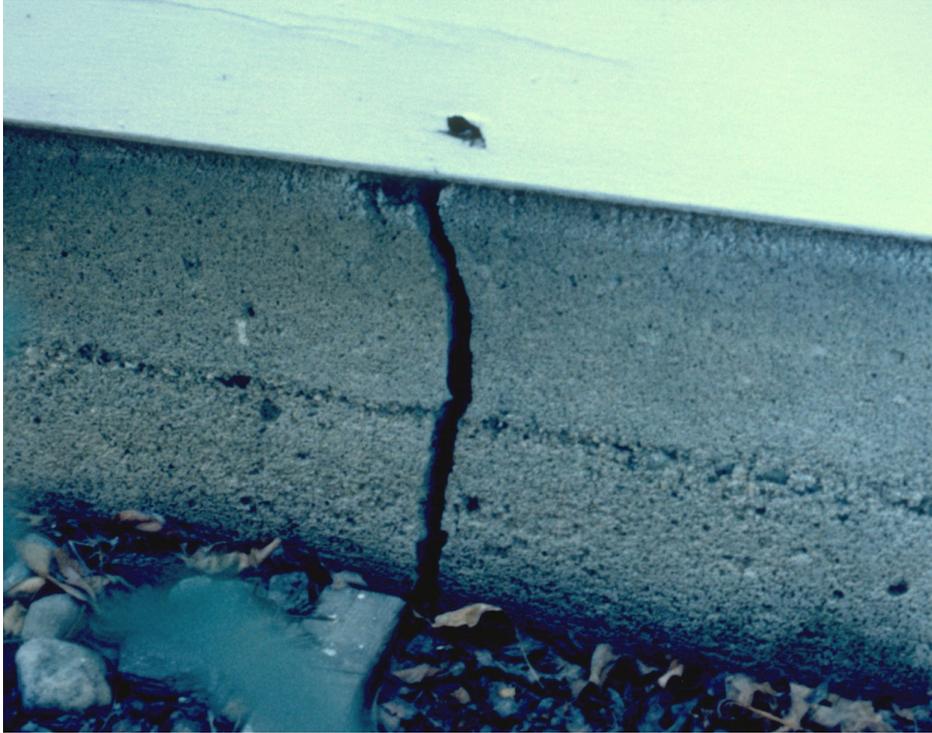
Figure 5-1 Shrinkage crack in unreinforced concrete perimeter footing wall.

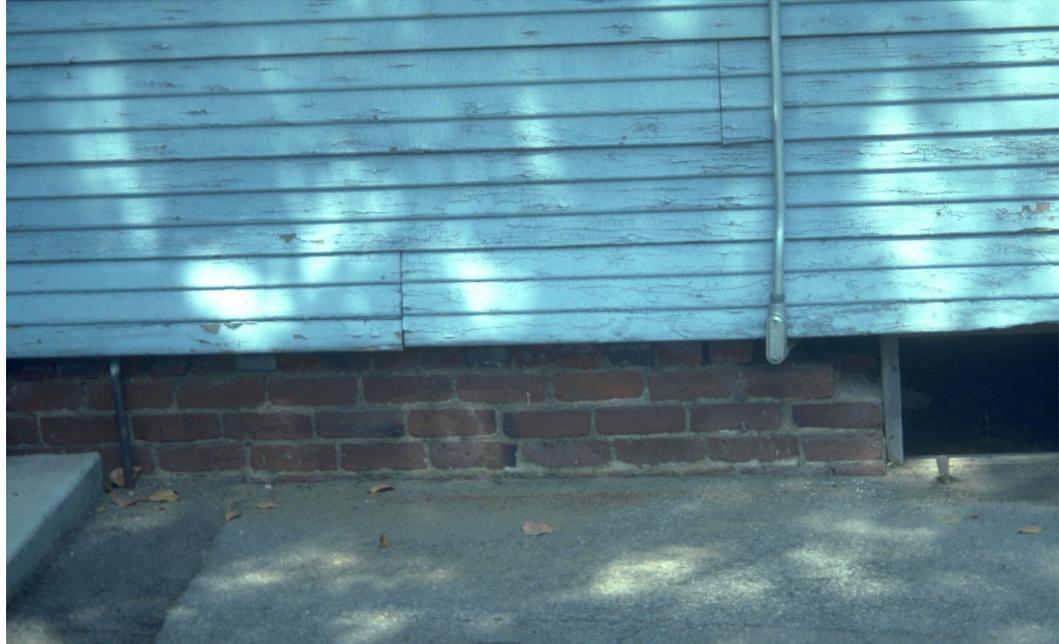
Figure 5-2 Brick masonry foundation wall.

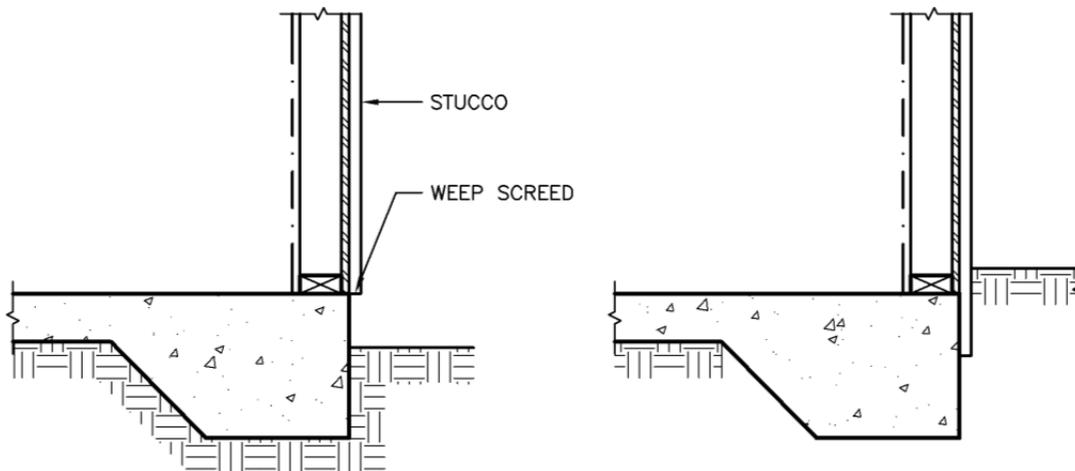
Figure 5-3 Left – A proper screeded stucco finish with soil clearance at a slab-on-grade foundation; Right - Unscreeded stucco placement and high soil height that can cause decay. Both conditions are similar for a crawl space foundation.

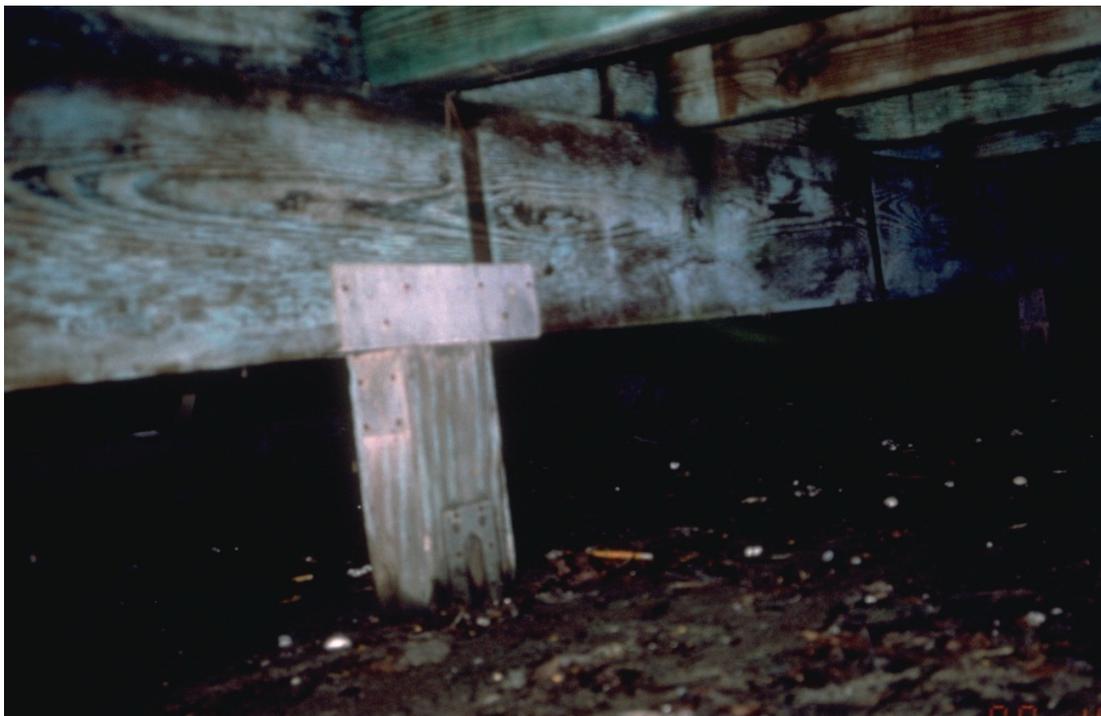
Figure 5-4 Decay of wood framing in damp crawl space.

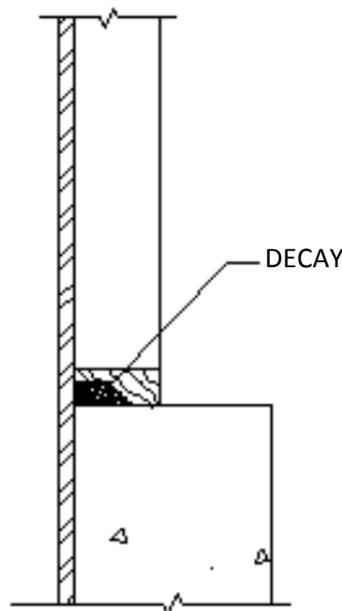
Figure 5-5 Section showing deep decay in sill plate.

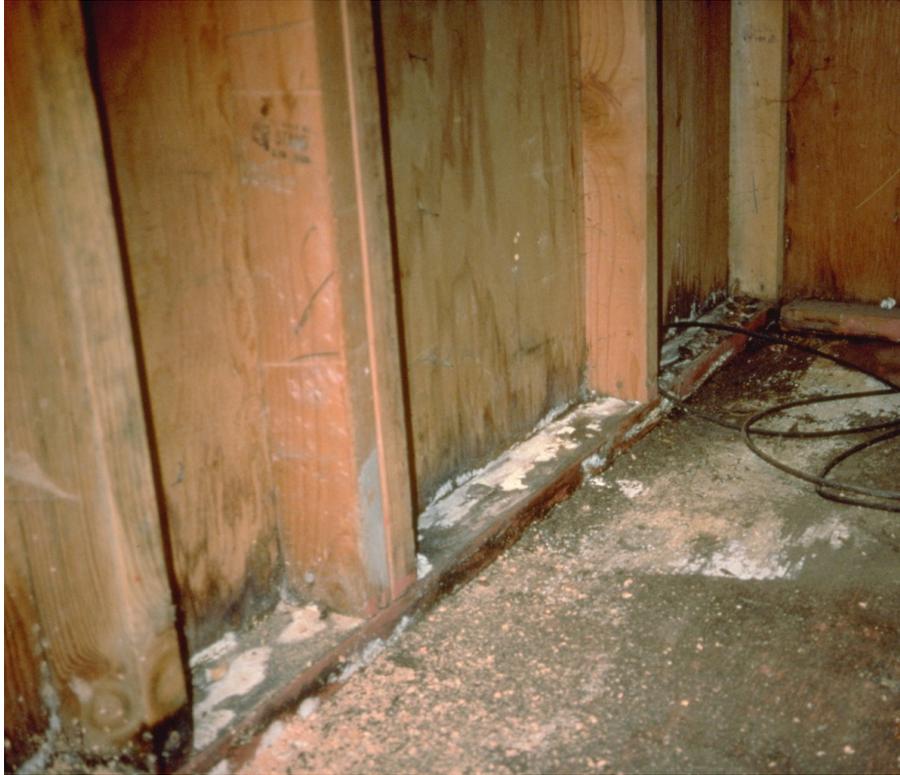
Figure 5-6 Obvious visible decay in a sill plate.

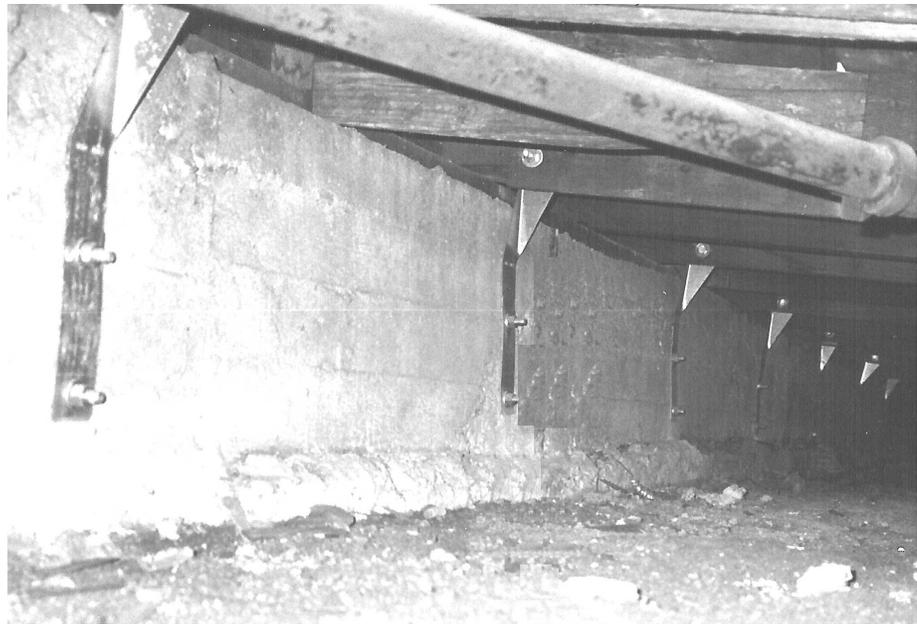
Figure 6-1 A retrofit anchor that is not appropriate for a retrofit to the IEBC Cripple Wall Provisions. Twist strap anchors between the foundation and the floor joists have insufficient strength to resist significant horizontal in-plane shear wall forces.

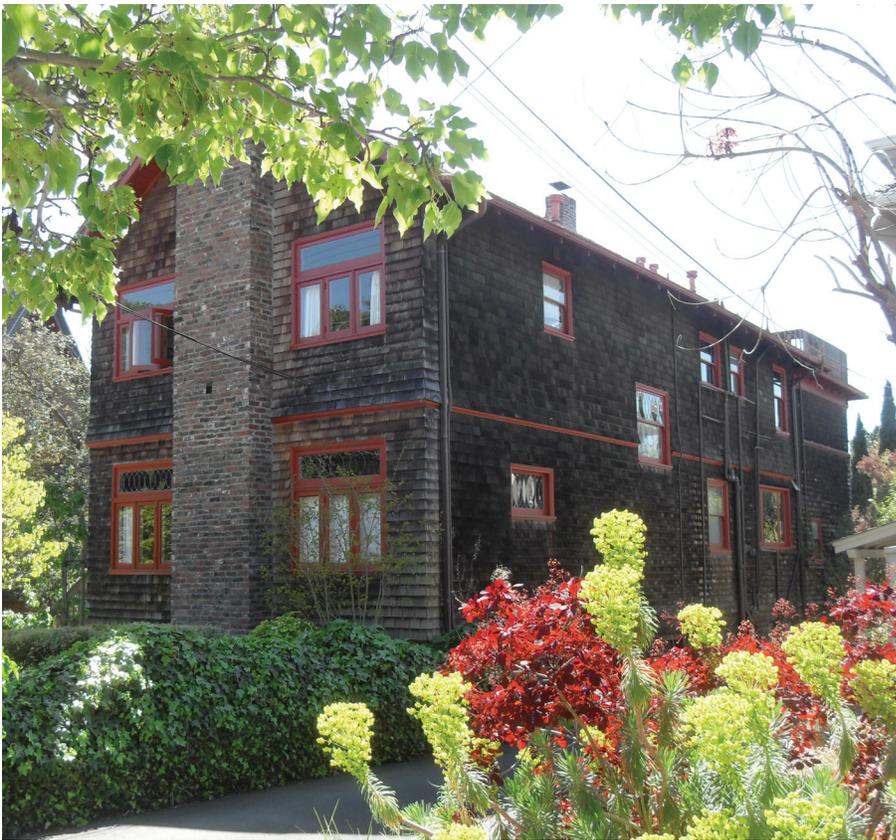
Figure 6-2 Cripple wall-type house with a narrow floor plan, with significantly shorter transverse walls than longitudinal walls (from ATC, 2002).

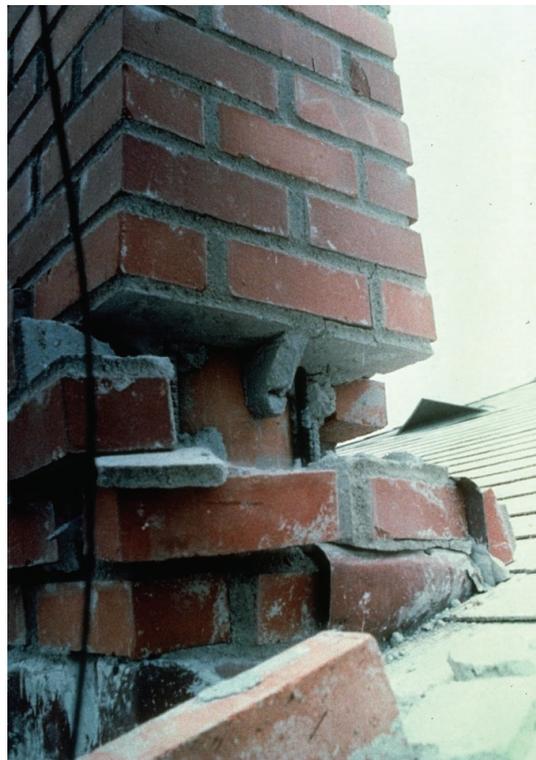
Figure 7-1 Chimney fractured at the roof line, with vertical steel reinforcement visible (from ATC, 2002).

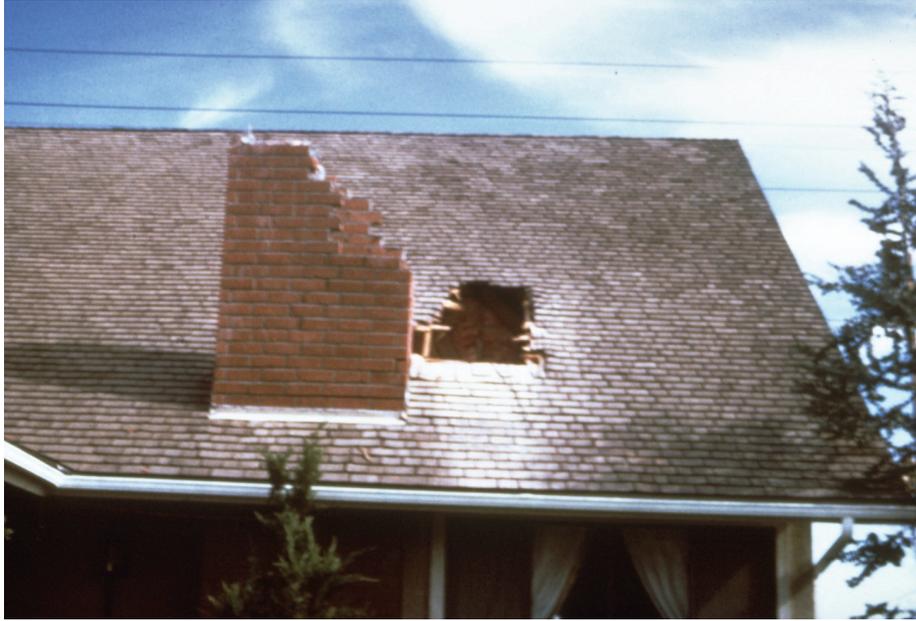
Figure 7-2 Masonry debris from an unreinforced chimney has fallen through the roof into the living spaces (from ATC, 2002).

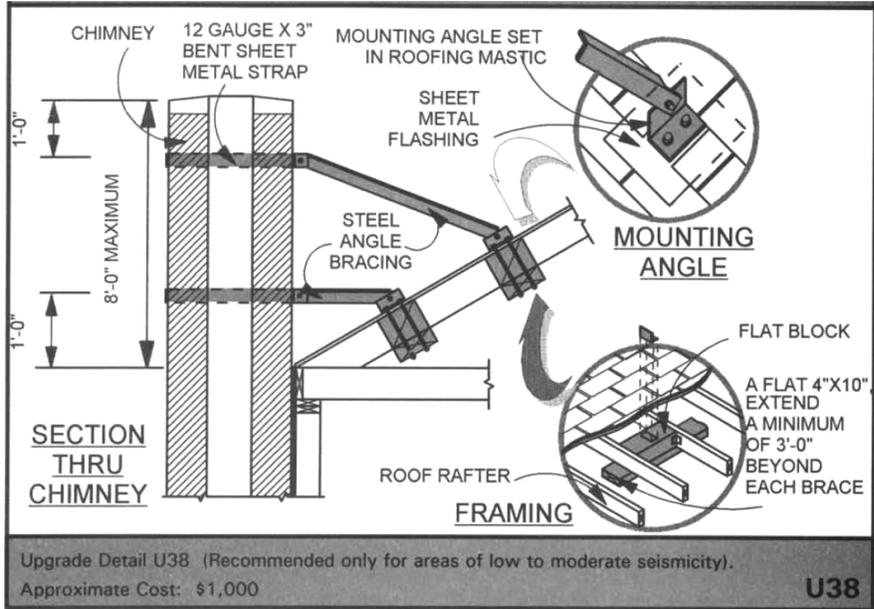
Figure 7-3 Prescriptive retrofit chimney bracing for areas of low-to-moderate seismicity (from FEMA E-74).

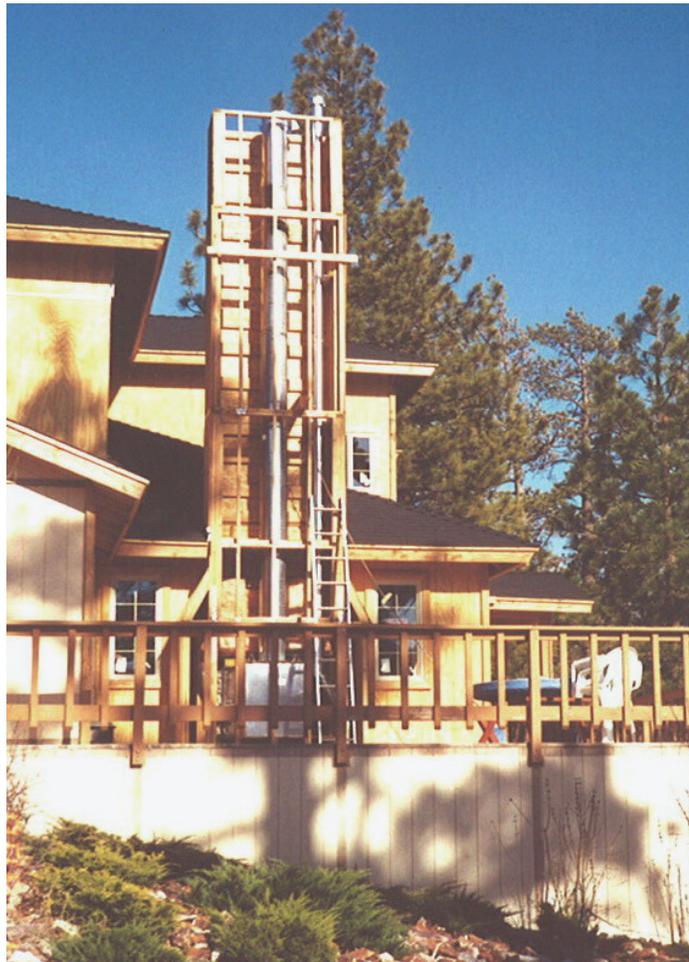
Figure 7-4 Non-masonry flue pipe with architectural enclosure.

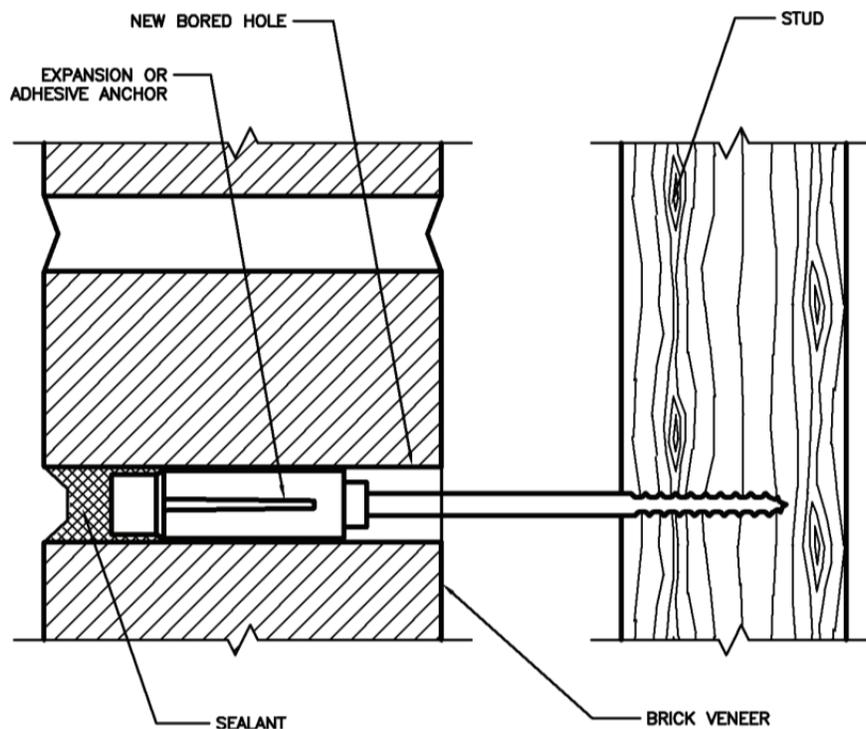
Figure 7-5 Typical retrofit fastener for brick or stone veneer (from ATC, 2002).

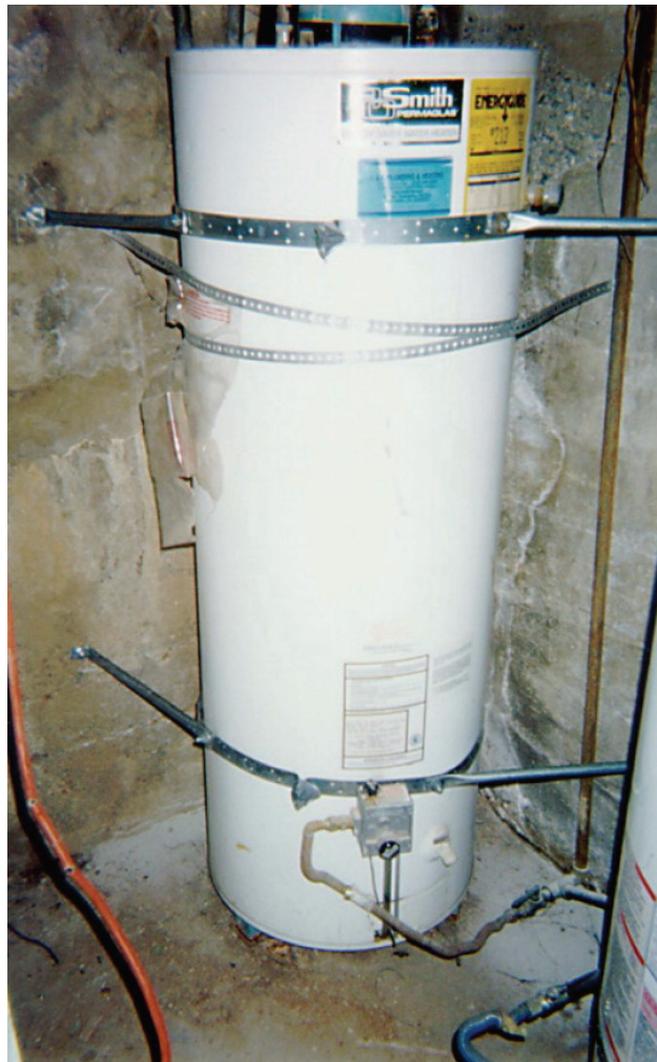
Figure 7-6 Water heater braced with straps and a V-shaped wall-mounted bracket.

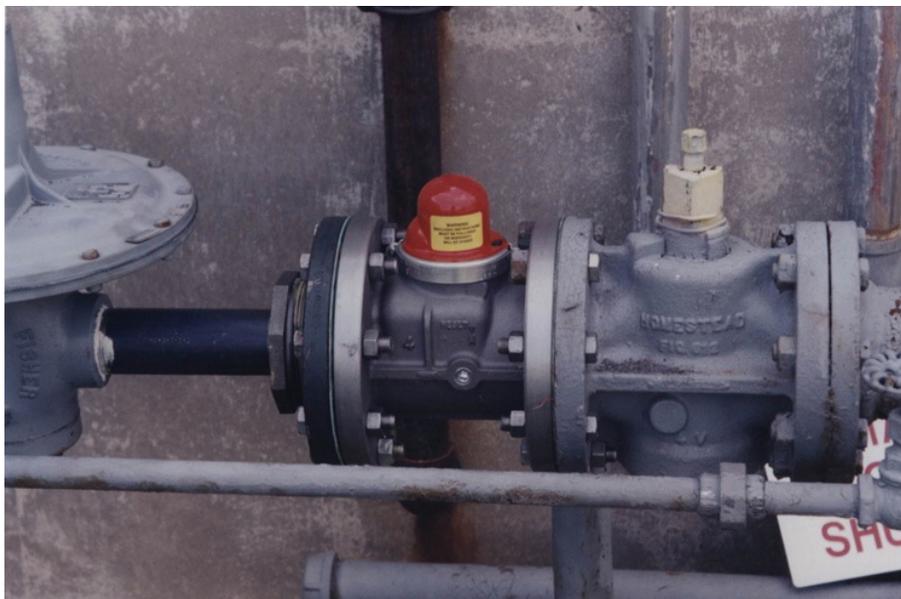
Figure 7-7 Typical installation of a seismically activated gas shutoff valve. The valve usually must be installed by an appropriately licensed contractor.

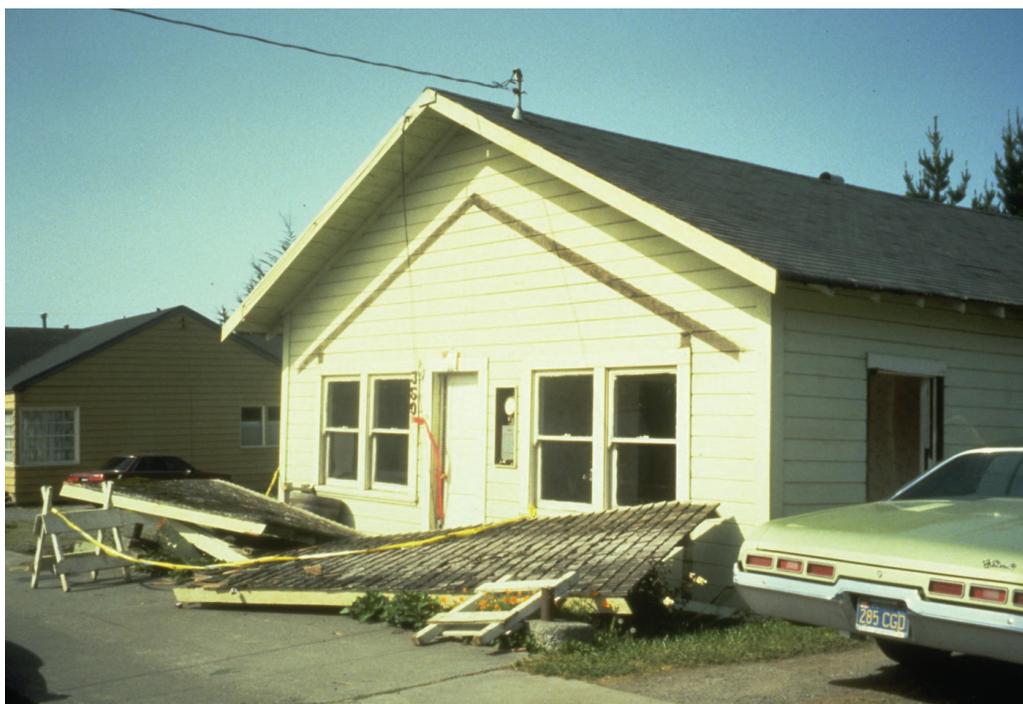
Figure 7-8 Porch roof failure (from ATC, 2002).

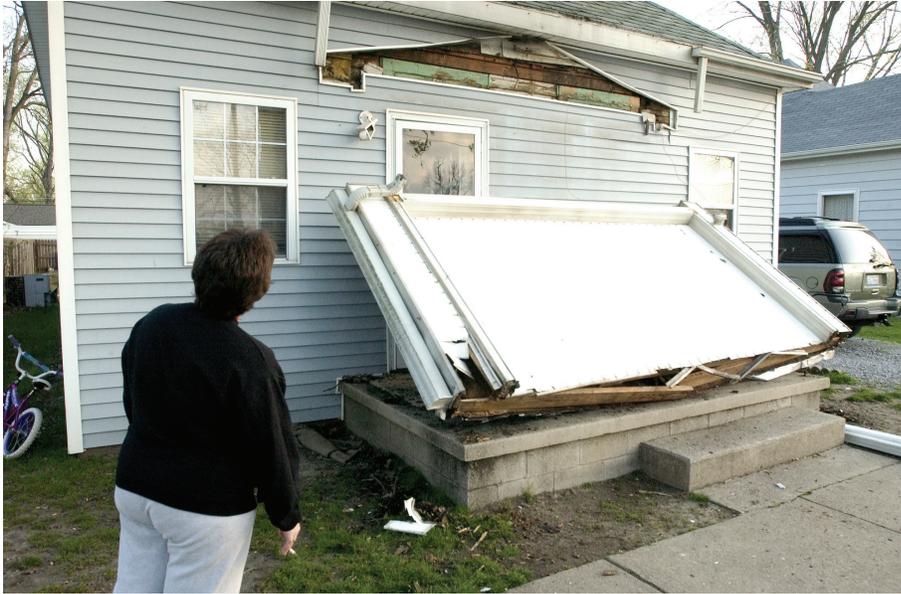
Figure 7-9 Porch roof broken off (and repositioned) in Mt. Carmel, Illinois, by the Richter magnitude 5.2 Mt. Carmel Earthquake in 2008. (Photo credit: Associated Press/Daniel R. Patmore)

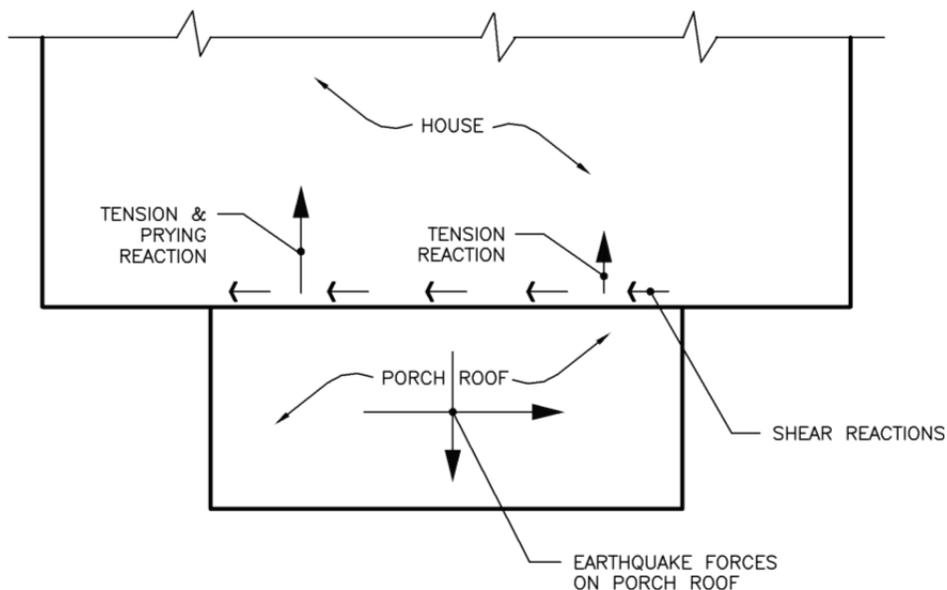
Figure 7-10 Earthquake forces and reactions on typical porch roof.

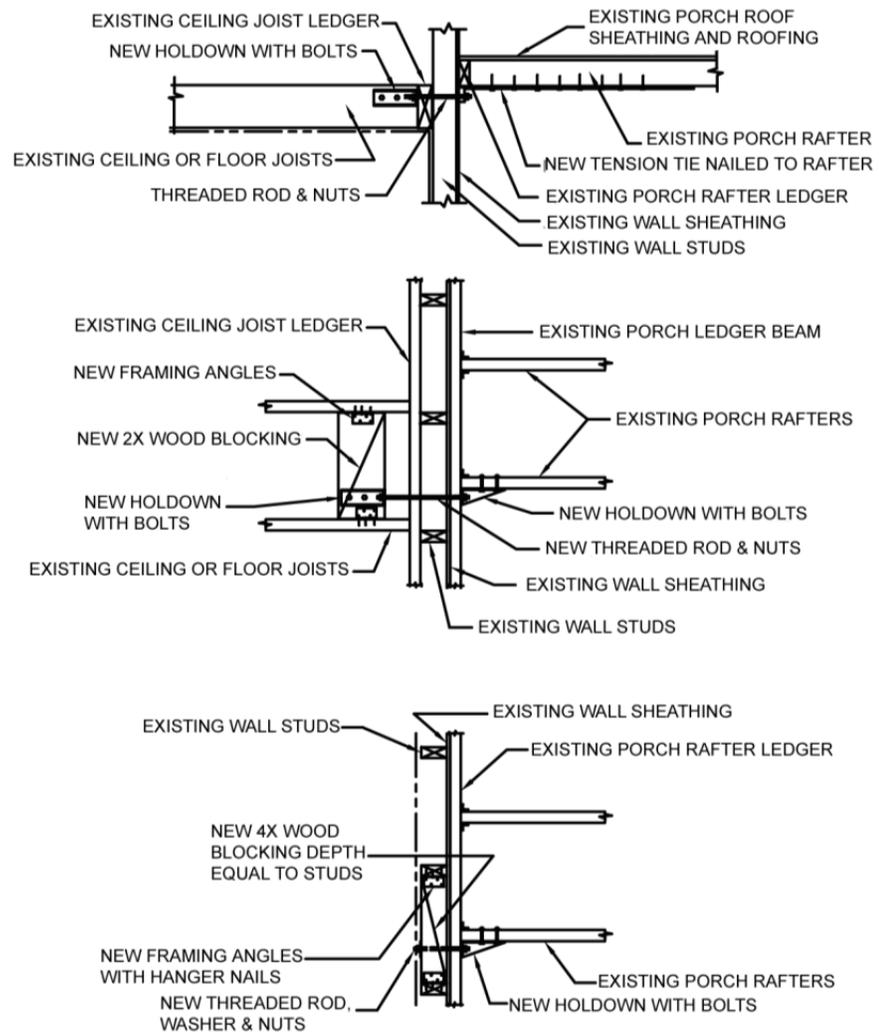
Figure 7-13 Schematic section and plan details of retrofit connections of porch roof framing to house framing (from ATC, 2002).

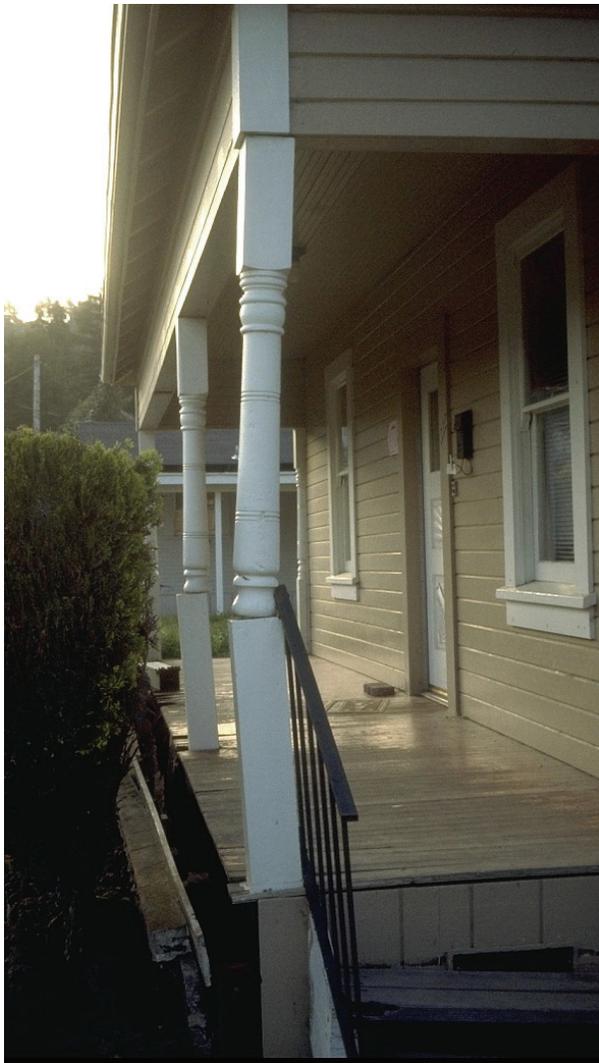
Figure 7-14 Failure of a porch roof support post by hinging at the middle (from ATC, 2002).
