Seismic Retrofit Guidelines for Detached, Single-Family, Wood-Frame Dwellings

FEMA P-50-1 / June 2012

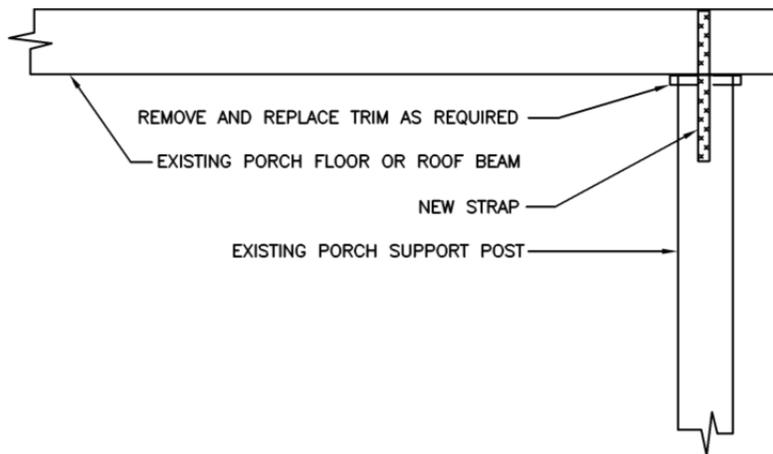
Figure 7-15 Typical strapping of porch roof support post (from ATC, 2002).

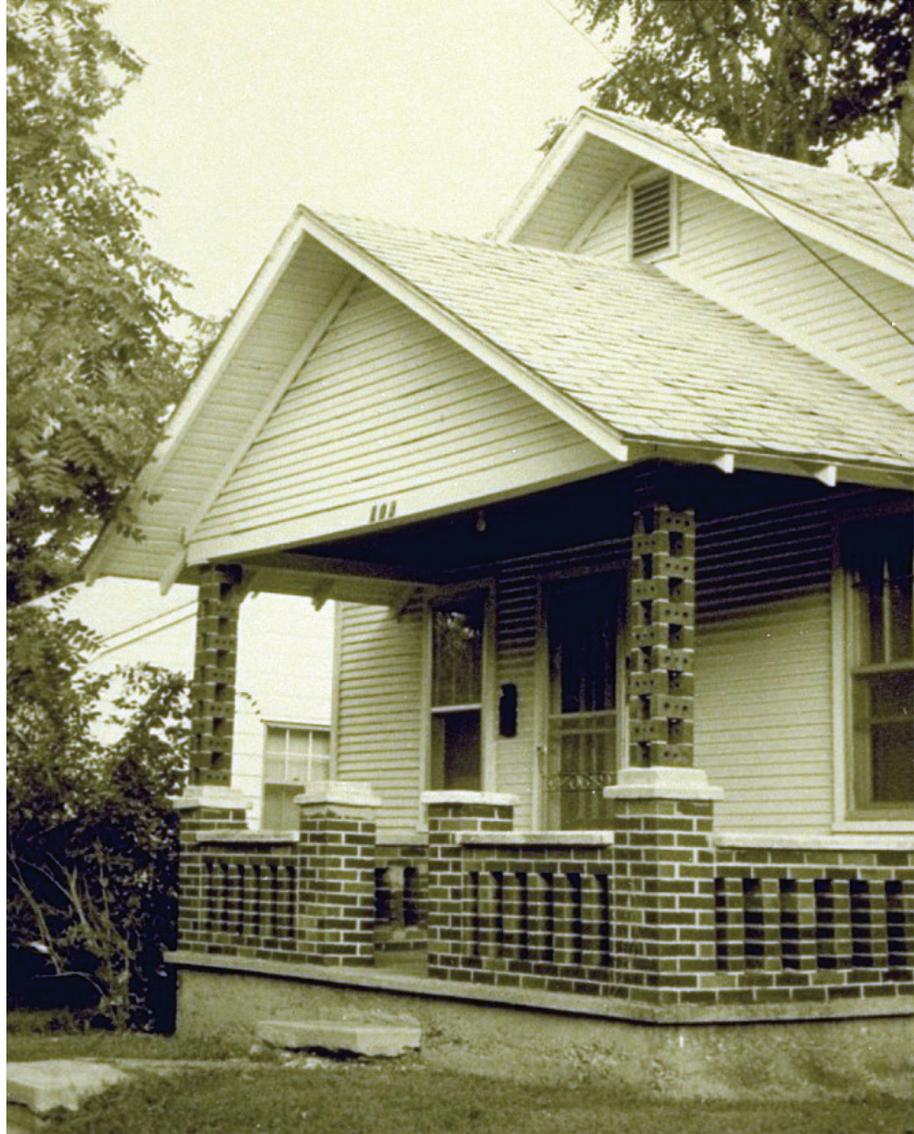
Figure 7-16 Brittle slender masonry porch support posts that will likely collapse during earthquake shaking (from ATC, 2002).

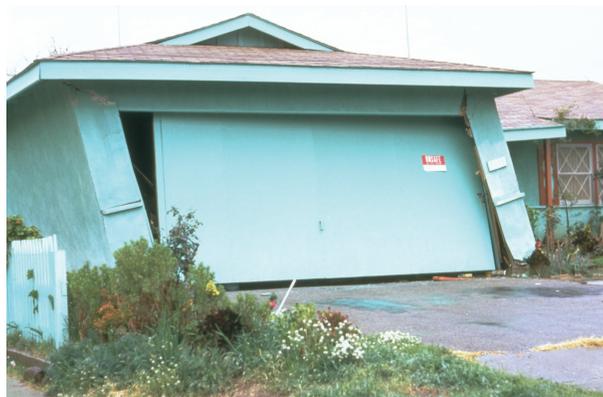
Figure 8-2 Earthquake damage at garage door opening in a one-story house (from ATC, 2002).

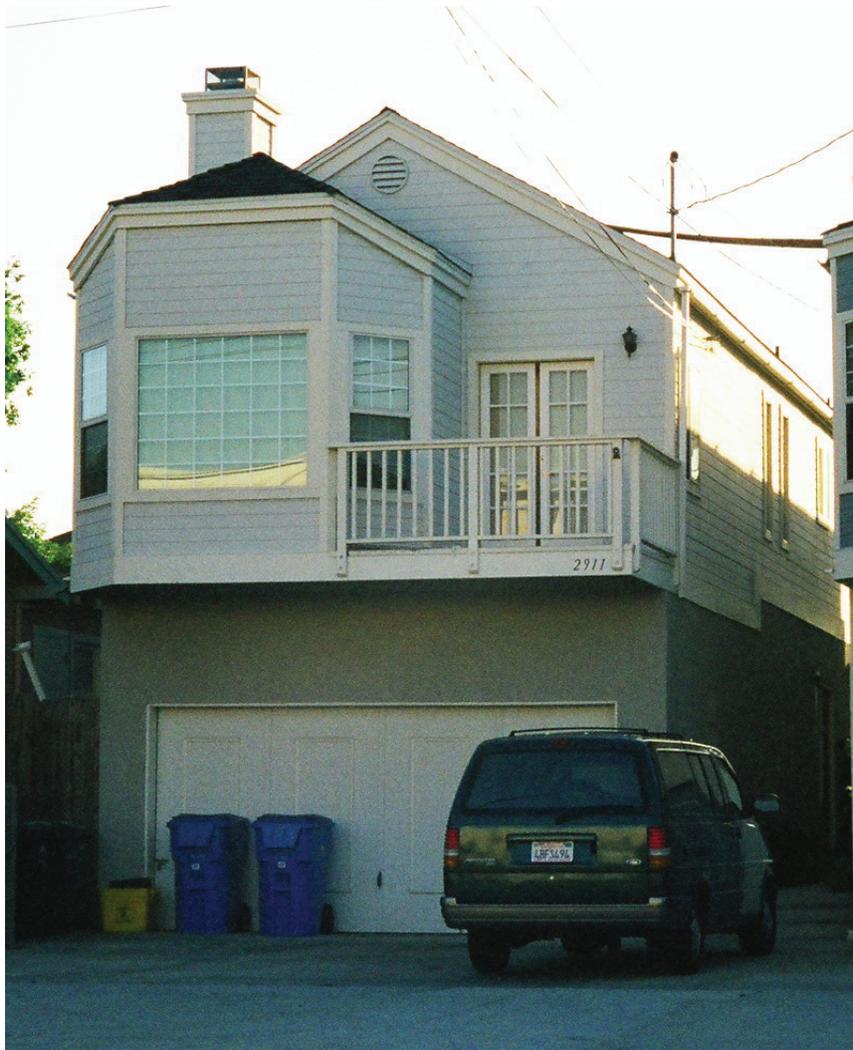
Figure 8-3 House where there appears to be insufficient wall width on each side of the garage door for effective wood structural panel shear wall sheathing (from ATC, 2002).

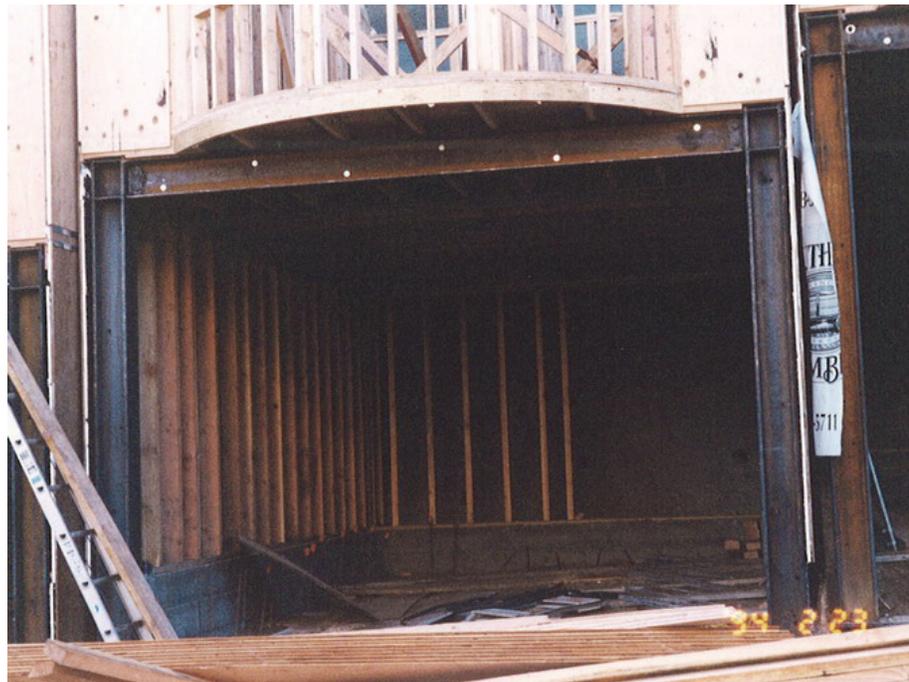
Figure 8-4 A steel moment-resisting frame at the garage opening of a row house (from ATC, 2002).

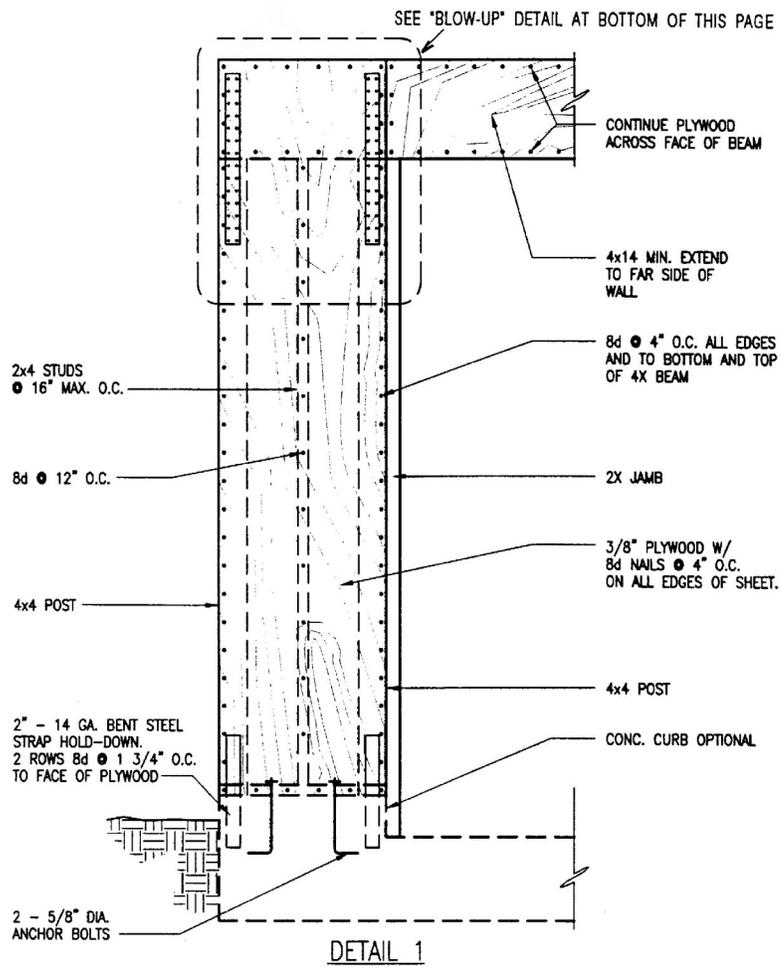
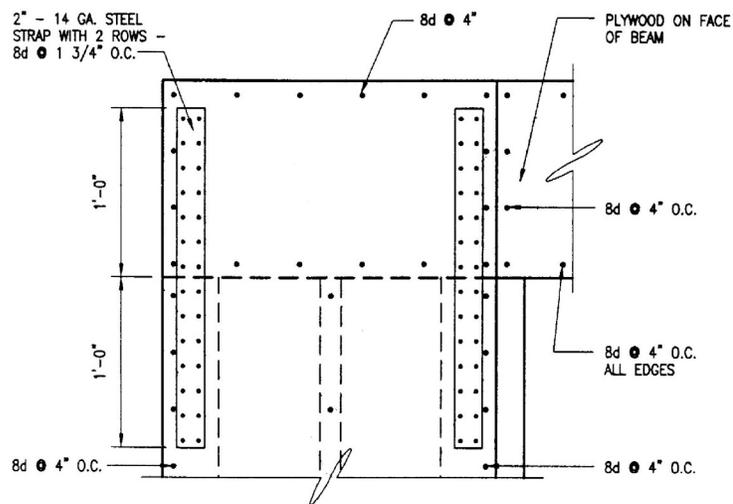
Figure 8-5 Field-built retrofit slender shear wall (from FEMA 232).

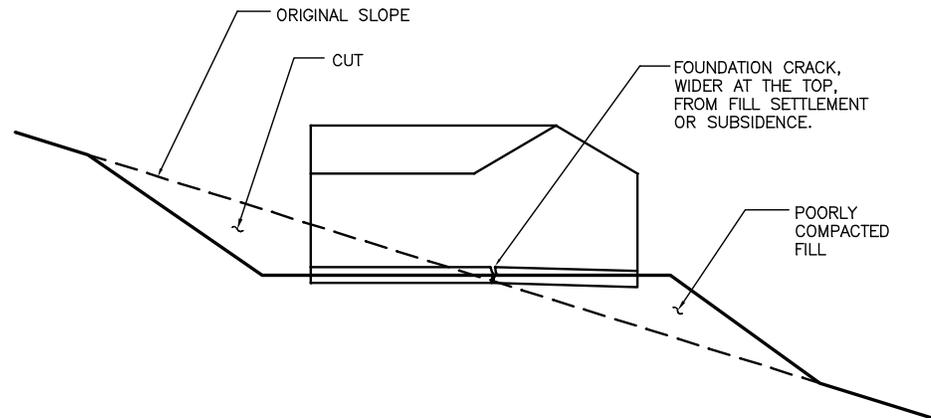
Figure 8-6 Foundation crack patterns indicative of fill settlement at a cut-and-fill house site (from ATC, 2002).

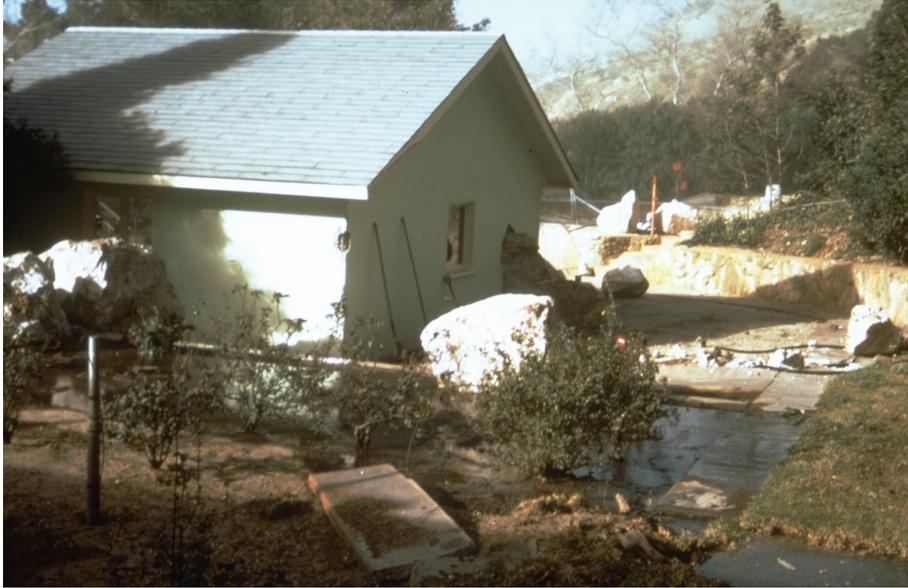
Figure 8-7 Boulder that was shaken loose from the slope above by an earthquake and came to rest against a house (from ATC, 2002).

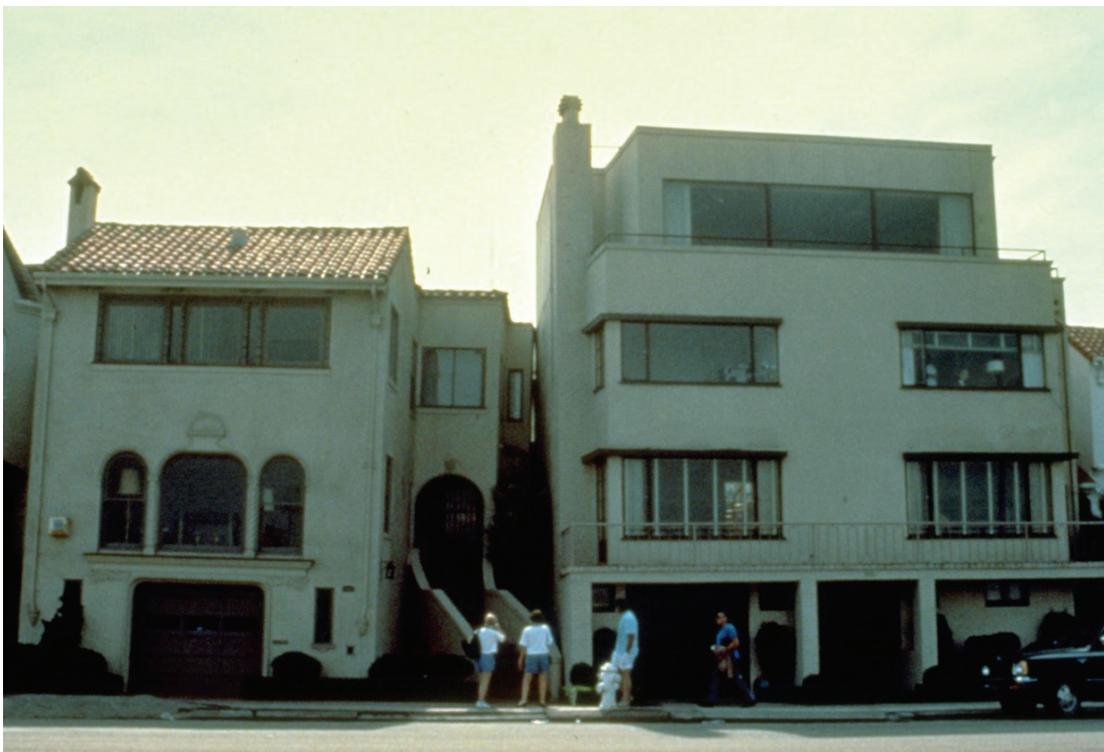
Figure 8-8 Differential settlement of two houses caused by liquefaction along their common property line (from ATC, 2002).

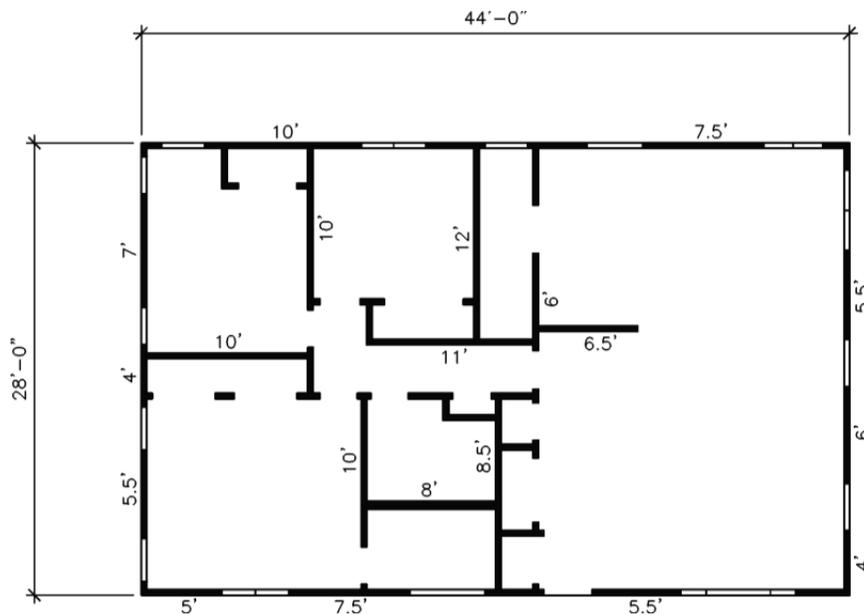
Figure 9-1 Example 1 floor plan.

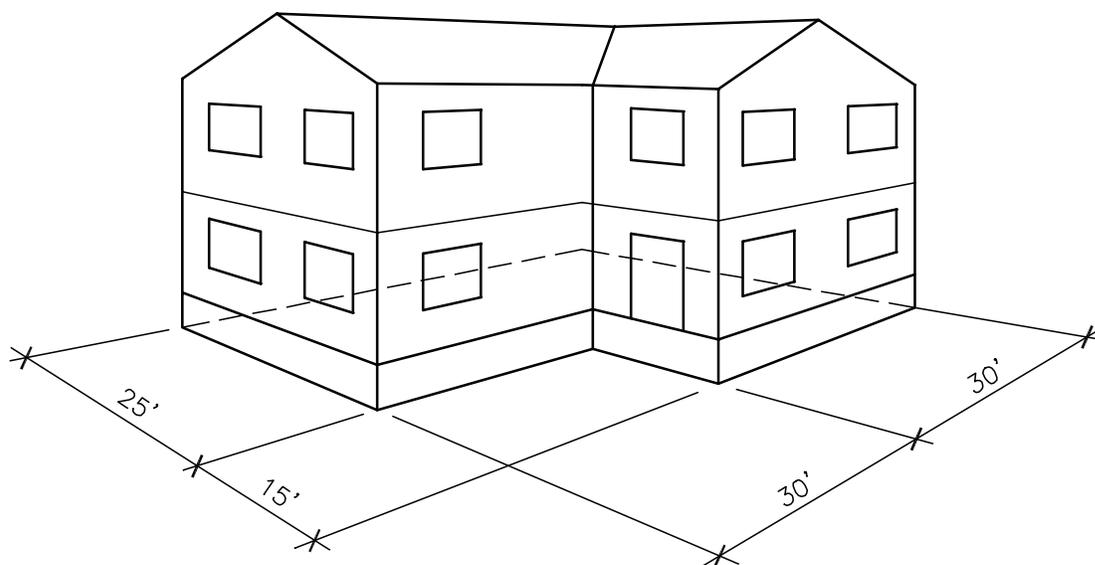
Figure 9-2 Example 3 two-story crawl space house.
