# JSCA's RECOMMENDATION "DESIGN AND DETAIL OF NON- STRUCTURAL ELEMENTS FOR STRUCTURAL, BUILDING AND BUILDING-EQUIPMENT ENGINEERS"

Aya Osada  
JR EAST Design Corporation  
Tokyo, JAPAN

June 2016 16th U.S.-Japan-N.Z. Workshop

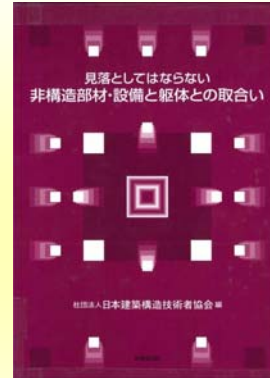
It described attention points **at the construction stage** with a focus on how to connect non-structural elements to structural frame.

JSCA, 2006, “How to connect non-structural elements and building equipment to structural frame”

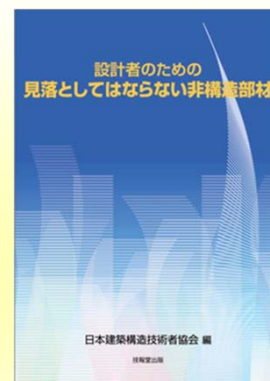
- **reminders** that engineers shall express seismic measures on drawings and particular specifications **at the planning phase**.
- JSCA’s recommendation of “The lessons from The Great East Japan Earthquake 2011” and “To secure the seismic safety of non-structural elements”
- The key points of the revision of cabinet order and announcement and policy trend
- Various types of material performance evaluation test and technical information

JSCA, 2015, “Design and Detail of non-structural elements for Structural, Building and Building equipment engineers”

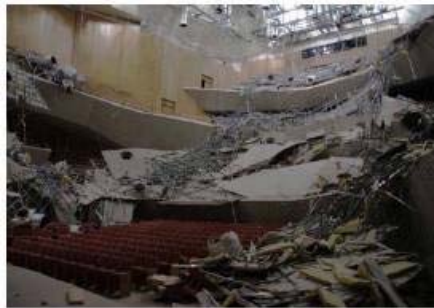
Seismic damage  
Case 1

- **Type of Damages** : Whole ceiling falling down
- **Cause** : It suffered a complex rocking motion due to concavo-convex ceiling shape. The seismic load was so large due to heavy dead load and ceiling members did not resist to these forces.
- **Countermeasure** : In case of complex ceiling shape, structural engineer should figure the dynamic motion of ceiling after the discussion with building and building-equipment engineers.

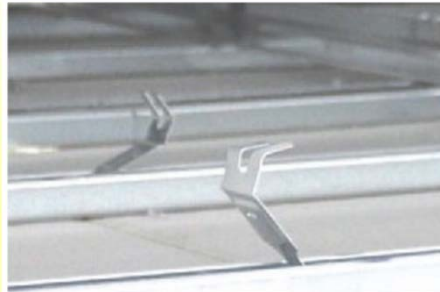
Seismic damage  
Case 2

Example of  
opened clip

- **Type of Damages** : Damages caused by collision to the wall
- **Cause** : Seismic brace did not existing. Ceiling frames were damaged by repeated collision to the wall. Attachments such as clips and hangers were slipped and ceiling board fall down.
- **Countermeasure** : This displacement should be controlled by arrangement of connecting brace.

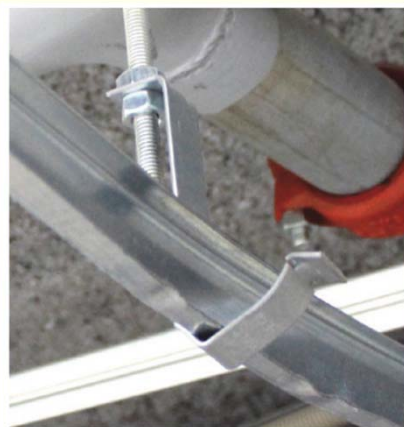
Example of broken hanger

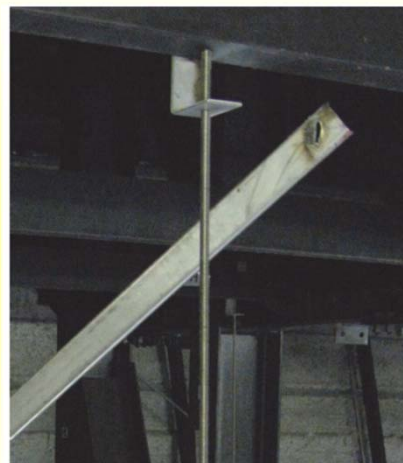
Example of fractured welding part

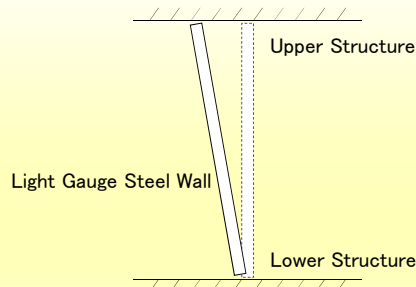
- **Type of damages** : Dropped off to out-of-plane
- **Cause** : Nails connecting wall-frame to structural-frame did not have enough bearing force.
- **Countermeasure** : It is recommended to use nails of large bearing force, or to use them in smaller pitch.

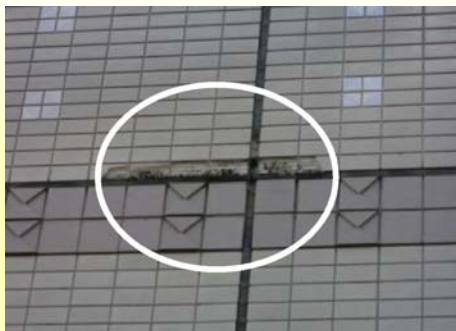
Example of tiles exfoliation

In case of non-curtain wall style, heavy damages were several cases at time of [The Great East Japan Earthquake 2011](#), only there were light damages such as joints moving or falling out of ceramic tiles at corner.

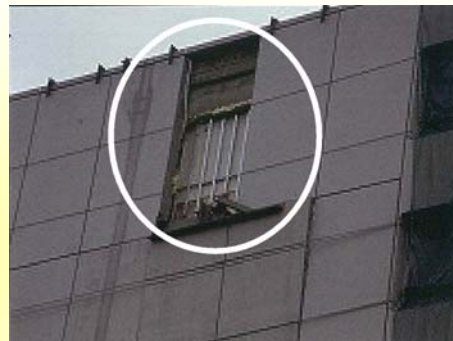
Example of panels drop off

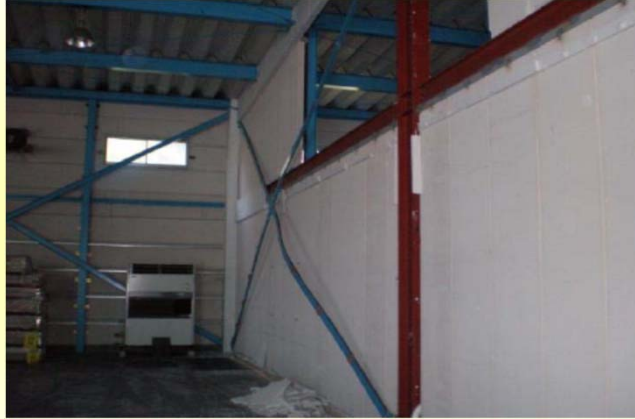
There were many damages which type of **two-staged wall** with intermediate collar. The main cause is that connecting part was damaged by **over drift**, **rotation** and **torsion moment in-plane** or **out-of-plane direction**.

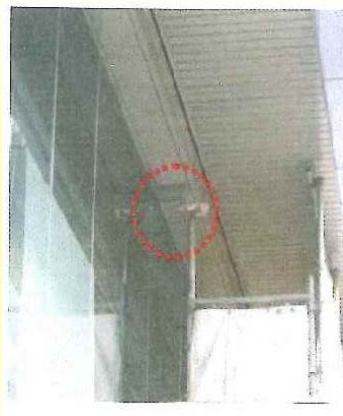
- **Type of damages** : Breaking or cracking of ribbed glass
- **Cause** : There was little clearance at face or edge of glass to supporting member.
- **Countermeasure** : The clearance should be wider than the story drift.

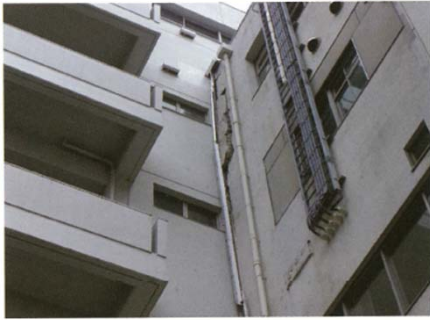
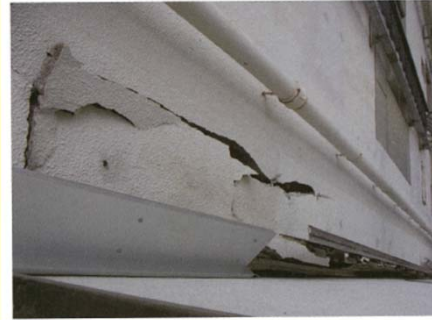
#### Seismic damage Case 1

- **Type of damages** : Clash between structures
- **Cause** : There was little clearance between structures.
- **Countermeasure** : The clearance should be wider than the story drift.

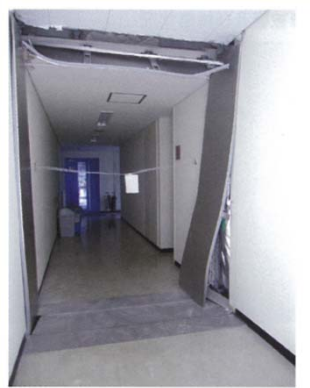
### Seismic damage Case 2

- **Type of damages** : Falling of EXP.J cover
- **Cause** : The EXP.J cover fell because it did not allow the displacement caused by story drift.
- **Countermeasure** : The cover shall be planned in details considering story drift.

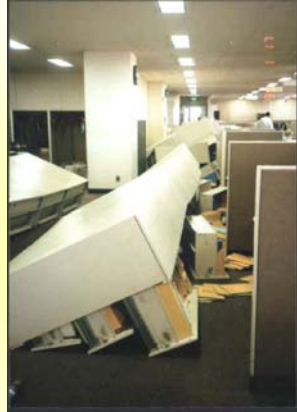
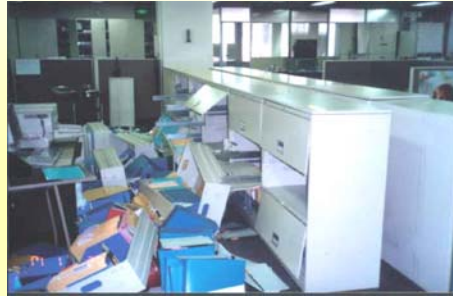
At time of **The Great East Japan Earthquake 2011**, furniture have over-turned, moved and fallen down where they are faced at **the escape route**. These caused problems to escape, rescue work and human safety at just soon after the earthquake. In case of a big earthquake, making sure to secure **human safety** and **their escape route** is very important.

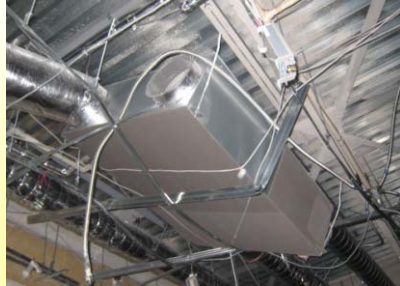
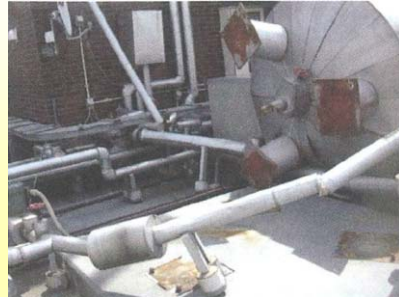
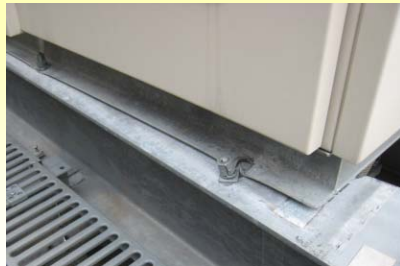
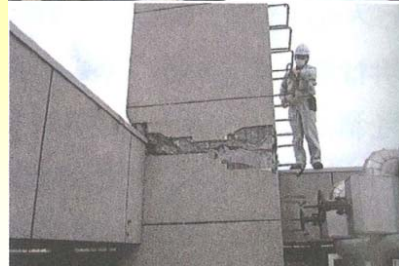
- (1) Damage and falling down of **suspended equipment inside ceilings**
- (2) **Over-turning equipment** on the roof
- (3) Damage of **equipment steel base**
- (4) Slipping out or breaking of **anchor bolts**
