EXPERIMENTAL STUDY ON DAMAGE REDUCTION SESIMIC RETROFIT TECHNIQUE FOR RC FRAME USING ULTRA HIGH STRENGTH FIBER CONCRETE

Tomohisa Mukai, Hidekazu Watanabe, Masanobu Sakashita, Masanori Tani,
Taku Ishioka, Takahiko Uchida, Shinsuke Hori, Toshio Maegawa, Motoi Kanagawa, Tsunehisa Matsuura
Building Research Institute, Building Research Institute, National Research and Development Agency,
Kyoto University, Toda Corp., Sato Kogyo Co.,Ltd., Maeda Corp., KUMAGAIGUMI Co.,Ltd.,
Nishimatsu Construction, Hazama Ando Corp.
Tsukuba, Kyoto, Tokyo/ Japan

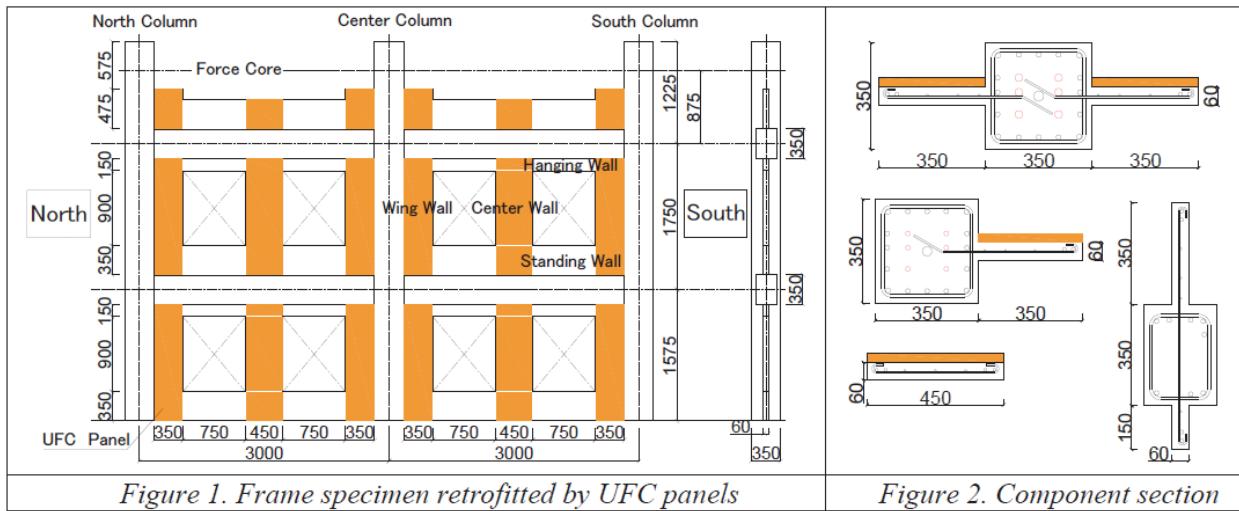
Figure 1. Frame specimen retrofitted by UFC panels

Specimens are 2 story and 2spans RC frame with non-structural walls such as wing, center, hanging and standing walls assuming typical governmental office building shown in Fig.1. The specimen scale is half

size to actual building and this thin wall has only single layer reinforcement shown in Fig. 2. Number of specimens is two, one is non-retrofitted and the other is retrofitted. UFC panels are installed at one side of non-structural walls using epoxy resin adhesive. Thickness of non-structural walls is 60mm. Vertical and horizontal reinforcement in walls is D6 rebar at 100mm interval. Edge reinforcement for center walls is two D10 and one for other walls is two D13. Columns are 350 mm square section with sixteen D16 rebars as longitudinal reinforcement. Beams are 250×350mm section with eight D16 rebars. The shear reinforcement for columns and beams is double D10 rebars at 50 mm interval. Steel type of longitudinal reinforcing rebar is SD345 for columns. Steel type of rebar is SD295, which diameter is smaller than 13 mm. Bar arrangement is shown in Fig.3.

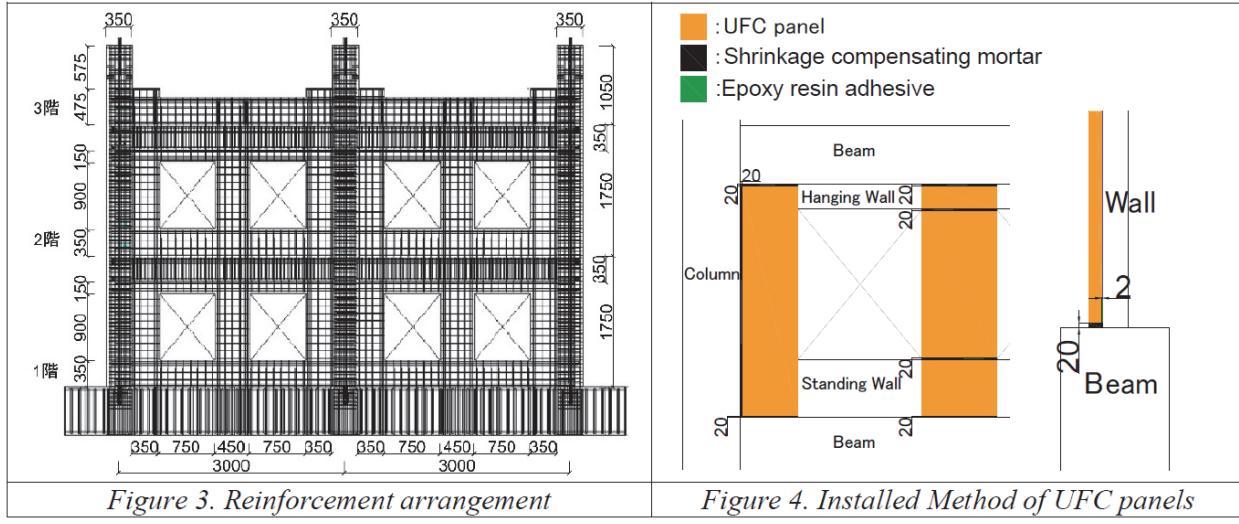
Figure 3. Reinforcement arrangement

UFC panels are pasted on the non-structural wall face from one side using the epoxy resin adhesive. The high strength non-shirnk mortar is filled in the gaps between beam and UFC panel and the epoxy resin is filled in the other gaps. Three UFC panels are installed at the wall composed of center and standing, hanging wall. Above installed method of UFC panel is shown in Fig.4.

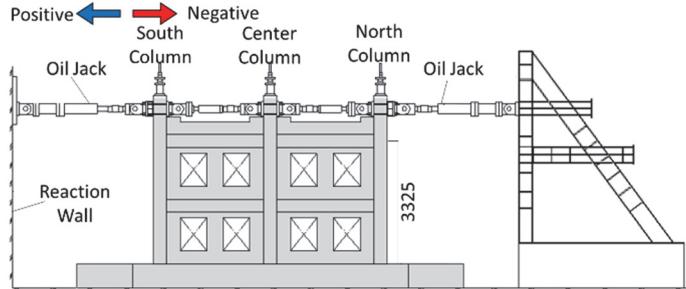
Figure 5. Loading Setup

Loading setup and loading path is shown in Fig. 5, 6 respectively. Cyclic loading was implemented using attachment with pin support at both ends to keep horizontal displacement at top of each column on 3rd story. Axial force was applied using un-bonded pc tendon and axial force ratio to column gross section area is 0.075 for outside columns, 0.15 for inside column. Horizontal oil jack was controlled by global drift angle R which is given by horizontal displacement at center of beam in top story divided by total height (=3.325m)

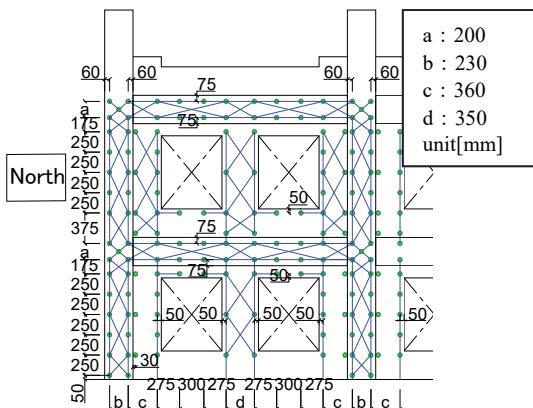
Figure 7. Displacement Transducer Setup

As for measurement plan, flexural and shear deformation for column and beam and shear deformation for wall is measured by displacement transducers shown in Fig.7. The strain at main bars and shear reinforcements for column and beam and reinforcing bars for wall are measured by strain gauges shown in Fig.8 to evaluate critical section of beam, plastic hinge portion and inflexion point of columns.

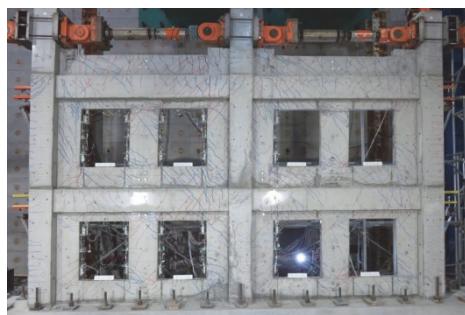
Photo 1. Damage state at $R=1.0\%$

Compression failure at both ends of center walls and wing walls on 2nd story were observed during R=0.5% cycle. Some flexural cracks at bottom end of inside column and shear crack at beam-column joint on 2nd and 3rd story were observed during R=0.5%. Shear cracks at every walls (maximum shear crack width at center wall at 1st story is approximately 4.0mm) and flexural crack at UFC panel in 1st story were observed and above compression failure were extended but Any compression failure at any components in 1st story were not observed during R=1.0% cycle shown in Photo 1. Finally, damage concentrated at joint of wing walls and hanging/standing walls on 2nd and 3rd story, at joint of wing walls and standing walls on 1st story, at both ends of every center walls were observed shown in Photo 2.

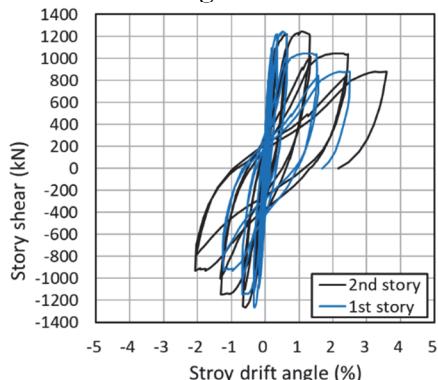
Figure 9. Story Shear and Story Drift Angle Relationships

Backbone curve of each story is shown in Fig.9. When 2nd story drift angle reached at 0.5%, maximum strength was observed and the strength was kept until 1.0%. Regarding the story deformation distribution, 2nd story drift angle is little bit larger than 1st story.

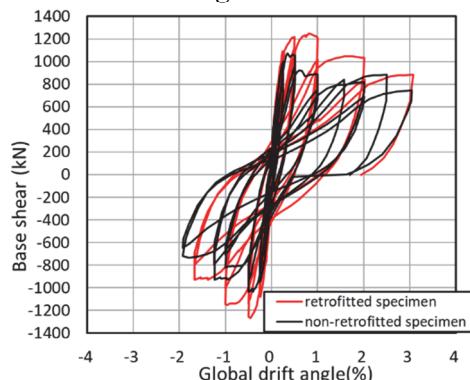
Figure 10. Comparison of Load – Displacement Relationships

The relationship between base shear (sum of horizontal oil jack) and global drift angle R for non-retrofitted specimen and retrofitted specimen is shown in Fig.10. The retrofitted specimen has larger horizontal strength than non-retrofitted one which rapid strength deterioration was observed at $R=0.5\%$. Fig 11 shows backbone curve which vertical axis is base shear divided by maximum strength to compare both specimens. (a) shows positive side, (b) shows negative side. As above mentioned, from Fig.11 (a), the retrofitted specimen has maximum strength at $R=0.5\%$, kept the strength until $R=1.0\%$ and then the strength dropped gradually comparing to the non-retrofitted one. After $R=2.0\%$, the ratio of base shear to maximum strength is almost same. On the other hands, from Fig.11(b), both specimens has maximum strength at $R=0.5\%$ and then the strength dropped soon. However the strength deterioration degree of the retrofitted specimen is more gradual than the non-retrofitted one.

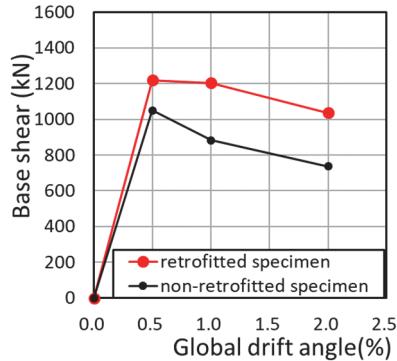
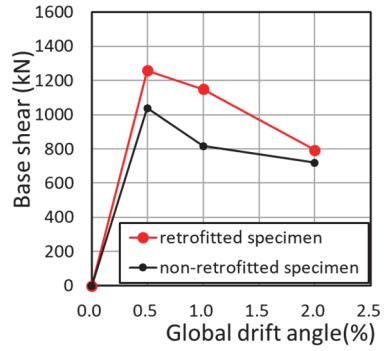
Figure 12. Simplified Backbone Curve

Fig 12 shows backbone curve which connected origin to peak points at $R=0.5, 1.0, 2.0\%$ respectively. Using the value given from Fig. 12, Fig.13 shows negative stiffness ratio which is negative stiffness after $R=0.5\%$ divided by the secant stiffness at $R=0.5\%$. (a), (b) are same as Fig.11. From Fig.13, until $R=1.0\%$, the retrofitted negative stiffness degree is considerably gradual, the value for positive and negative is -0.02 and -0.09 respectively. And until $R=+2.0\%$, degree of the retrofitted specimen for positive side is almost same to the non-retrofitted specimen.

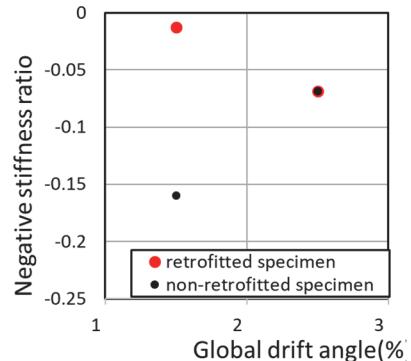
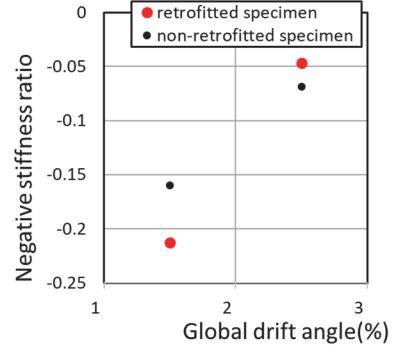
Figure 13. Negative Stiffness ratio After R=0.5%

Therefore, this results implies the effect of seismic retrofit is improvement of not only maximum strength, but deformation capacity.

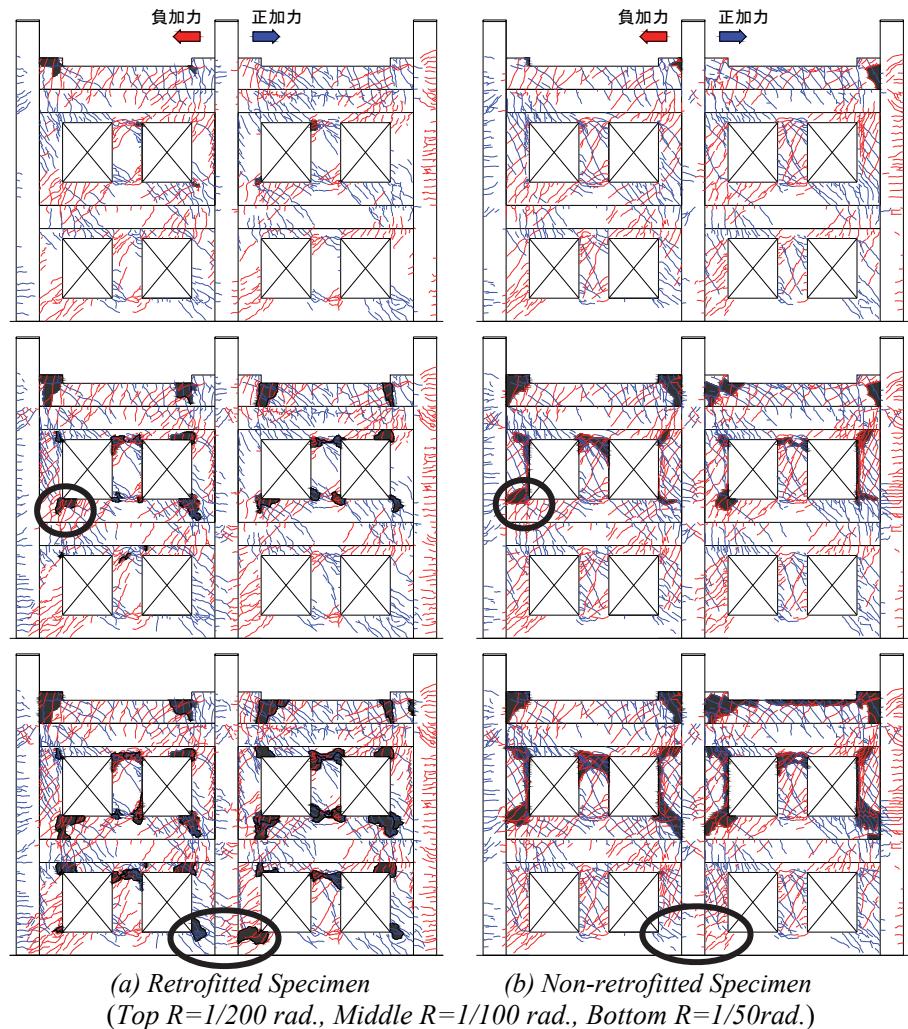
Figure 14. Damage States

Damage Distribution. Fig.14 shows damage states for the retrofitted specimen and the non-retrofitted specimen at peak of $R=0.5, 1.0, 2.0\%$. Black portion in this figure means spalling of concrete after compression failure.

It is confirmed that shear crack at center walls and wing walls of the retrofitted specimen was reduced comparing to the non-retrofitted specimen at $R=0.5\%$. The cause is assumed that rotational deformation was dominant due to rigid body rotational behavior of center wall with UFC panel and shear deformation component of these walls was controlled.

At $R=1.0\%$, spalling of concrete is observed at walls on 2nd story for both specimens. Spalling of concrete was observed at top end of center walls on 2nd story for the non-retrofitted specimen, and at both ends of center walls on 2nd story for the retrofitted specimen. Regarding the portion of concrete spalling, the portion for retrofitted specimen was observed at end of standing walls and the portion for non-retrofitted specimen was observed at end of wing walls as shown by circle marks in Fig.14. It is assumed that damage distribution was changed by retrofit works, since ultimate flexural strength of column with wing wall and UFC panel was improved and became larger considerably than the strength of beam with walls. This implies damage distribution was controlled by this retrofit technique.

At $R=2.0\%$, damage observed in the non-retrofitted specimen concentrated at walls on 2nd story. On the other hand, damage for the retrofitted specimen was observed at wing walls and center walls on 1st story. Additionally, the damage portion for retrofitted specimen was also observed at end of wing walls on connected standing wall as shown by circle marks in Fig.14. It is assumed that the end of wing wall on 1st story had plastic hinge, since beam with walls at 2nd story failed in flexure and then the maximum strength deteriorated and inflexion point of column with wing wall at 1st story moved up. Additionally, collapse mechanism was story collapse[3] for the non-retrofitted specimen and global collapse for the retrofitted specimen respectively. This implies collapse mechanism was controlled by this retrofit technique. Therefore, it is confirmed that this retrofit technique using UFC panels can reduce the damage of existing wing walls and center walls and control collapse mechanism at ultimate state.

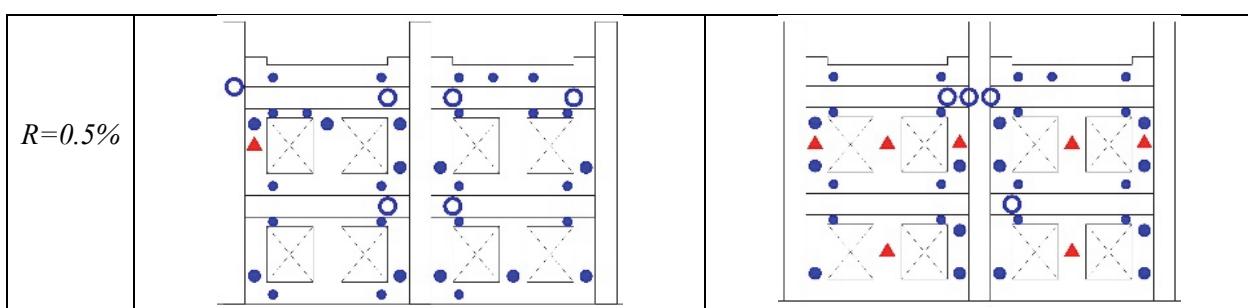
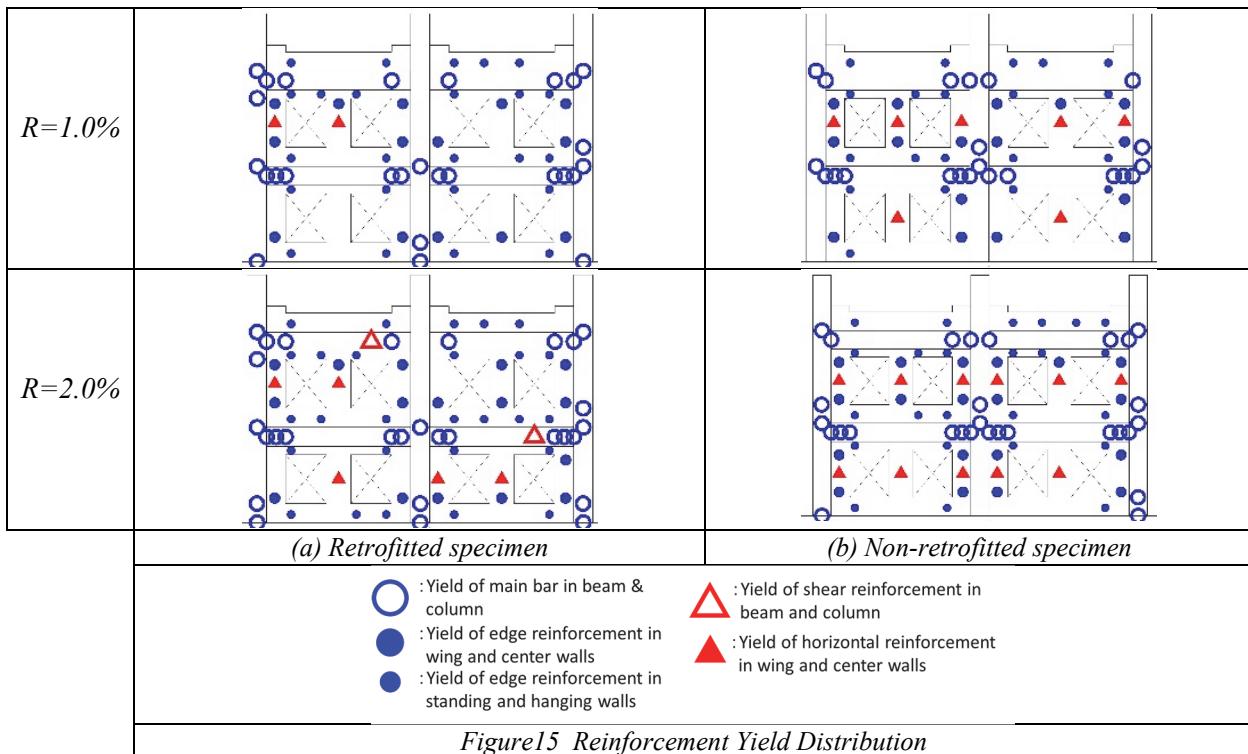
Figure 15 Reinforcement Yield Distribution

Reinforcing Bars Yield Distribution. Fig.15 shows yield distribution of each reinforcing bars such as main bar, shear reinforcement of beam and column, edge and other bars of each wall for both specimens. At $R=0.5\%$ where both specimens reached maximum story shear force, edge reinforcements at top of center walls on 2nd story yielded for the retrofitted specimen, horizontal reinforcements of center walls on 2nd story yielded for the non-retrofitted specimen. This result is consistent with other result that shear deformation of center walls was controlled by UFC panel as above described. Regarding yield portion of main bar in beam, the portion is at face of wing wall for the retrofitted specimen and at the face of column for the non-retrofitted specimen respectively. This implies the critical section of beam was kept at face of wing walls by UFC panel retrofit. Moreover, the edge bar of 1st story's wing wall on the connected standing wall yielded.

At $R=1.0\%$, main bars of column on 1st story for the retrofitted specimen yielded, it is assumed that the specimen reached global collapse mechanism. On the other hand, any main bars of column on 1st story never yielded for the non-retrofitted specimen.

At $R=2.0\%$, shear reinforcement of beam on 3rd story yielded. It is assumed that shear force carried by the beam became large, since critical section of this beam was kept at face of wing wall as above mentioned. Therefore, it is confirmed that yield distribution of reinforcing bars for both specimens was quite different and this retrofit technique using UFC panels can change collapse mechanism.
