# **RESEARCH AND DEVELOPMENT ON SAFETY OF BUILDINGS AGAINST NATURAL DISASTERS AND URBAN FIRES AT THE BUILDING RESEARCH INSTITUTE**

Mitsumasa MIDORIKAWA  
Building Research Institute,  
National Research and Development Agency  
Tsukuba, Ibaraki, Japan

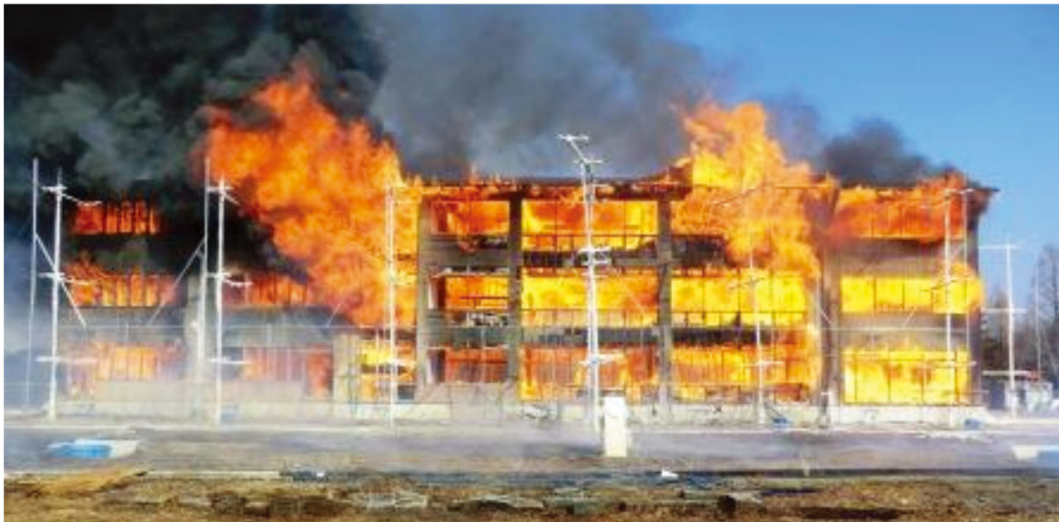
This photo shows the full-scale fire test for the wooden school building.

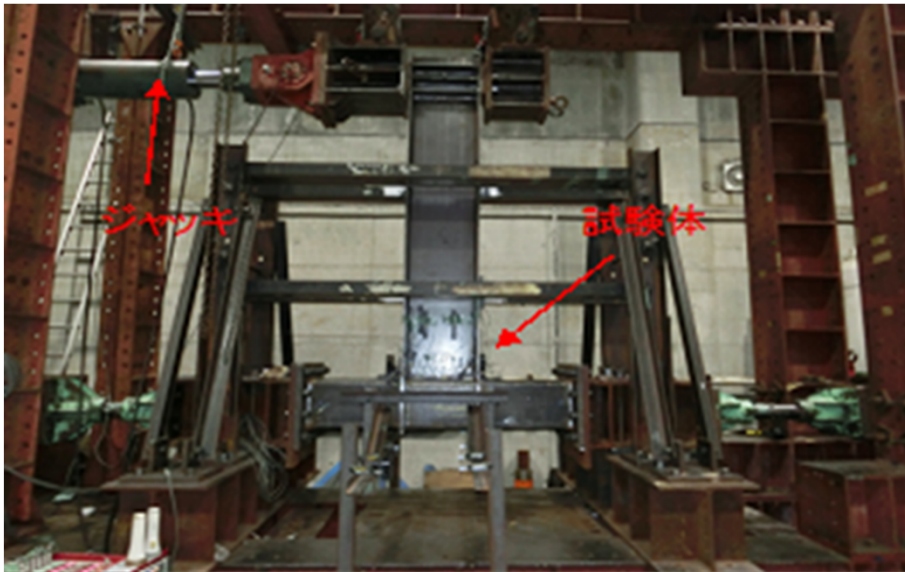
Photo 3. Cyclic loading test on beam.

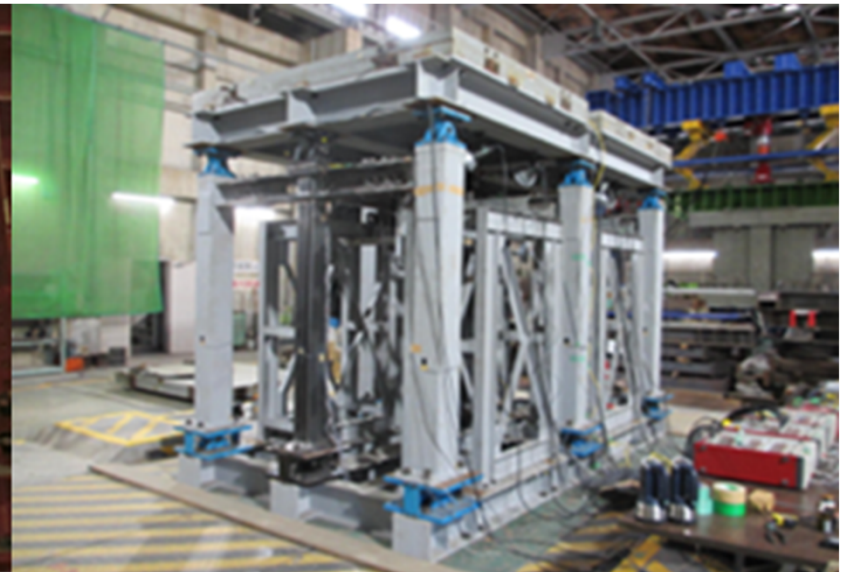
Photo 4. Shaking table test on two-bay frame

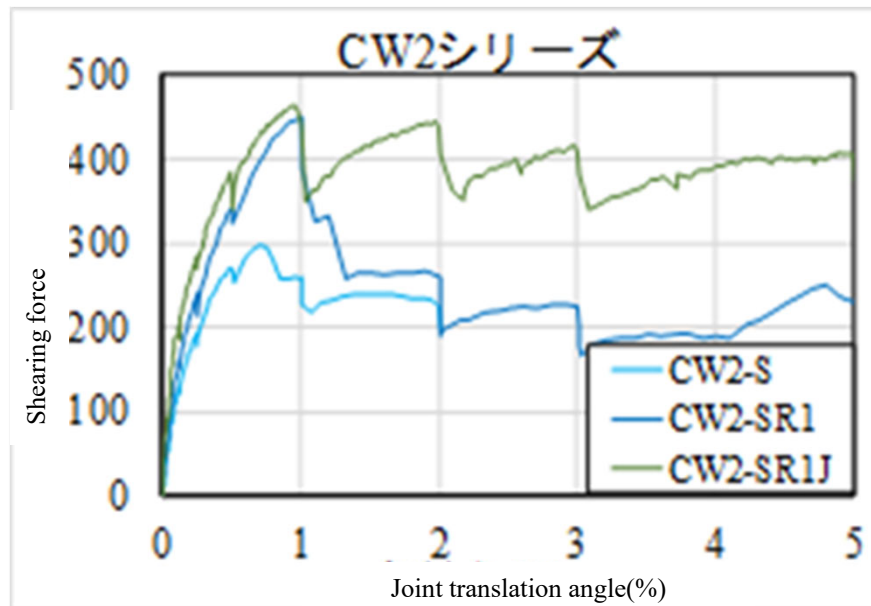
Figure 5. Effectiveness of seismic retrofitting using UFC Panel

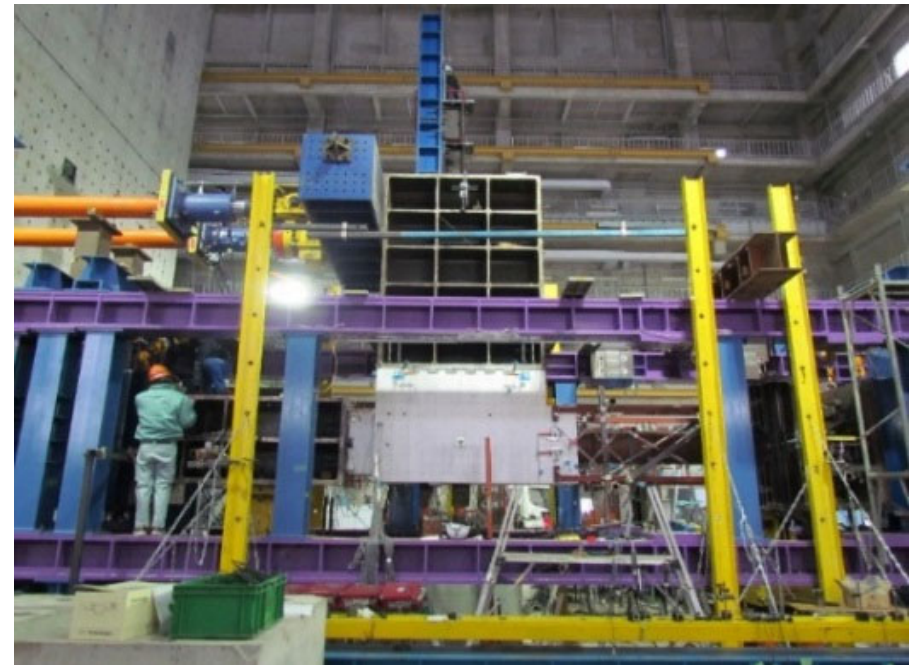
Full-scale experiment on a pile with pile-cap

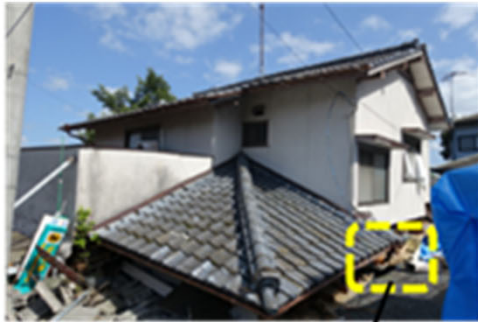
*Collapsed wooden house*

Old houses which do not conform to the current standards were severely damaged.

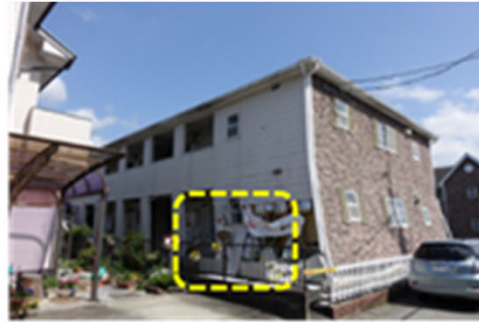
*Hugely tilted wooden apartment*

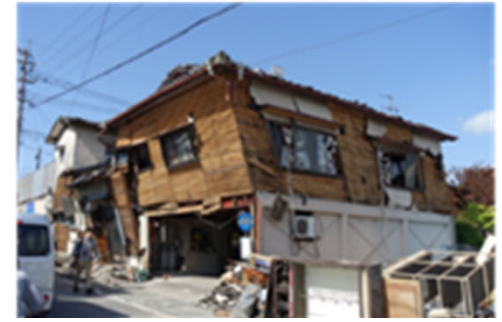
*Second floor hugely tilted in a S+W house*

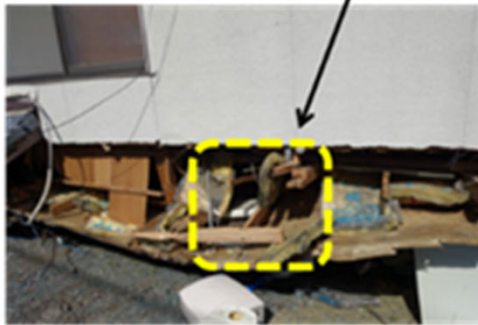
*The house shown above without column and brace wooden frame*

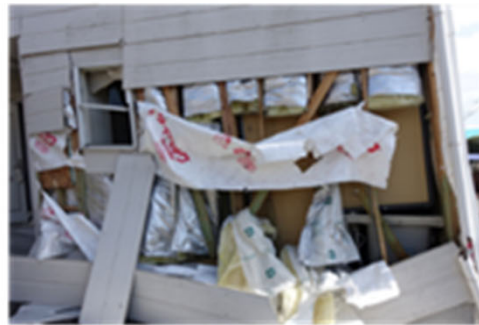
*brace part of the house shown above*

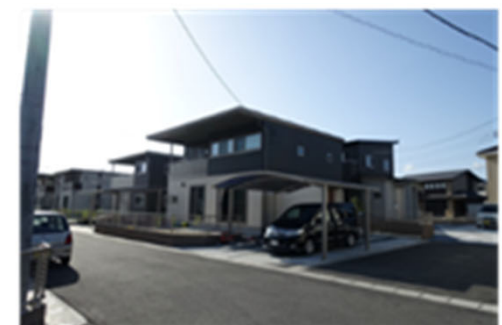
*wooden house in a new residential area*

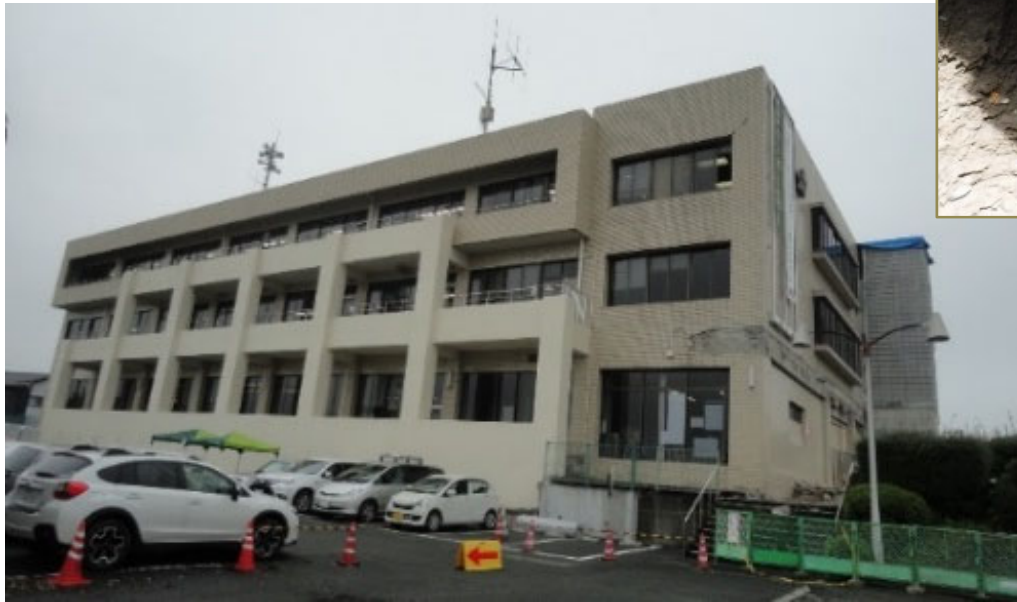
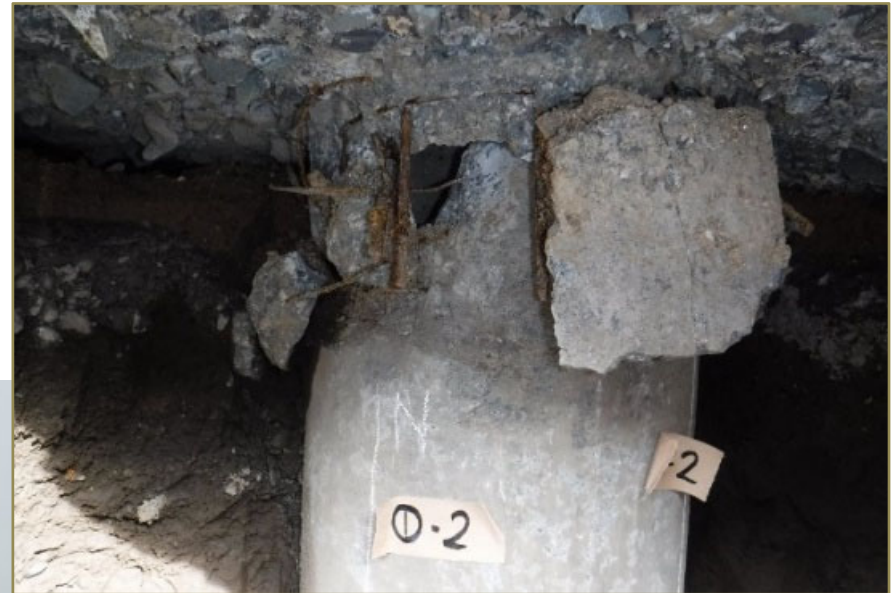
Local government office building (RC)

Pile foundation had been broken and the building slanted which had once been seismic retrofitted.

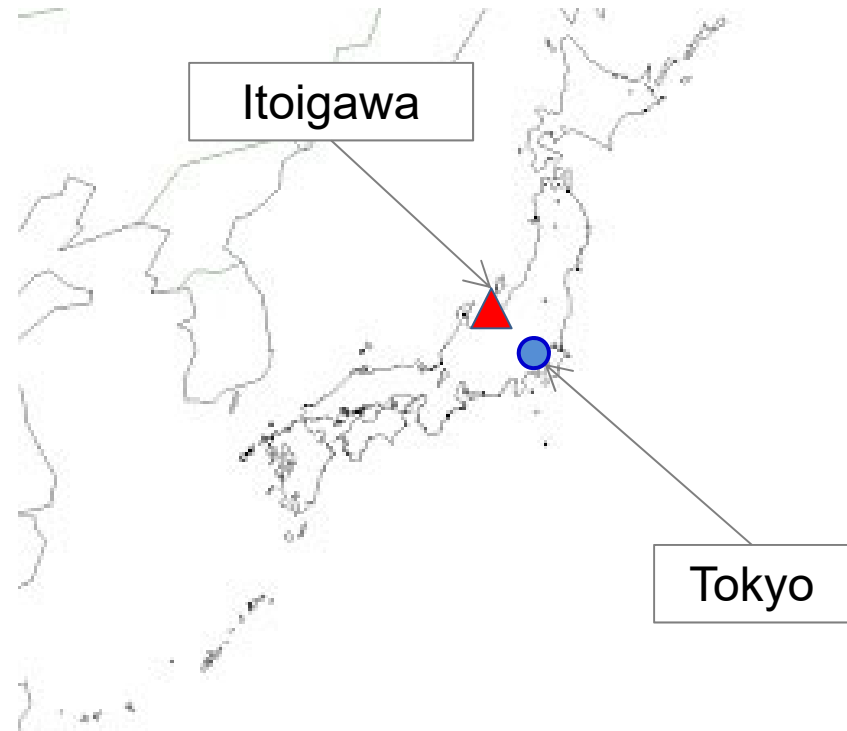
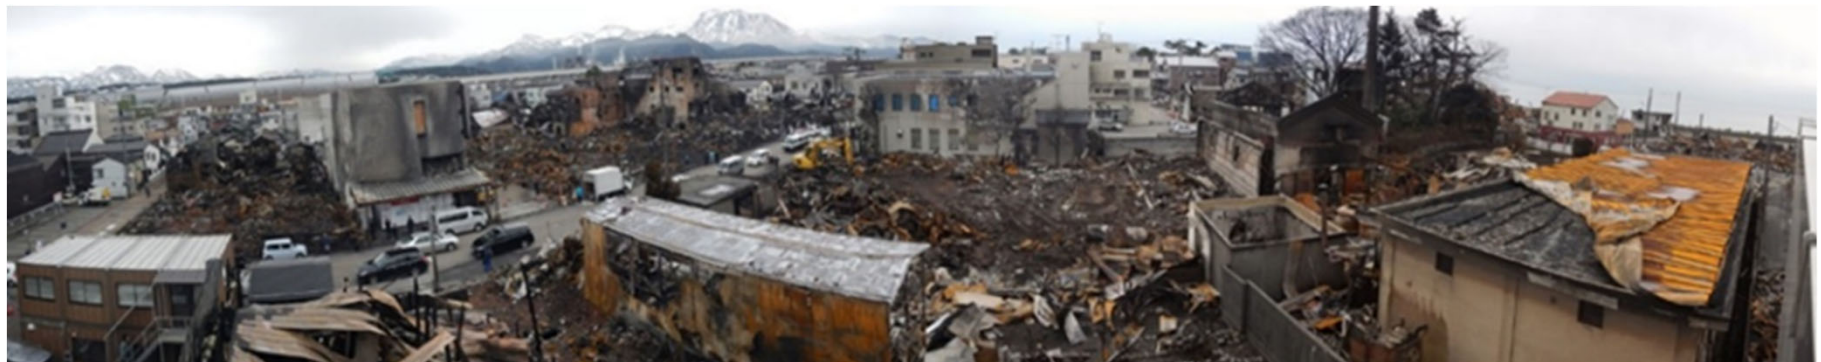
Photo 6. Damaged area in the Itoigawa city fire

- **147 burned buildings** (burned total floor area approximately 30,000m<sup>2</sup>)
- 17 injured people.

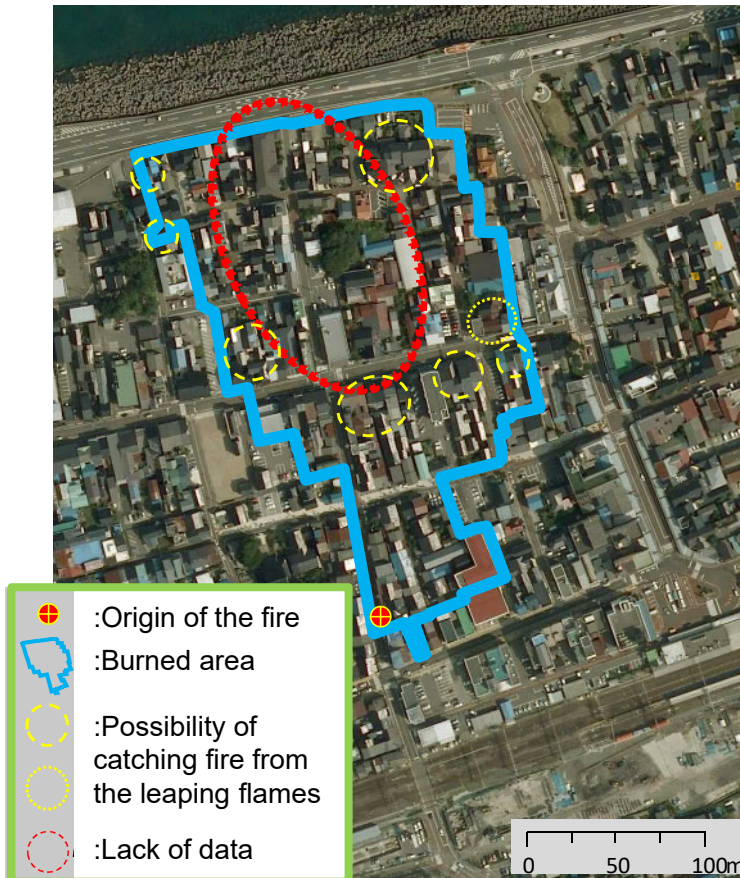
The Burned area and the Situation of Leaping flames

Average wind speed: 10m/s(aprx.)

Maximum instantaneous wind speed: 20m/s(aprx.)

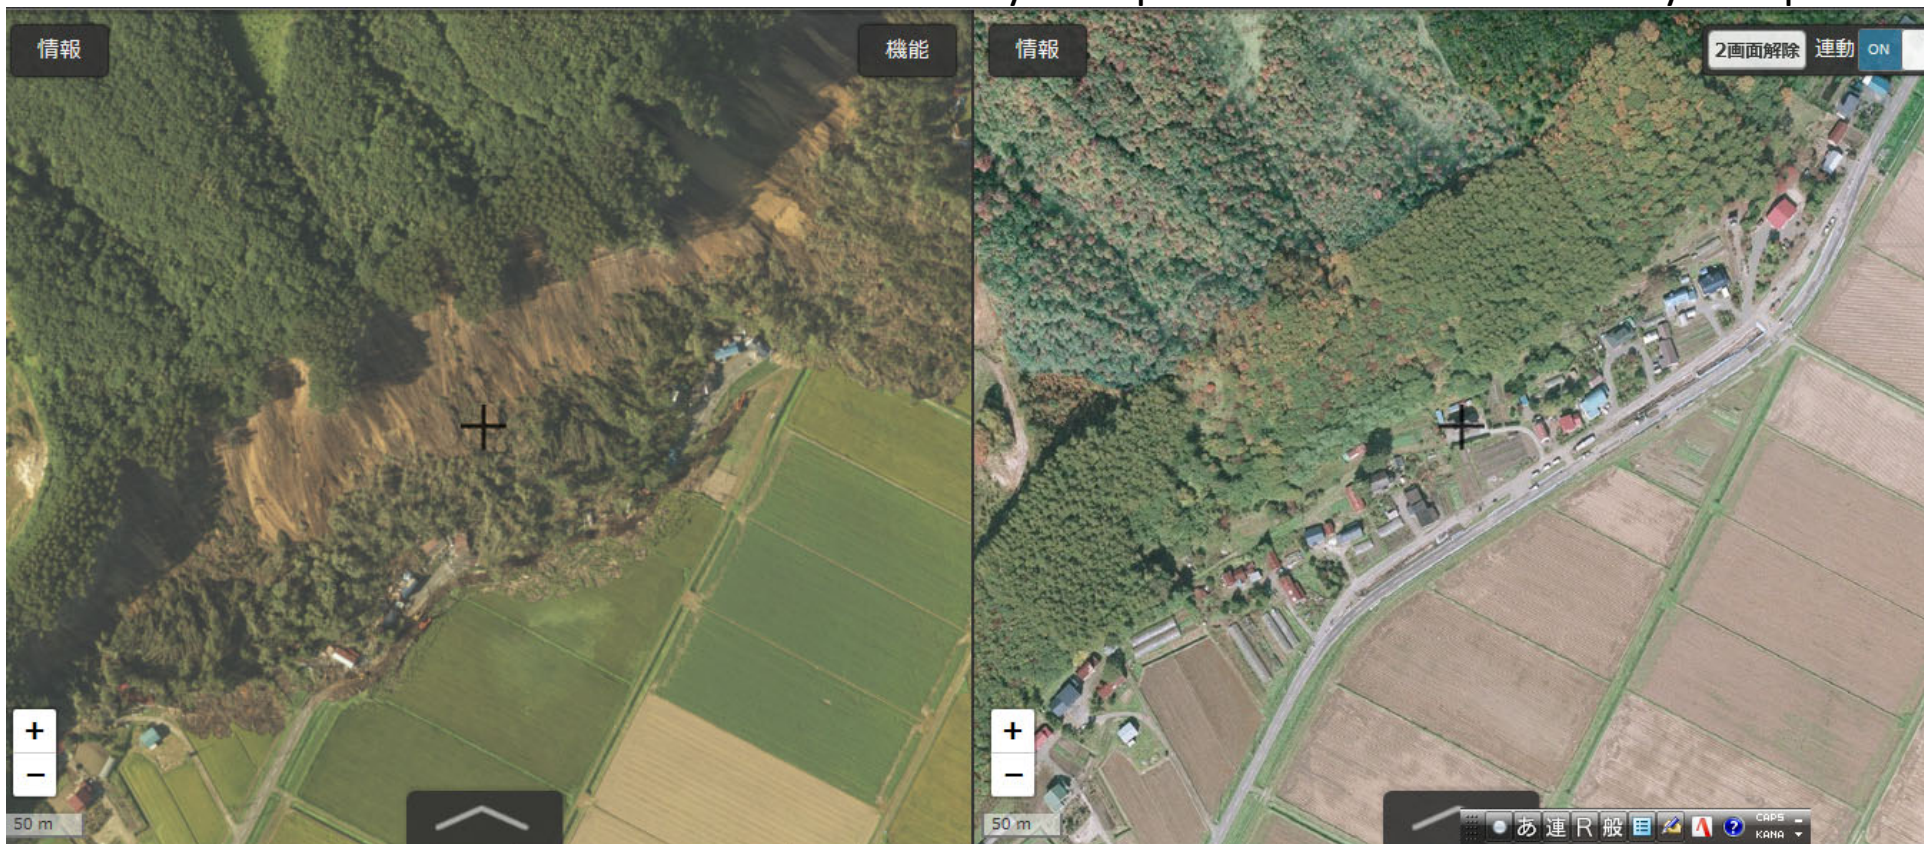
The landslides near the epicenter. The right photo shows the houses along the mountain, but the left one shows many of them were buried by the sediment after the earthquake.
