Background Document

FEMA P-58/BD-3.9.7

Fragility of Masonry Chimneys

John Oстераas, Exponent, Menlo Park, California
Helmut Krawinkler, Stanford University, Stanford, California

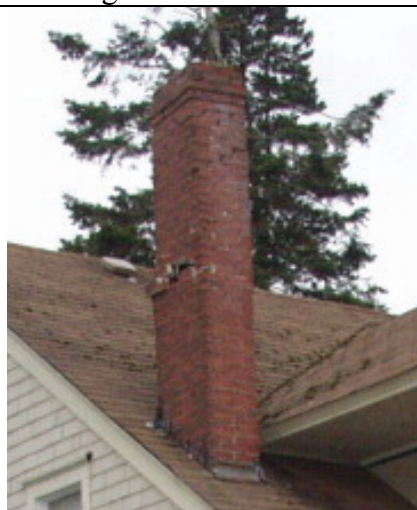
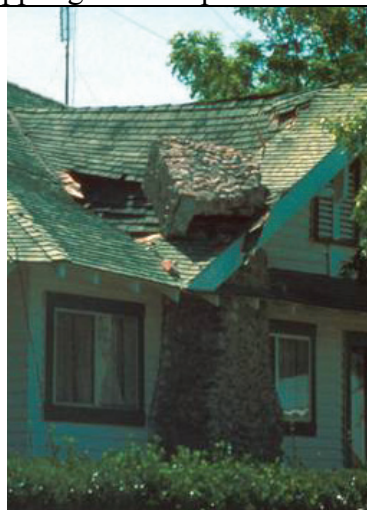
Table 1. Summary results

Fragility, damage measures, and consequences for:		
Component category:	Masonry chimneys, excluding industrial chimneys	
Basic composition:	Unreinforced masonry chimney as a component of woodframe building, including firebox and chimney, excluding interior veneer and ornamentation. May also include chimneys where presence of quality of reinforcing is unknown.	
Units:	Single chimney	
Demand parameter:	Peak horizontal ground accelerations	
Number of damage states:	2	
Damage states are:	<input checked="" type="checkbox"/> ordered; <input type="checkbox"/> mutually exclusive; <input type="checkbox"/> simultaneous	
Author and date:	J Osteraas, H Krawinkler, B McDonald, J Hunt; December 2010	
Damage states, fragilities, and consequences		
	DS1	DS2
Description:	Cracking with offset > 1/16"	Toppling of all or portion
Illustration:

Median demand (θ):	0.35g	0.5g
Total dispersion (β):	0.6	0.6
Repairs required:	Rebuild above break or replace entire chimney ¹	Rebuild above break or replace entire chimney ¹
