Background Document

FEMA P-58/BD-3.8.3

Fragility Curves for Components of Steel SMF Systems

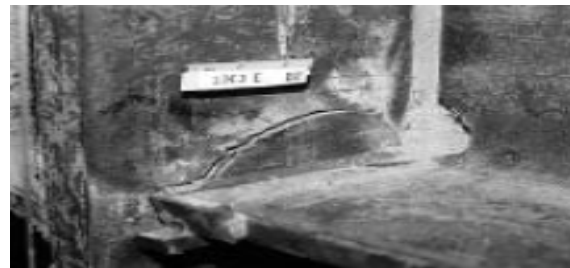
Damage State 1A: Fracture of lower beam flange weld and failure of web bolts (shear tab connection), with fractures confined to the weld region. Repair will typically require gouging out and re-welding of the beam flange weld, repair of shear tab, and replacing shear bolts. This damage state was widely observed in buildings damaged in the Northridge earthquake and laboratory tests.

- 1A) **DS-1A:** Fracture of lower beam flange weld and failure of web bolts (shear tab connection), with fractures confined to the weld region. Repair will typically require gouging out and re-welding of the beam flange weld, repair of shear tab, and replacing shear bolts.

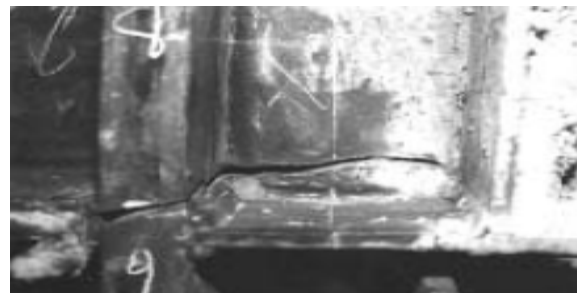
Damage State 1B: Similar to *DS-1A*, except that fracture propagates into column flanges. In addition to measures for *DS-1A*, repairs to column will be necessary that will involve replacing a portion of the column. While not as prevalent as *DS-1A*, this damage state was observed both in damaged buildings and one of the reported tests by Leon et al (1998). The available data suggests that *DS-1A* and *DS-1B* occur at similar deformation levels and that the occurrence of one versus the other is somewhat random.

- 1B) **DS-1B:** Similar to *DS-1A*, except that fracture propagates into column flanges. In addition to measures for *DS-1A*, repairs to column will be necessary that will involve replacing a portion of the column.

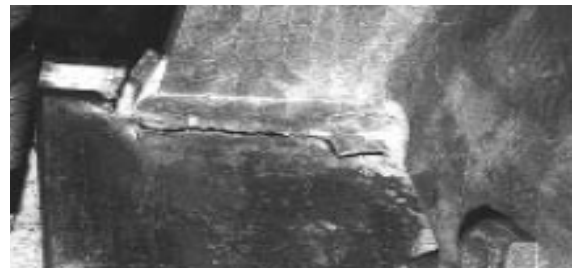
Damage State 2A and 2B: Fracture of upper beam flange weld, either alone or combined with *DS-1* type damage. Fracture may be confined to beam flange region (*DS-2A*) or propagate into column (*DS-2B*). Repairs will be similar to those required for *DS-1*, except that access to weld will likely require removal of a portion of the floor slab above the weld. This damage state was observed in damaged buildings but was not reported in laboratory tests. Its absence in laboratory tests is presumed to be due to the fact that most tests

- 2A) **DS-2A:** Fracture of upper beam flange weld, either alone or combined with *DS-1* type damage. Fracture is confined to beam flange region. Repairs will be similar to those required for *DS-1A*, except that access to weld will likely require removal of a portion of the floor slab above the weld.

- 2B) **DS-2B:** Similar to *DS-2A*, except that fracture propagates into column flanges. In addition to measures for *DS-2A*, repairs to column will be necessary that will involve replacing a portion of the column.

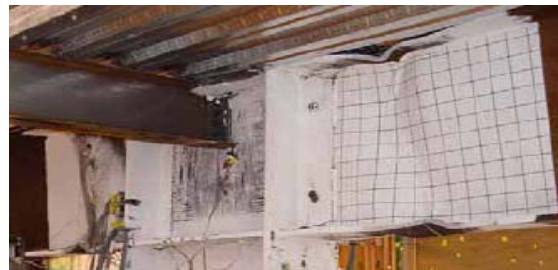
Damage State 1: Local beam flange and web buckling. The likely repair state for DS-1 is heat straightening of the buckled web and flanges.

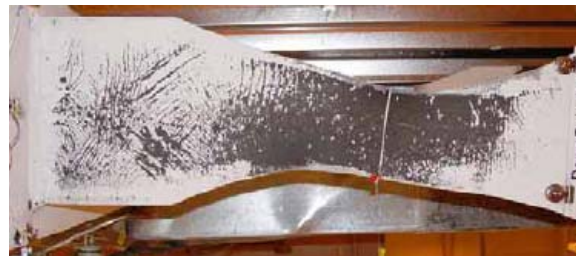
Damage State 2: DS1 plus lateral-torsional distortion of beam in hinge region. Repair by heat straightening may be possible, but it is likely that the distorted portions of the beam may need to be replaced.

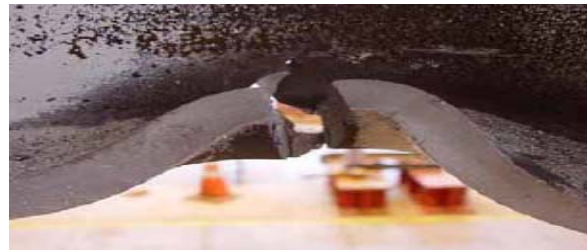
Damage State 3: Low-cycle fatigue fracture of beam flanges in buckled region of RBS. The fracture is usually precipitated by DS-1 and possibly DS-2. Repair will necessitate removal and replacement of distorted and fractured portion of beam.

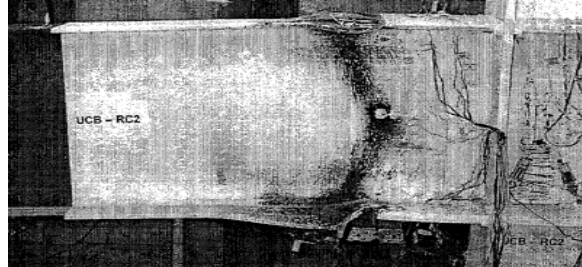
Damage State 1: Local beam flange and web buckling. The likely repair state for DS-1 is heat straightening of the buckled web and flanges.

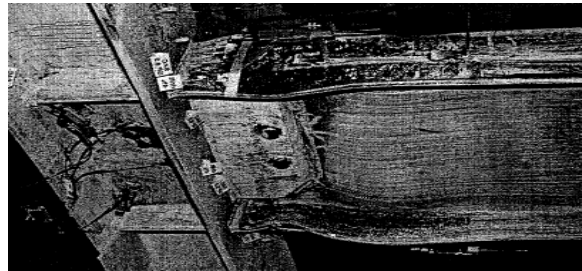
Damage State 2: DS1 plus lateral-torsional distortion of beam in hinge region. Repair by heat straightening may be possible, but it is likely that the distorted portions of the beam may need to be replaced. In contrast to RBS details, DS-2 was only observed in about one-quarter of the tests.

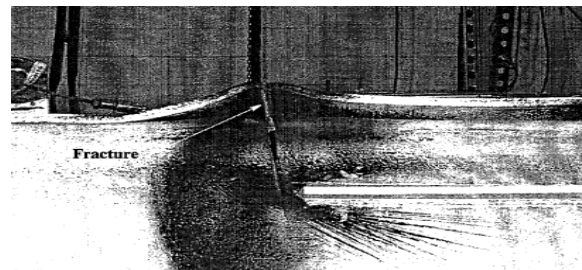
Damage State 3: Buckling associated with DS-1 (and sometimes DS-2) that leads to low-cycle fatigue fracture of beam flanges in hinge region or adjacent to the flange weld, sometimes accompanied by severe distortion of beam. Repair is likely to involve replacing the distorted and/or fractured portions of the beam.

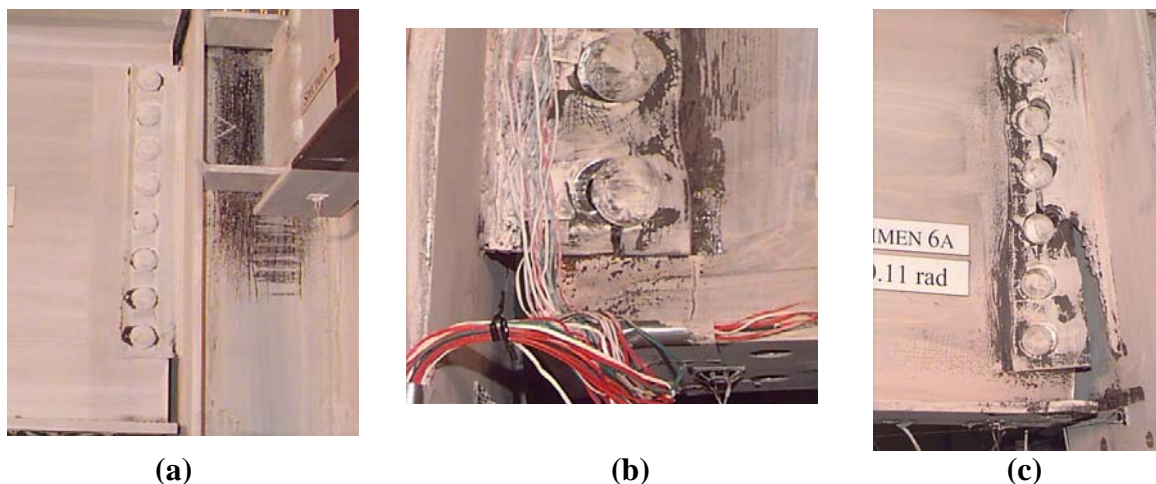
Damage State 3: Complete separation of shear tab, close to complete loss of vertical load resistance. Repair will include complete replacement of shear tab and installation of new bolts. Repairs will require shoring of beam.

Figure 3.1 Illustrations for damage states of shear tab connections (a) DS-1, (b) DS-2, (c) DS-3.

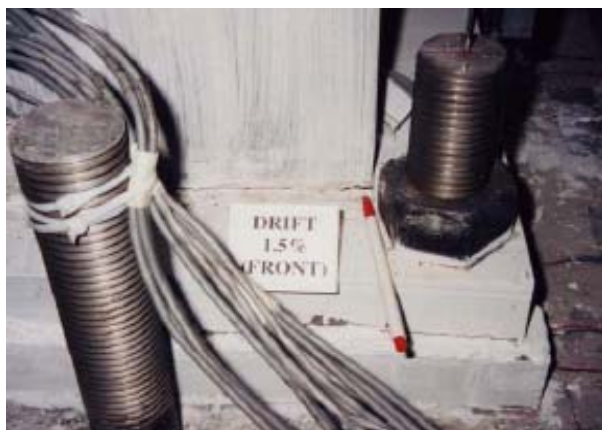
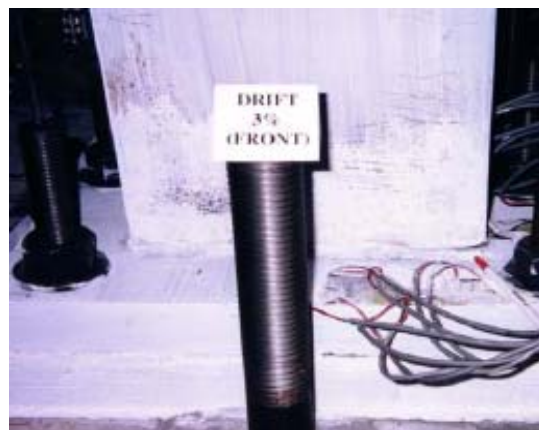
Figure 4.1 Illustration of DS-1 Fracture Initiation at Column Based Plate

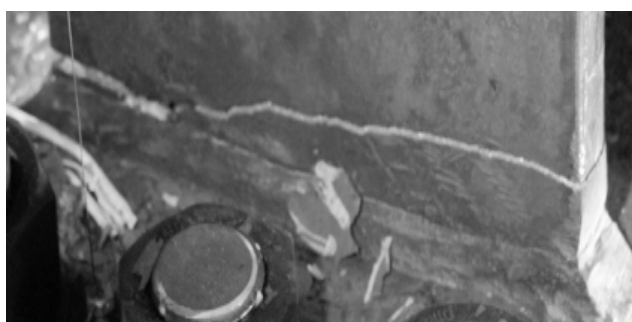
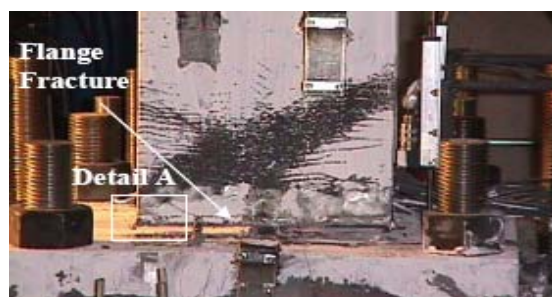
Figure 4.1 Illustration of DS-2 Brittle Fracture Propagation at Column Base Plate

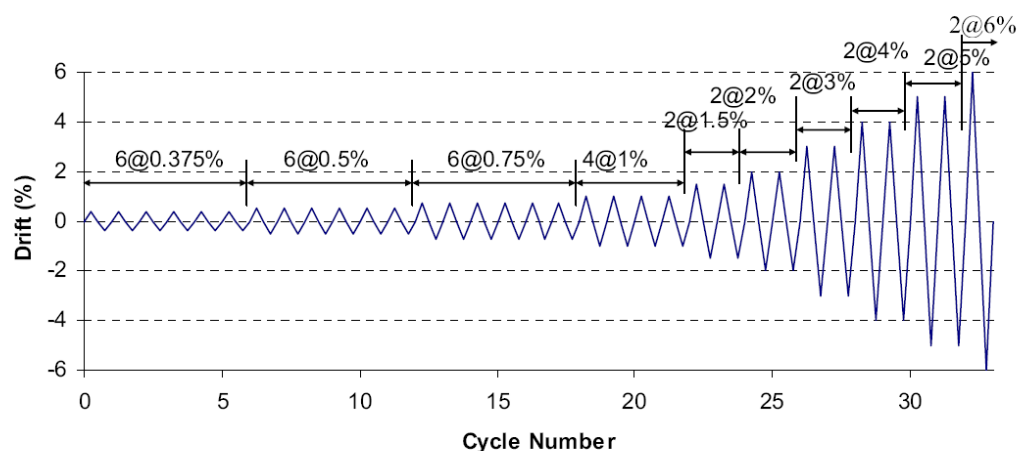
Generally, all of the connection test used the SAC loading protocol (or a close variant of this), except for the six tests of column base connections by Burda and Itani (1999). The SAC loading protocol is shown in Figure B1.1.

Load Step #	Drift	Number of Cycles, n
1	0.00375	6
2	0.005	6
3	0.0075	6
4	0.01	4
5	0.005	2
6	0.015	2
7	0.005	2
8	0.02	2
9	0.005	2
10	0.03	2
11	0.005	2
12	0.04	2
13	0.005	2
14	0.05	2
15	0.005	2
16	0.05	Until failure

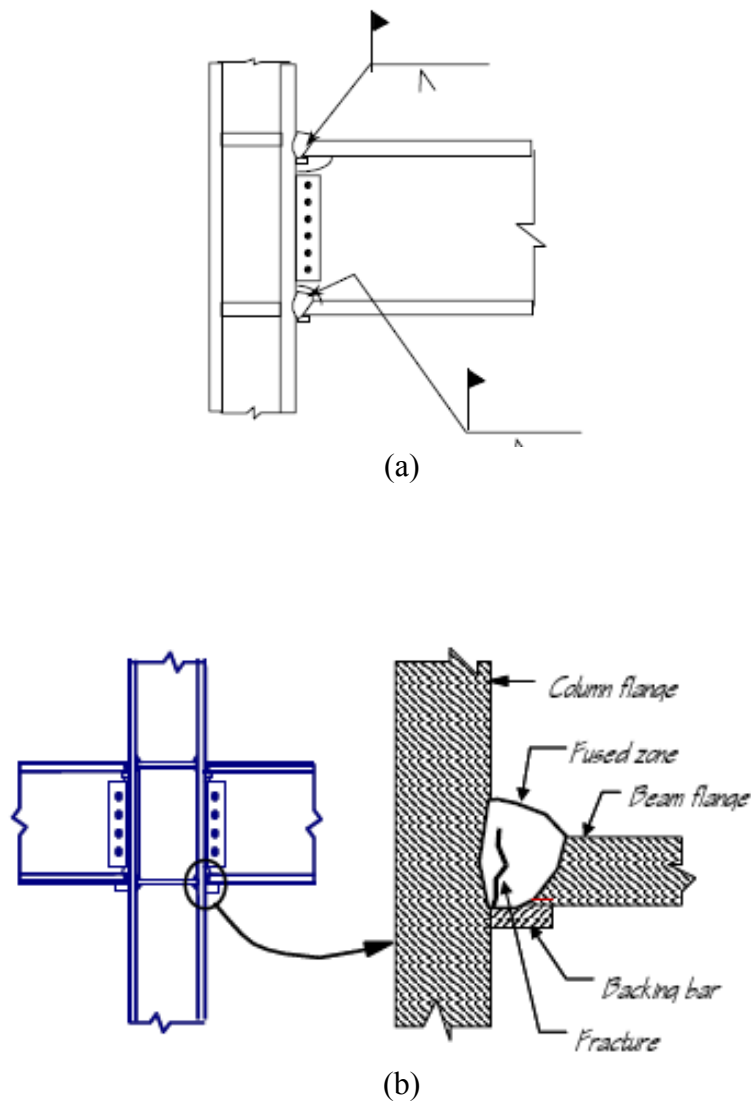
Figure B2.1 Typical Pre-Northridge moment connections a) Exterior connection b) Interior connection

Shown in Figures B2.1 to B2.4 are typical details for the beam-column connections, shear tab connections, and column base connections as reported in the literature for steel SMF systems.

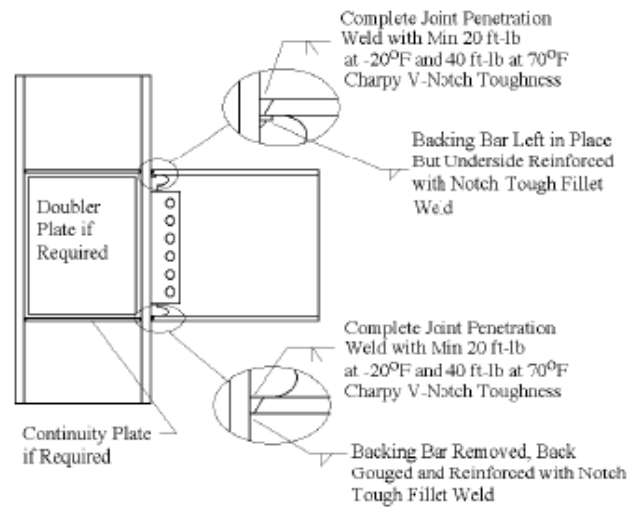
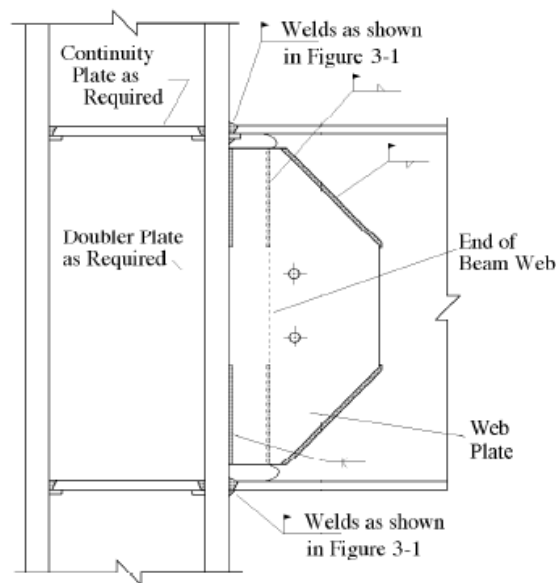
Figure B2.2 Post-Northridge Beam-to-Column connections a)Welded Flange Bolted Web b) Free Flange Connection

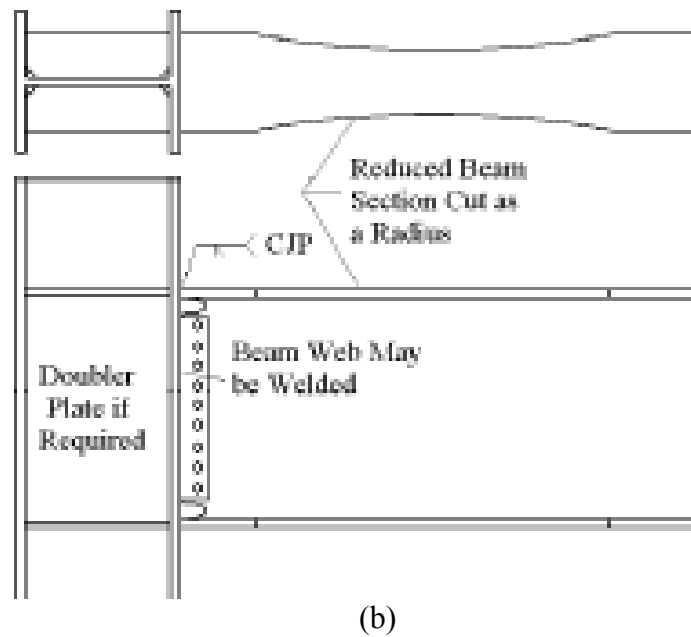
Figure B2.3: Post-Northridge Beam-to-Column connections a) Cover Plate Connections b) Reduced Beam Section

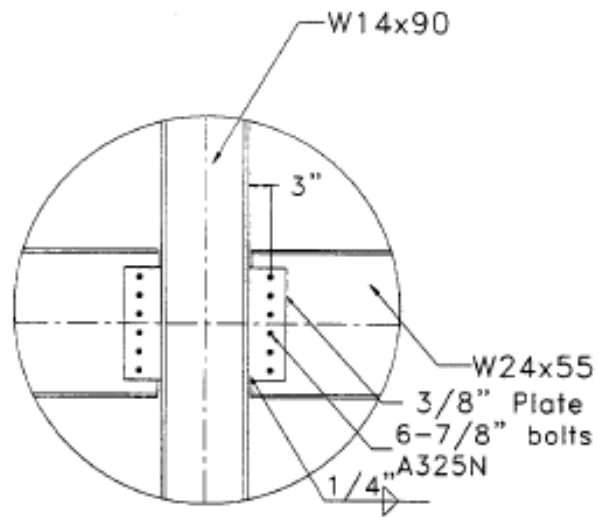
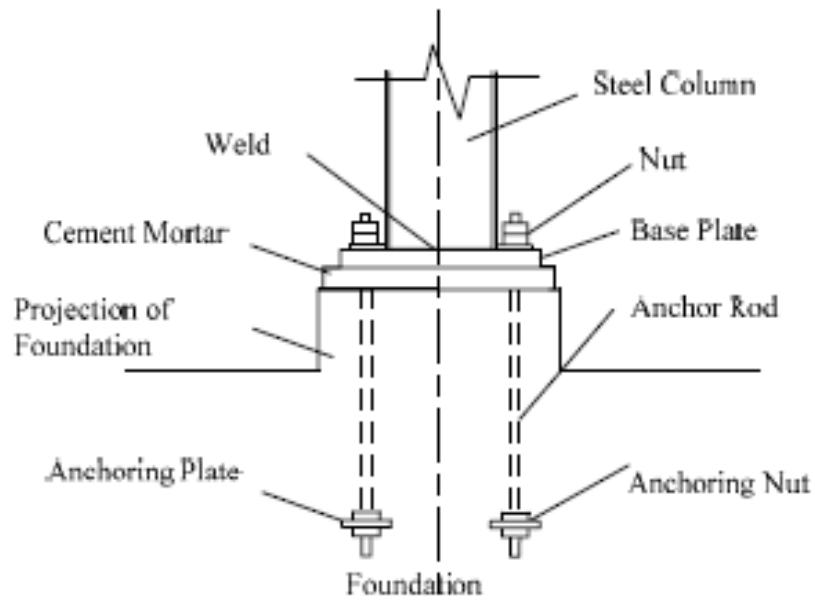
Figure B2.4: a) Typical Gravity Beam Shear connection, b) Column Base Plate connection

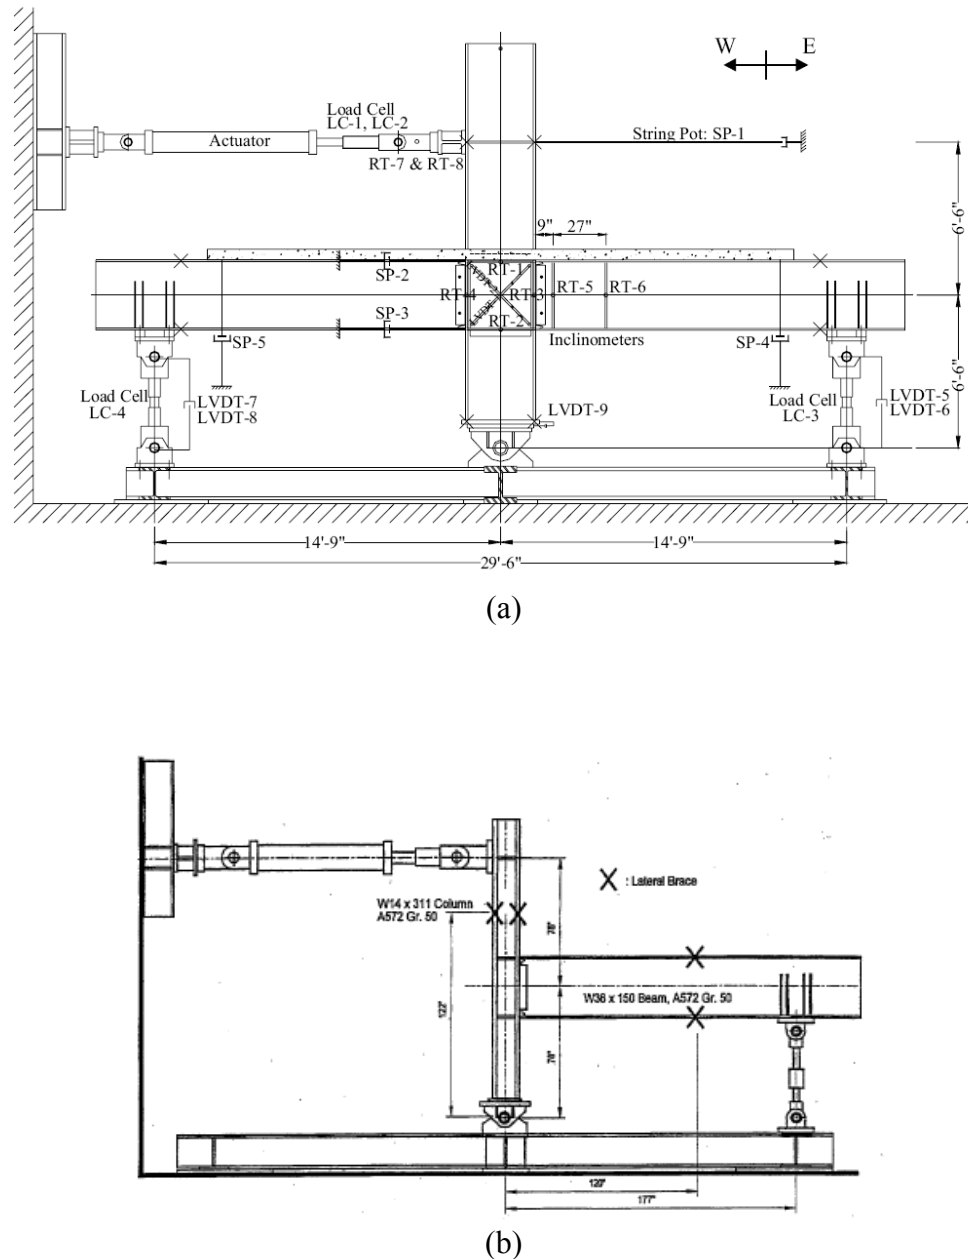
Figure B3.1: Test configurations of Beam-to-Column connections a) Test Configuration 1 – Interior b) Test Configuration 1 - Exterior

Figures B3.1 to B3.5 shown the typical test configurations for the steel frame components. The figure titles indicate the test configuration types as references in the spreadsheet database of test information.

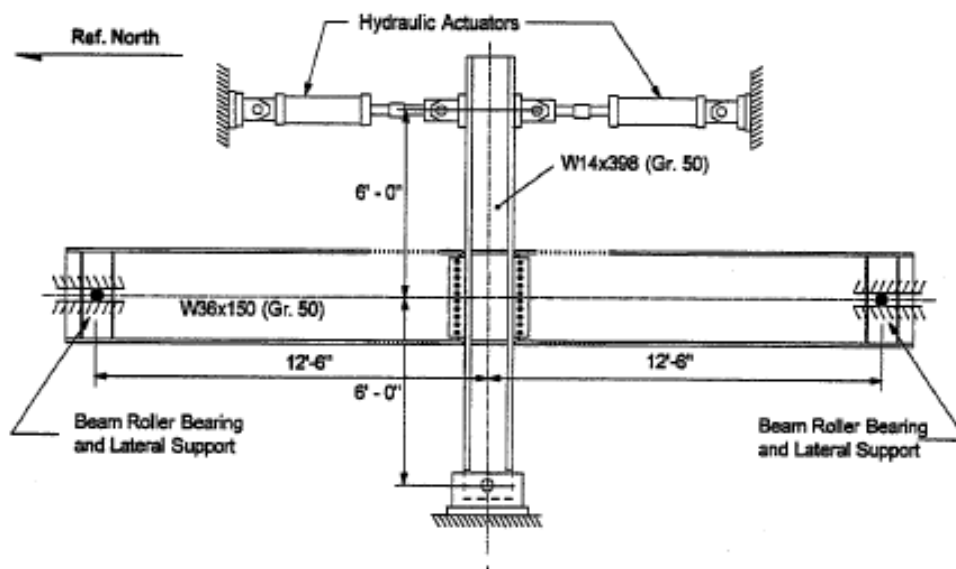
Figure B3.2: Beam-to-Column Test Configuration 1^T – Interior

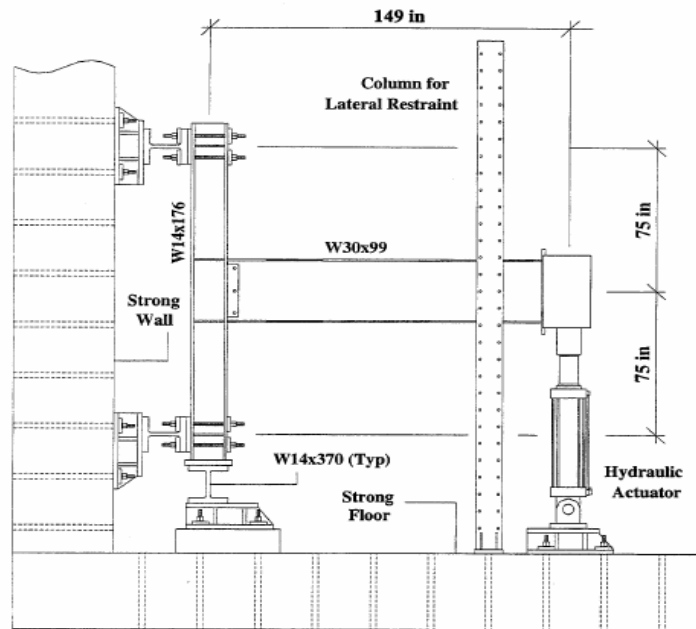
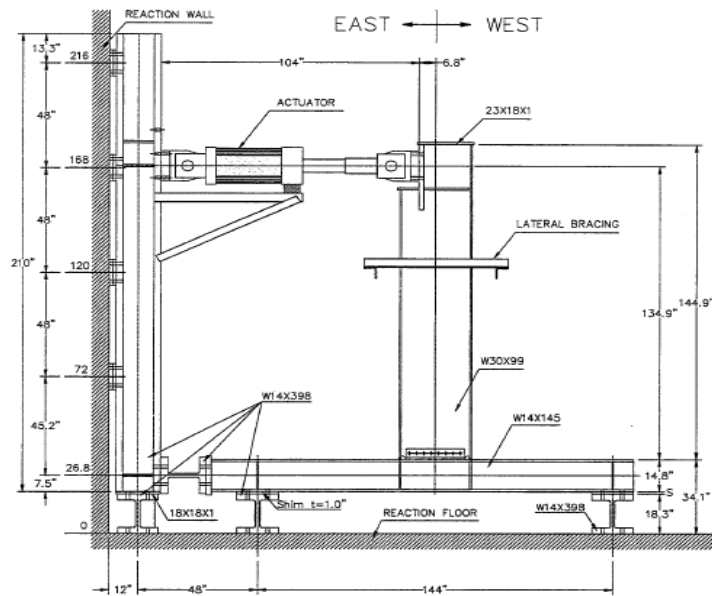
Figure B3.3 Test configurations of Beam-to-Column connections a) Test Configuration 2 – Exterior b) Test Configuration 2^T - Exterior

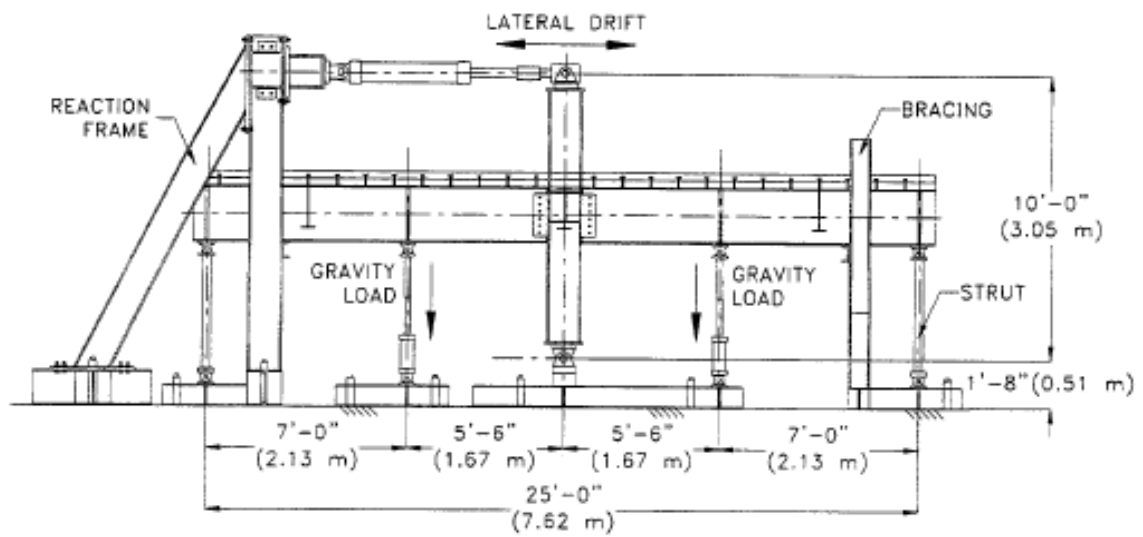
Figure B3.4: Gravity beam shear test configuration

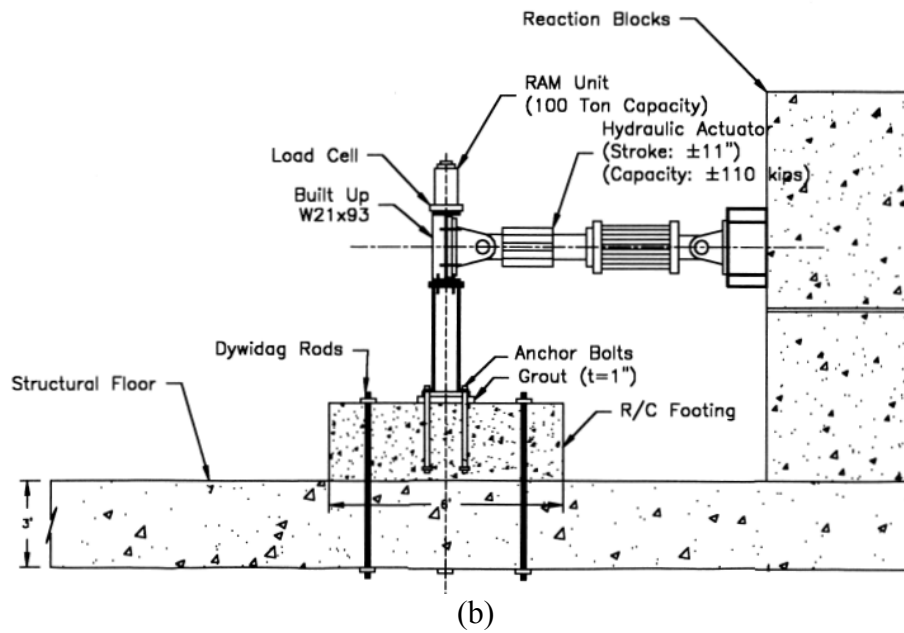
Figure B3.5: Column Base Plate test configurations a) Burda and Itani (1999)

b) Fahmy (1999)

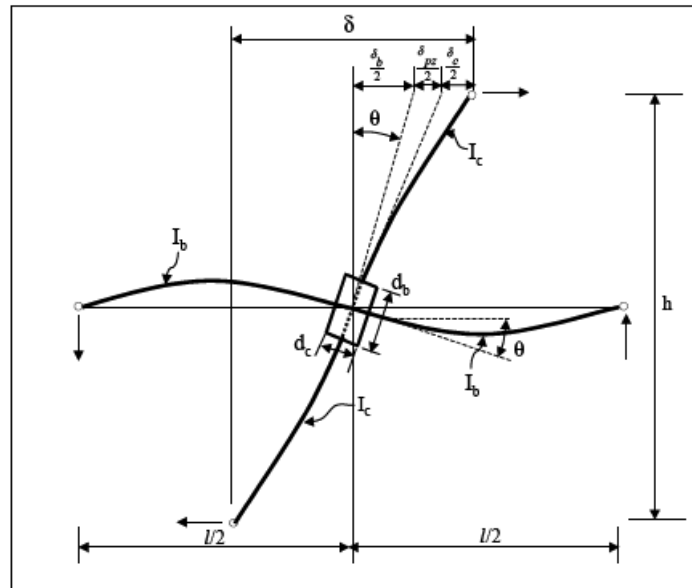
Figure B4.1 Equivalent building drifts (Gupta and Krawinkler (2002))

For beam-to-column connections the test results were transformed to equivalent building drift based on the idealized definitions shown in Figures B4.1 and B4.2

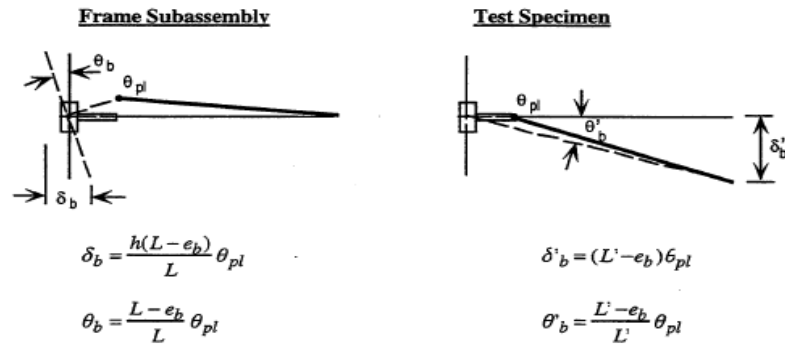
Note that θ_{pl} is significantly larger than θ_b if e_b is large (improved connection).

Figure B4.2 Test specimen to frame subassembly (Gupta and Krawinkler (2002))

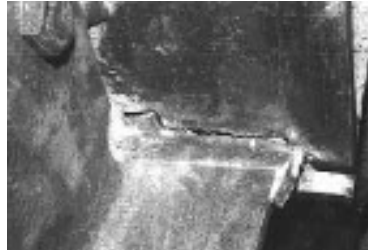
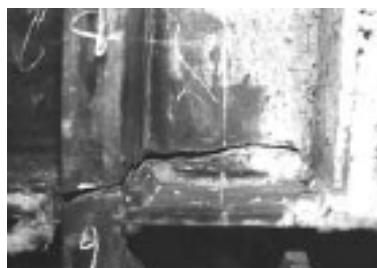
Figure C.1: Pre-Northridge Beam-Column failure modes a) Fracture at fused zone. b) Column flange “divot” fracture c) Fracture through Column Flange d) Fracture Progresses into Column Web

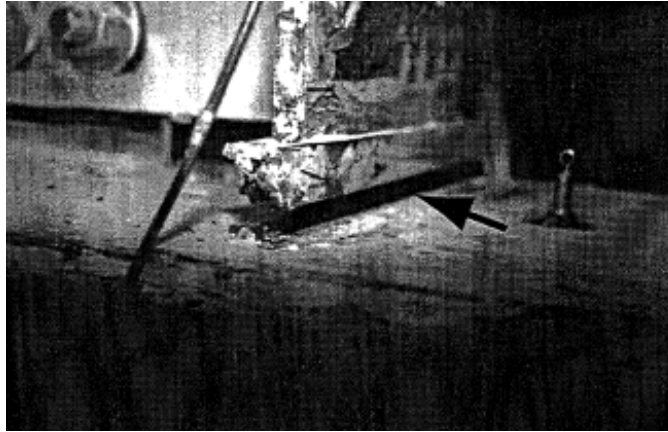
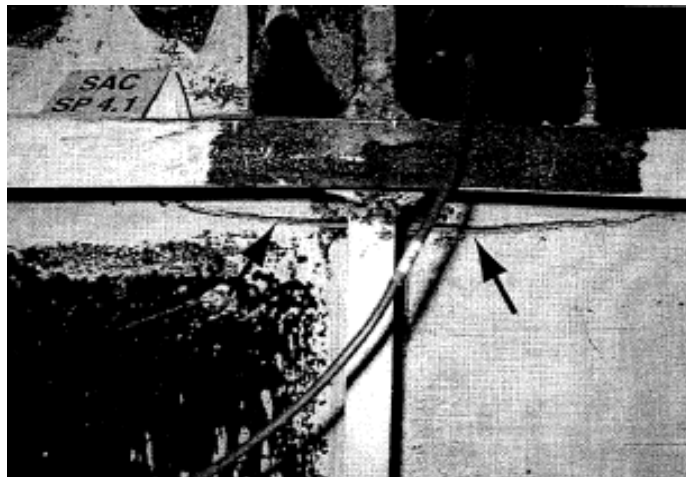
Figure C.2: Pre-Northridge Beam-Column failure modes a) Column web K-zone failure b) Divot pull out fracture of the bottom flange weld along the backing bar.

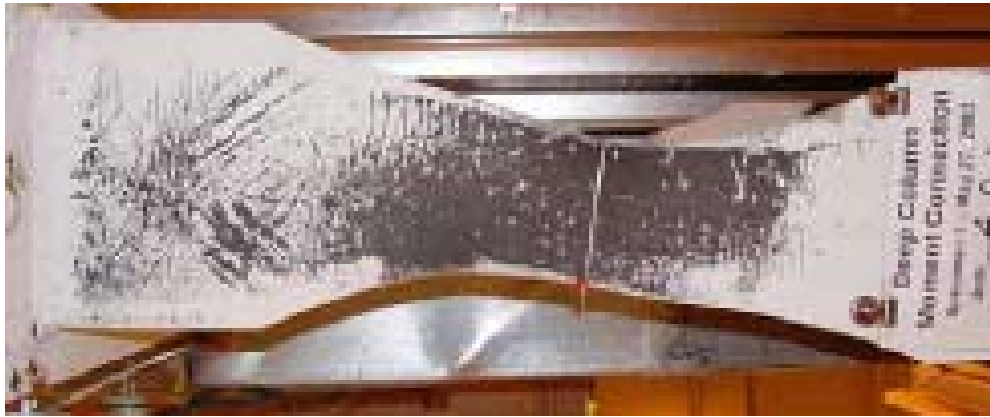
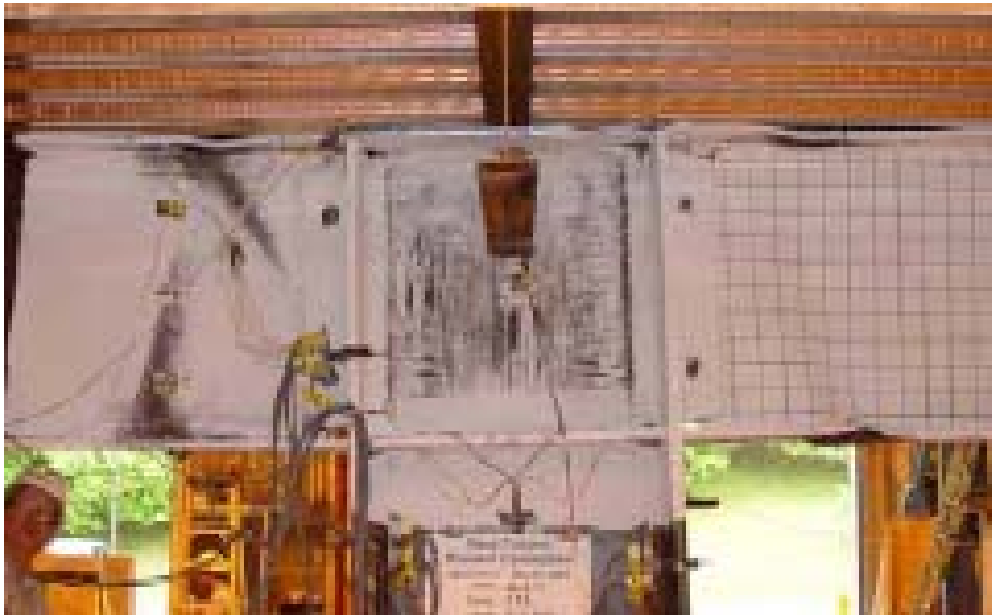
Figure C.3: RBS failure modes a) Bottom flange out-of-plane movement at 4% drift b) Yielding and buckling in connection region at 4% drift

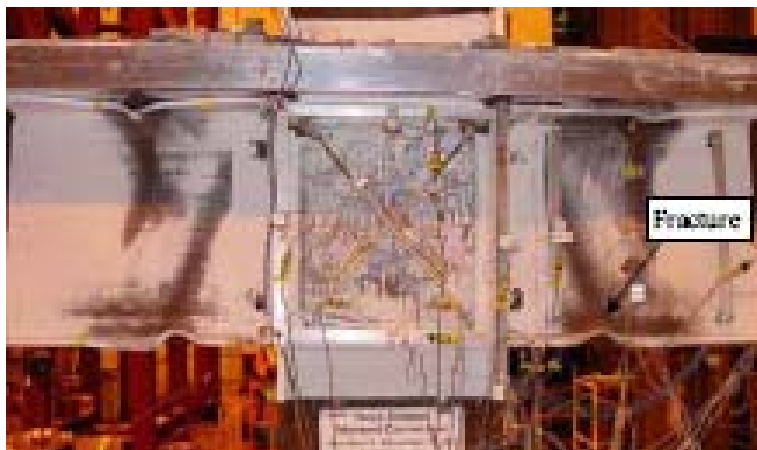
Figure C.4: 4 RBS failure modes a) Fracture in bottom flange at 5% drift. Low cycle fatigue fracture in hinge region b) Pronounced beam yielding and local buckling at RBS, fracture in the east beam bottom flange at center of RBS at 5% drift.

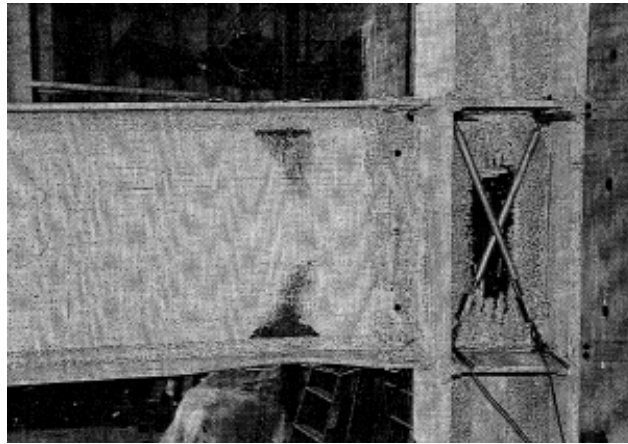
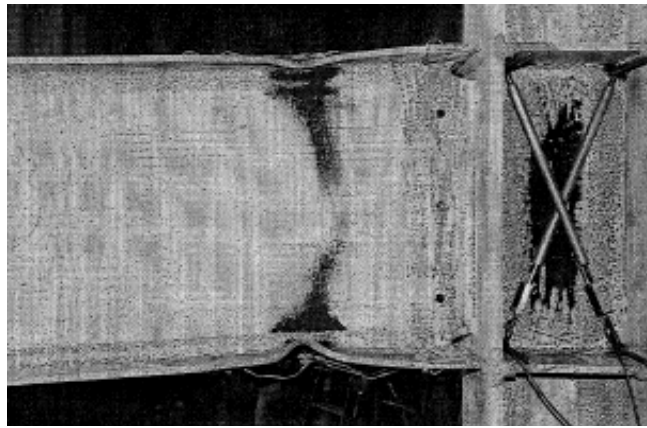
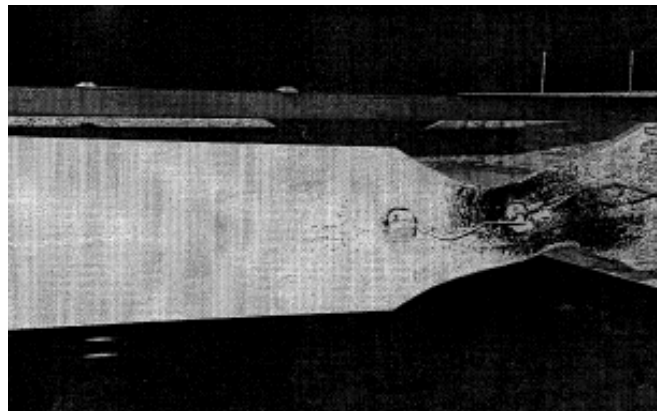
Figure C.5: RBS failure modes a) Yielding pattern at 3% drift b) Yielding and buckling pattern at 4% drift c) Lateral torsional buckling of bottom flange at 4% drift

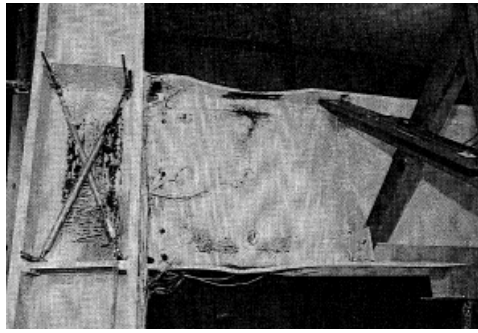
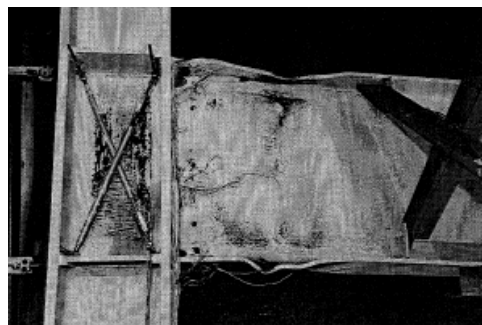
Figure C.6: RBS failure modes a) Local buckling at 3% drift b) Lateral torsional buckling at 4% drift c) Increased local buckling and lateral torsion buckling at 5% drift.

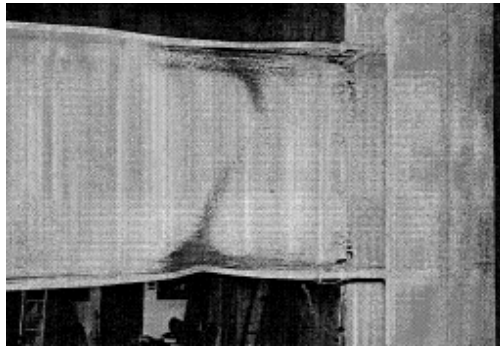
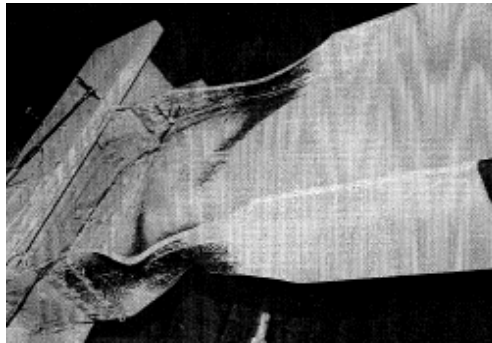
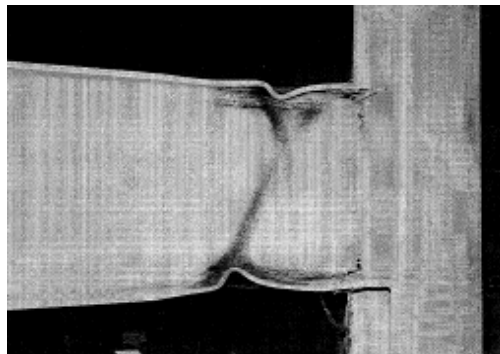
Figure C.7: RBS failure modes a) Flange local buckling at 3% drift b) Lateral torsional buckling and twisting of beam at 4% drift c) Increased buckling caused strength degradation and test halted at 5% drift

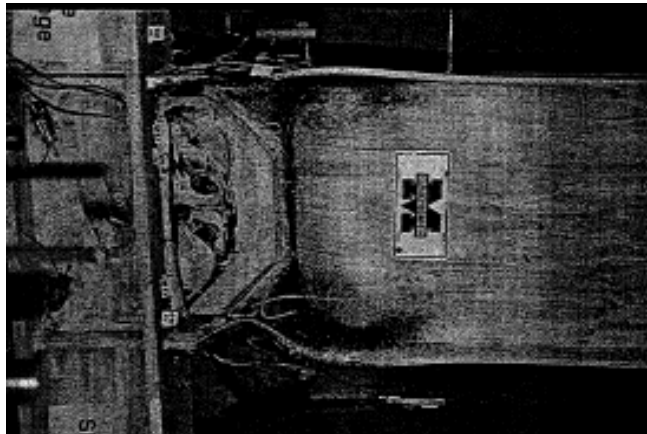
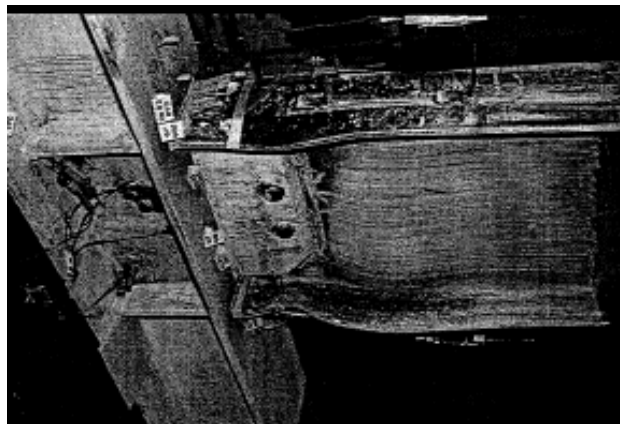
Figure C.8: Free Flange connection failure modes a) Plastic hinge in the beam at 4% drift
b) Lateral torsional buckling and twisting of beam at 4% drift.

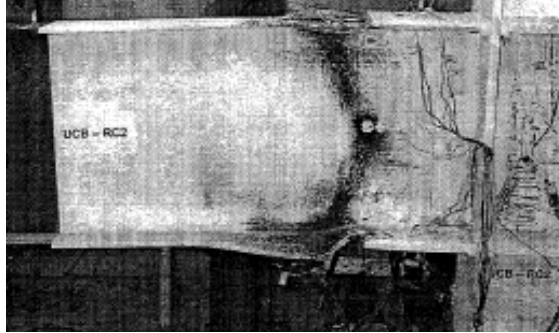
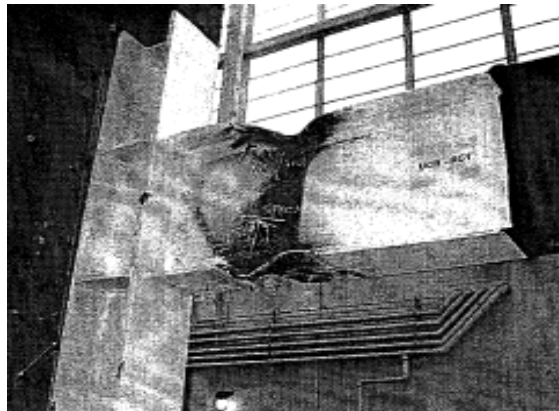
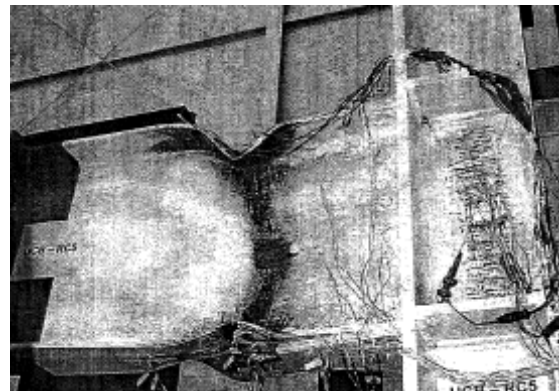
Figure C.9: Cover Plate connection failure modes a) Beam flange local buckling and web local buckling at 3% drift b) Beam flange local buckling and web local buckling at 4% drift c) Increased buckling and ductile tearing in beam flanges at buckled region at 5% drift

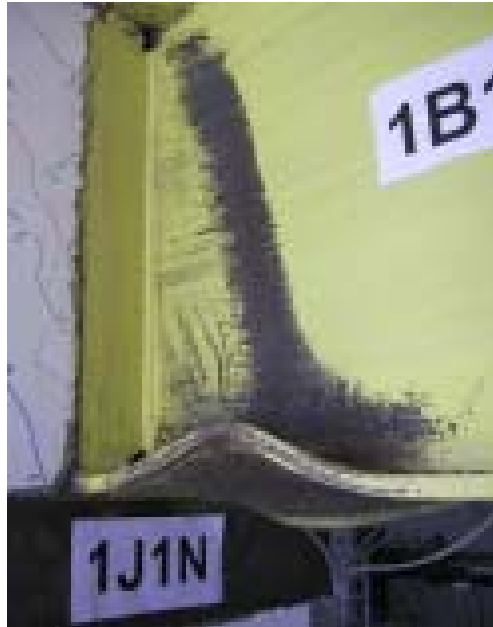
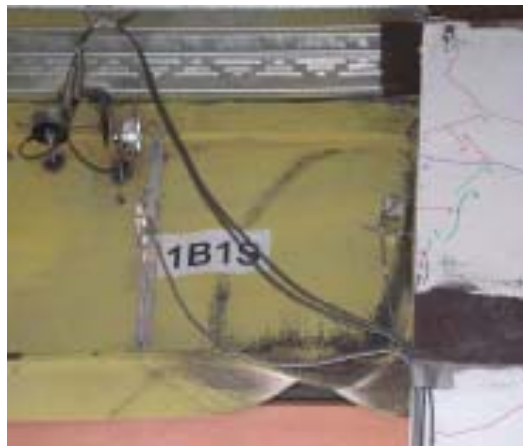
Figure C.10: System effects and effects of slab on top in an RCS frame. The top flange deforms much less when slab is present a) Yielding and local buckling at approximately 3% drift b) Yielding and local buckling at approximately 5.5% drift.

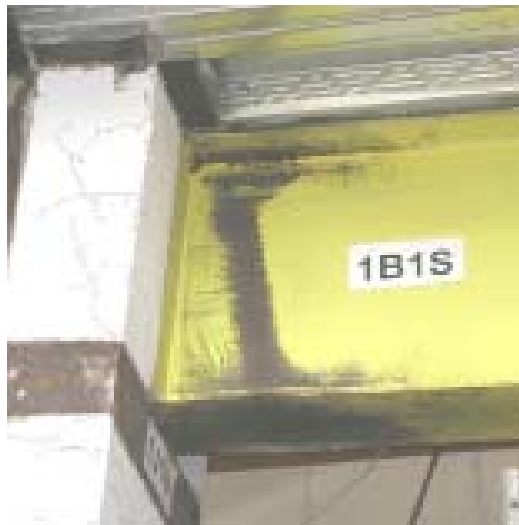
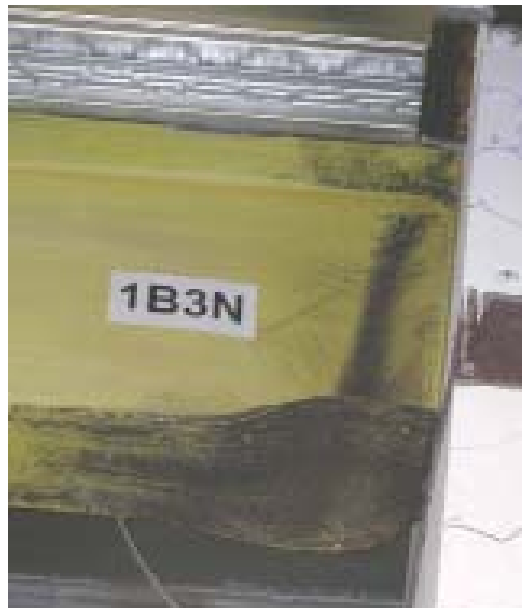
Figure C.11: System effects of RCS frame. a) Tension side. Yielding and local buckling. Buckles have nearly straightened out on the tension side. b) Compression Side. Yielding and local buckling

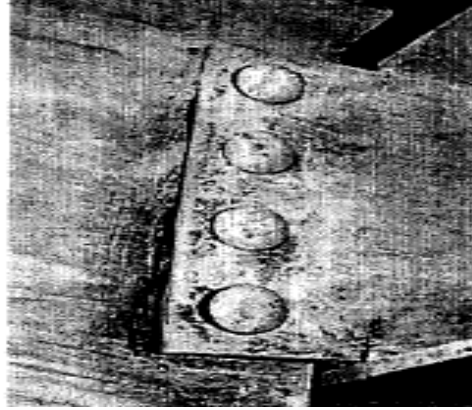
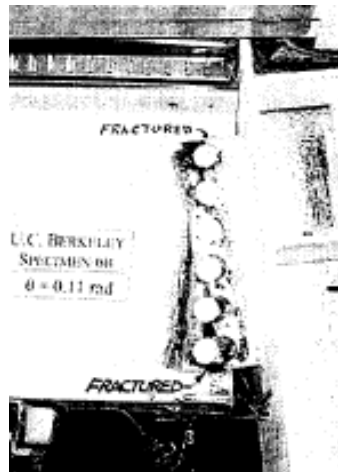
Figure C.12: Failure modes of Gravity Beam Shear connections a) Elongation of bolt holes b) Small crack at the bottom of shear tab c) Shear tab completely fractured

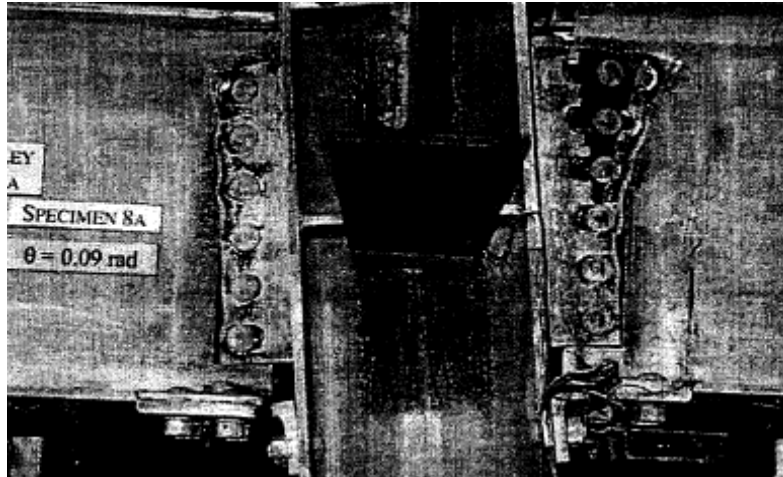
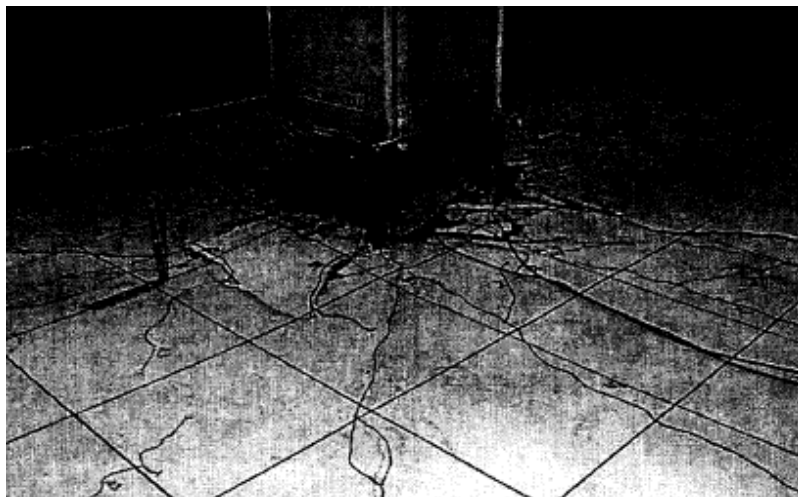
Figure C.13: Failure modes of Gravity Beam Shear connections a) Interior gravity beam shear connection at the end of test. Shear tab fracture at 9% drift. b) Cracking of concrete around column at 9% drift.

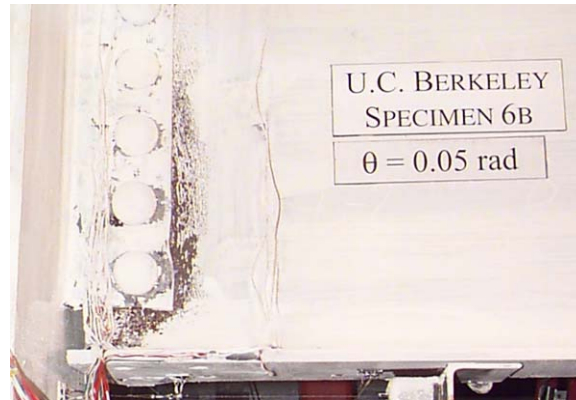
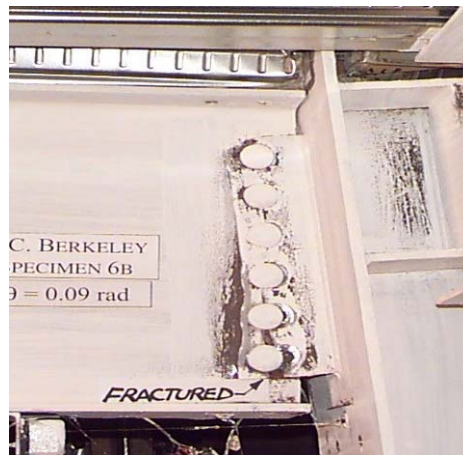
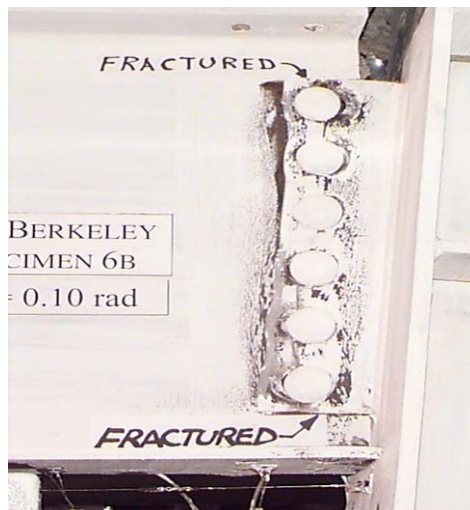
Figure C.14: Failure modes of Gravity Beam Shear connections a) Partial tearing at bottom of tab and elongation of bolt holes at 4% drift b) Fracture through most of shear tab at 9% drift c) Fracture through shear tab at 10% drift.

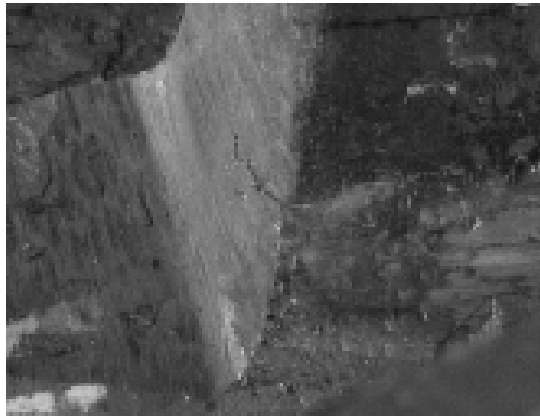
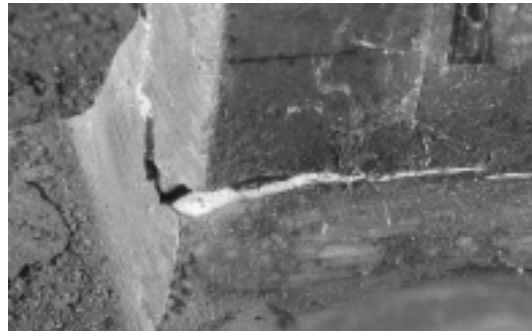
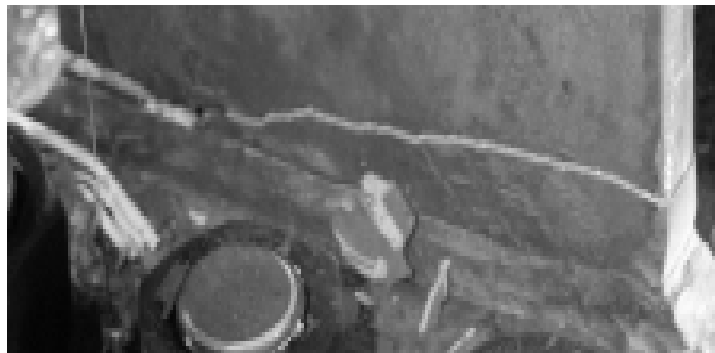
Figure C.15 Failure modes of Column Base Plate connections a) Ductile crack initiation b) Maximum extent of ductile crack c) Complete fracture of column flange

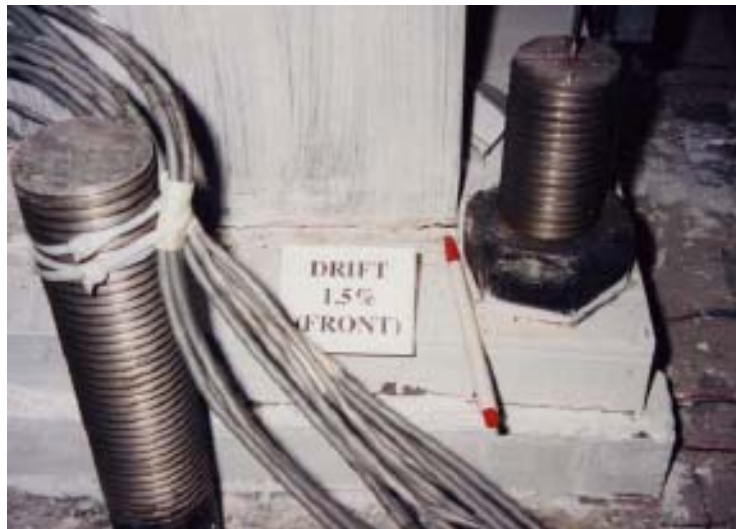
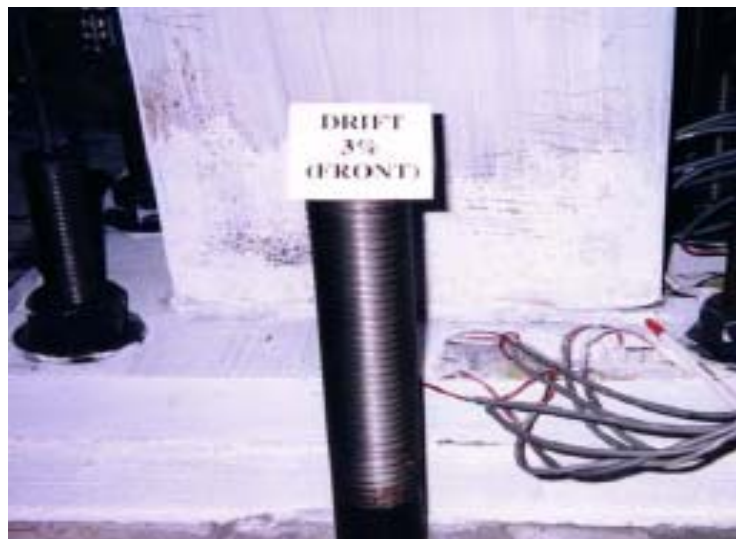
Figure C.16 Failure modes of Weak-Axis Column Base Plate connections a) Initiation of ductile fracture at column flange tip at 1.5% drift level b) Fracture has propagated into column flange at 3% drift level.
