BUILDING SEISMICALLY RESILIENT COMMUNITIES BY EFFECTIVE SEISMIC RISK REDUCTION AND DISASTER RECONSTRUCTION PROGRAMS

H. Kit Miyamoto and Amir SJ Gilani
Miyamoto International
West Sacramento, CA, US

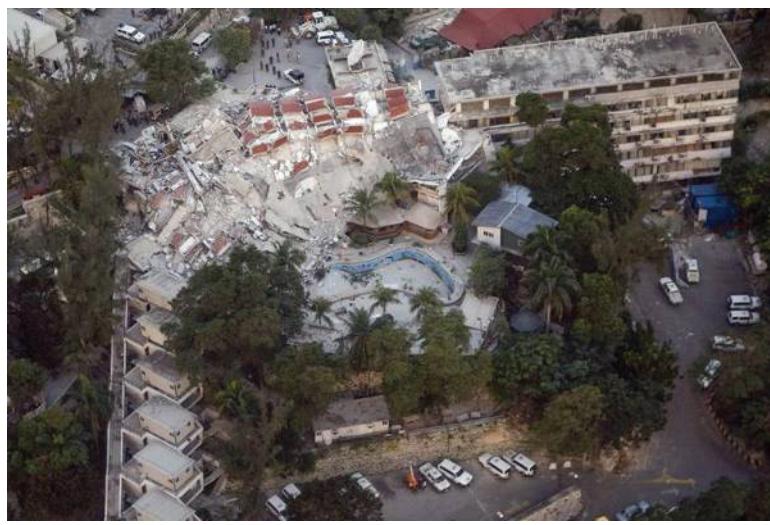
Figure 1. Collapsed UN building (UNDP Global 2010)

2010 Haiti Earthquake. The catastrophic 2010 Haiti earthquake has had a tragic effect on the lives of more than 3 million people, including over 200,000 casualties, over 1,000,000 displaced people, and financial losses that crippled the country's economy. Thousands of buildings collapse, including the United Nations (U.N) headquarters Port-au-Prince; as shown in Figure 1.

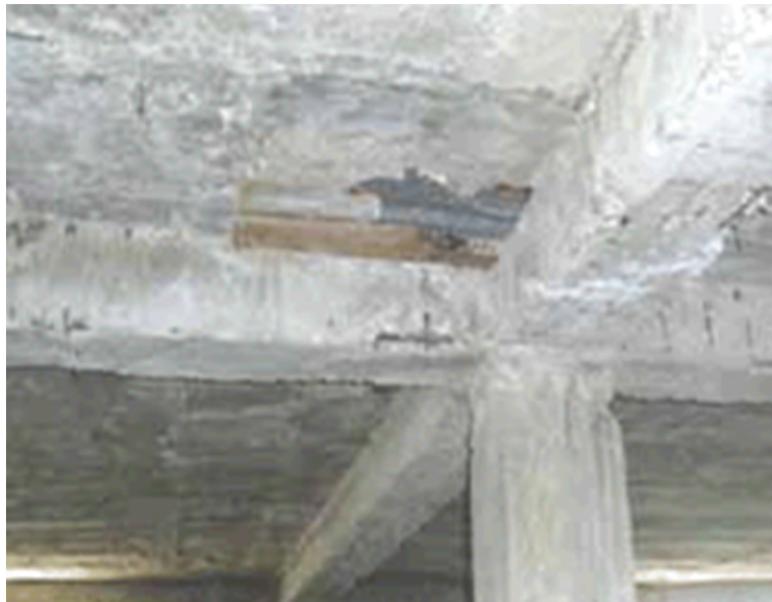
Figure 2. Example of poor construction in Haiti

Similar to past and recent events in other developing countries such as Indonesia, Pakistan, and Turkey, the main causes of the devastation can be attributed to several factors. Among them: This earthquake caused devastation disproportional to its magnitude. If any form of standard of seismic design and construction had been used in Haiti, many lives and much of the economic loss could have been avoided. The main observed factors that exacerbated this tragedy were the following: a) Design and construction practices had not considered earthquake forces properly. In addition, many engineers and contractors had neither formal education nor experience in earthquake-resistant design methodologies. b) Absence of an accepted building or seismic engineering code, and proper quality control system in design, and construction. In addition, no formal building review process was in place. c) The rapid growth of low-income neighbourhoods due to migration into the city from outlying areas. In these neighbourhoods, unsafe housing had been built using substandard construction materials and practices. d) Lack of preparedness by the national government, local agencies, international organizations, emergency responders, and citizens for a major earthquake. Many of the structures in Haiti as well as other developing countries are constructed of either what is referred to as non-ductile concrete, unreinforced masonry (URM), or other stone-type block construction. These particular building types are seismically vulnerable and pose a life-safety hazard. An example of poor construction in Haiti is shown in Figure 2.

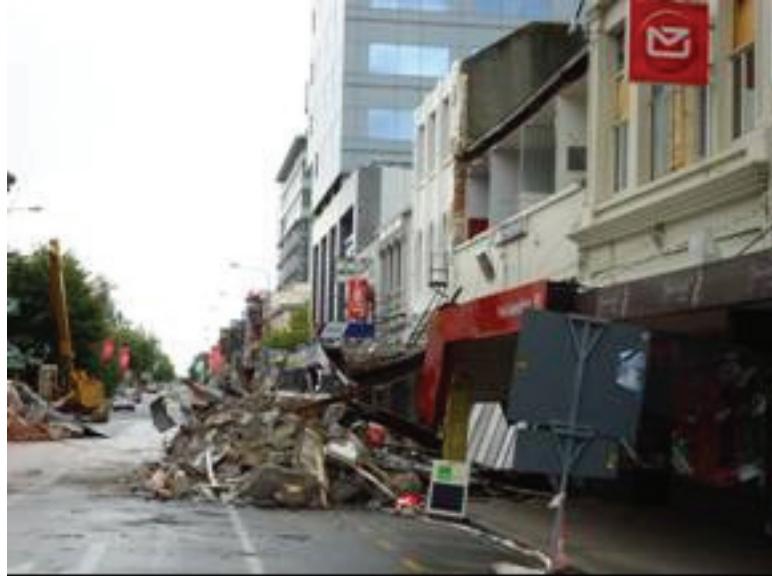
Figure 3. Collapsed masonry buildings in the CBD

2011 New Zealand Earthquake. The magnitude-6.3 February 2011, New Zealand, earthquake caused more than 160 deaths and damage costing over US\$20 billion. Many buildings were damaged; over 30% of the brick and stone buildings in the central business district (CBD) either collapsed or sustained major damage (see Figure 3) resulting in total closure of the CBD for period of several months because many of the remaining buildings were considered unsafe (Miyamoto International 2011).

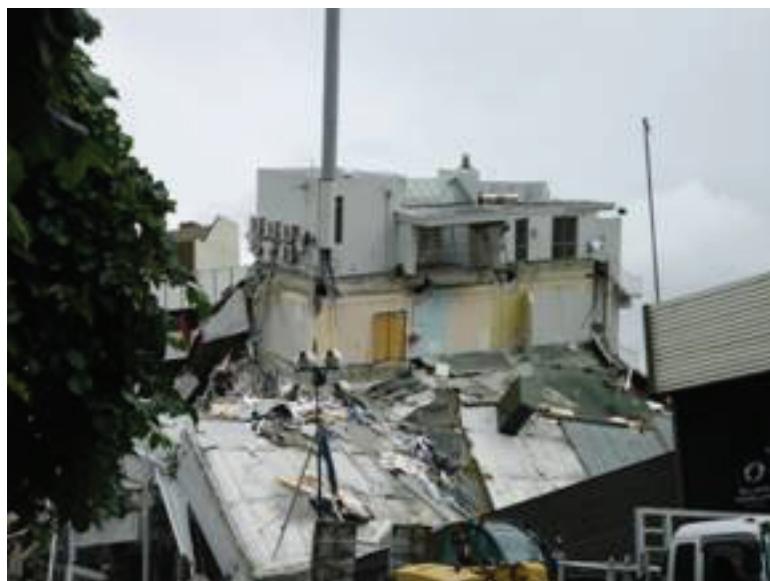
Figure 4. Collapsed nonductile concrete building in the CBD

September 2010 earthquake (which had no direct fatalities). The 2011 Earthquake caused extensive liquefaction and ground failure, which also led to widespread loss of water and electricity. The severity of this earthquake was unexpected in Christchurch and points to the same problem that exists in many other urban areas that are close to active faults. The level of damage to modern (post-1980) construction was alarming. Over 50% of the building stock—more than 1,300 buildings—are expected to be claimed as total losses. Many of these buildings were designed and constructed using modern seismic codes. Nonetheless, they sustained significant structural and nonstructural damage, and many have to be demolished. Similar observations were made following the 2010 Chile earthquake. In both countries, modern seismic codes are advanced and local engineers are quite capable, and there are tight construction standards. It is important to note that the building codes likely did what they were intended to do: that is, to provide life safety and prevent collapse. However, the codes do not have provisions for either the building condition after an earthquake or financial losses as a result of an earthquake.

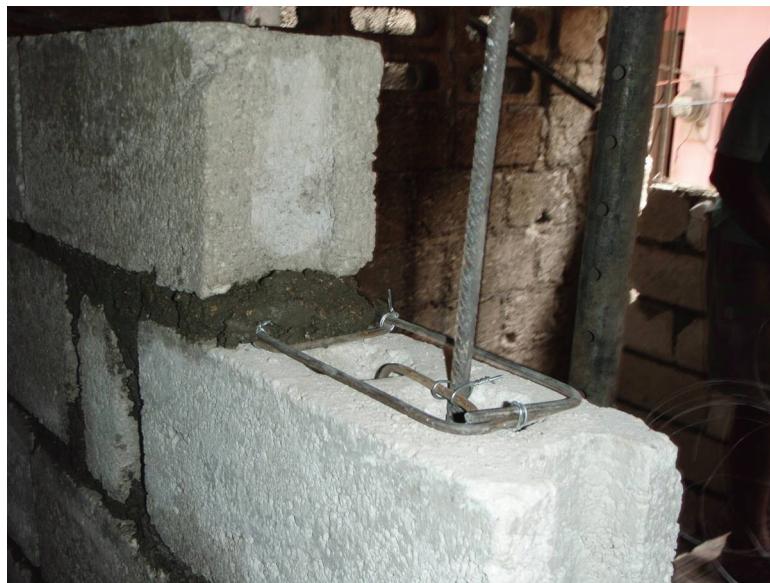
Figure 5. Example of acceptable reconstruction in Haiti

The seismic rehabilitation of thousands of buildings that is currently under way (see Figure 5) will allow many more thousands to return home, and provide a safe and seismically resilient community for citizens. At the time of this paper, over 9,000 houses have been reconstructed under various programs; see Table 2.

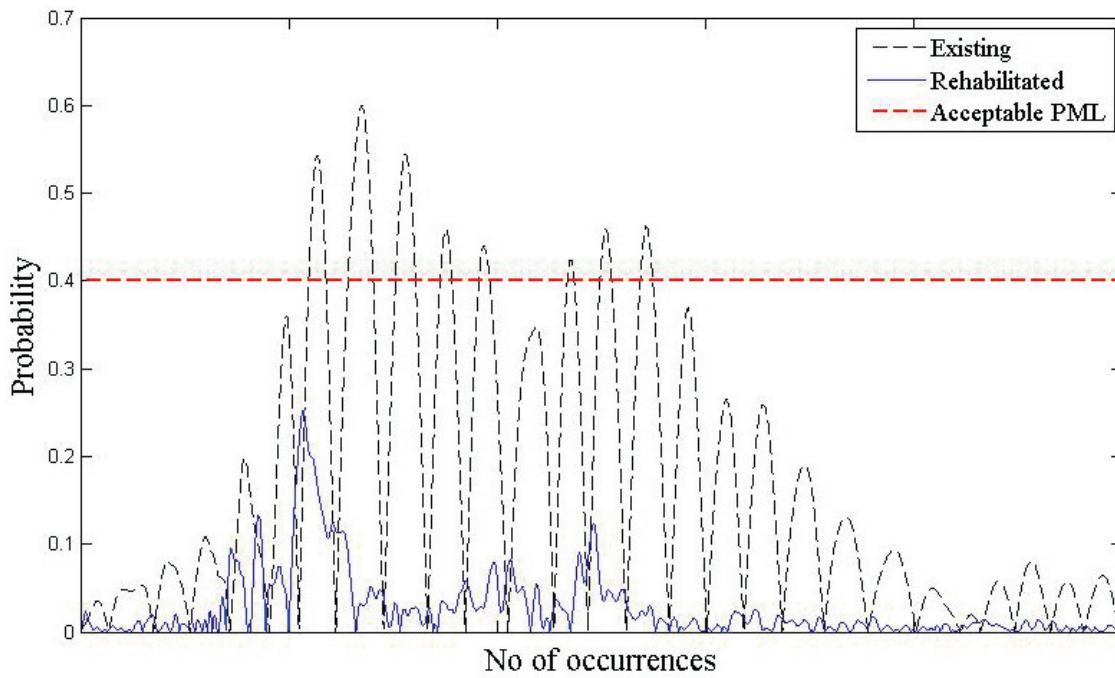
Figure 6. Example of PML analysis

In risk management language, this matrix is also directly related to what is commonly referred to as “probable maximum loss” (PML). PML implies the level of damage (casualties, financial loss, and loss of income) that can be expected for a given building at a given level of earthquake. As shown in Figure 6, seismic rehabilitation and/or reconstruction should be such that this example building whose analyzed performance was above acceptable PML level and thus inadequate—would be strengthened so that its post-retrofit damage index is below the PML threshold resulting in significant risk reduction. The low level of PML in this example was achieved by using an innovative seismic protective device (such as

isolators and dampers) which protect structural and nonstructural components. The concept of PML is especially relevant to developing countries and for critical facilities in these countries. In many instances in these countries, the level of seismic hazard and the risk associated with it are not well known. By conducting a preliminary (often referred to as a “phase I”) analysis, an approximate but accurate estimate of the PML for a given structure and/or group of buildings in a facility can be determined quickly. This PML estimate can then be used to prioritize the buildings for further analysis and possible retrofit within the allocated budget.
