# Lessons from the Postearthquake Safety Evaluation in the 2010-2011 Canterbury, New Zealand Earthquakes and Implications for Updating ATC-20

Presentation at the  
14<sup>th</sup> U.S.-Japan Workshop on  
the Improvement of Structural  
Design and Construction  
Practices

*Bret Lizundia  
Rutherford + Chekene  
San Francisco*

*December 2012*

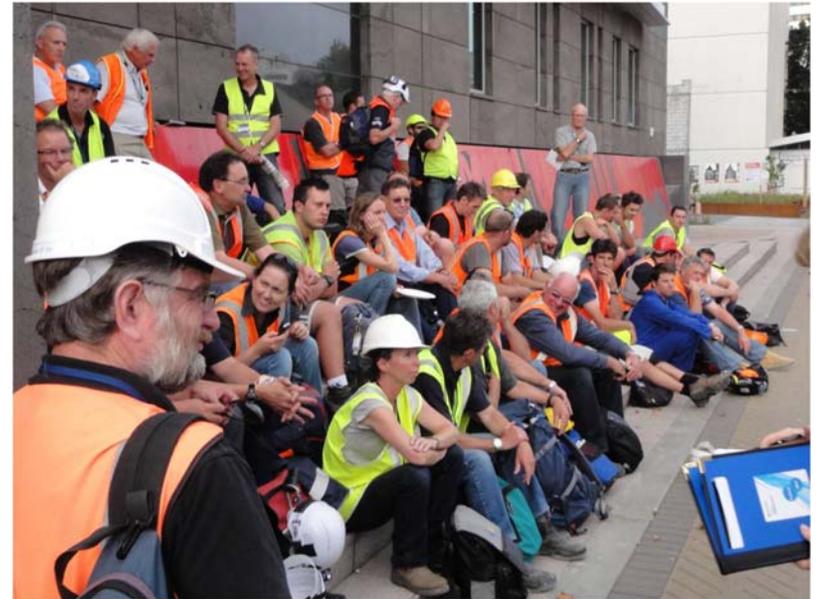
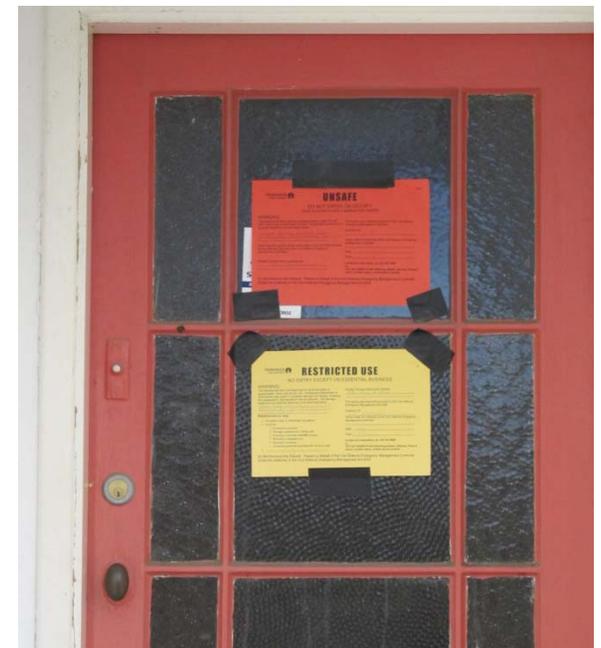
- New Zealand guidelines were under development.
- No training manual and less guidance than ATC-20 family
- Heroic volunteer efforts, but evaluators had limited training and no credentialing program
- Old placards were not always removed and ink faded.
- **RESTRICTED USE** placard not fully utilized; as “No Entry Except on Essential Business” subtitle confused issue

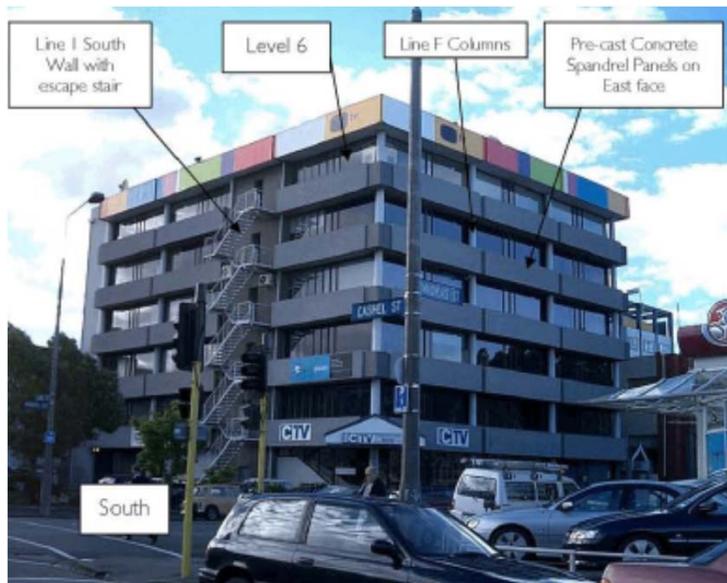
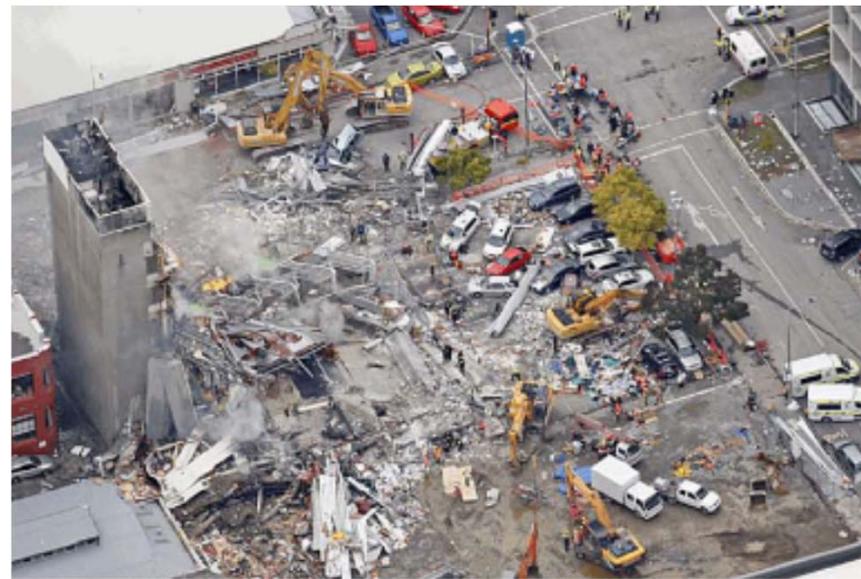
Photo Credits: Hyland and Smith (2011)

- The “bad” building problem
  - *Is it appropriate to provide an INSPECTED tag to a building with a known form of hazardous construction (such as URM bearing walls or nonductile concrete)?*
  - *The INSPECTED placard merely means that the building is as safe and as viable as it was before the earthquake; it is not a guarantee of future performance.*
