EVALUATION OF PERFORMANCE OF TAIWAN HOUSING STOCK AND SCHOOLS DURING THE $M_w6.4$ KAOHSIUNG/MEINONG EARTHQUAKE OF FEBRUARY 6, 2016

Ramon Gilsanz, Cathy Huang, Jessica Mandrick, Joe Mugford
Gilsanz Murray Steficek LLP (GMS)
New York, N.Y. USA

Shyh-Jiann Hwang, Tsung-Chih Chiou
National Center for Research on Earthquake Engineering (NCREE)
Taipei, Taiwan

Abstract

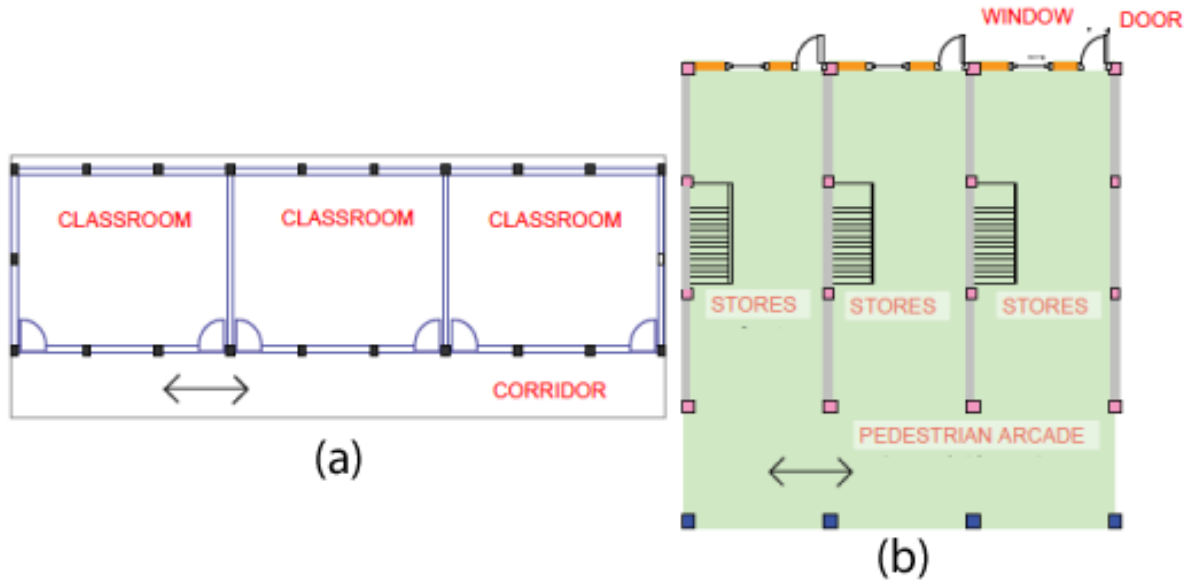
Figure 4: Typical Floor Plans (a) School Building; (b) Street House

During an earthquake, these buildings typically fail at the first floor, parallel to the “long” direction (i.e. “street direction”) of the building. The amount of wall area parallel to the street is significantly less at the first floor than at the floors above, and also less than that in the “short” direction.

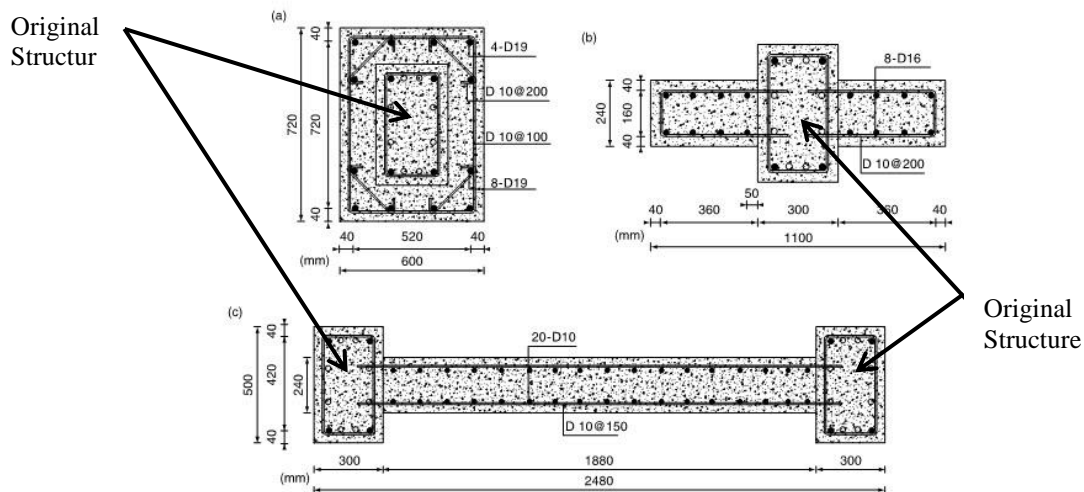
Figure 5: Typical Reinforcing Cross Sections: (a) Existing Column Jacketing; (b) Shear Panels Adjacent to Existing Columns; Shear Wall Between Existing Columns (Hsiao et al. 2014)

The analyzed school buildings with insufficient strength are tagged for retrofit. A solution is developed to strengthen the building to meet the required demand under the peak ground acceleration (Figure 5) . Typical reinforcing schemes include the introduction of new moment frames, shear walls, jacketing of columns or introducing shear panels adjacent to existing columns.
