The Kumamoto, Japan Earthquake of 2016: Summary of Observations and Key Lessons

U.S. – Japan – New Zealand
Workshop on the Improvement of Structural Engineering and
Resiliency
Nara, Japan – June 27-29, 2016

The Kumamoto Earthquake Investigation: A Preliminary Report

April 29, 2016

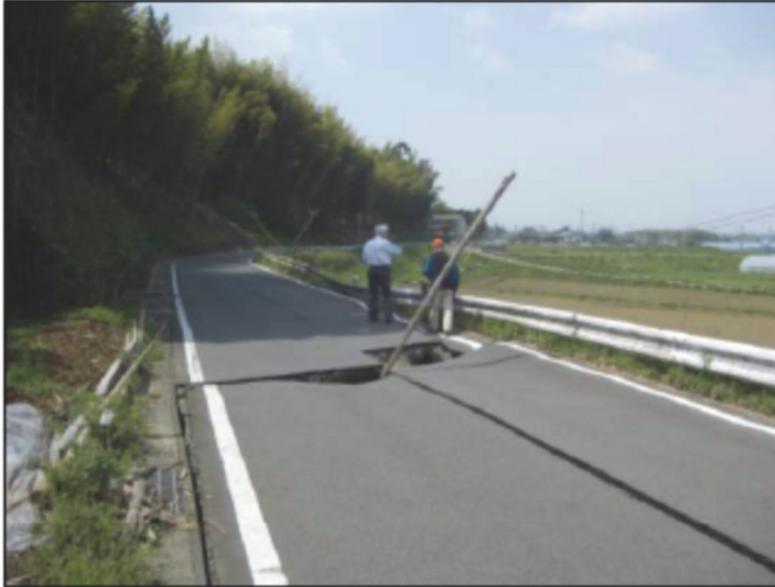
The fault rupturing the surface on a road in Mashiki Town

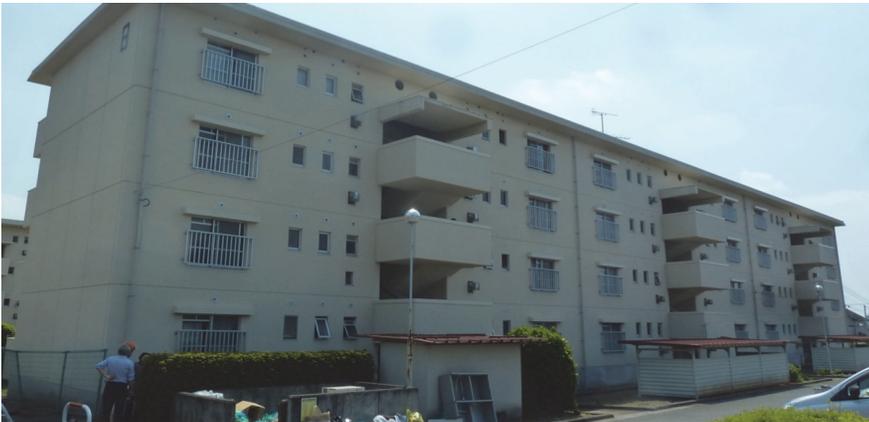
One of several undamaged public housing apartment buildings in Mashiki in the hills just above most of the houses shown in this report. The reinforced concrete structures are built with shear walls and have relatively little glazing when compared to most modern apartment buildings along the West Coast of North America. The inhabitants reported, however, that the contents of their apartments suffered extensive damage, as would be expected in such a strong earthquake in the vicinity of the causative fault.

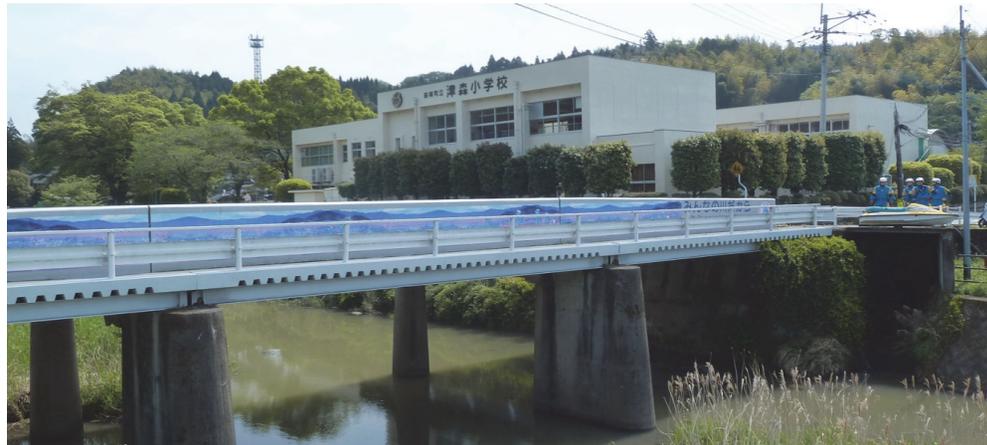
The Tsumori Elementary School in Mashiki, the town most affected by the destructive Kumamoto earthquake. The bridge leading to the school was a major concern for the principal of the school, as it provides access to the school for many of the students. We did not find any significant damage.

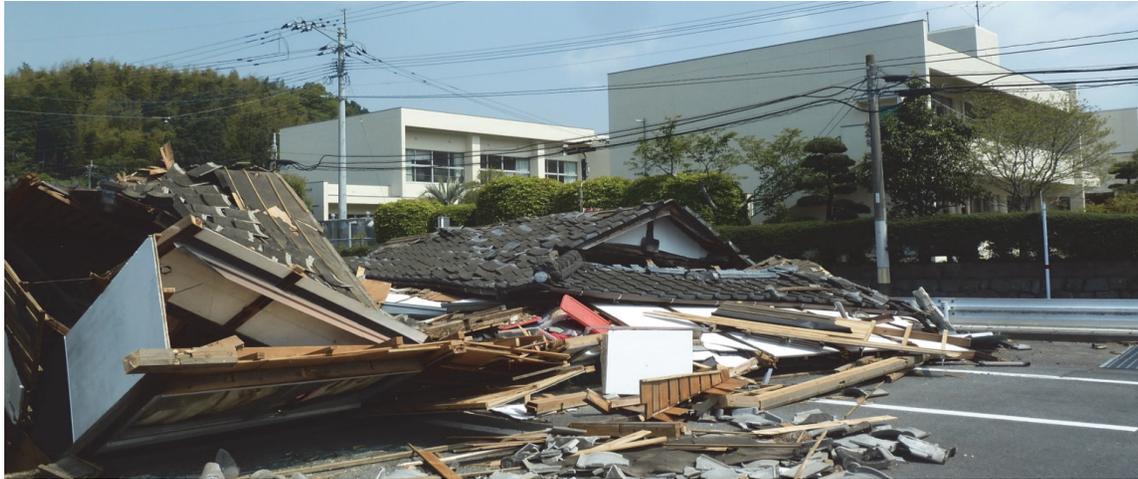
A view of the school from a neighboring house. Contrast the performance of the virtually undamaged school with that of the collapsed house just across the street.

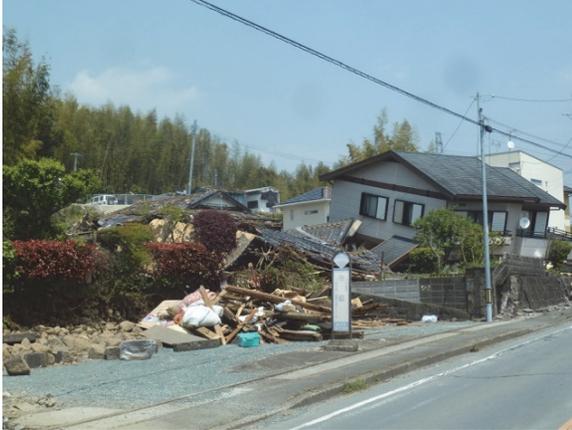
Views of collapsed buildings around the school. The bottom photograph is from inside a classroom, looking at a collapsed small commercial building across the river (also shown in the left photo above).

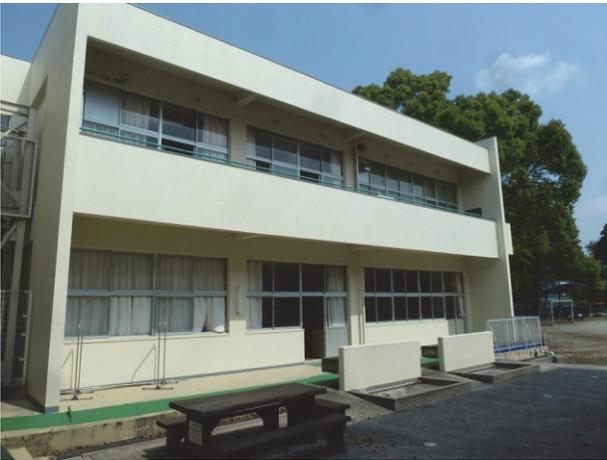
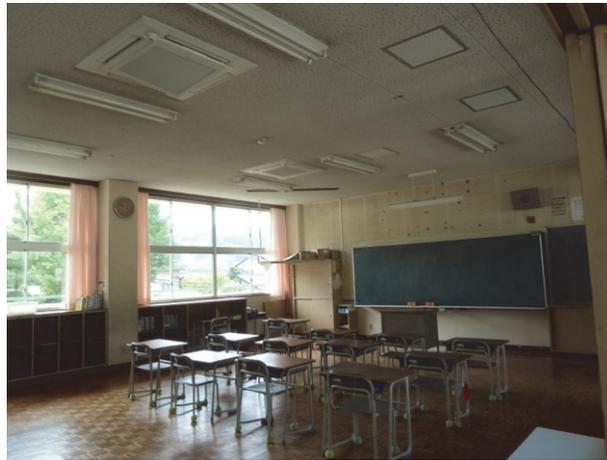
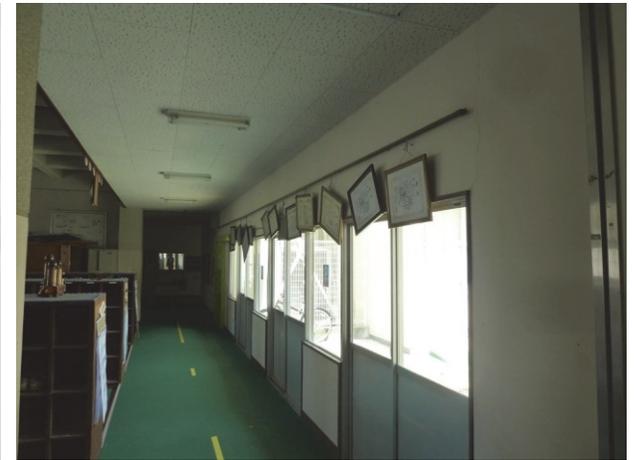
Additional photos of the practically undamaged interior and exterior of the elementary school.

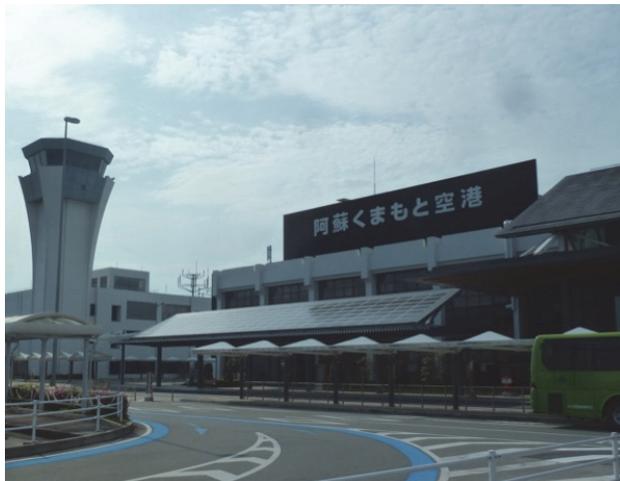
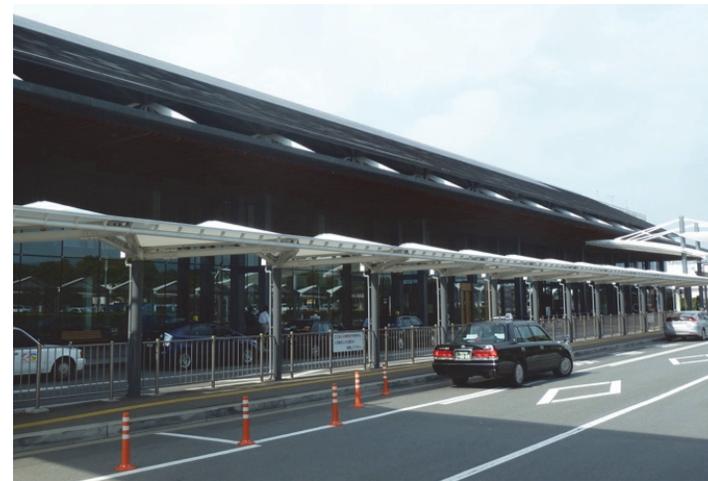
Exterior views of the newer steel framed Domestic Terminal building. The control tower is to the left. There was no obvious significant structural damage.

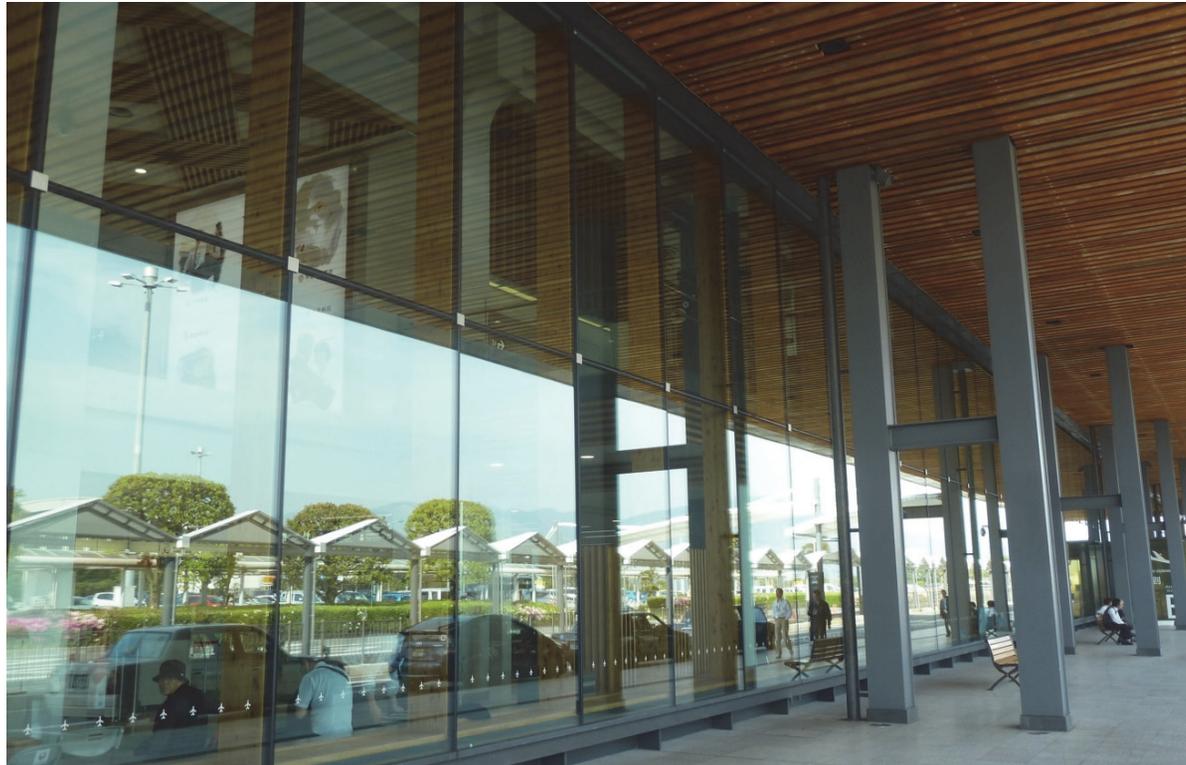
A notable success at the new terminal was the performance of the glazing. We found no damage to these large glass panels. Given the strength of the shaking at the airport, the design details for the glazing should be studied in further detail. Details such as these are difficult for engineers to analyze. Further, they are difficult to test on shake tables. Post-earthquake experience data, such as what we collected at the Kumamoto Airport, are valuable for future designs as well as for the development of adequate and not overly conservative building code requirements for architectural and equipment details.

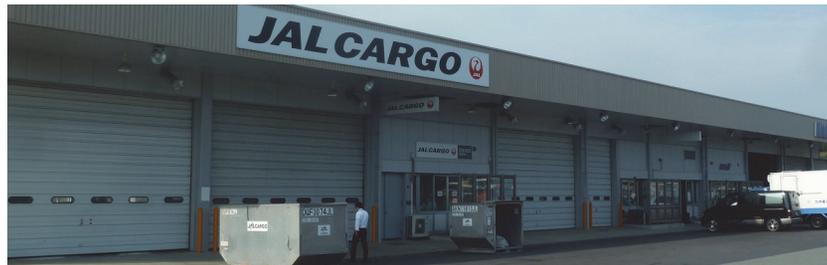
The airport has several steel framed warehouses, hangars, and other service buildings. None appeared to have significant structural damage, including older steel structures that were designed and built to outdated codes. Over time, and in many earthquakes these types of structures, have proven to be much lower risk than comparable concrete frame, precast or tilt-up, and shear wall structures.

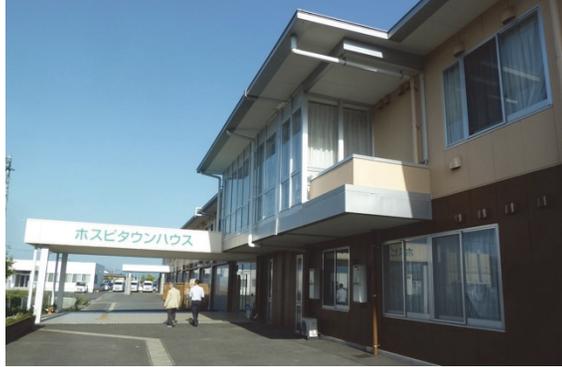
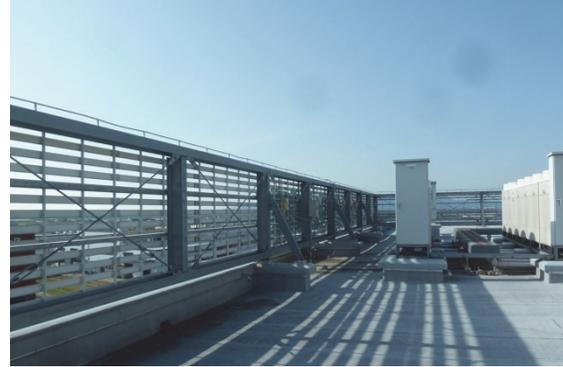
A partial view of one of the two-story hospital buildings (left) and the undamaged steel framed and braced parapet on the roof of the 6-story main building.

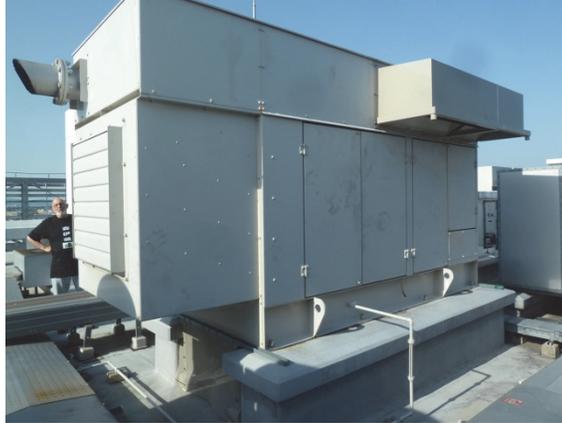
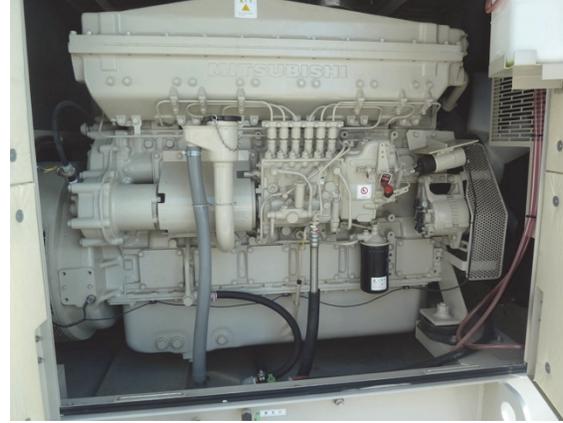
The emergency diesel, located on the roof of the six-story main building, started up upon loss of off-site power. The diesel, plus a second generator in another building, provided adequate power to the hospital following the earthquake until off-site power was restored.

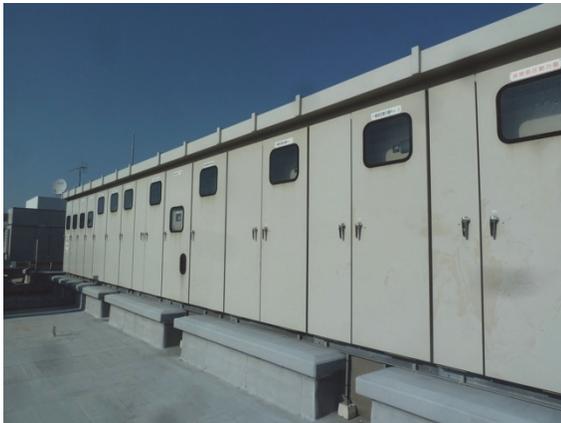
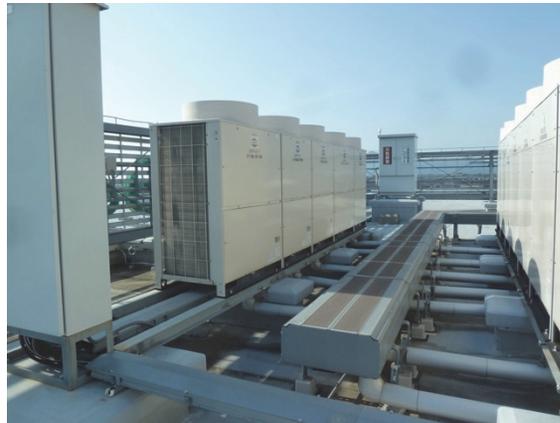
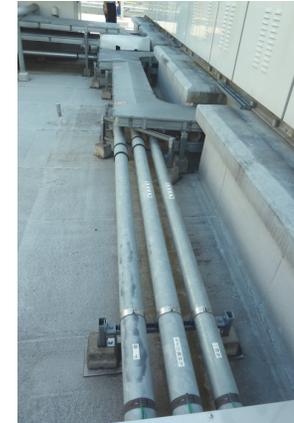
Some of the equipment on the roof of the six-story main building, none of which was damaged in the earthquake. Our investigation revealed good design details for the anchorages and braces of the equipment, piping, and other systems.

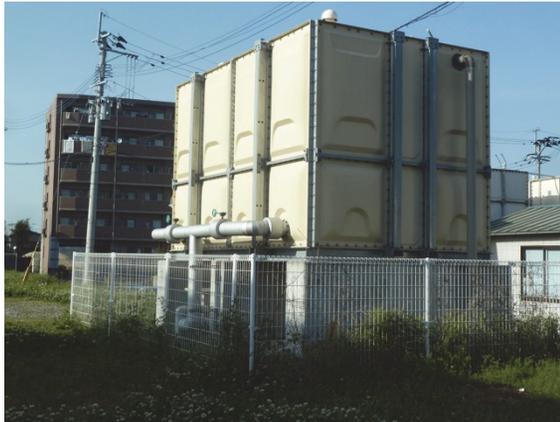
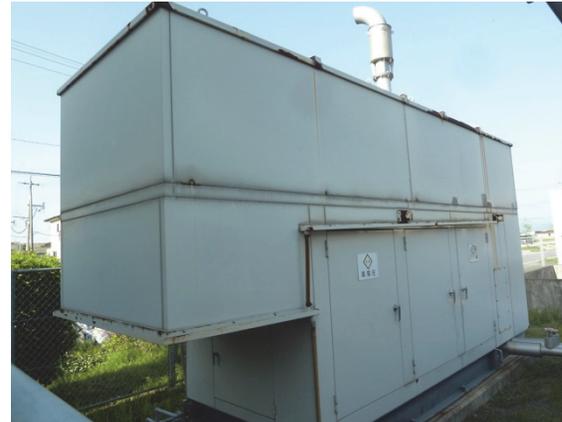
Other anchored equipment at ground level had no damage, including the two potable water tanks on the left and a diesel generator on the right.

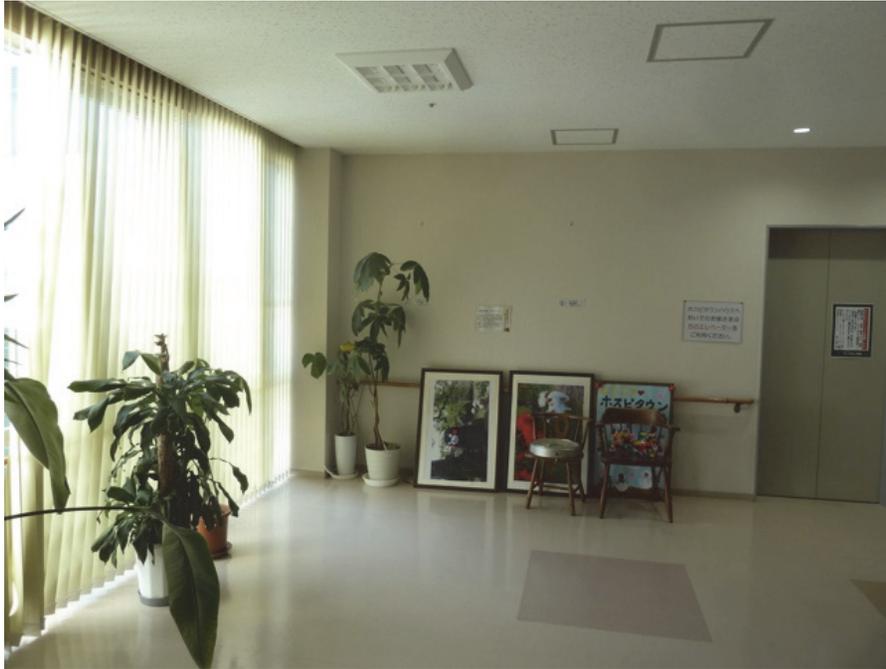
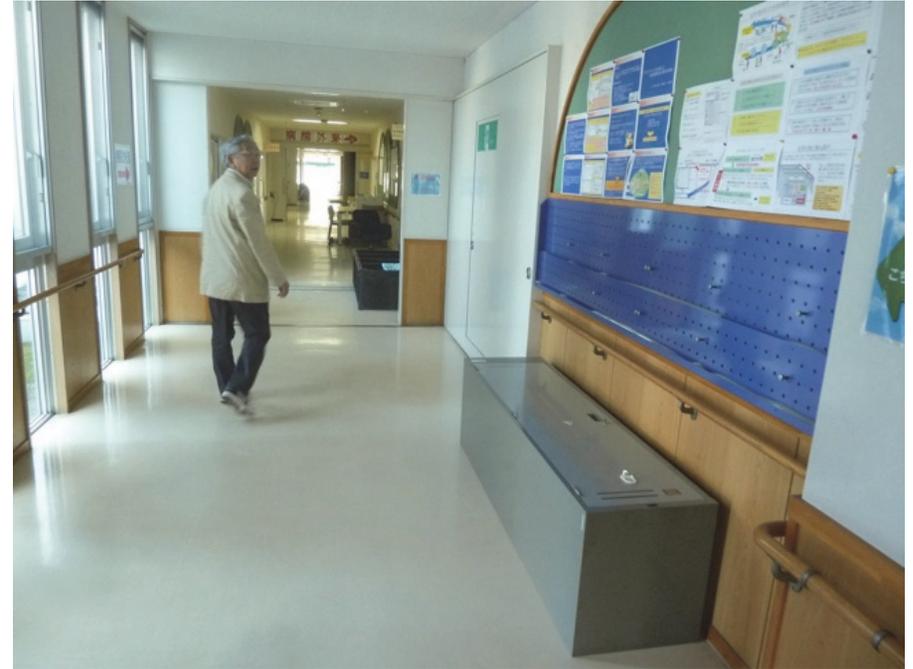
Out of concern for further aftershocks, the hospital staff placed art and other wall-mounted objects on the floor (left). Heavy furniture that can overturn, such as the tall cabinet on the right, were also lowered to the floor so that they would not tip over in aftershocks. I have visited many hospitals, and other public buildings along the Pacific West Coast and throughout the world after earthquakes – this thoughtful precaution was a first for me. Japan has experience with what to do after earthquakes.....
