# PERFORMANCE OF BASE-ISOLATED BUILDINGS UNDER THE 2011 EAST JAPAN EARTHQUAKE

Yoshikazu Fukasawa\*

Soon after the earthquake, the Japan Society of Seismic Isolation (JSSI) established a research committee to find the actual performance of base-isolated buildings.

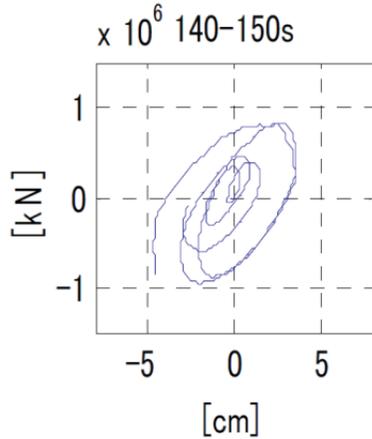
Figure 1. Restoring Force Characteristic(A)

We estimated the relative displacement between the base and 1<sup>st</sup> floor by integrating twice the acceleration records. By using this relative displacement and acceleration records, we estimated the restoring force characteristic of the seismic isolation level. The characteristic during 140 to 150 seconds is shown in Fig.1. This figure also shows that the damping system worked effectively. The estimated orbit of this building is shown in Fig.2.

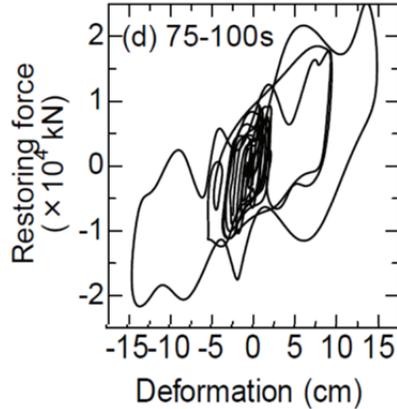
Figure 3. Restoring Force Characteristic(B)

The characteristic during 75 to 100 seconds is shown in Fig.3. This figure also shows that the damping system worked effectively. The estimated orbit of this building is also shown in Fig.4
