RESEARCH ON SEISMIC EVALUATION AND RETROFIT OF CONDOMINIUM IN JAPAN

NAKANO TOKIE¹, Dr.Eng. ABE SHIGETAKA²
NTT Facilities Research Institute¹, NPO Corp. PASTS²
Tokyo, Japan

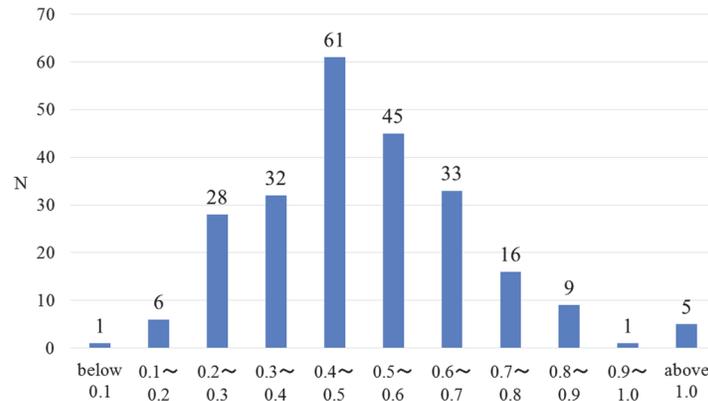
Fig.1 shows minimum I_s values of a check results of 237 condos which takes 36.6% of 646 buildings and minimum I_s values means the smallest I_s value throughout all floors and X,Y directions of the building. Average I_s is 0.49. It is unsafe performance level. *Fig.2* shows ratio of 3 groups. Group1 is good seismic performance i.e. $I_s \geq 0.6$ and no need of reinforcement, 64 condos, 27.0% of total. Group2 is unsafe performance level i.e. $I_s < 0.6$ and had been certificated reinforcement plans by JSCA, 104 condos, 44.0%

Fig. 1 Smallest I_s of all condos by the result.

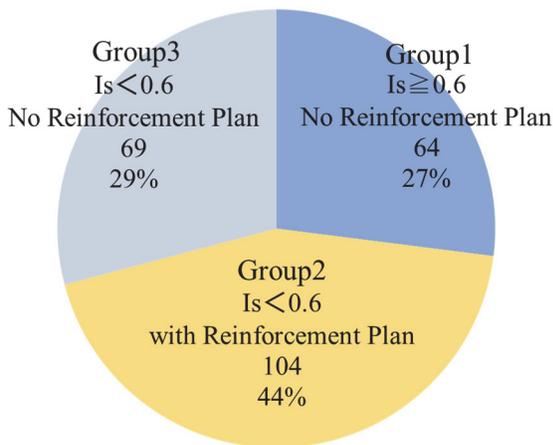
of total. Group3 is also unsafe performance level i.e. $I_s < 0.6$ and have no reinforcement plans, 69 condos, 29.0% of total.

Fig. 2 The ratio of the reinforcement on condos by the result.

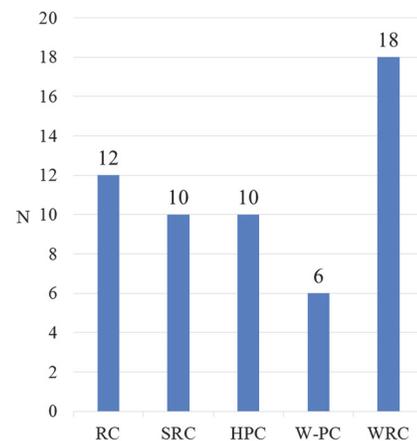
Fig.3 indicates structural type classification and its number of $I_s \geq 0.6$ condos. That reinforcement of these condos is unnecessary. In addition to usual RC and SRC construction, WRC, W-PC, HPC are predominant structure type because of its volume of walls.

Fig. 3 Structure type classification of non-reinforcement condos, $I_s \geq 0.6$.

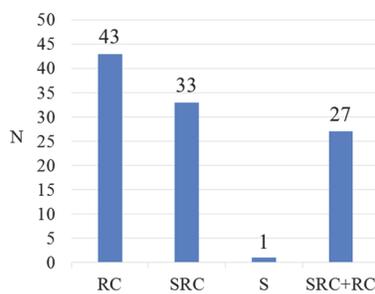
The structure classification in reinforcement target condos is shown in Fig.4. 43 condos, 41.8% of total, are RC construction and average number of stories is 5.8 stories. 33 condos are SRC, and average number of stories is 11.5 stories. Mixed structure is defined as lower part of building is SRC, and upper part of building is RC. 27 condos are mixed structure, and average number of stories is 9.9 stories. So, the

Fig. 4 Structure classification in reinforce condos.

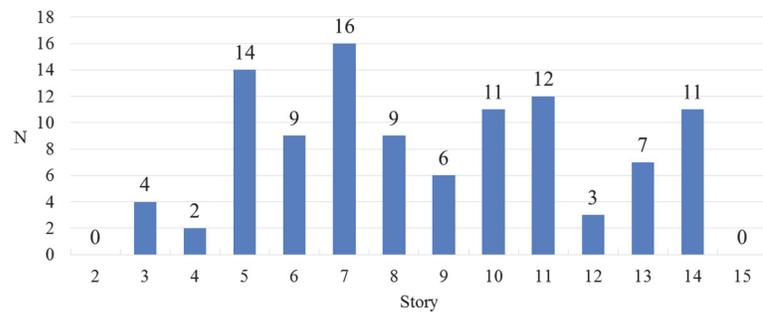
The number of stories above ground on the reinforcement target condos is shown in Fig.5. 7 storied condos are 16 that are the most in number, 15.5% of total. Middle-high-rise condos, more than 10th floor, built with SRC or mixed structure are the second one, there are 44 condos, 42.7% of total.

Fig. 5 The number of stories above ground in reinforce condos.

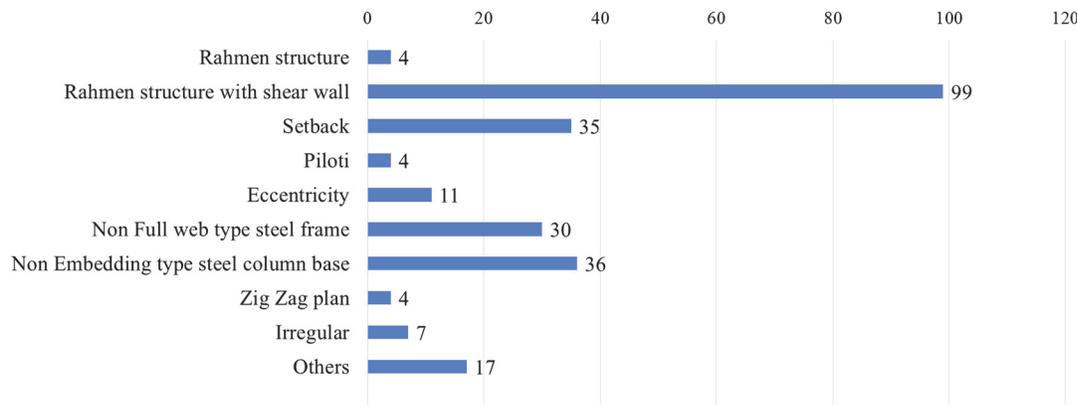
The structural feature of the reinforcement condos are shown in Fig.6. The rhamen structures with shear wall are predominant in RC, SRC and mixed structure. The ridge direction, the condos built with rhamen system has wing walls, some kind of non-structural walls and something. Therefore the wall volume is insufficient. On the other hand, the span direction, condo has lots of shear walls of residents border use. And there are a lot of setbacks to use up the ratio of building volume. Unexpectedly, there are only 4 condos with piloti on the 1st floor.

Fig. 6 The structural feature of the reinforcement condos.

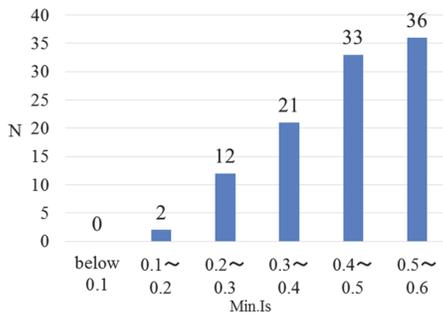
3-2. Is value and ΔIs. The number of condos and the smallest Is by seismic evaluation on each condos is shown in Fig.9. The Is is smallest Is in floors and both directions. For most condos, Is value indicates more than 0.4 and less than 0.6, but there are serious ones i.e. Is value is less than 0.3. The number of condos and increased Is value, ΔIs, by the reinforcement is shown in Fig.10.

Fig. 9 Smallest Is value by seismic evaluation

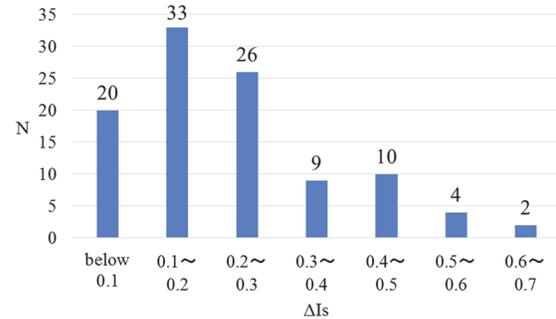
80 condos, 77.7% of total, Δ Is less than 0.3, are the most common. And there are 22 condos, 22.3 % of total, Δ Is were increased more than 0.3.

Fig. 10 Increased Is value Δ Is by reinforcement

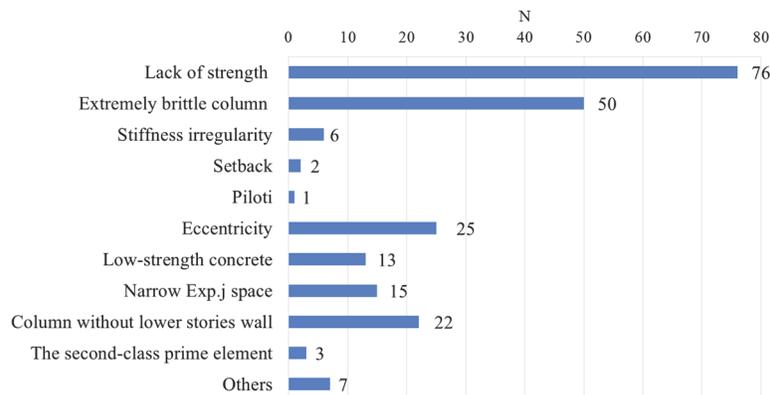
The most common reasons which Is by seismic evaluation is small, is lack of strength by uneven distribution of shear wall. The second ones are that ductility index is small by existence of extremely brittle columns and large eccentricity, lower floor column without wall.

Because of the difference in the shear wall volume of the ridge direction and span direction, Is values of both directions are different and it is particular to condo. Various small opening like fanlight opening, door opening and equipment opening in the ridge direction make columns easily brittle. (Fig.11)

Fig. 11 The structural weak points of condos by seismic evaluation

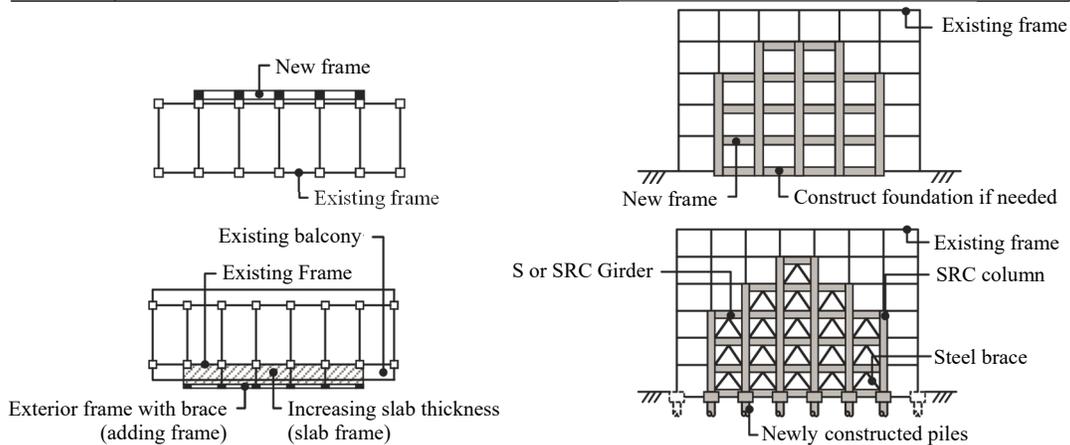
Fig. 12 Exterior Frame and Exterior Frame with Brace (adding frame) (reference 2)).

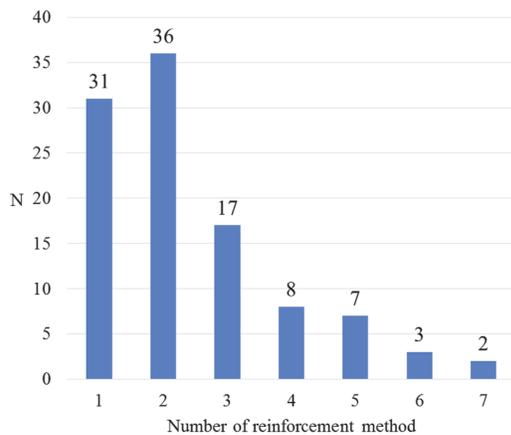
The number of adopted reinforcement method in one condo and number of these case condos are shown in Fig.13. The condos reinforced with only one method are 31, 29.8% of total, and that with less than 3 kinds of reinforcement method are 84, 80.8% of total, and it occupies the most. The reinforcement method of among 104 condos ,49 condos which $\Delta I_s \geq 0.2$ are investigated.

Fig. 13 The number of adopted reinforcement method in one condo.

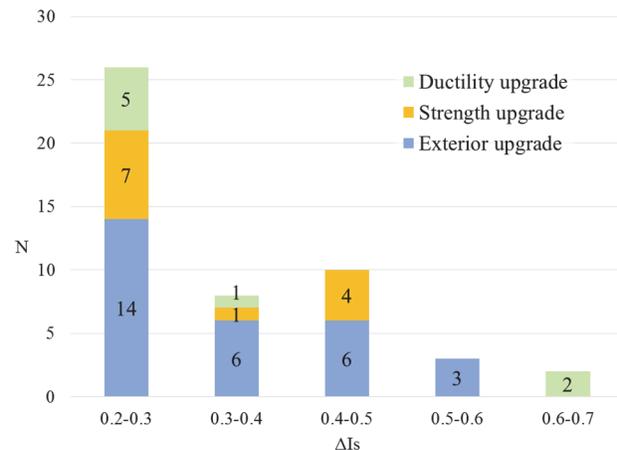
The reinforcement methods is consist of three, i.e. exterior frame strength upgrading method, strength upgrading method and ductility upgrading method. The result is shown in Fig.14. The exterior frame upgrading method is adopted much more than conventional method except for the case ΔI_s is large extremely.

Fig. 14 Reinforcement method used for $\Delta I_s \geq 0.2$ condos.

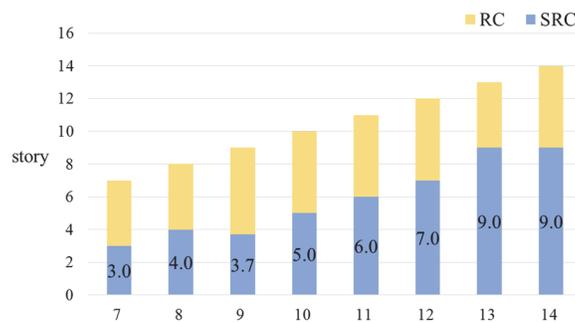
3-4 The examination of SRC and Mixed structure. As shown in Fig15, the ratio of the floor including steel frames is 43% (7 story) to 64% (14 story) to all floors in mixed structures. And it seems natural for the ratio of steel frame become increasing according to the condos height.

Fig. 15 The number of floors including steel frames in mixed structures.

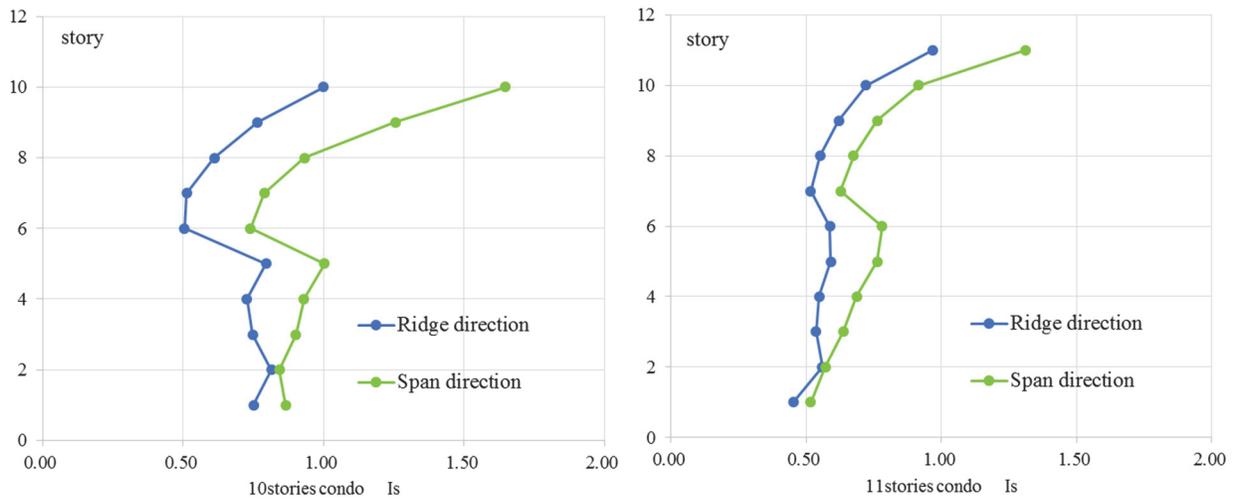
The mean I_s in ridge direction and span direction of each floor about 10 storied (8 condos) and 11 storied (5condos) is indicated in Fig.16. I_s value in span direction where shear wall exists is much larger than I_s in ridge direction. I_s value along height direction in mixed structure condos are low in middle floors as shown in Fig.16. Because I_s value can be found below 0.6, middle floors reinforcement become necessary. This would happen in accordance with the influence of the change of the structure in the middle floors from SRC to RC.

Fig. 16 Mean I_s value distribution of the condo along height direction in mixed structure.

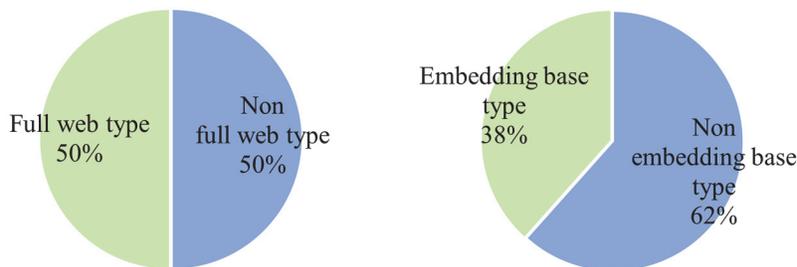
The investigation results of 33 condos columns in all SRC structure and 27 SRC columns in mixed structure are shown in Fig. 17. From these results, non-full web steel frame (grid-shaped, see Fig. 18) are 30 condos, 50% of all, and non-embedding type column base are 36 condos, 60 % of all.

Fig. 17 The ratio of non-full web steel frame and non-embedded column base in SRC and mixed structure.

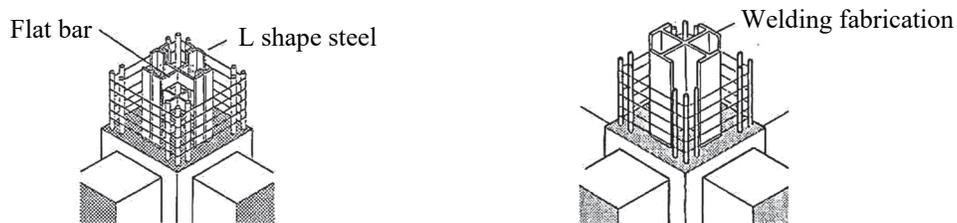
Fig. 18 non-full web steel frame (grid-shaped) and full web steel frame
