*17th U.S.-Japan-New Zealand
Workshop on the Improvement of
Structural Engineering and Resilience*

**LEGAL RUMBLINGS IN CALIFORNIA HIGH-RISES:
EMERGING LIABILITY PATTERNS WHEN FIELD PERFORMANCE FALLS SHORT
OF DESIGN PREDICTIONS**

Mark N. White, Esq.
Law Offices of Mark N. White
Berkeley, California U.S.A.

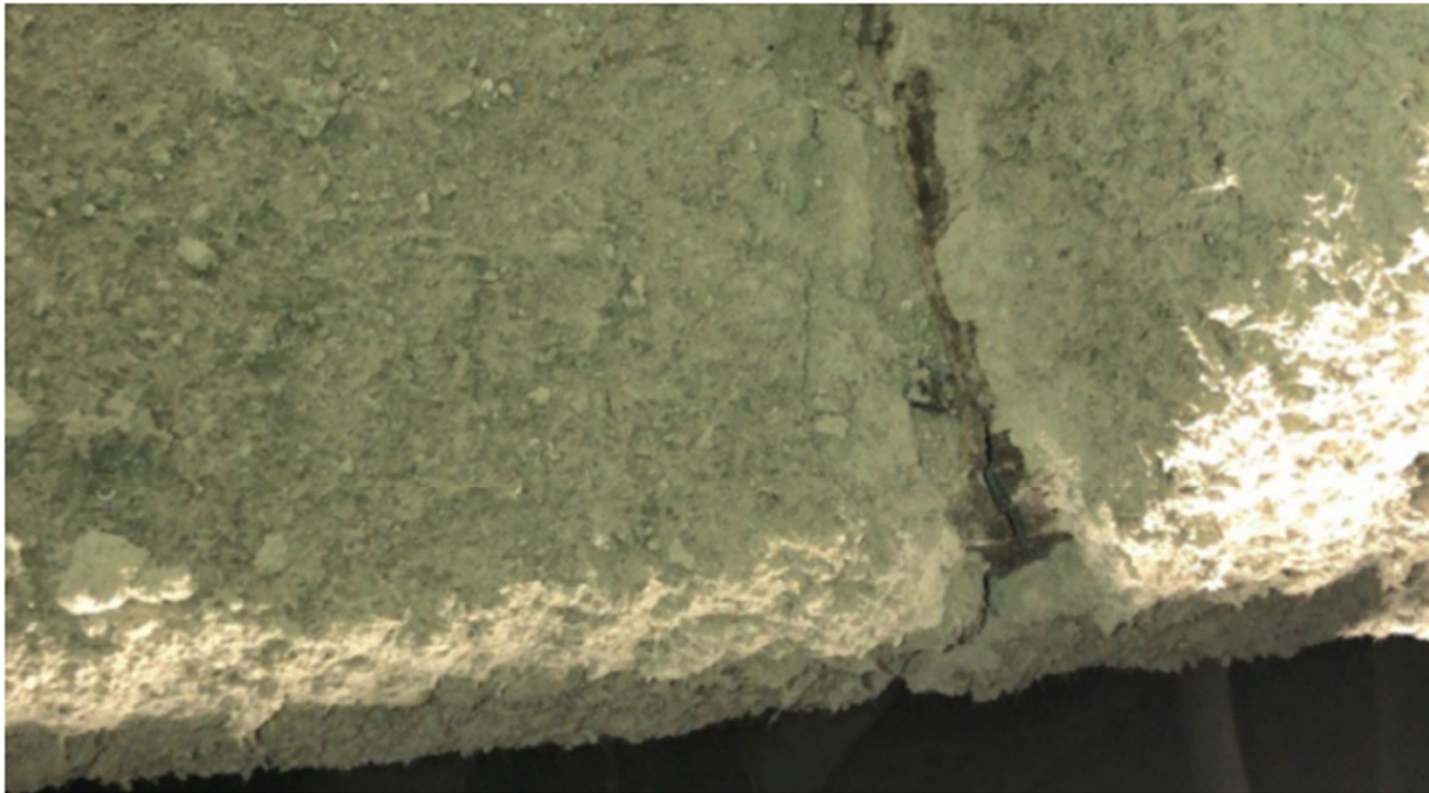
The Field Performance Gap at the Transbay Transit Center:

Cracks in two girders were discovered a few weeks after the Center opened.

But in late September, transit center workers discovered a fissure in one of the structure's steel beams. The center and its public rooftop park were temporarily shut down for further inspections, and one more cracked beam was found in the same area as the first.
