## FEMA P-58/BD-3.9.21

# Fragility of Air Handling Units

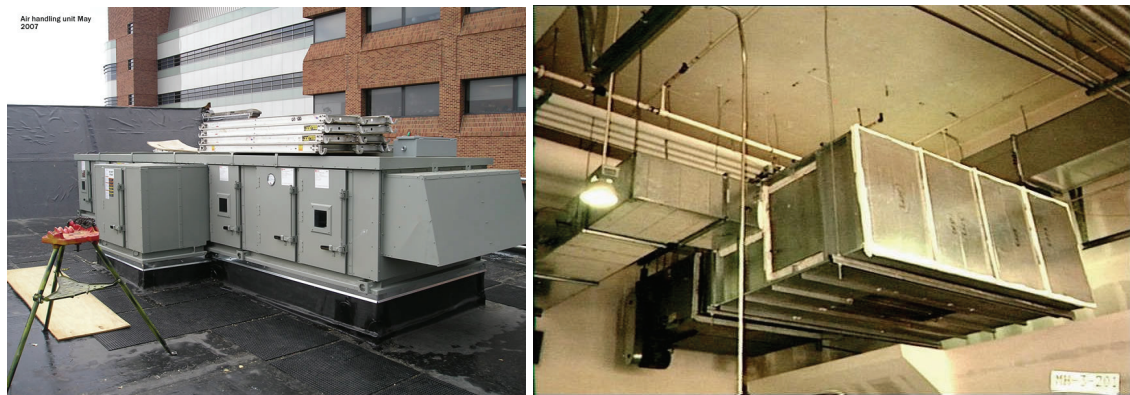
**Figure 1. Roof mounted and rod hung air handling units**
