Background Document

FEMA P-58/BD-3.9.19

Fragility of Motor Control Centers

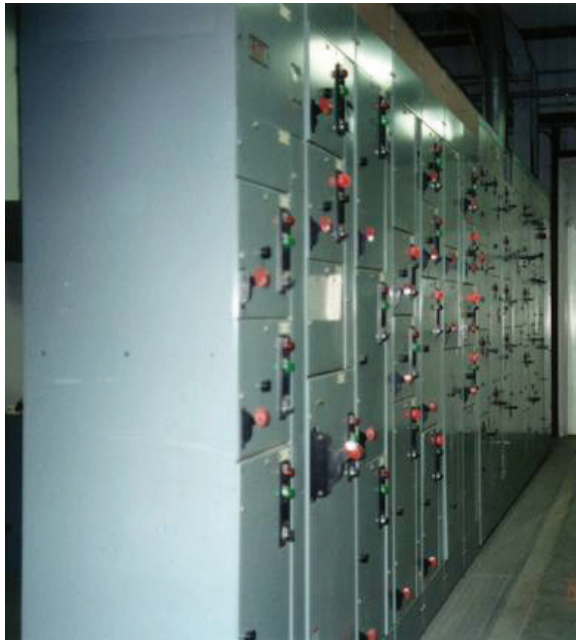
Figure 1. Motor control center (EPRI)
