FEMA P-58/BD-3.9.3

Seismic Fragility of Building Interior Doors

SEISMIC FRAGILITY OF BUILDING INTERIOR DOORS

Prepared for ATC-58 by
Eduardo Miranda, PhD

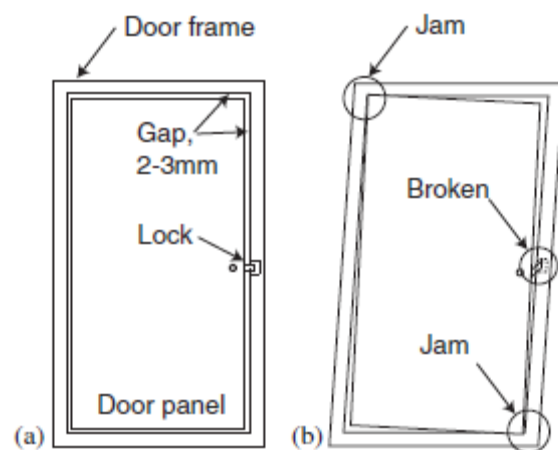
Figure 1. Door subjected to lateral deformations (after Lee et al. 2007)

Lee et al. (2006, 2007) tested various configurations of interior partitions with metal studs. One of the specimens included a door.

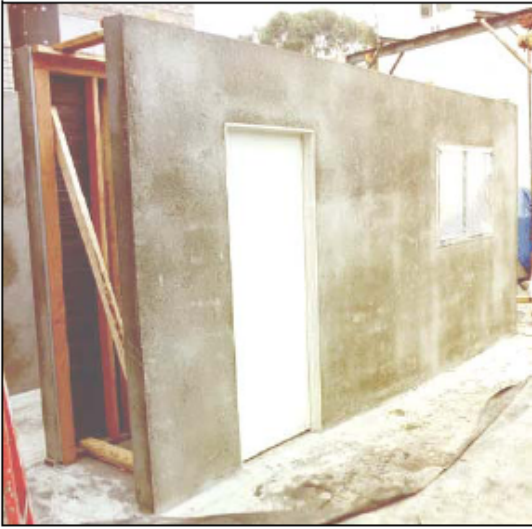
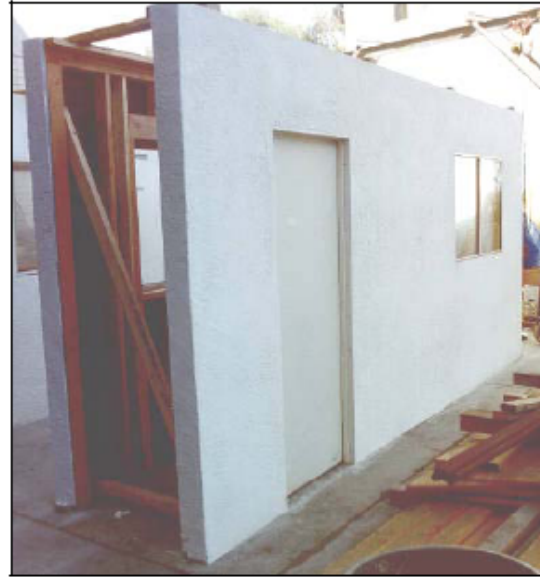
Figure 2. Examples of specimens tested by Arnold et al 2003.

Arnold et. al 2003 Tested eleven full-scale wall specimens with wood studs and ½ in gypsum wallboard. Four of the six walls with an aspects ratio of three had double-hung windows, casement windows, and prehung doors installed.

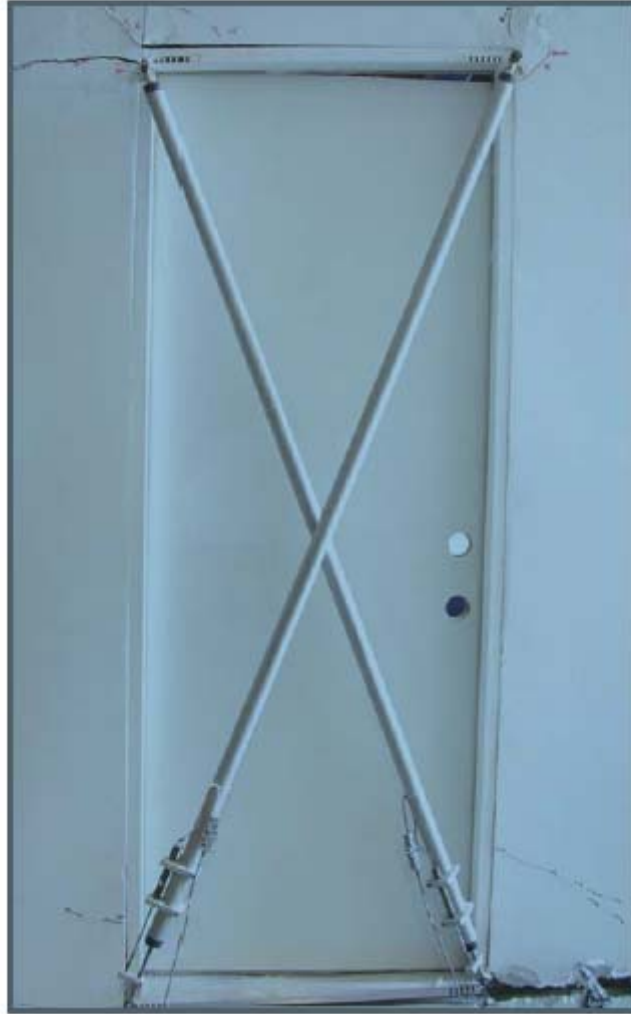
Figure 3. Example of door at large levels of deformation (After Arnold et al.).

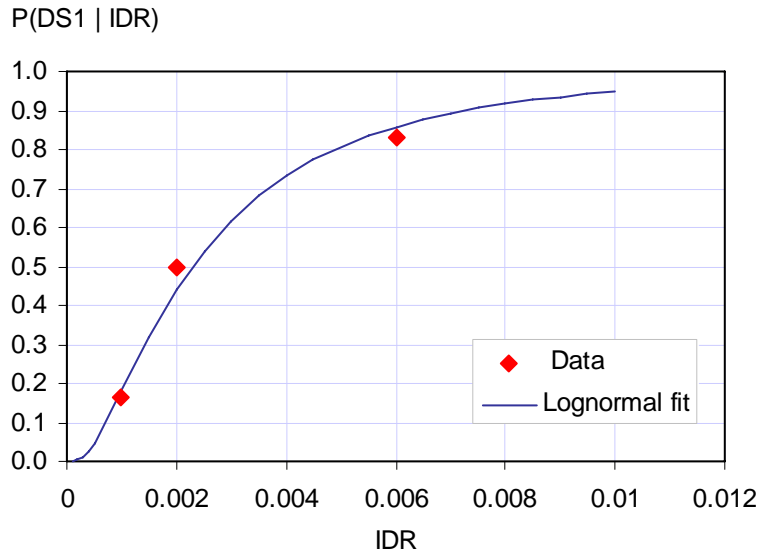
Figure 4 shows the empirical cumulative distribution function corresponding to damage state 1. As shown in this figure doors were reported to be jammed in some specimens at very low values of interstory drift (0.001) while in others this damage state was not reported to occur until drift ratios reached 0.006. Also shown in the figure is the fitted lognormal distribution. The parameters of the lognormal probability distribution correspond to the geometric mean and the logarithmic standard deviation of the data. As shown in the figure the lognormal probability distribution provides a relatively good fit to the data.

Figure 4. Fragility function corresponding to damage state 1.

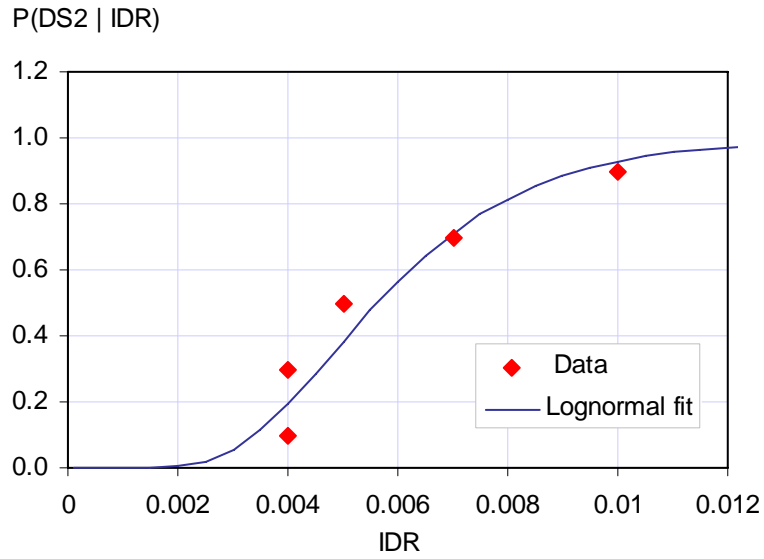
Figure 5 shows cumulative distribution functions corresponding to damage state 2. The figure shows both the empirical cumulative distribution function and the fitted lognormal distribution. As shown in this figure this second damage state was reported to occur for interstory drift ratios ranging from 0.004 to 0.01.

Figure 5. Fragility function corresponding to damage state 2.
