FEMA P-58/BD-3.9.2

Seismic Fragility of Building Interior Cold-Formed Steel Framed Gypsum Partition Walls

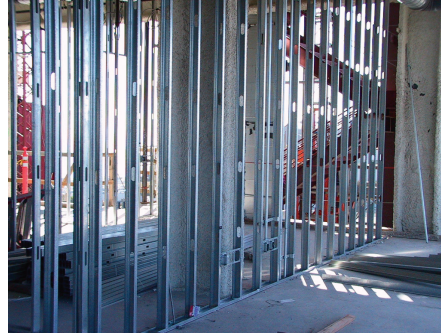
Figure 1: Framing of typical interior partition (photo by E. Miranda).

The objective of this document is to summarize the development of fragility functions for interior non-load-bearing gypsum wallboard partitions commonly used in building construction. The partition assembly consists of C-shaped cold formed metal studs (the most commonly used are gage 20 and gage 25 with a web depth of 3-5/8 in.), U shaped horizontal cold-formed metal tracks in the top and bottom and gypsum wallboard as facing material. Typically one layer of gypsum wallboard is used on each side of the steel framing with the two most commonly used thickness being 1/2 inch and 5/8 inch, however many other configurations exist depending on the desired fire rating and sound isolation requirements. The fragility functions developed here are intended to be representative of those using gypsum wallboards satisfying ASTM C36 Specification for Gypsum Wallboard or the more recent ASTM C 1396 Specification for Gypsum Board and Section 2205 of the 2000 International Building Code (IBC), and ASTM C 645, Specification for Non-Load (Axial) Bearing Steel Studs, Runners (Track), and Rigid Furring Channels for Screw Application of Gypsum Board. An example of typical framing of an interior gypsum wall partition is shown in Figure 1. As shown in this photograph studs typically have punched holes (with geometry varying from manufacturer to manufacturer) to accommodate plumbing, electrical, telecommunication (e.g., telephone, internet, etc.) or other types of installations. Figure 2 shows examples of electrical and plumbing installations inside of building partitions.

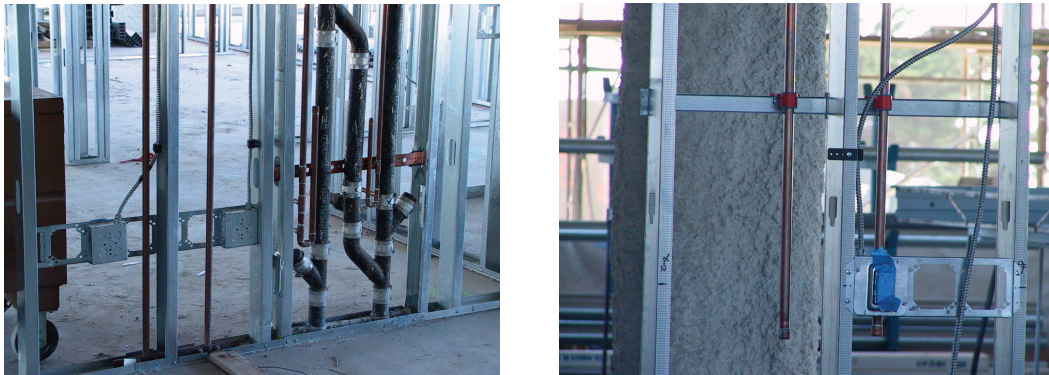
Figure 2: Examples of plumbing and electrical installation in gypsum wallboard partitions (photos by E. Miranda).

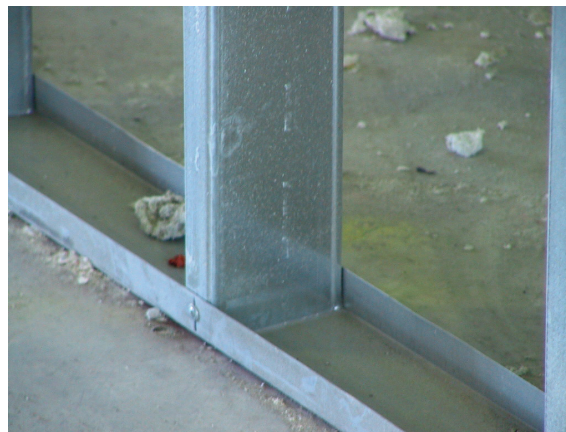
Figure 3: Photo of typical connection between stud and lower track (photo by E. Miranda).

Although standards exist for the materials, thicknesses, stud and track geometry, stud separation, height limitations, etc., there is a wide variety of detailing and installation practices which are primarily based on recommendations from different manufacturers and local building trade practices. Some manufacturers recommend screwing the studs to the horizontal tracks while others only recommend this at certain locations. ASTM C754 requires that studs located adjacent to door and window frames, partition intersections, and corners be anchored to runner flanges by screws, or by crimping at each stud and runner flange. In California the studs are typically screwed to the bottom and top tracks. Often, but not always, the top track has vertically slotted holes of the flanges, in what is commercially referred to as “slip track”, to accommodate vertical deflections of the floor system without introducing vertical deformation/loads to the partition. Examples of typical connections between studs and upper and horizontal tracks (sometimes referred to as runners) are shown in Figure 3, Figure 4 and Figure 5.

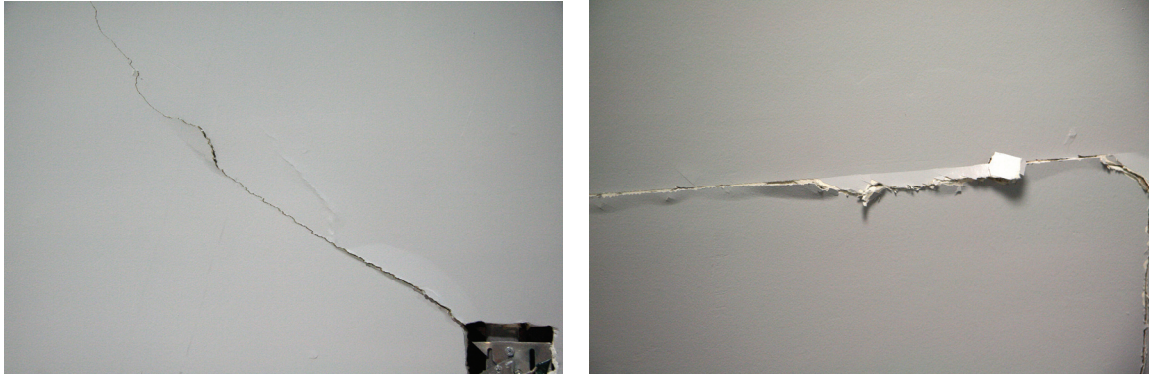
Figure 9: Examples of damage stage 2 (tests by R. Retamales et al. 2007, photos by E. Miranda).

DS-2 consists of severe cracking, crushing or out of plane buckling of the gypsum wallboards such that replacement of the wallboards becomes necessary. Repair would involve removing the damage wallboards and subsequent taping, pasting, sanding and painting. DS-2 also includes damage to boundary studs that can be easily replaced. Figure 9 shows photos that illustrate this kind of damage.

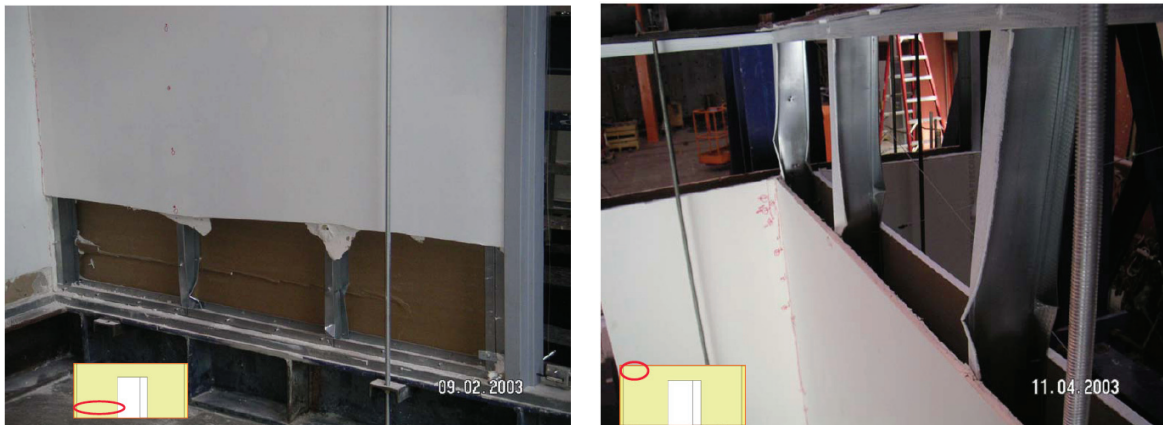
Figure 10: Example of damage stage 3 (photos by A. Bersofsky).

DS-3 involves severe damage to the partition including not only severe damage to the gypsum wallboards and the screws connecting them to the studs and tracks but also damage to the steel framing such that replacement of the partition becomes necessary. This type of damage typically involves local buckling and/or fracture of the metal studs. Figure 10 shows a couple of photos that illustrate this damage state.
