Background Document

FEMA P-58/BD-3.9.32

Interior Cold-Formed Steel Framed Gypsum Partition Walls

REVISION OF SEISMIC FRAGILITY FUNCTIONS FOR BUILDING INTERIOR COLD-FORMED STEEL FRAMED GYPSUM PARTITION WALLS

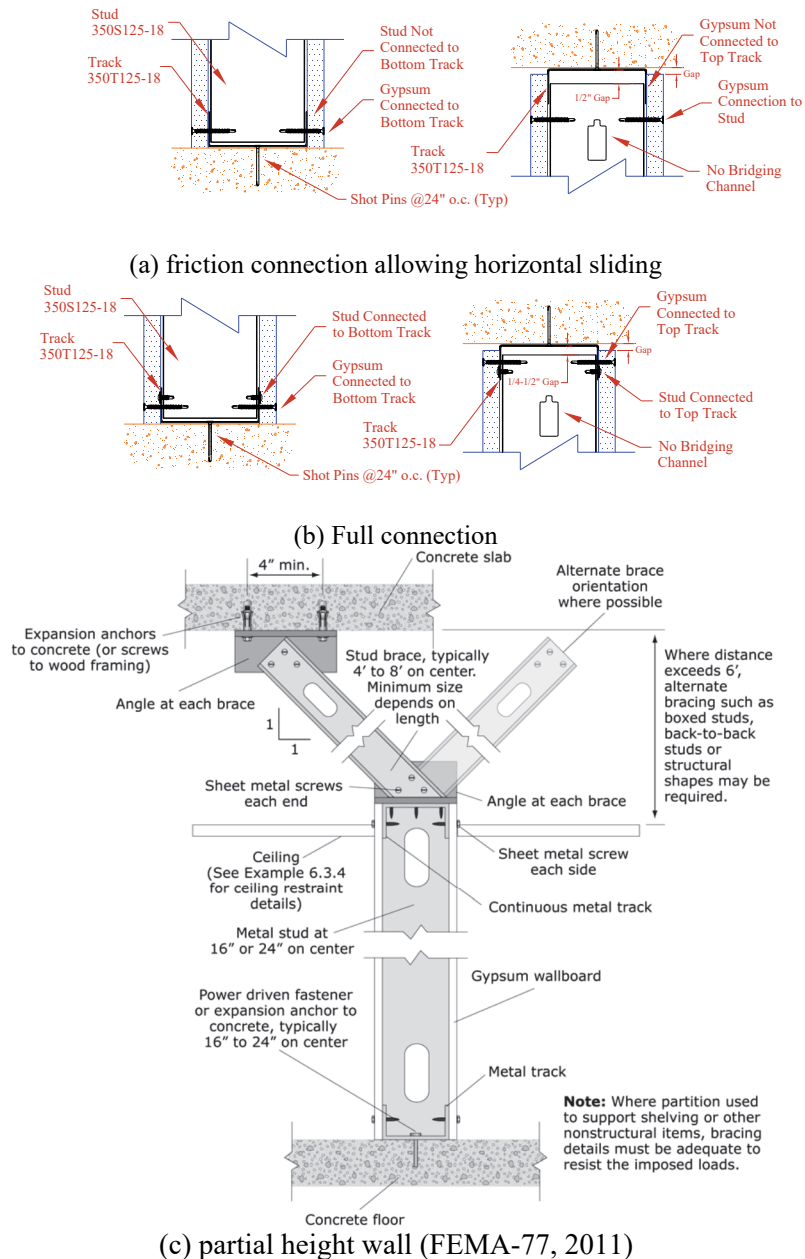
Fig. 1. Connection details for cold-formed steel indoor partition walls

- **Full Connection** with screws connecting studs and gypsum wallboard to bottom and top tracks
- **Friction Connection/Horizontal Slip Track** with no direct connection between wallboard and studs to top track allowing the wall to slip relative to the top track. Return walls may limit the free movement of the walls.
- **Friction Connection/Horizontal Slip Track With No Returns** with no direct connection between wallboard and studs to top track allowing the wall to slip relative to the top track. Only the boundary studs are typically connected to the top track.
- **Partial Height Walls** with diagonal bracing connecting the top track to the slab above

The types of walls considered here are interior non-load-bearing gypsum wallboard partitions. The walls consist of vertical C-shaped cold formed metal studs connected to horizontal cold-formed metal tracks attached directly to the building floor slabs at the top and bottom. Gypsum wallboard, typically in one layer of 1/2 inch and 5/8 inch thickness is screwed to the metal studs and finished with mud taping at the joints then painted for the finish. A more detailed description of the wall types examined here and variations in construction is available in Miranda and Mosqueda (2011). For the purposes of this study, the walls are categorized into the following groups depending on details of the connections between the gypsum wallboard and the studs to the top tracks. Connection details are illustrated in Figure 1:

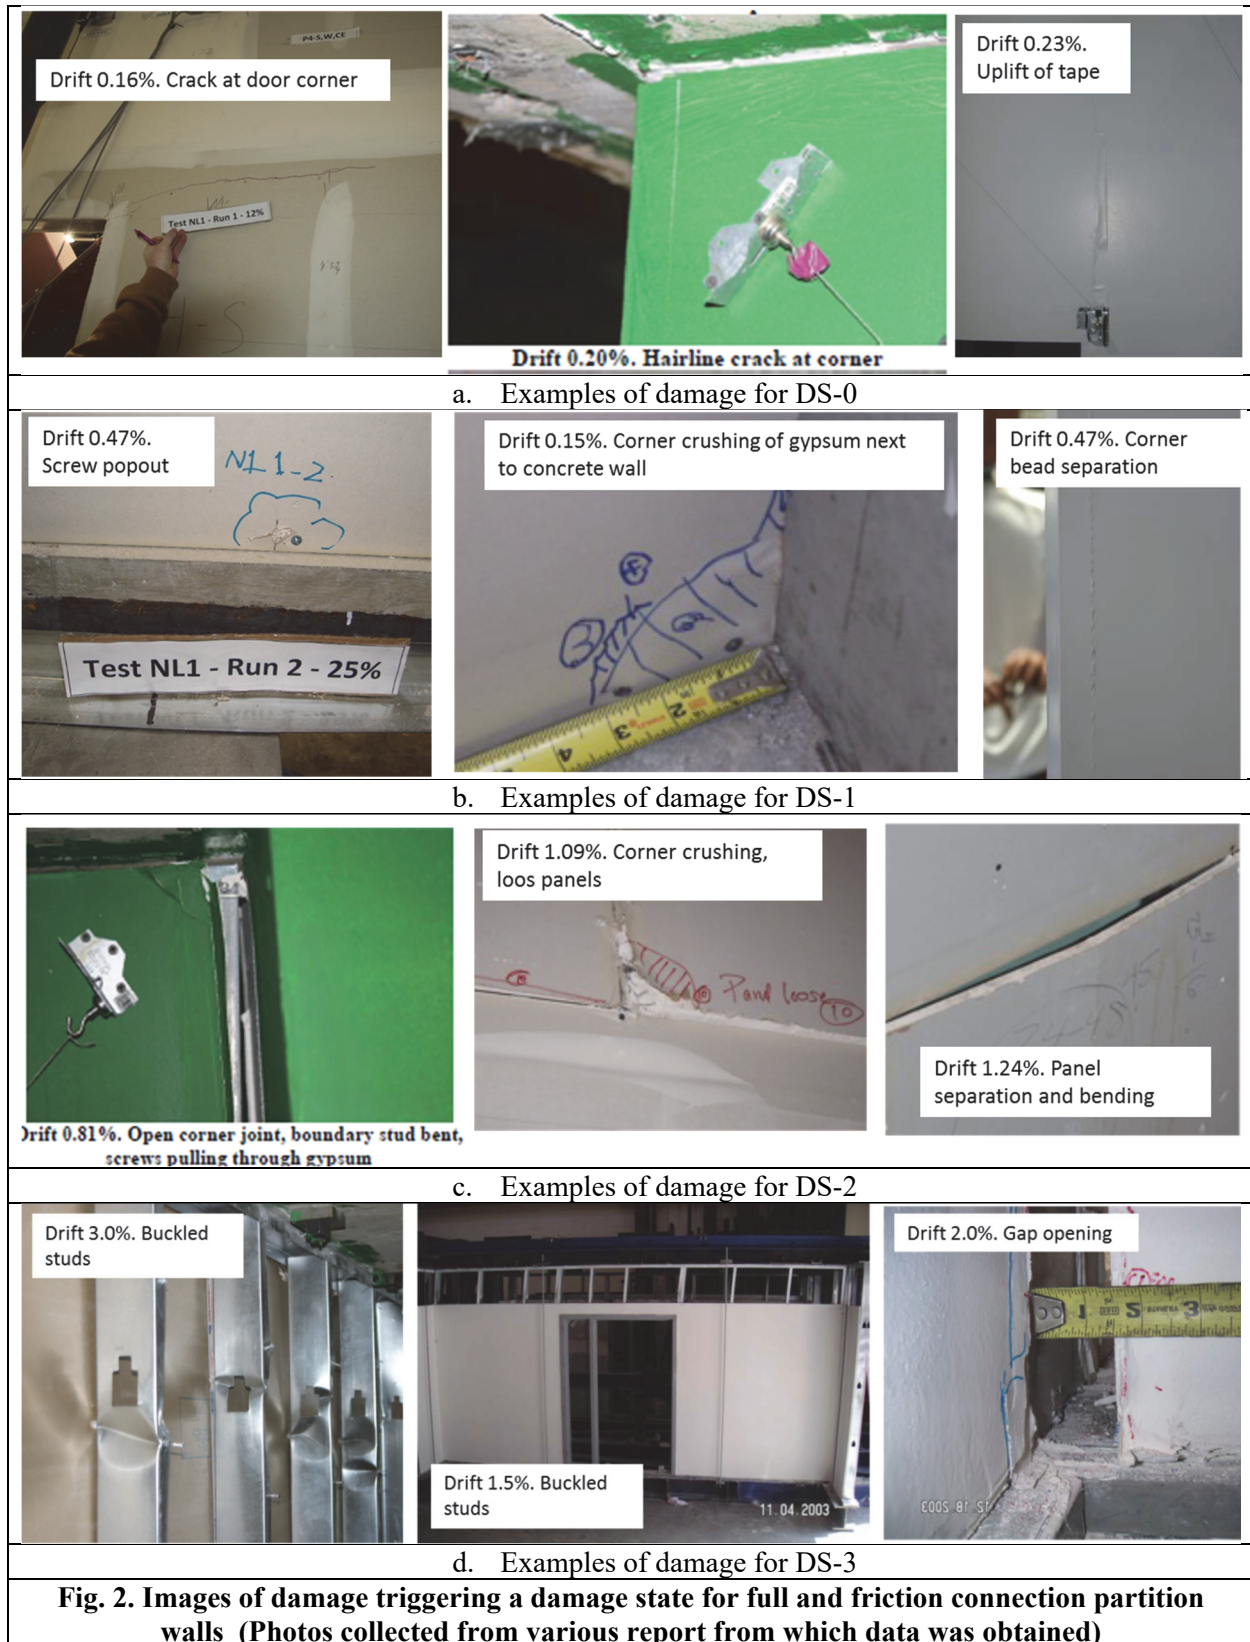
Table 1. Revised damage states for full and friction connection partition walls.

Damage State		Description of Damage	Repair Action
DS-0	Localized visible damage to the upon close inspection	Hairline cracking of wall board or joints, visible screw pop out, light warping or cracking of tape. Damage could be taken for normal wear and tear	Localized repair mainly around corners and edges of wall. May require light pasting and repainting.
DS-1	Local damage to the walls	Significant screw pop-out, cracking of wall board, warping or cracking of tape, slight crushing of wall panel at corners	Retape joints, past and repaint. May require cutting and replacing corner sections of board. Repair 5% wallboard, 10% retape, 25% paint
DS-2	Local damage of gypsum wallboards and/or steel frame components	Moderate cracking or crushing of gypsum wall boards (typically in corners). Moderate corner gap openings, Bending of boundary studs	Remove and replace 10% of wall board (both sides), re-tape and paste 25% of wall, paint 50% of wall. Replace boundary studs ~ 5 intersections per 100 ft of wall.

DS-3	Severe damage to walls	Buckling of studs and tearing of tracks. Tearing or bending of top track, tearing at corners with transverse walls, large gap openings, and walls displaced.	Remove and replace 50% length of metal stud wall, both sides of the gypsum wall board and any embedded utilities, and tape, paste and repaint. 50% wall replacement, 100% paint

To address this concern, a preliminary damage state was defined as DS-0 to account for the drift demand at which visible damage initiates. This corresponds to the first observation of damage as reported in many past research studies. Consequently, the actual damage associated with the three damage states DS-1, DS-2 and DS-3 were increased in severity. The definition of damage states were revised as shown in Fig. 2 and Table 1 to include the optional DS-0 and redefine the remaining three damage states to better correlate to the required repair actions. Partitions with full or friction connections had similar failure modes and thus use the same definition of damage states and repair actions. Partial height walls showed a different sequence of failure, requiring different definitions for damage states and repair actions as defined in Table 2. Following this revision to the damage state definitions, the experimental data had to be sorted to define the corresponding drift at which the newly defined damage state were observed. This was accomplished by reviewing photographs of the reported damage where available for each specimen or by the description of damage provided by previous testing programs.

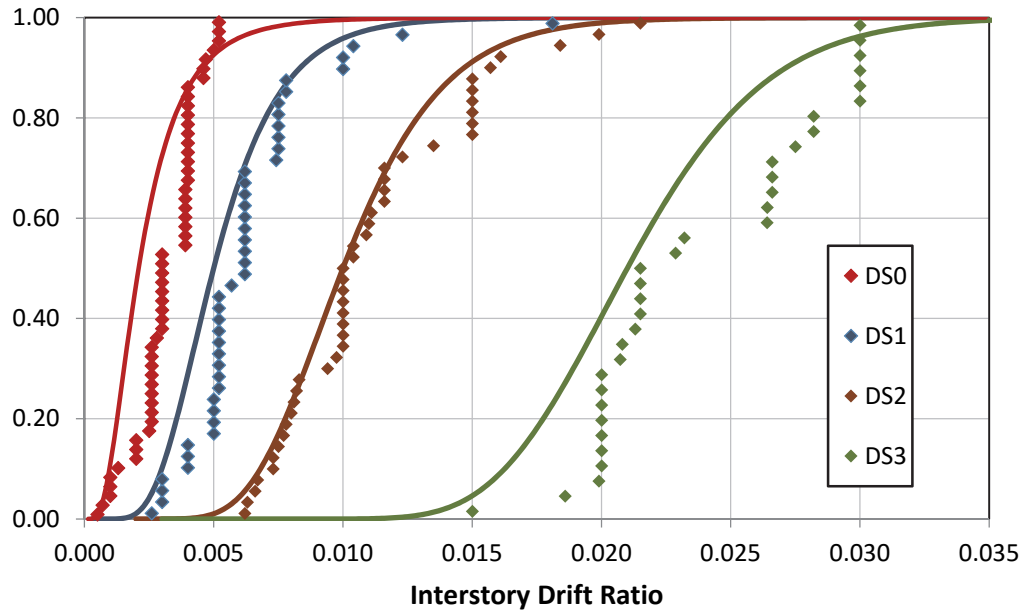
Fig. 3. Fragility functions with recommended parameters compared with experimental data for full connection partition walls

Considering the data with damage states as defined in this report, the calculated parameters for fragility functions are provided in Table 8 for Method A and Method B. Recommended values based on fit to the data are also provided in the table for each type of wall considered and each damage state. Note that the fitted lognormal distribution should ideally sit on top of the test data since the y-scale indicates the percent of specimens that achieved a damage state for a given drift. The recommended values were adjusted to improve this fit. Fragility functions using the recommended parameters are plotted in Figures 3 through 6 on top of the raw experimental data.

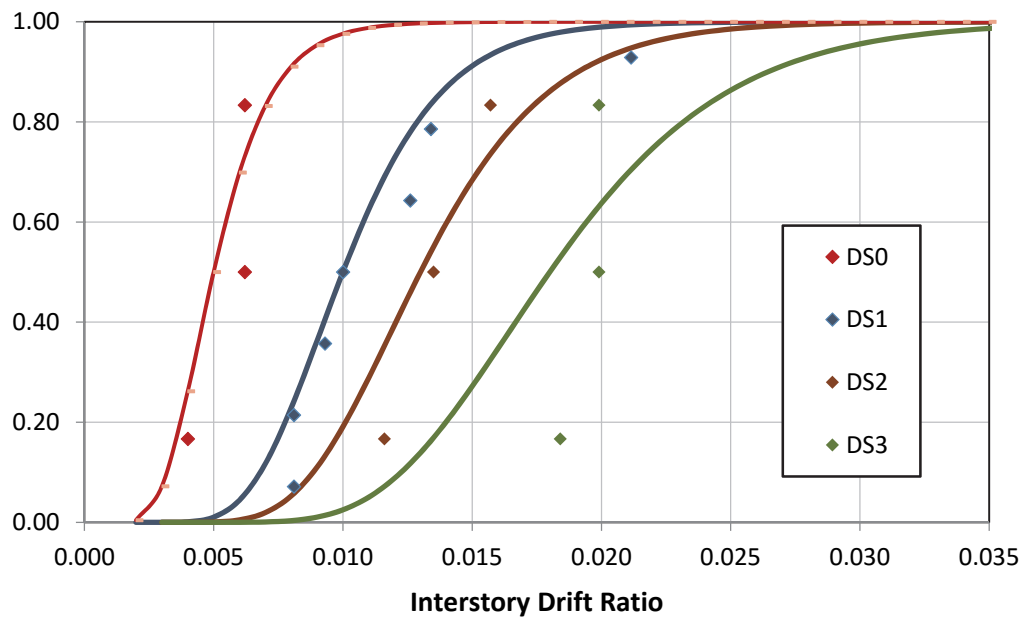
Fig. 4. Fragility functions with recommended parameters compared with experimental data for partial height partition walls

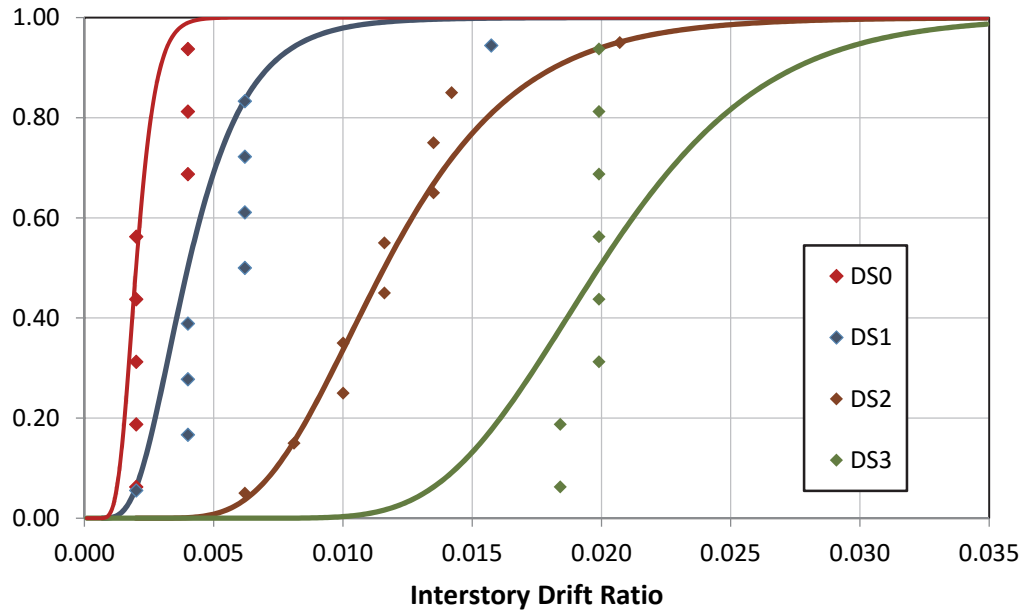
Fig. 5. Fragility functions with recommended parameters compared with experimental data for friction connection partition walls with returns

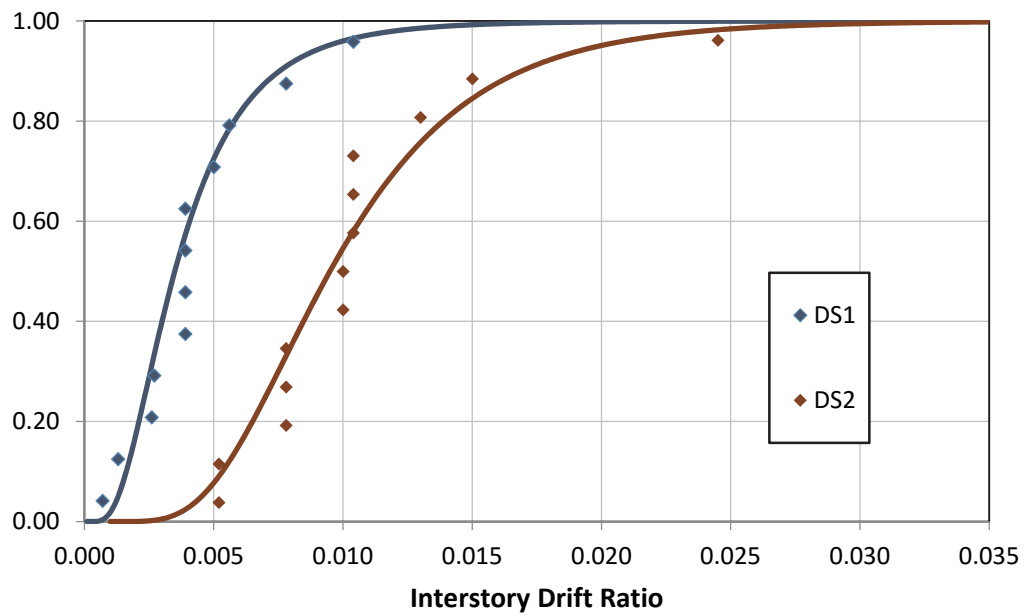
Fig. 5. Fragility functions with recommended parameters compared with experimental data for friction connection partition walls with no returns
